**WATCHTOWER**  
HOME INSPECTIONS

## RESIDENTIAL REPORT

2400 Dalhousie St  
Victoria, BC V8R 2H6

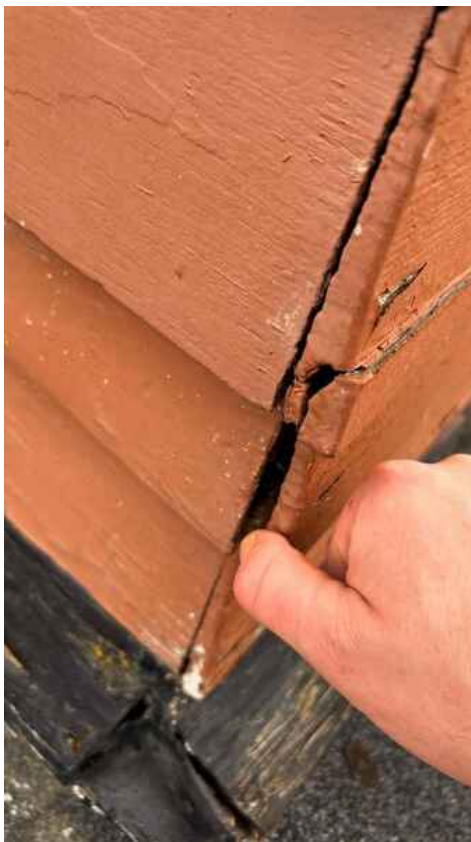
The exterior siding, fascia, and wood portions of the home generally appear to be well-maintained and looked after. However, some areas of concern were noted, including chipped paint, loose boards at the corner joints, and a few lifted siding boards. A cracked board was also observed in sections of the third level of the siding.

Loose corner joints

- **Action Required:** It is recommended to address these issues upon possession by repainting and sealing any exposed or expanded joints. This will help prevent moisture intrusion and maintain the exterior's integrity.
- **Monitoring:** Regularly inspect for gaps in paint or siding over time, as early detection and repair will protect against further deterioration.

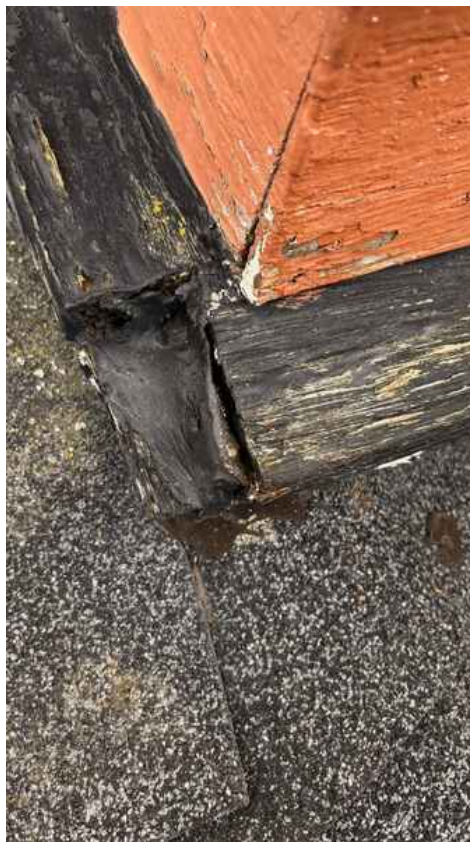
Deteriorated Trim

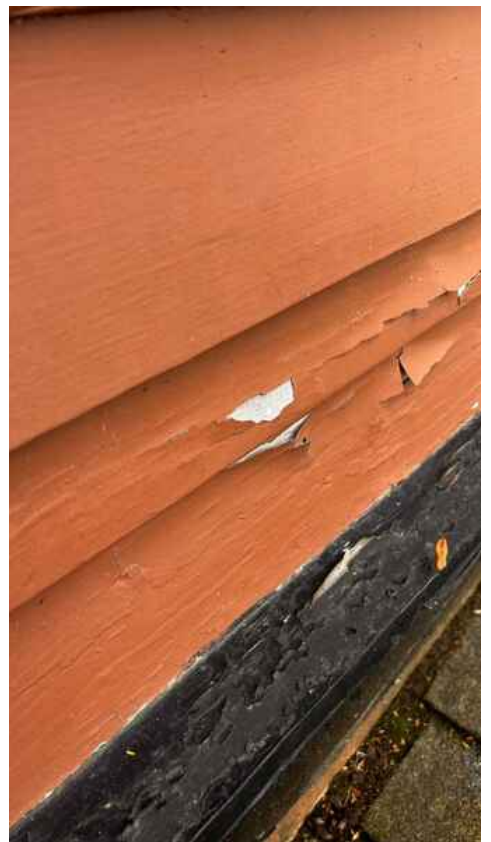
Peeling Paint

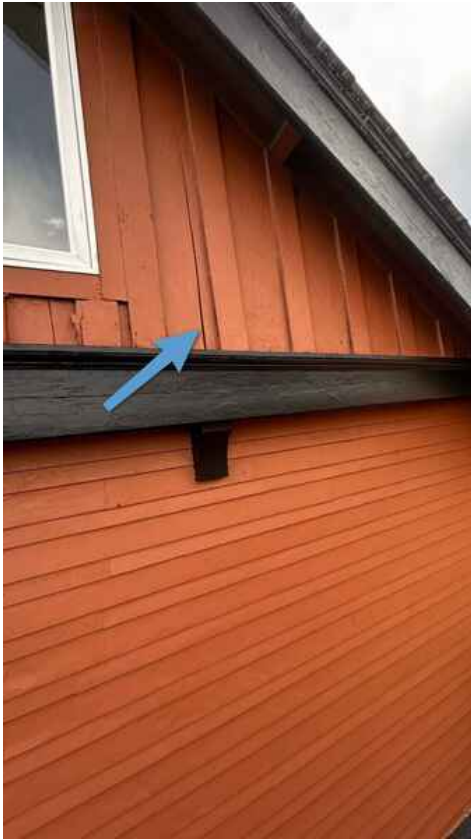
Cracked Siding board

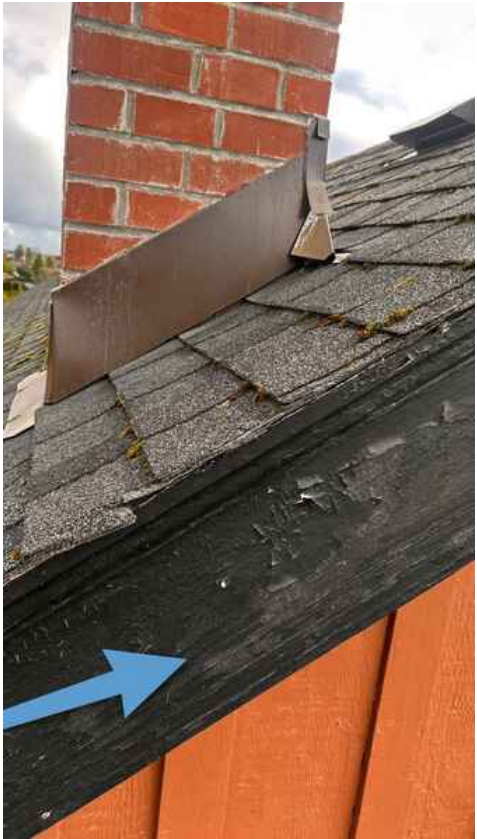
Peeling Fascia Paint

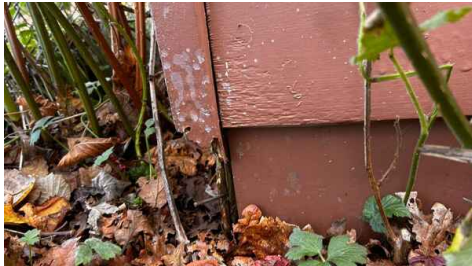
At the rear of the property, particularly around the back garage, sections of the siding were observed to be either too close to grade or completely buried in the soil. Additionally, the siding near the rear patio by the koi pond was also very close to grade. While no rot was detected on the siding of the main portion of the house during the inspection, it is important to maintain the landscaping to ensure that 6 to 8 inches of the foundation remains visible around the exterior. Proper clearance helps prevent moisture wicking, pest intrusion, and long-term deterioration of the siding. This maintenance should be performed upon possession to ensure the longevity of the home's exterior.

Grade is rotting the siding (garage)

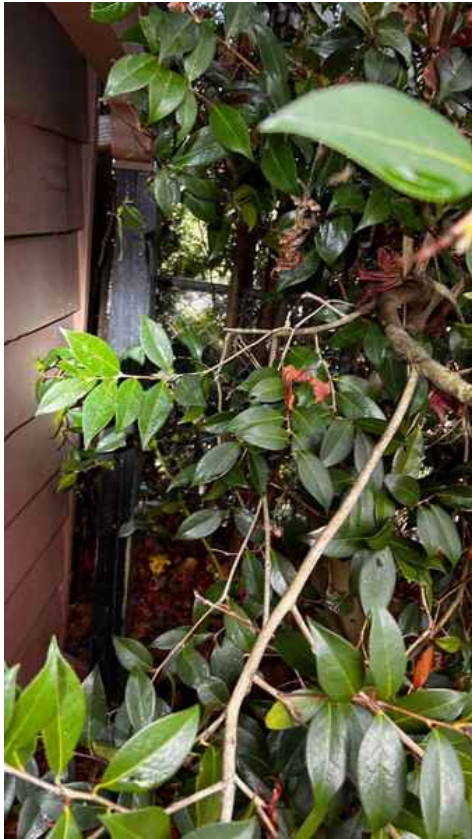
A recurring issue on this property is the presence of vegetation growing too close to the home, including trees, bushes, and blackberry bushes, particularly at the rear of the garage structure. Vegetation was observed touching the siding in multiple areas. It is recommended to trim back all vegetation to maintain proper airflow, allow the exterior to dry effectively, and reduce the risk of pest intrusion. This maintenance should be addressed upon possession and monitored regularly to prevent potential damage to the siding and other exterior components.

Trim Back Vegetation

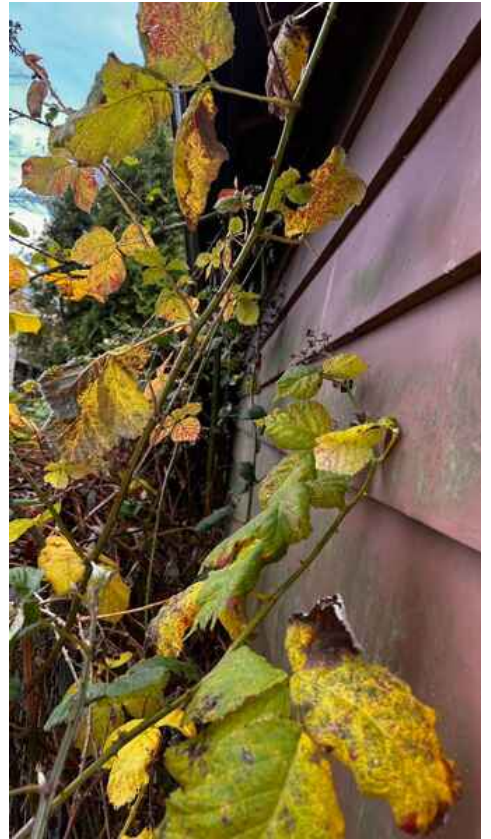
Vegetation too close to sidign

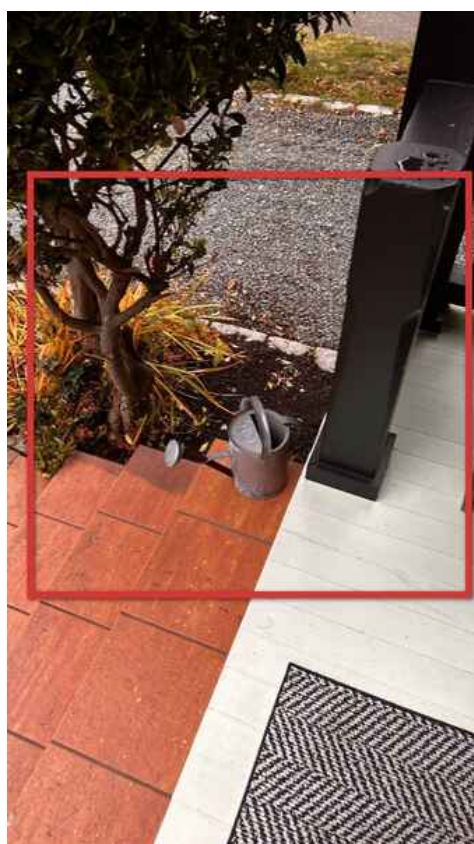
1. Koi Pond: Located in the rear backyard, the koi pond does not have a surrounding fence, which could pose a safety risk, particularly for small children. Adding a fence or barrier around the pond may enhance safety.
2. Front Entryway Steps: The steps leading to the front entryway lack a railing on the left-hand side, which could increase the risk of falls. Installing a handrail could improve safety and accessibility.
3. Utility Room/Crawlspace Entry: The entry stairway to the utility room/crawlspace is quite steep, requiring care when accessing this area. Adding handholds or improving the entryway could reduce the risk of falls.

Potential Fall Hazard

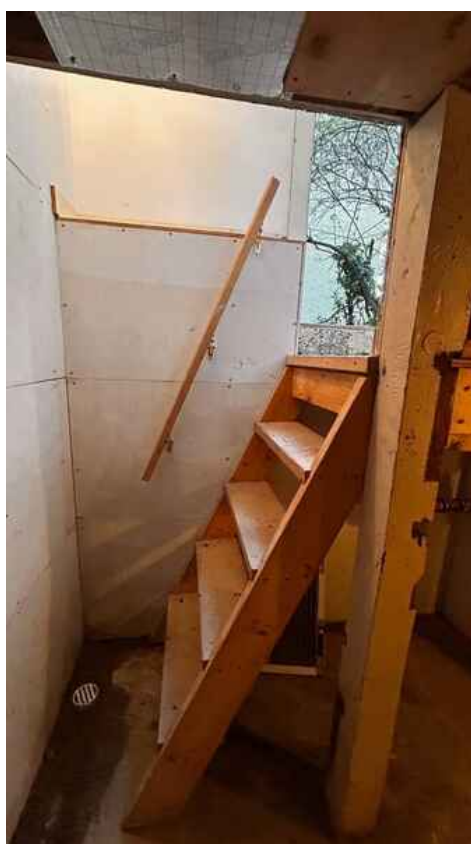
Very steep stairs

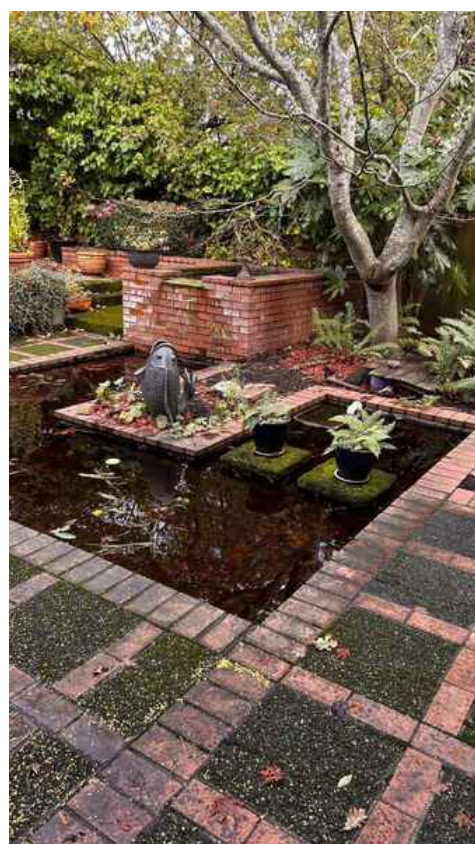
Area potentially dangerous to small children

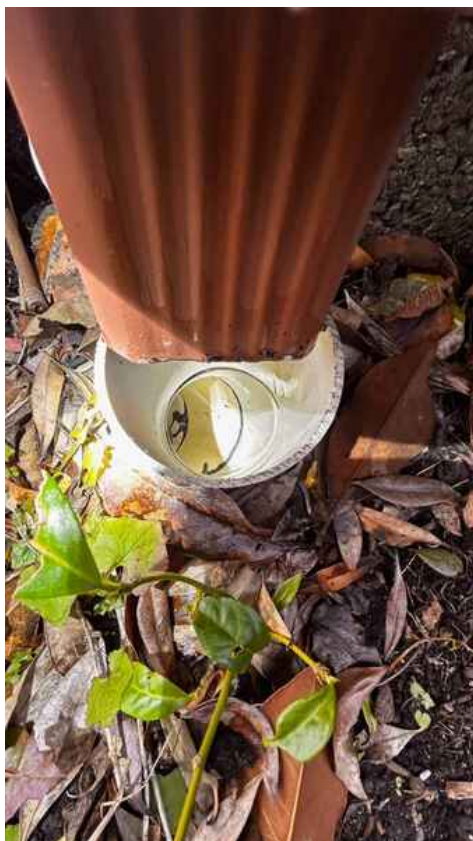
While the property's grade is generally flat, some areas of the landscaping may encourage water to pool against the siding, which could lead to potential moisture issues over time. Additionally, a portion of the landscaping is encroaching on the PVC risers, increasing the risk of debris clogging the perimeter drain system. To mitigate these concerns, it is recommended to have a landscaper assess and adjust the landscaping upon possession to ensure water is diverted away from the foundation and to clear any vegetation near the drainage system. This will help maintain proper water management and protect the property from potential drainage issues.

Grade nearly encroaching on riser

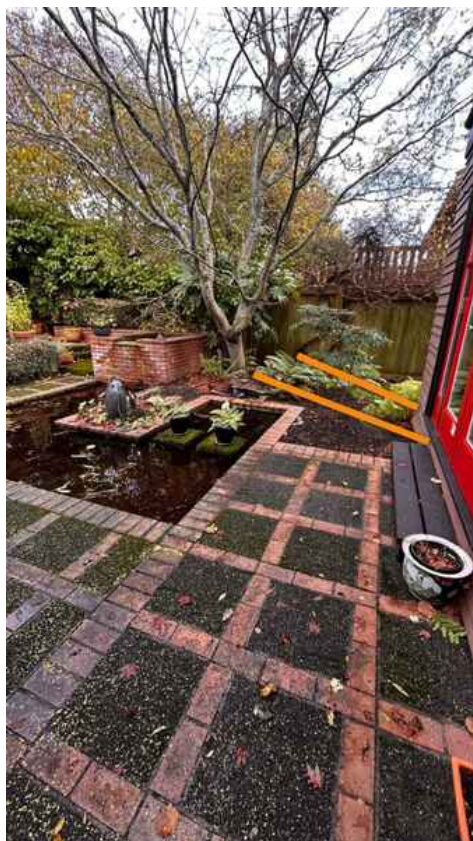
Adjust landscaping

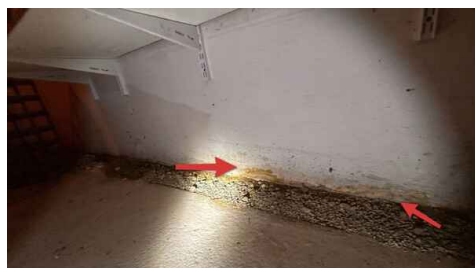
In the utility room, signs of moisture were observed along the perimeter, with some areas showing evidence of water contact on the wood interior wall material. It appears that sections of the perimeter were cut out to install perforated drain tile, and a sump pump was present but sealed, making it inaccessible for a thorough inspection. Due to the moisture observed and the unknowns regarding how effectively the system is managing water, a professional drainage scope is necessary to determine the current condition of the system, evaluate whether the moisture is being handled effectively, and identify any potential repairs or improvements needed to ensure long-term functionality.

Evidence of moisture in wall material

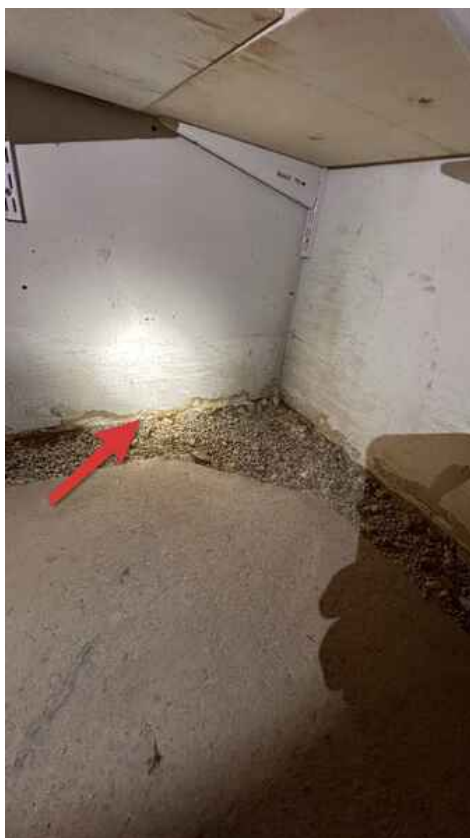
Moisture noted in wall material

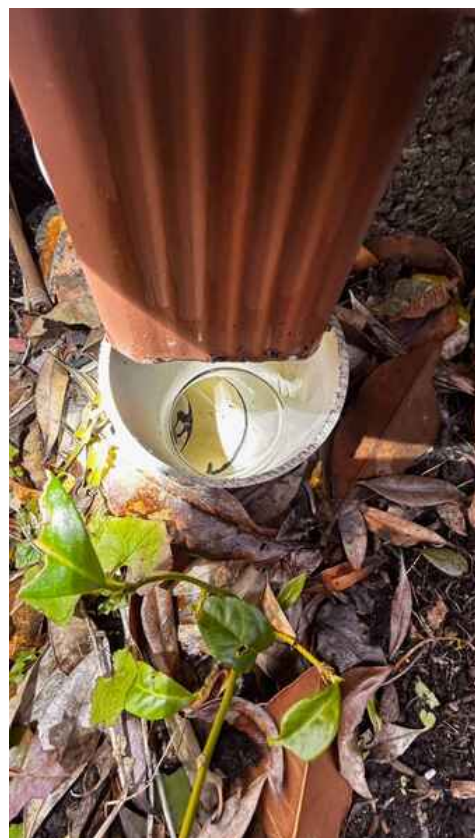
The risers for the perimeter drainage system throughout the property appear to be PVC, which is a durable and modern material. However, due to the age of the home and additional concerns noted in the utility room, a perimeter drainage scope is strongly recommended to provide further insights into the system's condition and functionality.

Scope Perimeter Drainage

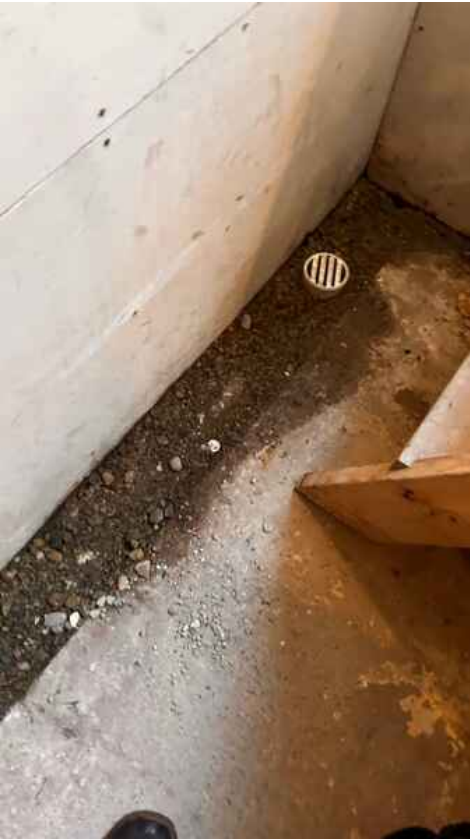
Moisture Noted in Perimeter

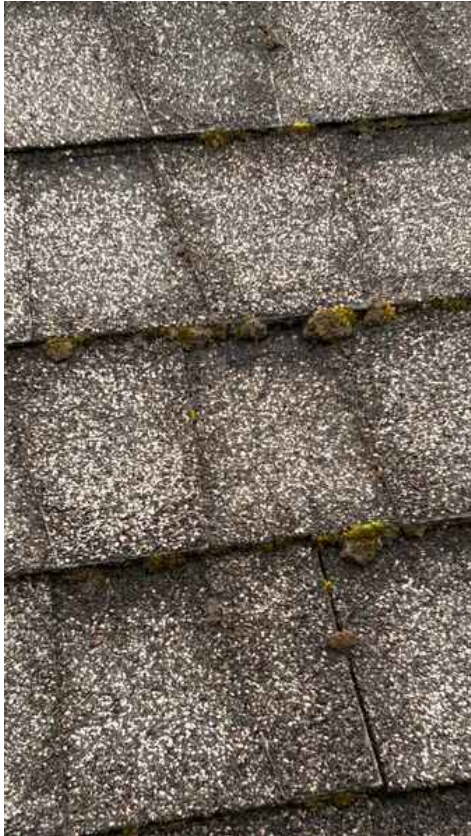
The roof surface exhibited several issues requiring attention, including exposed and proud fasteners that could lead to potential water intrusion, areas of exposed fiberglass matting indicative of wear and aging, moderate moss growth on the north side of the main roof, and a torn or shredded ridge shingle over the garage that compromises the roof's ability to shed water effectively.

Granular loss

Immediate maintenance should be performed upon possession to address these concerns and prevent further deterioration. Consulting a professional roofer is recommended to carry out these repairs and provide a more comprehensive assessment of the roof's condition, including an estimate of its remaining lifespan. This proactive approach will help maintain the roof's integrity and protect the home from potential water damage.

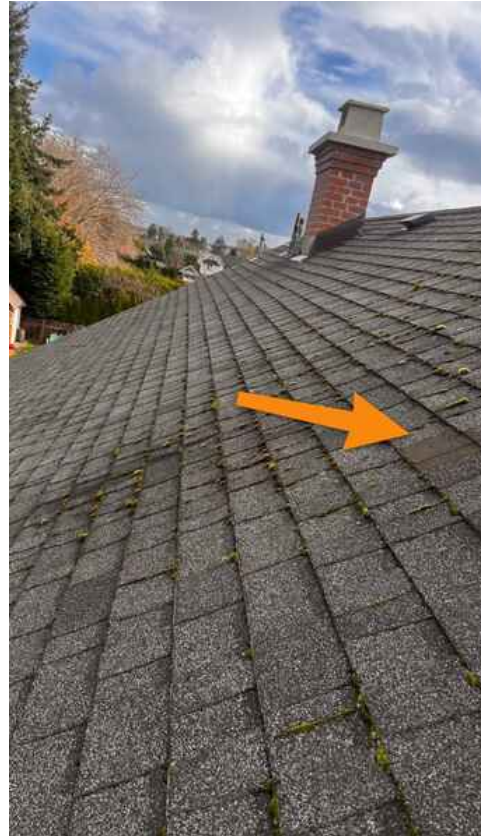
Granular loss (nearly bald shingle)

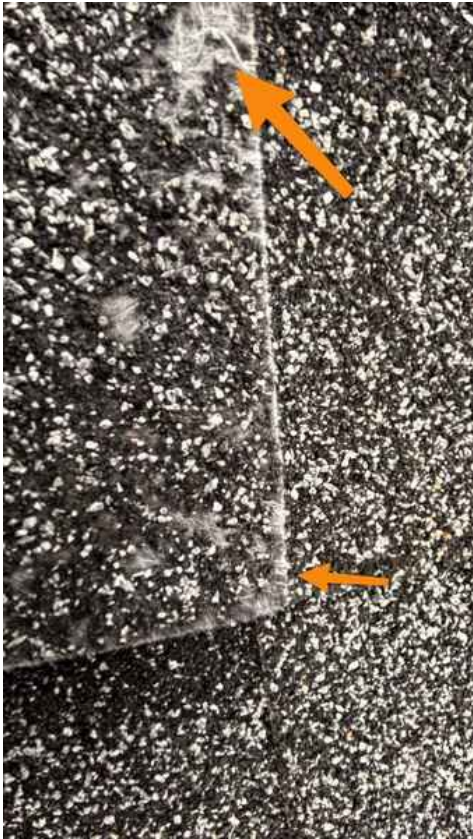
Fiberglass matting visible

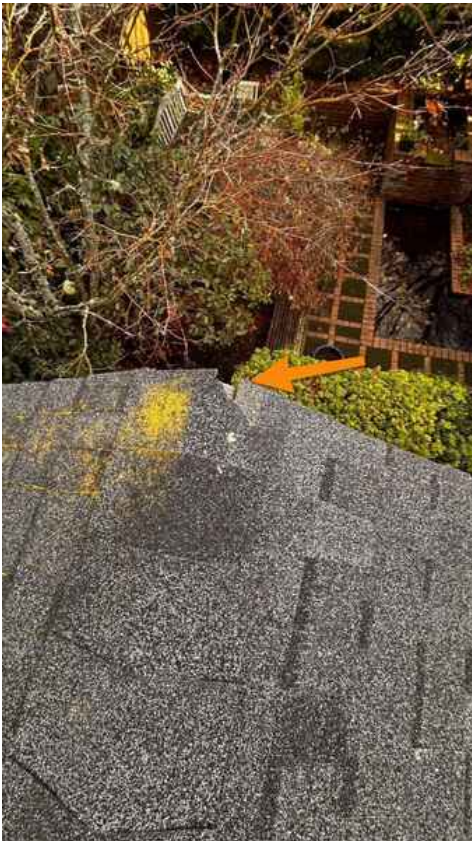
Torn Ridge shingle

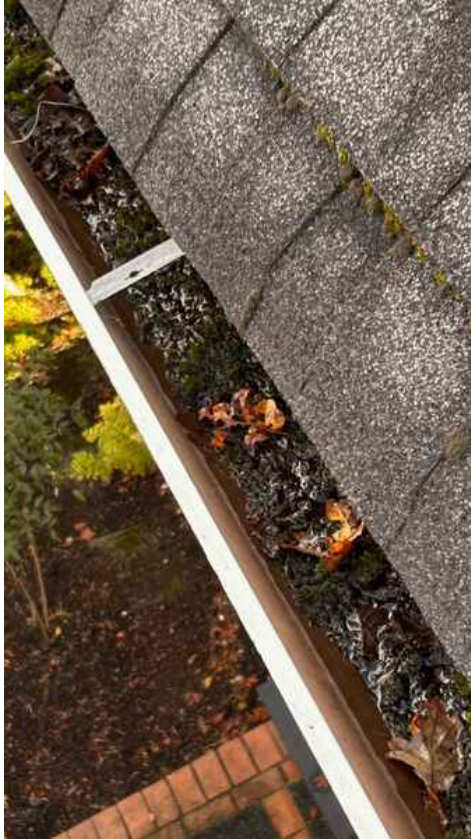
The gutters on the property were observed to be significantly clogged, likely due to the proximity of vegetation and the current season. Additionally, the gutter on the north rear side of the home appeared to be slightly loose/ drooping, which may affect its ability to drain water effectively. Regular cleaning and maintenance are essential to ensure the gutters properly direct water away from the home, preventing potential water damage to the roof, walls, and foundation. It is recommended to clean the gutters and secure the loose section upon possession, and to establish a routine cleaning schedule, particularly during heavy foliage seasons, to maintain proper drainage.

Moss and Debris in Gutter

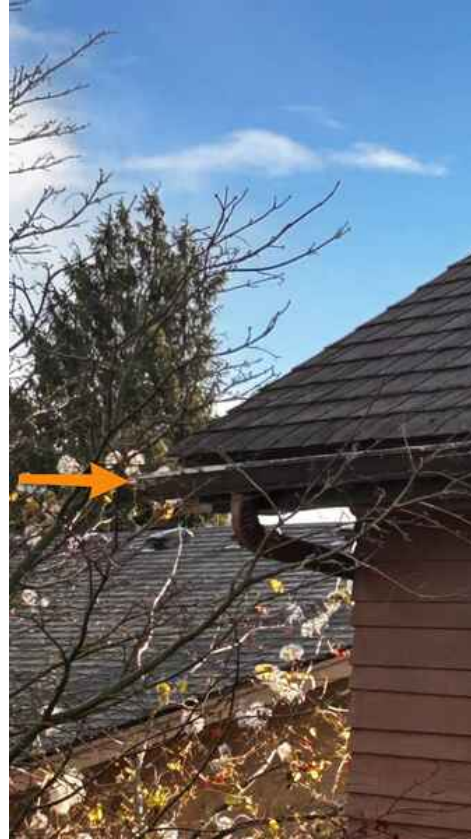
Loose/Leaning Gutter

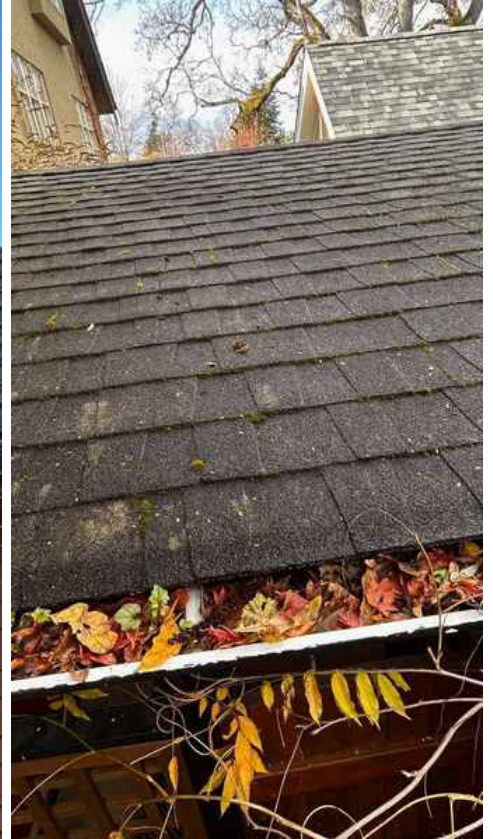
Clogged Gutter

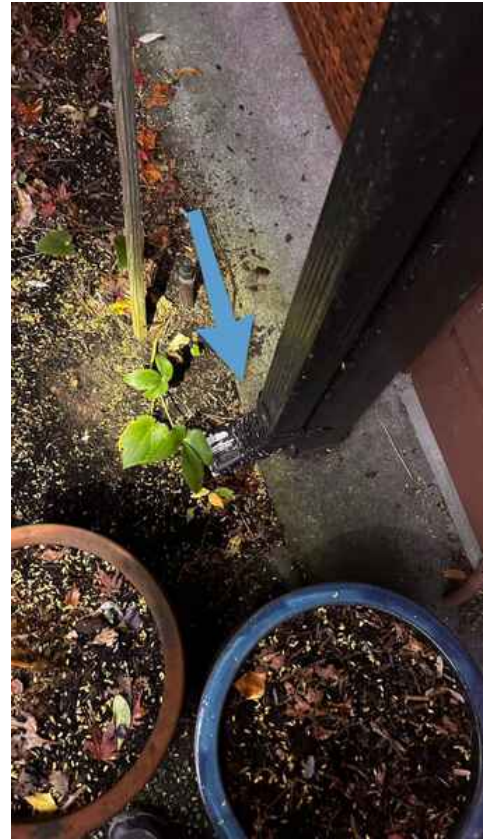
A downspout on the garage structure was observed to discharge water too close to the foundation. It is recommended to extend the downspout to direct water farther away from the structure. This will help prevent potential moisture issues and protect the foundation over time.

Extend Downspout

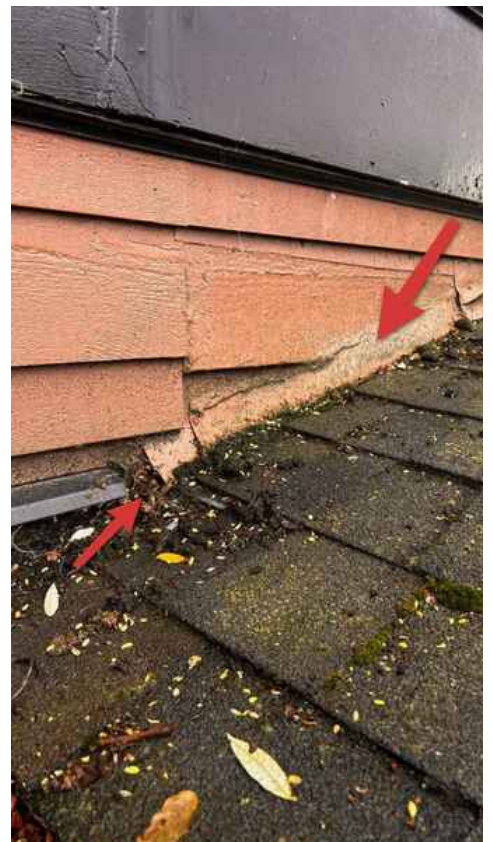
At the intersection where the roof of the garage meets the main portion of the home, the flashing was observed to be improperly installed. While no water intrusion was detected in this area at the time of inspection, the flashing should ideally be installed beneath the siding and consist of staggered step flashing to meet best practices. Proper flashing installation ensures long-term protection against water intrusion and is recommended to be addressed during any future roof or siding work to maintain the integrity of the structure.

Significant Deficiency

Flashing needs attention

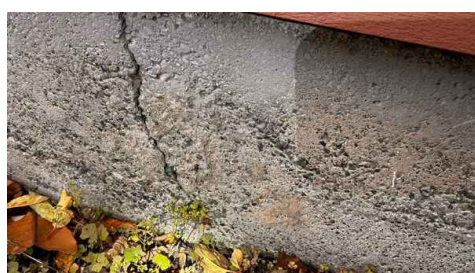
Several foundation cracks were observed, varying in size. While most are minor, one crack exceeds a quarter inch in width, which warrants further evaluation. Cracks of this size may indicate potential structural movement or stress. Additionally, evidence of honeycombing was noted throughout the visible portions of the foundation. Honeycombing refers to areas where the concrete did not consolidate properly during the original pour, leading to voids and uneven surfaces. While often a cosmetic issue, it could potentially impact the foundation's integrity over time. It is strongly recommended to consult a structural engineer to assess the condition of the foundation and determine if the home is experiencing ongoing movement. A professional evaluation will help ensure the long-term stability and safety of the structure and provide guidance on any necessary repairs or monitoring.

Front crack under porch

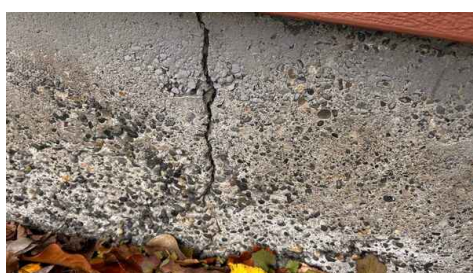
Front Crack

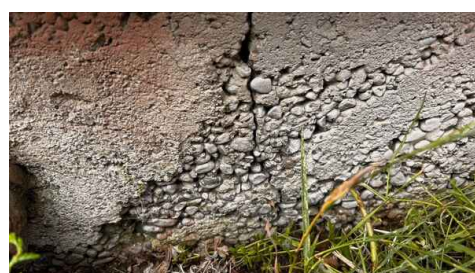
Crack + Honeycombing

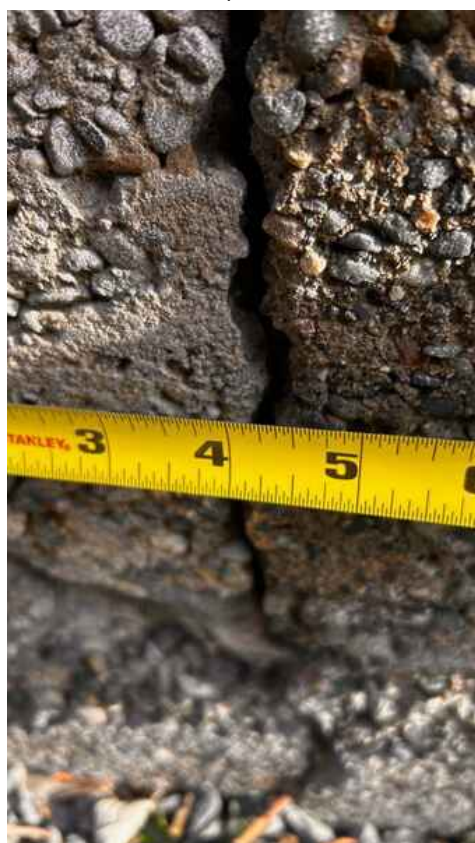
Left side of home crack

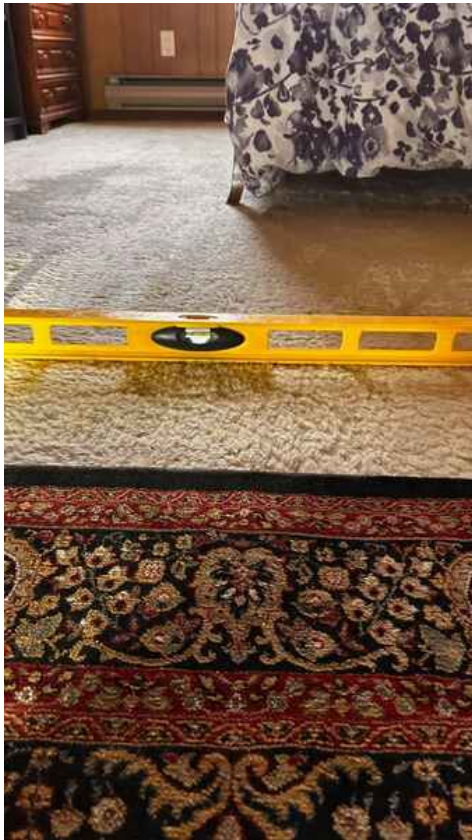
On the third level of the home, some floor displacement was observed. Additionally, a slight bow was noted on the ceiling near the rafter wall. On the second floor, the bathroom door would not shut properly, which could also indicate some structural movement or settling over time.

Floor displacement

While these conditions may be typical for a home of this age, they should be monitored for any changes. If significant movement or further displacement is observed, consulting a structural engineer is recommended to assess the underlying cause and ensure the long-term stability and safety of the home.

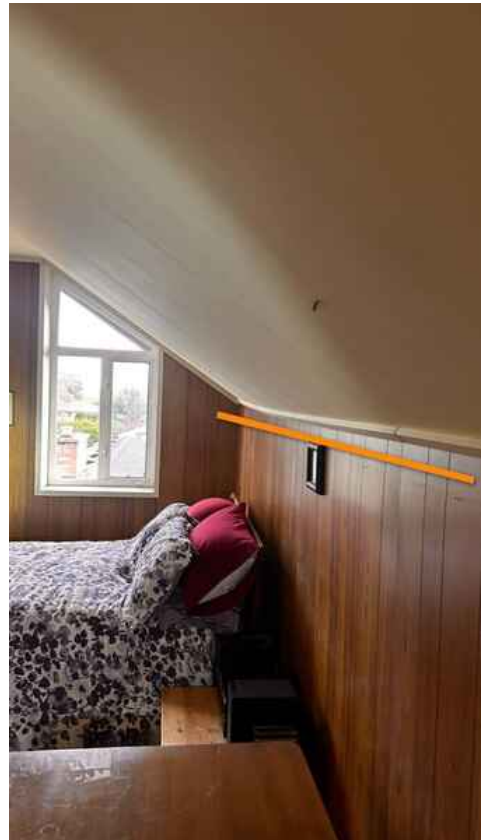
Wall bow

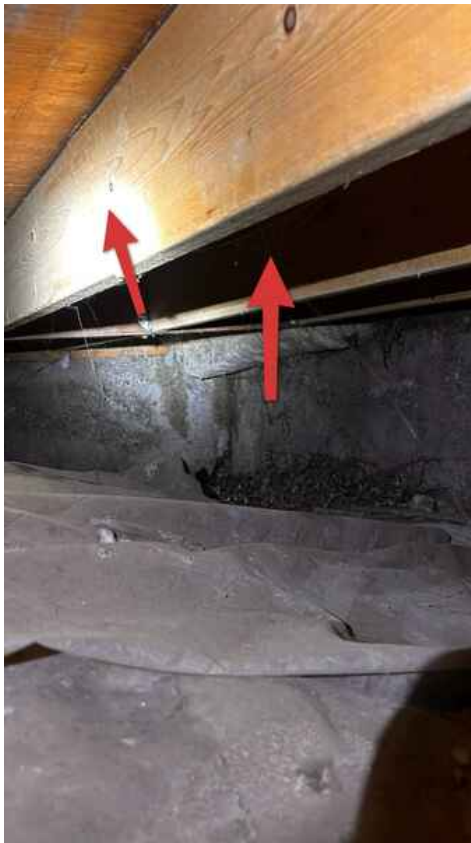
- **Insulation:** Multiple sections of insulation were missing or not properly secured to the underside of the crawlspace ceiling. Properly reinstalling and strapping the insulation is recommended to ensure consistent thermal performance.
- **Efflorescence and Moisture Intrusion:** Minor efflorescence was observed, indicating moisture movement through the foundation. In the southeast (front right) corner of the crawlspace, evidence of water intrusion was noted, likely originating from above grade. However, due to the confined nature of the crawlspace, the exact source could not be determined.
- **Foundation Crack:** A significant crack in the foundation was observed on the interior of the crawlspace. This is consistent with other foundation concerns noted in this report and is documented in the accompanying photos for reference.

Insulation Voids

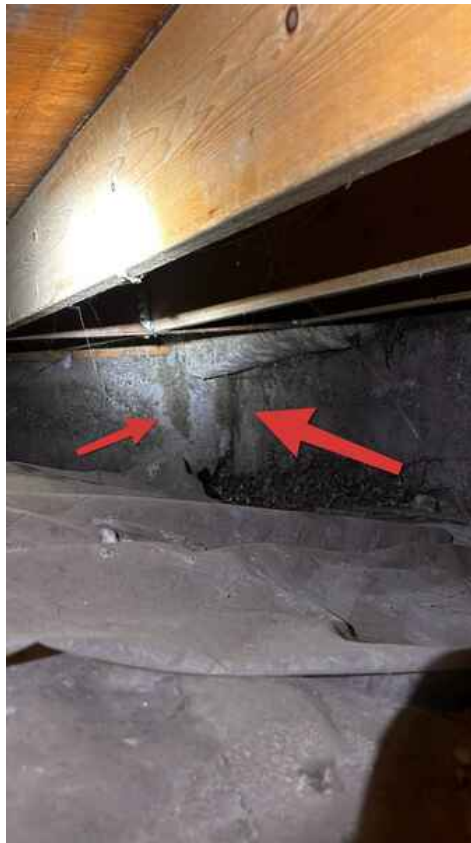
Moisture from corner

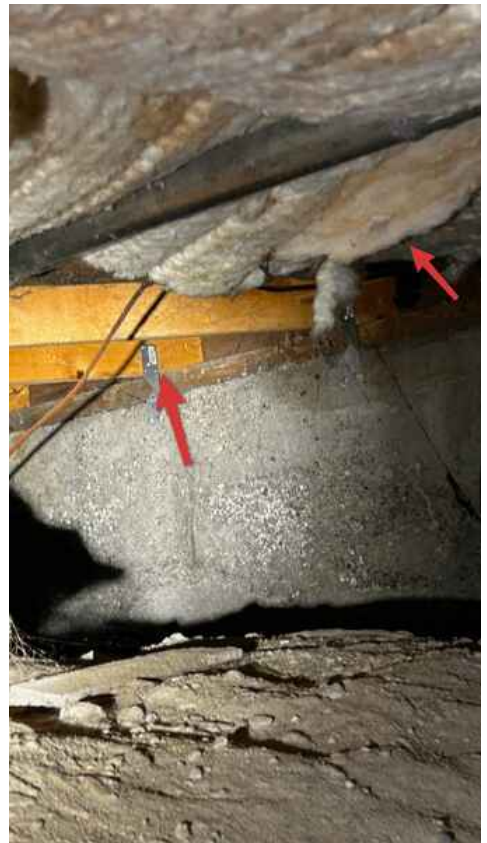
Newly installed joists and clips were also observed in the crawlspace, suggesting recent structural work. It is recommended to obtain documentation from the sellers regarding these modifications, including any reports or evaluations from a structural engineer and records of completed work.

Drooping insulation + evidence of modern joists & clips

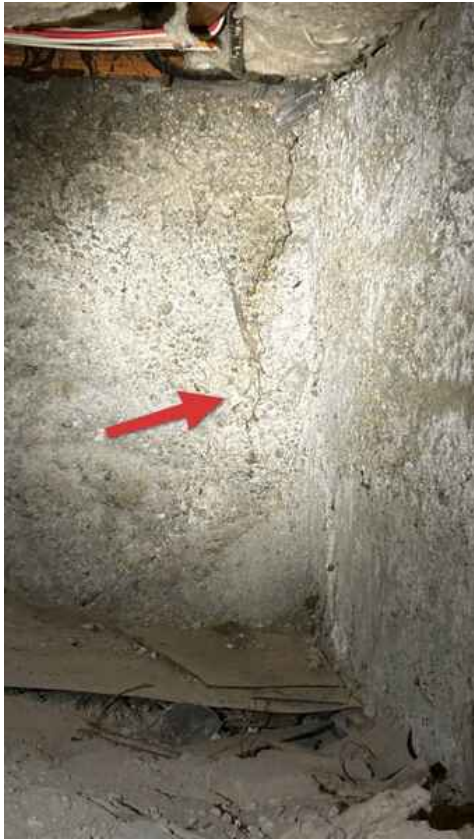
Foundation crack

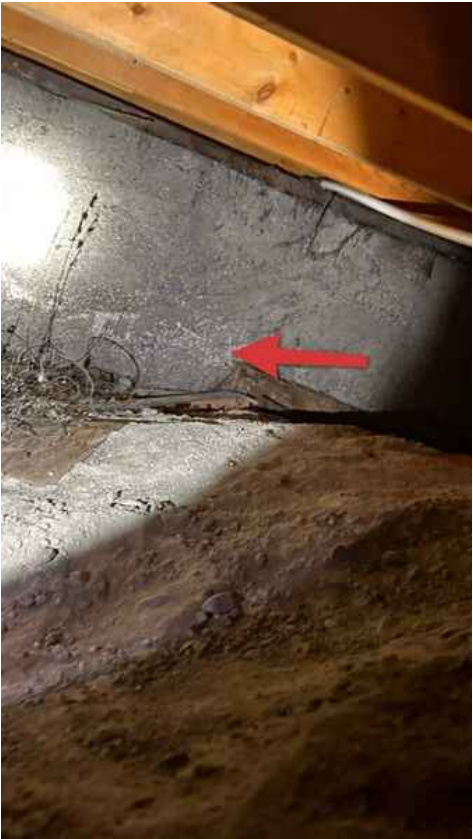
Minor efflorescence

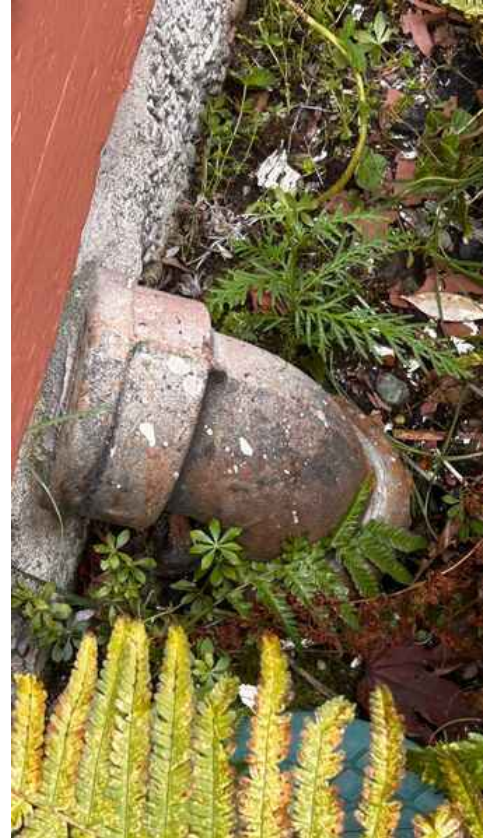
Significant Deficiency

The home features a cast iron drain waste pipe on the right side of the home that appears to be intended for sewer/ waste drainage. Due to its age, the pipe is past its expected service life, which could potentially raise concerns with insurance providers. It is recommended to consult a licensed plumber to determine whether this pipe is still in active use. If it is, replacing it may represent a considerable expense.

Cast Iron Drain Waste pipe

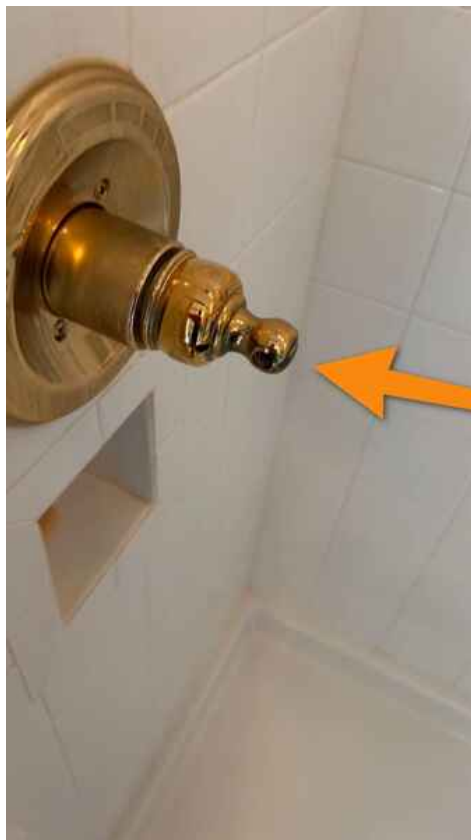
Missing hardware

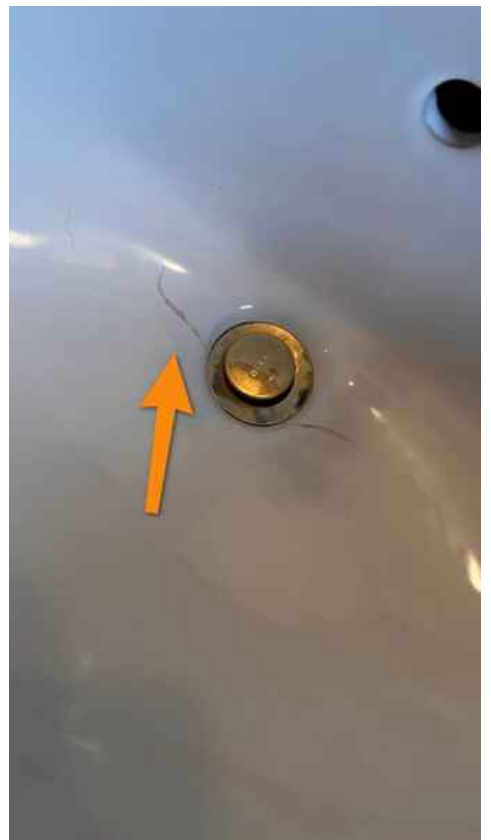
Basin scuffs

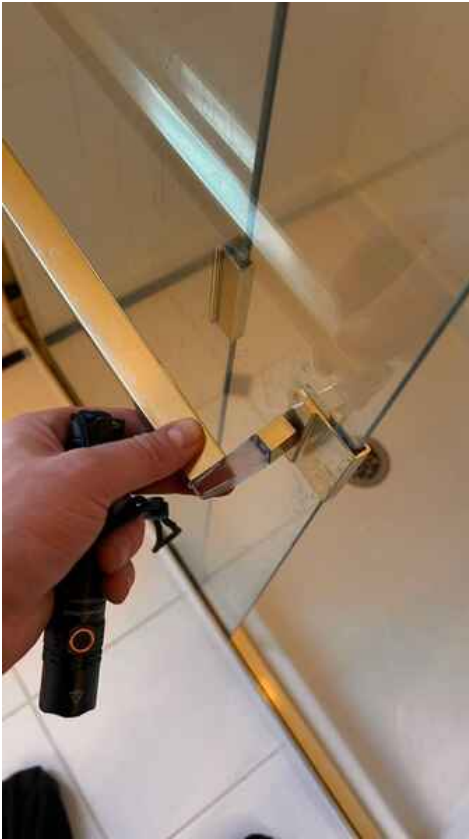
Loose handle

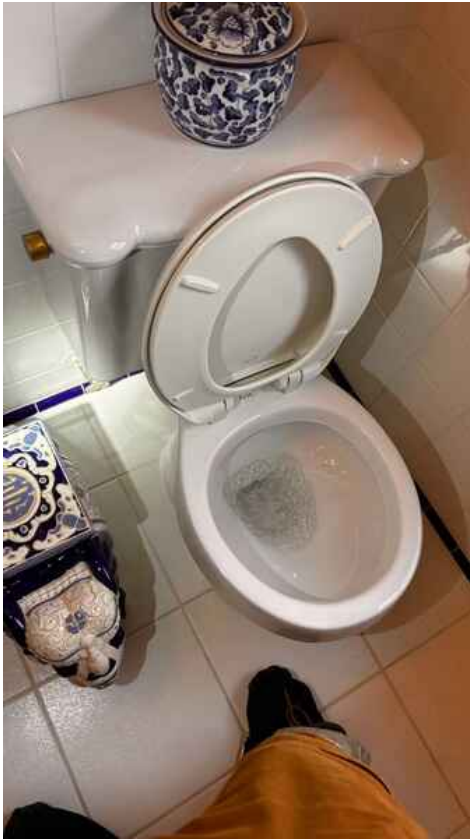
agressive flush

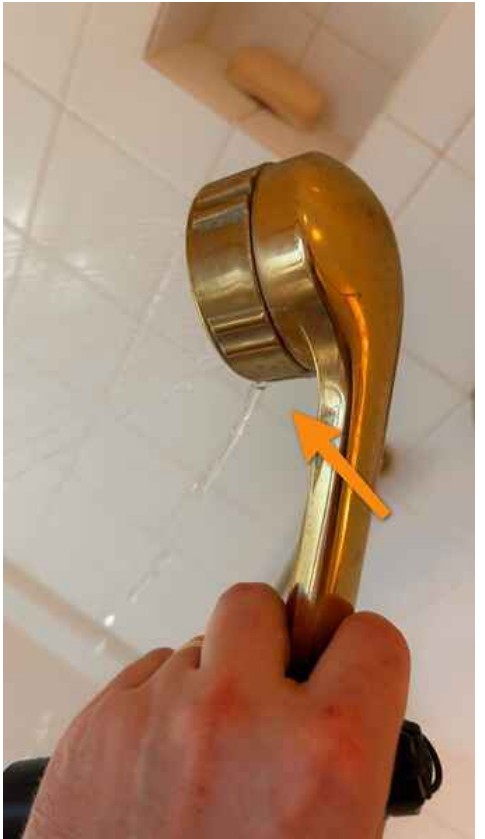
Sporadic Showerhead

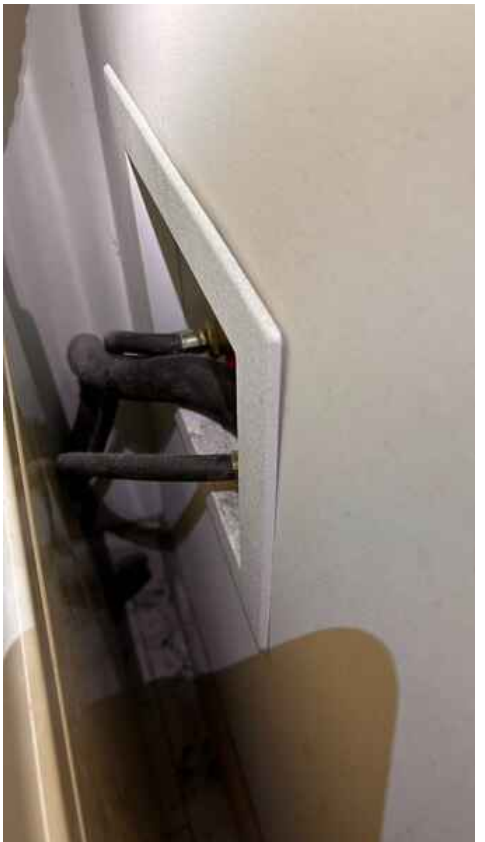
It is recommended to upgrade the washer hoses to steel-braided hoses. Plastic hoses are more prone to leaks and ruptures, which can lead to significant water damage. Steel-braided hoses provide greater durability and reliability, reducing the risk of failure.

Marginal Defect

Upgrade to steel braided hoses

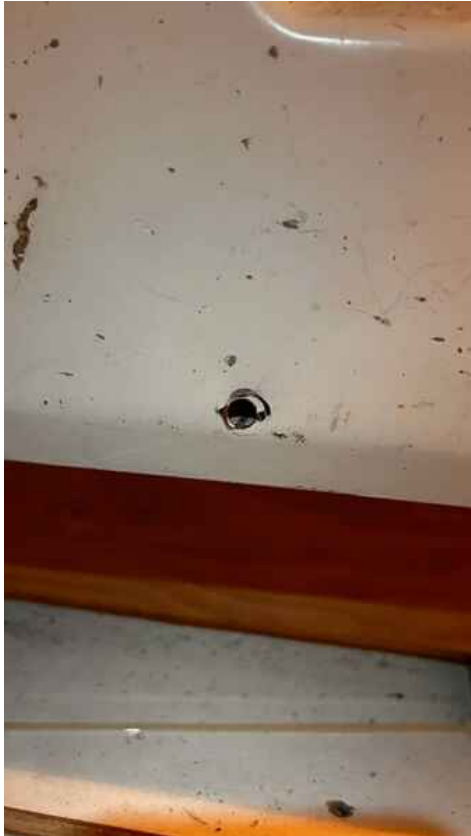
Panel screw wont latch

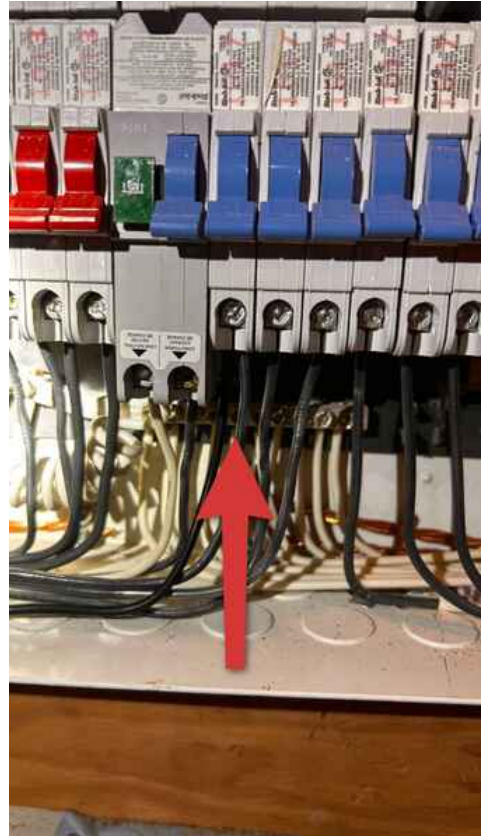
The sub-panel next to the main panel exhibited a double-tap connection, a condition where two wires are connected to a single breaker terminal that is not designed for it. This should be corrected to ensure safe operation. Furthermore, one of the sub-panel cover screws was unable to latch securely into its screw hole, leaving the cover incompletely fastened. It is recommended to have these issues addressed by a licensed electrician to ensure the safety and functionality of the electrical system.

Double tapped breaker

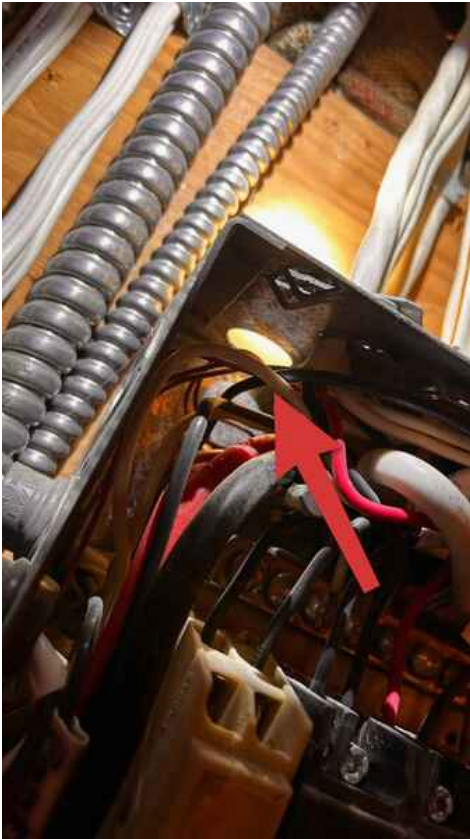
The main electrical panel was observed to have an unprotected opening, which compromises its ability to contain a fire in the event of an electrical issue. It is recommended to have this opening properly sealed. Additionally, the panel appeared quite crowded, which may limit space for future circuit additions and warrants attention during any electrical updates.

Unprotected opening/ missing knockout

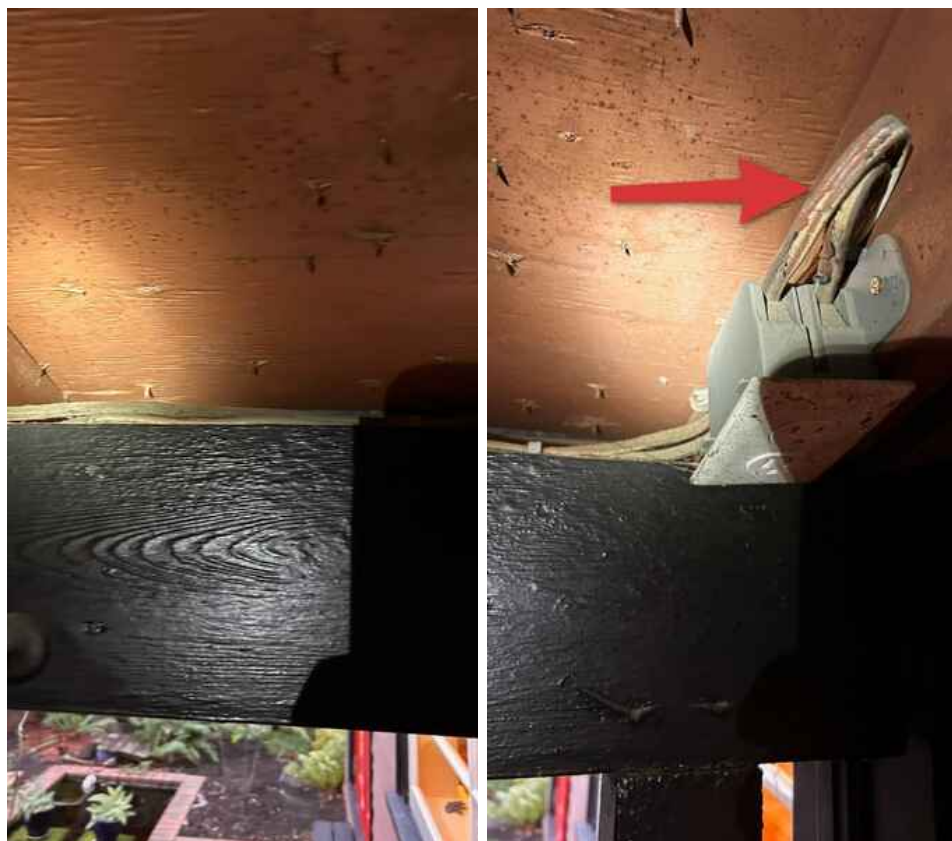
The garage appears to be powered by an unarmoured electrical conductor running outside, which does not meet current safety standards. It is recommended to replace this with either a conduit or BX cable to provide proper protection and compliance. Additionally, the size of the conductor suggests that the garage may have a limited power supply, which could restrict the use of certain electrical equipment or appliances. Consulting a licensed electrician is advised to address these issues and ensure the electrical system in the garage is safe and adequate for its intended use.

Conductor needs to be BX (protected)  
or in conduit

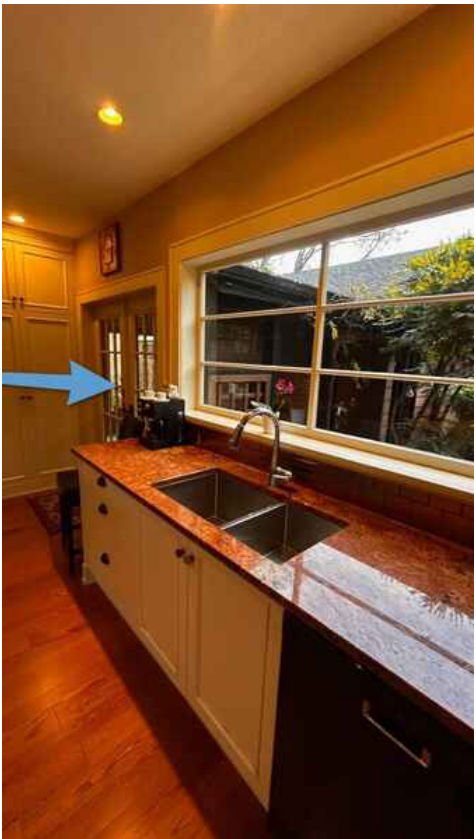
The French door leading to the kitchen area was observed to have one fully functional door, while the second door was somewhat difficult to latch securely. Although it did eventually close, it may require minor adjustment for smoother operation. This is noted for awareness and does not pose an immediate concern.

French Door may need adjusting

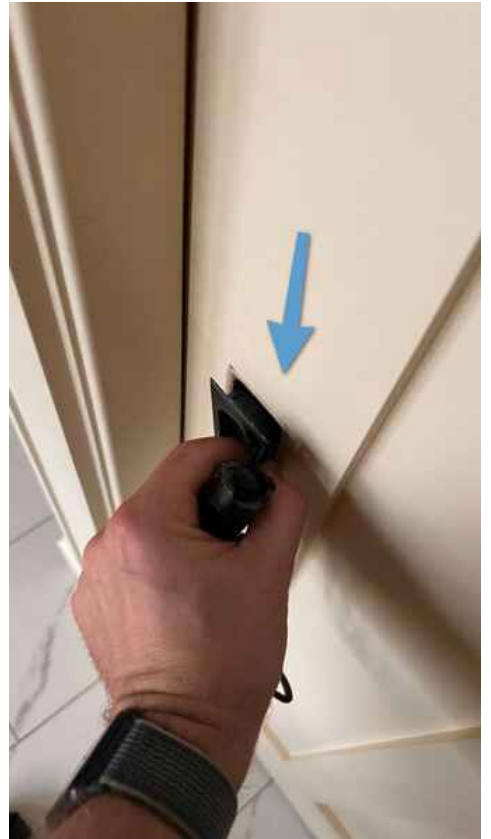
The pocket door in the master bathroom has a loose piece of hardware. It is recommended to secure the hardware to ensure smooth operation and prevent further wear or damage.

Loose hardware
