**WATCHTOWER**  
HOME INSPECTIONS

## RESIDENTIAL REPORT

2400 Dalhousie St  
Victoria, BC V8R 2H6

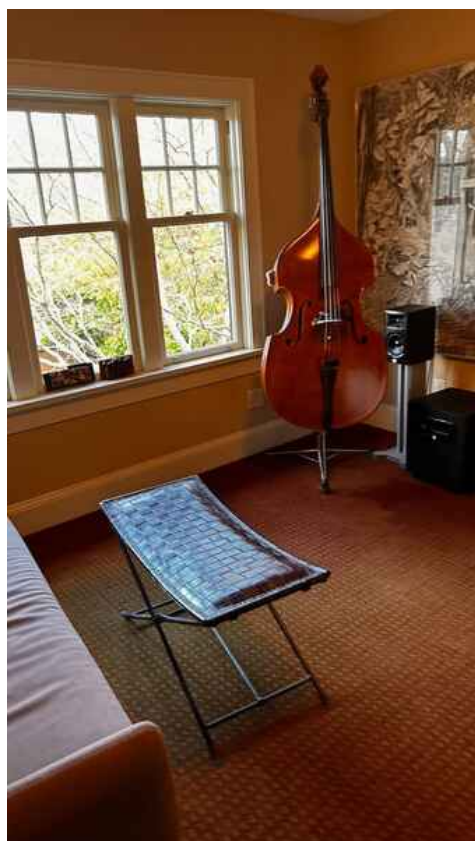
The majority of the windows on the property appear to be original single-pane wood sash and frame windows, which, while characteristic of the home's age, are less energy-efficient compared to modern windows. Some windows function well, with updated hardware, but others were noted to be sticky, which could raise concerns about egress, particularly if the rooms are intended to be used as bedrooms.

Original Windows (single pane)

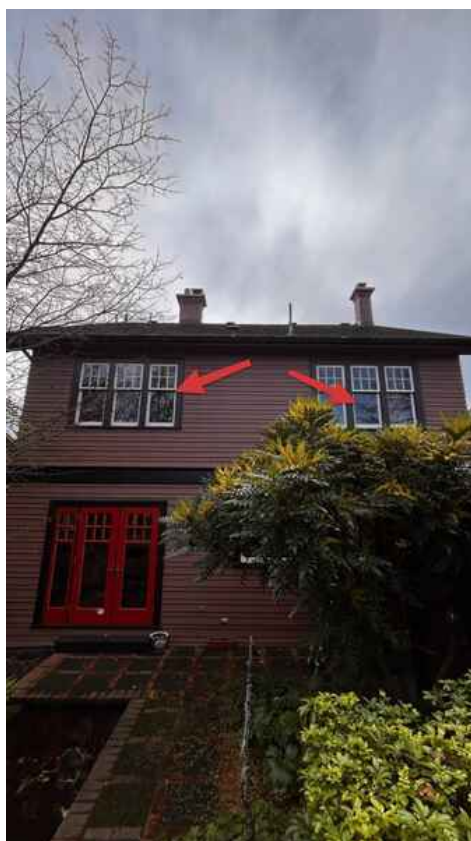
Some windows difficult to operate

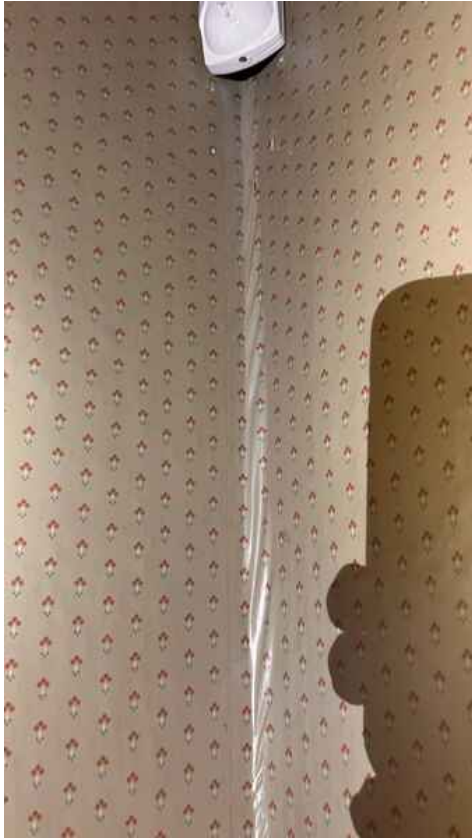
Various cosmetic issues were noted throughout the home, which are beyond the typical scope of a home inspection. These include several bulges in the wallpaper, cracks in some of the paneling in the dining room, and other minor imperfections. While not all cosmetic deficiencies were documented, these observations are provided to give a general sense of the home's condition. Addressing these issues is optional and primarily a matter of personal preference and aesthetics.

Wallpaper bubbling

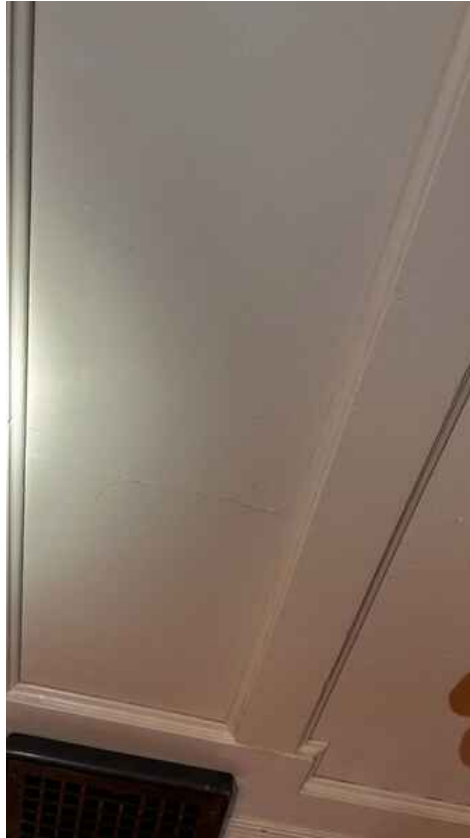
Cracked paneling

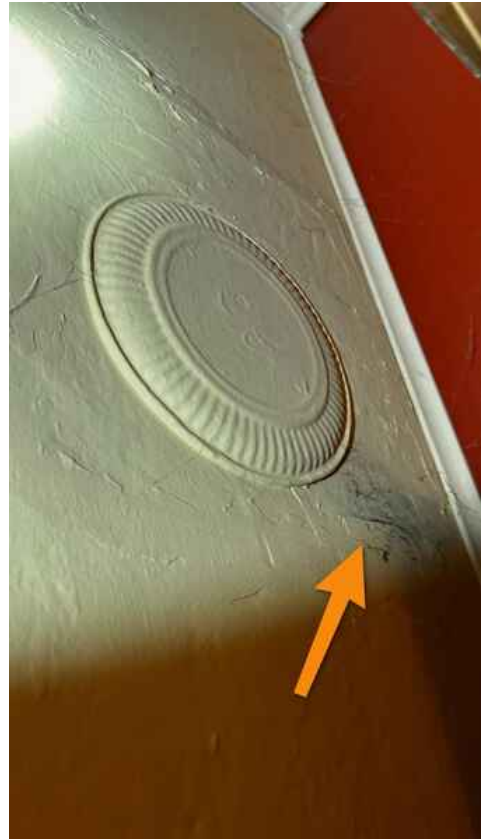
In the second-level bedroom/study, a pie tin was observed along one of the walls, which is typically indicative of a capped-off old chimney. The pie tin was not properly sealed, allowing soot and remnants of previous chimney material to escape. It is recommended to properly seal this area to prevent further debris from coming through and to maintain a clean and safe environment in the room.

Seal chimney properly

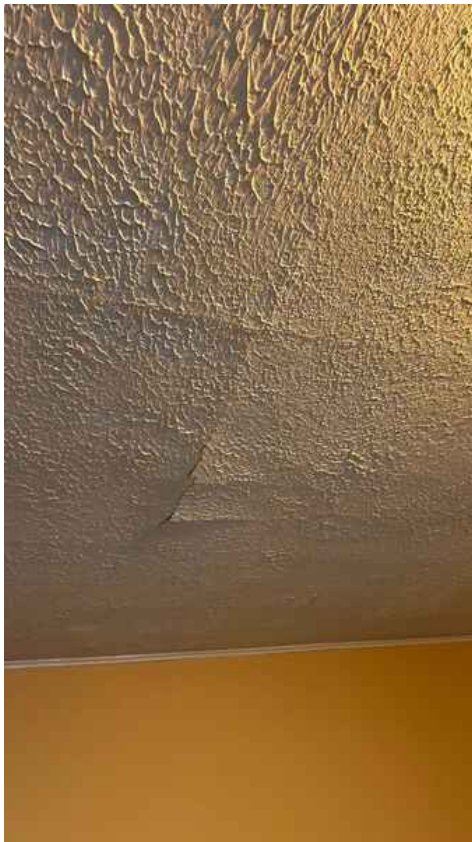
The ceiling in one of the bedrooms or the study displayed areas of peeling and cracked plaster. This appears to be a cosmetic issue typical of older homes. Repairing the affected areas is recommended to restore the room's appearance and prevent further deterioration.

Cracked plaster

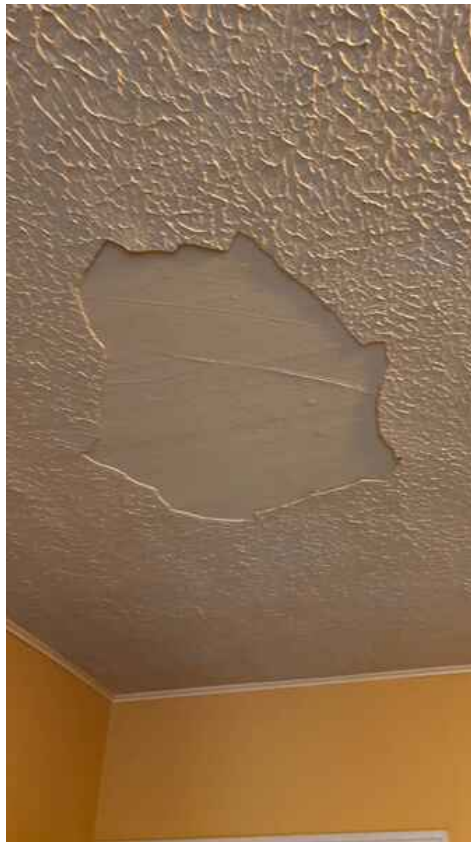
Plaster Falling

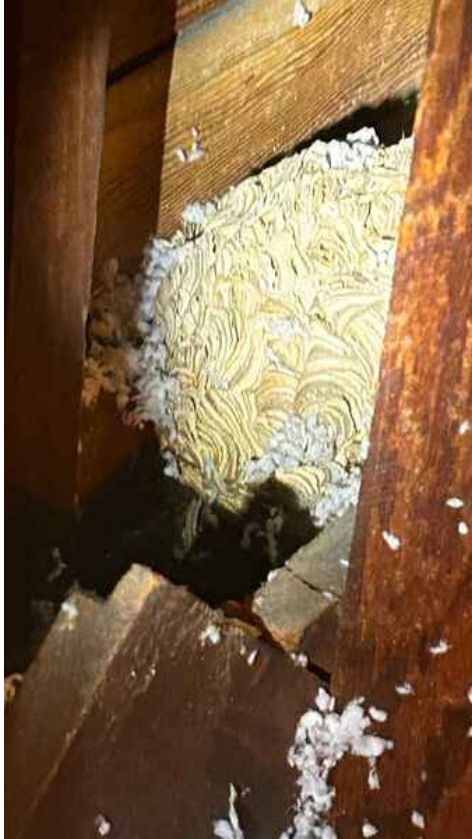
During the inspection, several wasp or insect nests were discovered, including a large nest on the rear portion of the side entry to the attic and another sizable nest in the crawlspace. Additionally, what appeared to be raccoon droppings were observed on the roof connecting the garage and the main portion of the home, and rat droppings were found inside the garage.

Wasp nest in attic

These findings indicate potential pest activity in and around the property. It is recommended to engage a professional pest control service to address the insect nests, assess the extent of rodent and raccoon activity, and remove any droppings safely. Further, sealing any potential entry points and maintaining a clean exterior environment will help deter future infestations.

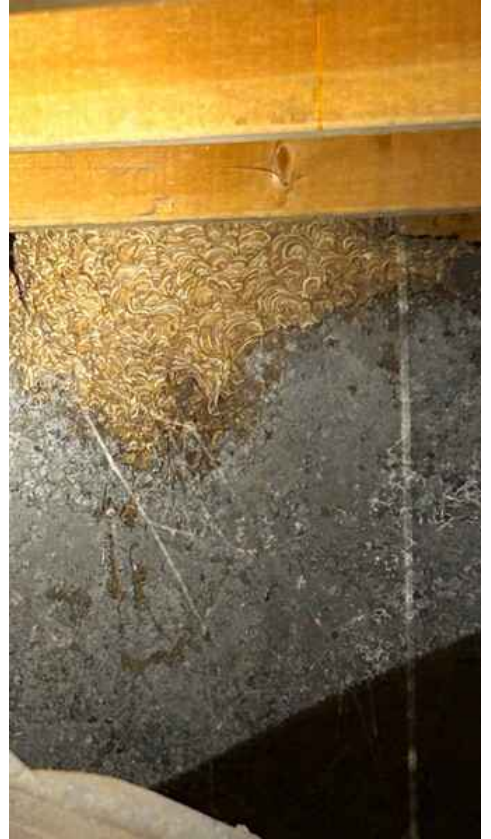
Wasp nest in crawlspace

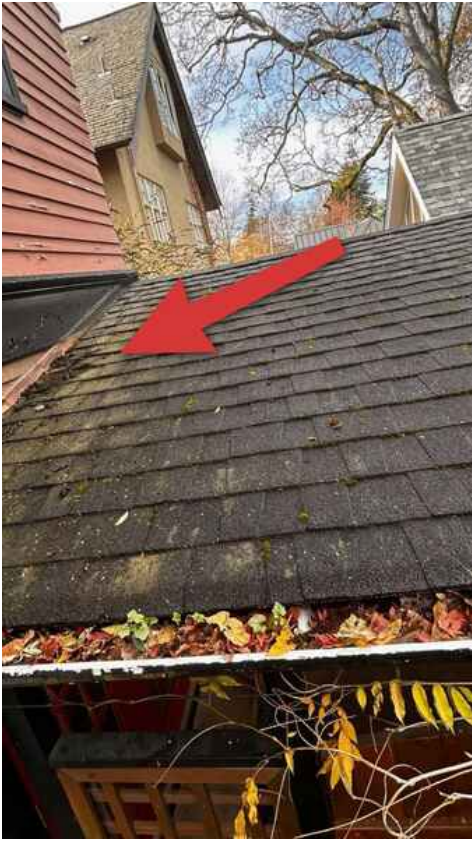
Possible racoon droppings on roof

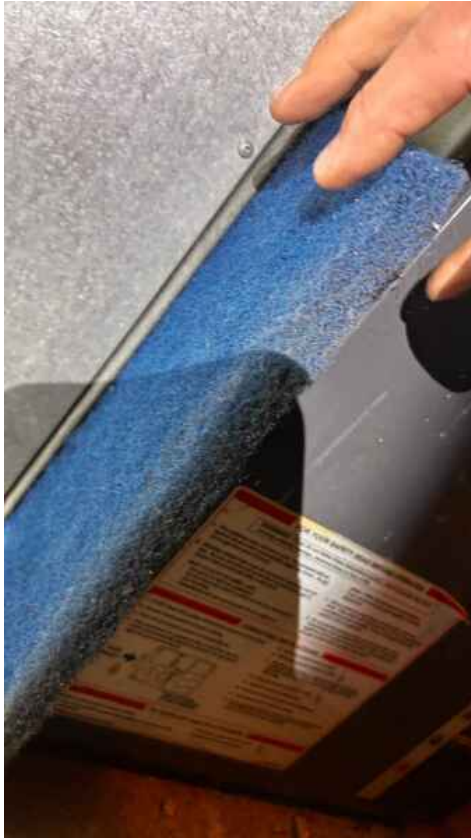
The furnace was equipped with an improper filter that appeared to be curling into the blower compartment. This may interfere with the blower's operation and reduce the system's efficiency. It is recommended to replace the filter with a properly fitted 3M or equivalent high-quality filter. Regular replacement as needed will ensure optimal performance and prevent potential damage to the blower.

Upgrade filter and change regularly

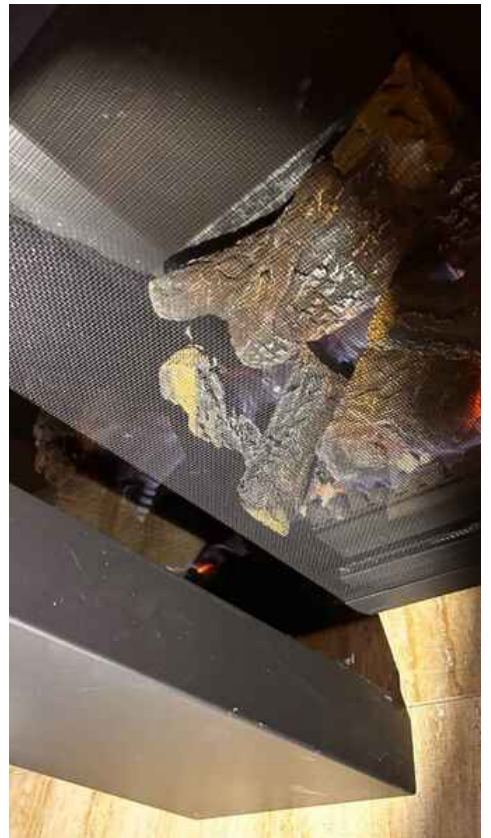
Gas fireplace was operational at the time of inspection. However, it is recommended to have it professionally serviced upon possession to ensure optimal performance and safety.

Service Fireplace

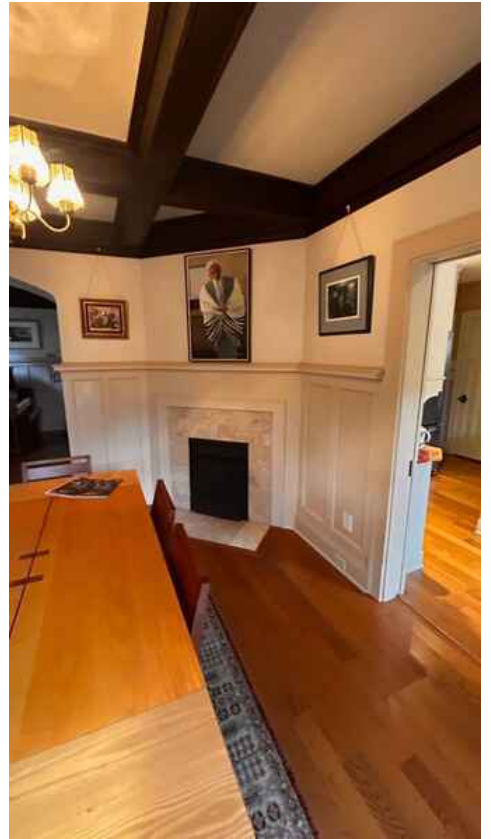
Significant Deficiency

WETT inspection required before use

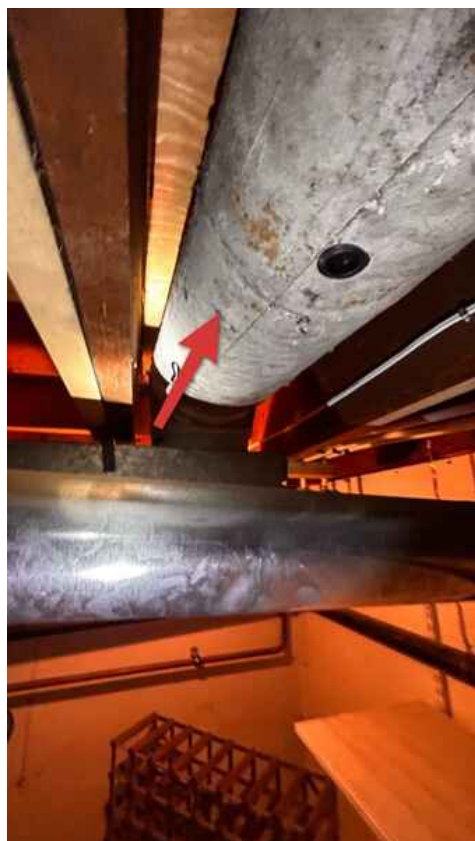
While asbestos is a product associated with health risks when disturbed, it poses no immediate danger if left intact and undisturbed. It is important to be aware of its presence, particularly if major renovations are planned in these areas. In such cases, proper precautions, including professional removal or containment, should be undertaken to ensure safety. Otherwise, the asbestos-containing materials can remain as they are without issue.

Ducting has asbestos tape

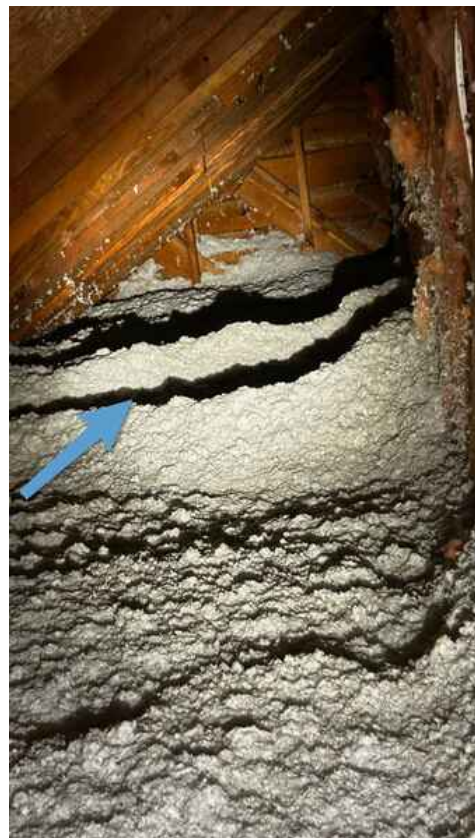
In the rear portion of the attic, particularly on the side of the home, a low spot or valley in the insulation was observed. This may be due to wind washing or previous work done in the area where the insulation was not replaced evenly. This is not a significant concern, but it is recommended to redistribute or "fluff" the insulation to restore consistent coverage, ensuring optimal thermal performance.

Displaced Insulation

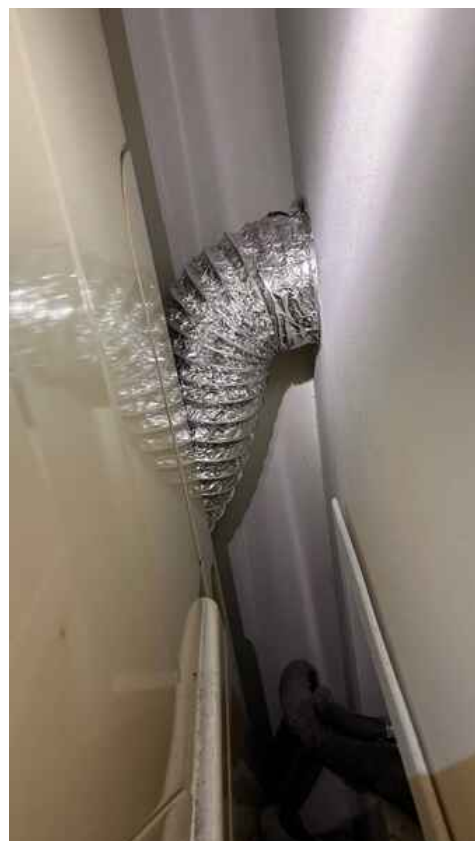
The material connecting the dryer to the vent is corrugated non-metallic, which can encourage lint buildup and clogging. Upgrading this connection to a smooth, metallic material is recommended to reduce the risk of blockages, improve airflow, and enhance safety by minimizing the risk of fire. Additionally, it is advised to clean out the dryer vent that leads to the exterior upon possession and establish an annual cleaning routine to further reduce fire risks and maintain efficient dryer operation.

Upgrade to smooth metallic and establish annual cleaning schedule
