WATCHTOWER HOME INSPECTIONS

RESIDENTIAL REPORT

7124 Willis Point Road, BC

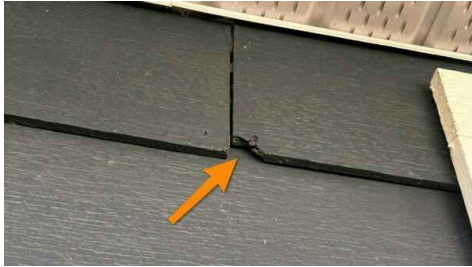
MINOR SIDING CRACKS

A few areas of the fibre cement siding have loose fasteners and a few areas that are cracked, and there is also a crack in the wood siding on the upstairs room dormer, with one section appearing to be missing material. These are minor issues, but regular maintenance is recommended to ensure the siding continues to perform as it should, protecting the home from weather exposure. Timely repairs upon possession will help maintain the integrity and appearance of the exterior.

Chipped Siding

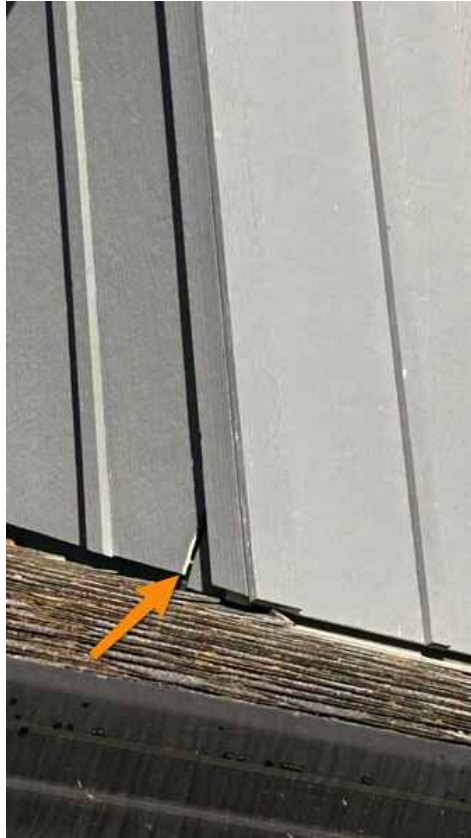
Cracked piece

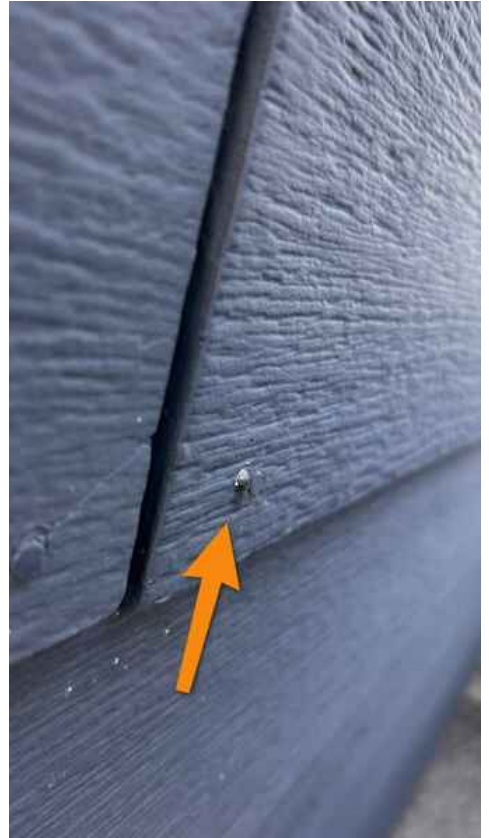
Loose fastener

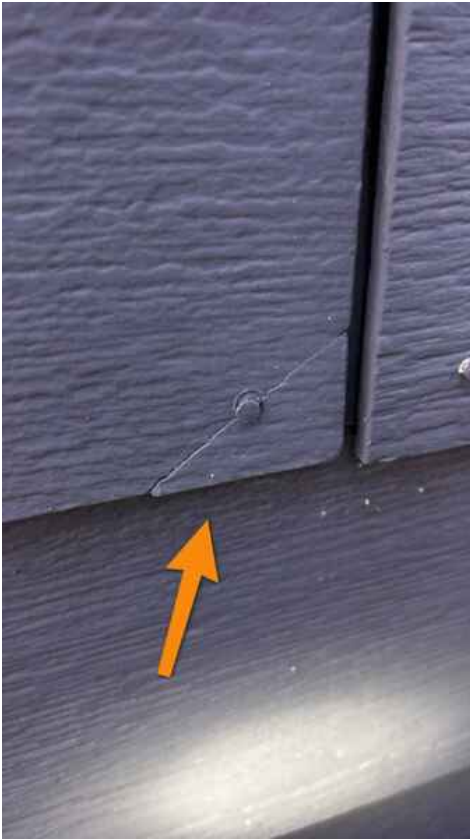
Cracked siding

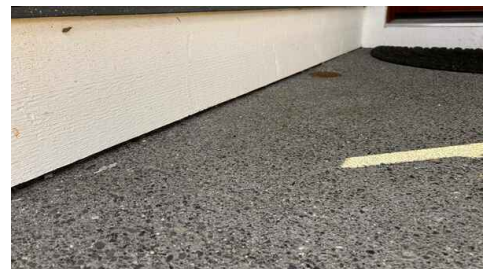
SIDING TOO CLOSE TO GRADE IN A FEW AREAS

In a few areas around the property, the siding is too close to the grade, possibly due to the slab being poured after or the siding installed too low. While not an immediate concern, it's important to monitor these areas to ensure water does not pool against the foundation or siding. If left unchecked, the siding can absorb moisture like a sponge, potentially leading to long-term issues in the wall assembly. Proper water management around the exterior will help prevent future problems.

Siding close to ground

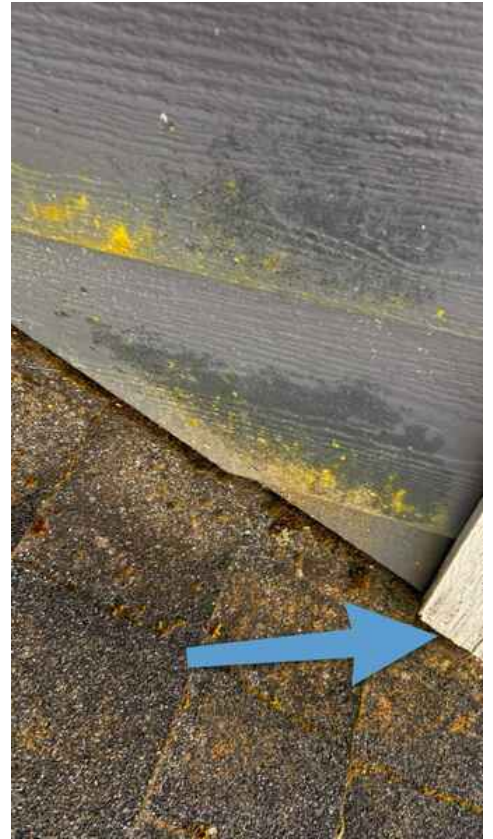
MINOR TRIM ROT NOTED ON MASTER SUITE BALCONY

A small amount of trim rot was observed where the master suite balcony extends onto the side of the roof surface. This could be a minor drainage issue where water is being diverted towards the dormer. It is recommended to repair or replace the affected trim upon possession to prevent further deterioration. Regular monitoring of this area is advised to ensure the issue does not worsen.

Trim Decay/ Moss

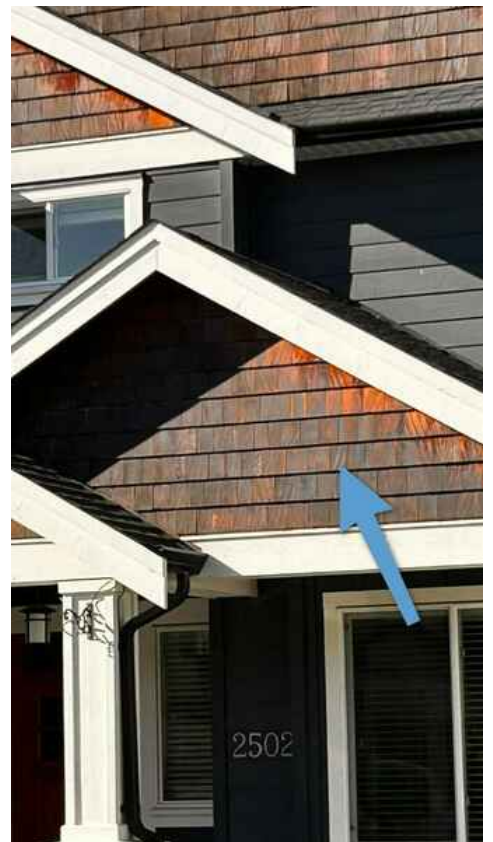
MINOR DISCOLOURATION ON FRONT WOOD SHINGLING

The wood shingling on the front of the home, shows some discolouration, potentially due to sun exposure or another factor. This is likely cosmetic in nature and does not affect the performance of the siding. If you wish to restore the aesthetic, it is recommended to consult a painter for refinishing. The siding itself remains functional, and the issue is purely aesthetic, with no immediate concerns.

Shingle Discolouration

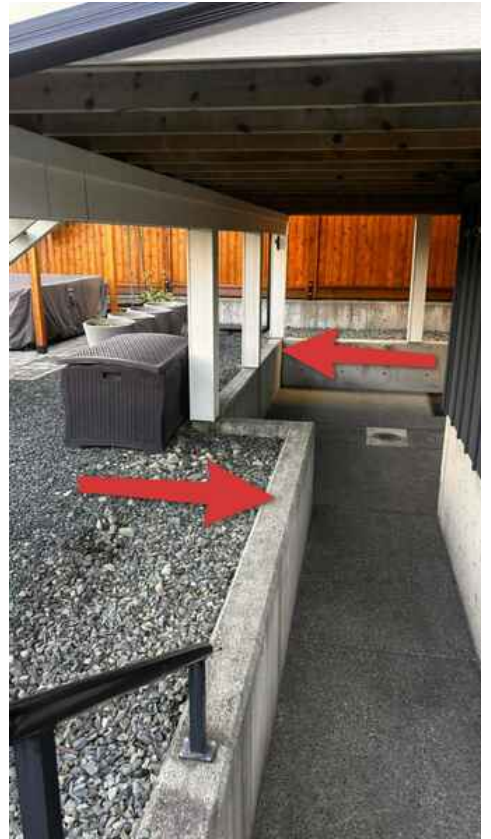
FALL HAZARD AT BASEMENT SUITE ENTRY/ PORCH

The entry to the basement suite includes a set of stairs, but the surrounding area features a 4-foot drop from a concrete retaining wall. While this is not designed as an entry point, it could pose a safety risk, particularly for children who may be playing near the area. It is recommended to be mindful of this potential hazard and consider adding protective barriers or railings to improve safety. This issue should be addressed upon possession, especially if young children will be present.

Potential Fall Hazard

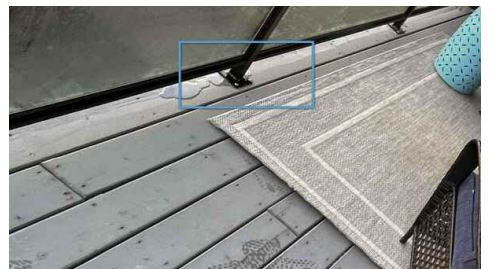
DECK GUARD RAIL HARDWARE EXPOSURE

The hardware securing the guard rail on the deck surface is facing upward, which may allow water to enter the system and cause long-term deterioration. To increase the longevity of the hardware and prevent potential water intrusion, it is recommended to apply waterproofing, caulk, or mastic on top of the exposed hardware. This simple preventative measure should be addressed upon possession to help maintain the deck's structural integrity.

Add Mastic to Hardware

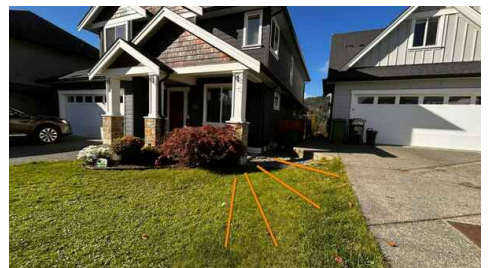
GENERAL GRADING OF PROPERTY

Overall, the grading of the property is adequate, but there is an area in the front yard where the grade slopes slightly towards the house, which could potentially direct water toward the structure. It's recommended to inquire with the sellers about any issues they may have experienced during heavy rainfall or periods of intense weather. Additionally, it's important to monitor this area during heavy rain to ensure water is effectively diverted away from the foundation, helping to prevent any potential drainage or moisture-related issues.

Negative Grade

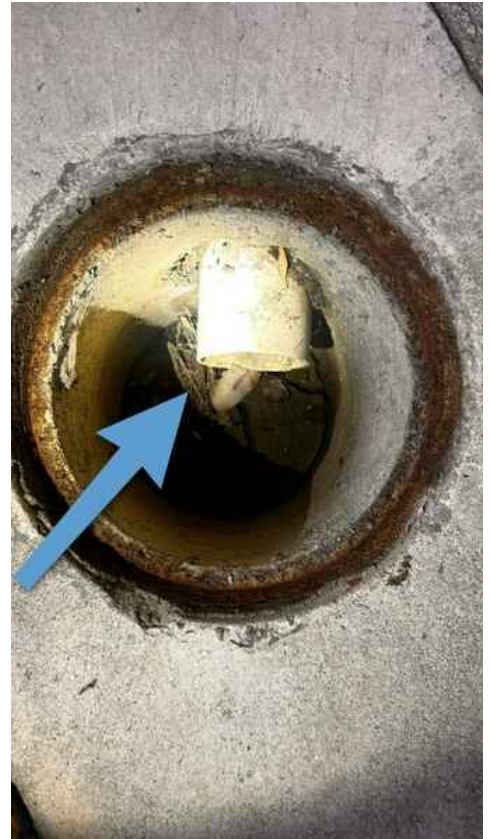
BASEMENT ENTRY DRAIN FOR DOWNSTAIRS SUITE

The basement entry to the downstairs suite features what appears to be an effective drain. However, the drainpipe should have a 90° elbow facing downward to help prevent debris from entering the perimeter drainage system. It is recommended to add this modification upon possession to maintain the proper function of the drainage system and reduce the risk of blockages.

Add 90 deg Elbow (face down) to Drain pipe

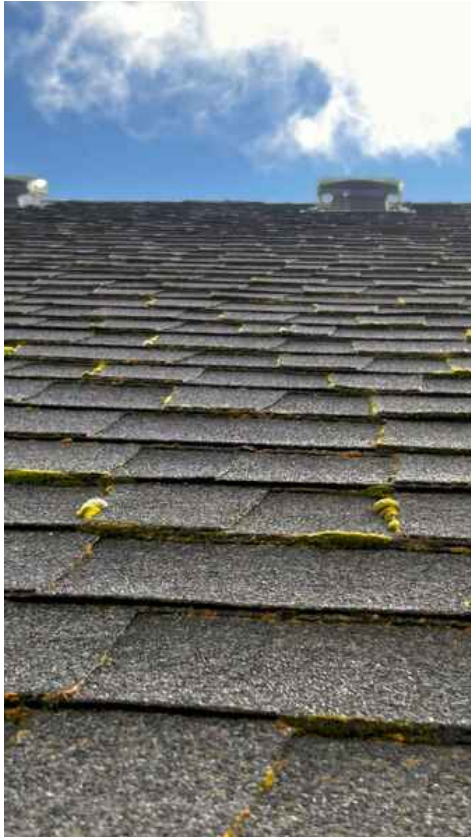
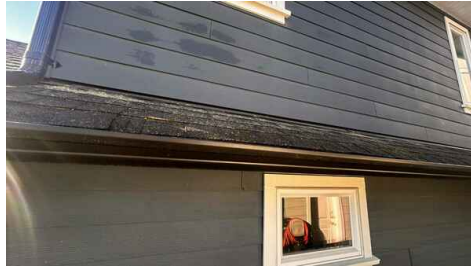
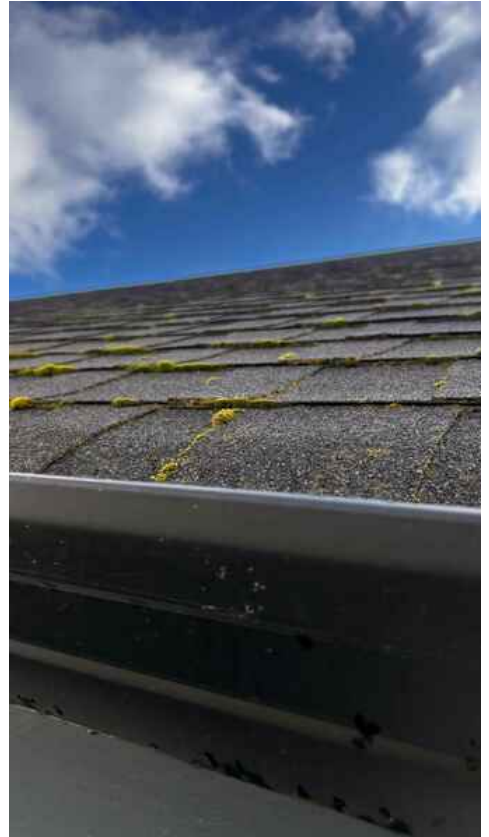
LIGHT MOSS DETECTED ON ROOF SURFACE

A light amount of moss was detected on the roof surface and overhangs. While not a significant concern at this stage, it's advisable to have it removed to prevent any long-term moisture retention, which could eventually lead to shingle deterioration. Regular maintenance will help keep the roof in good condition and avoid future issues.

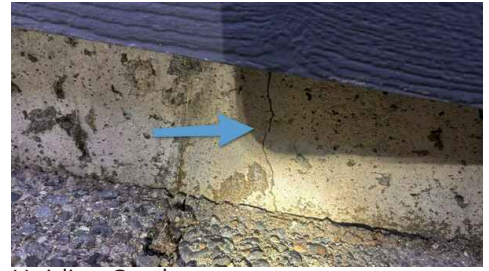
MINOR FOUNDATION CRACK ON LEFT SIDE OF HOME

A very minor hairline crack was observed on the left side of the home's foundation, likely a typical shrinkage crack. This type of crack is common and not a cause for concern at this time. It is recommended to monitor the crack quarterly for any signs of movement or widening, and consult a professional if changes are observed.

Hairline Crack

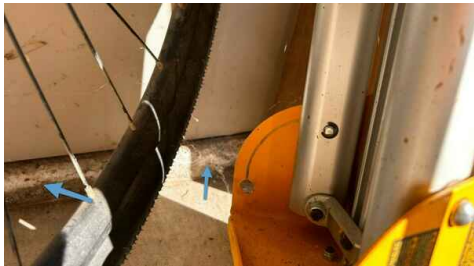
EFFLORESCENCE NOTED ON GARAGE FOUNDATION EXTERIOR

Efflorescence was observed at the curb of the garage foundation, most notably adjacent to the main entry of the house. This white, chalky residue is typically left behind by water moving through the concrete at some point, though it doesn't necessarily indicate active moisture issues. It could be residual from construction or past water movement. While it's not inherently a cause for concern, it's important to be aware of it and monitor the area to ensure proper drainage and water management around the foundation.

Efflorescence Noted On Foundation Curb

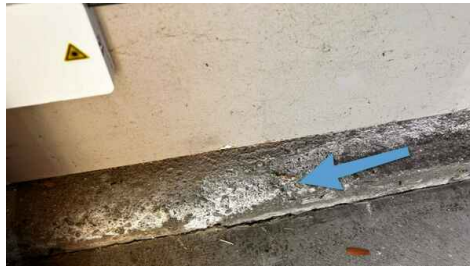
Efflorescence

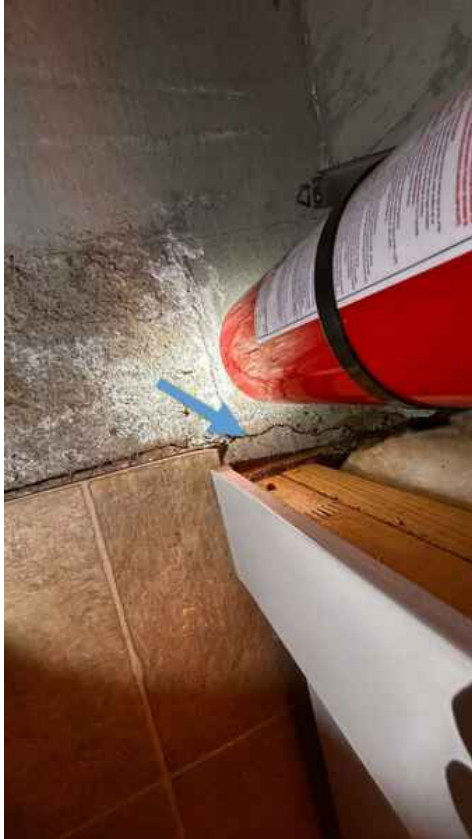
MINOR SHRINKAGE CRACKS IN GARAGE AND UTILITY ROOM

Minor shrinkage cracks were observed in the garage concrete slab, which is common and not indicative of structural concerns. Additionally, minor cracks were noted in the utility room near the linoleum, close to the furnace/heat pump area. While these cracks are typical and not currently a concern, regular monitoring is recommended to ensure they do not worsen over time. No immediate action is necessary.

Shrinkage Crack in basement slab

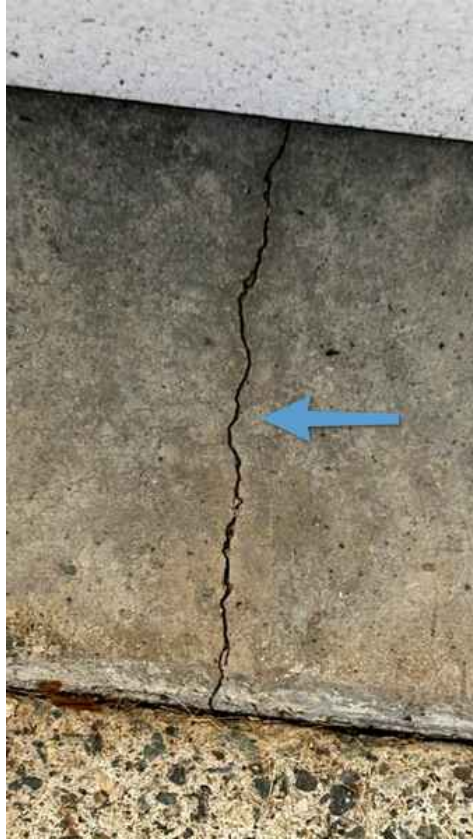
Garage Slab Shrinkage Crack

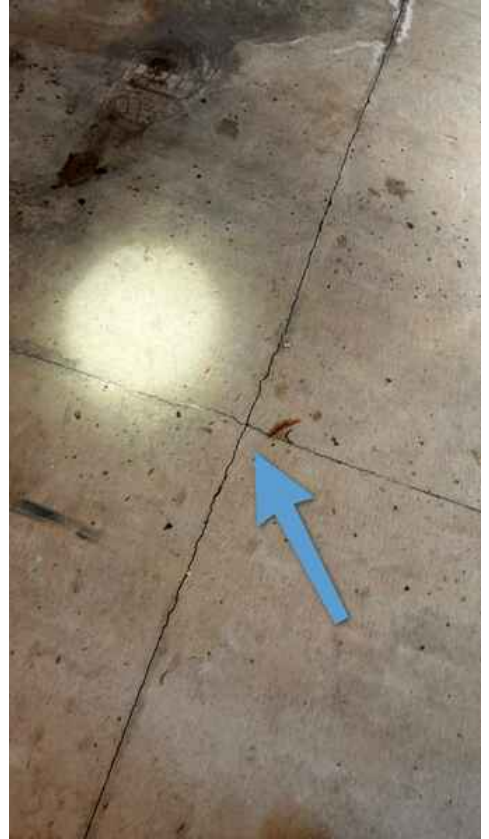
Garage Slab Shrinkage Crack

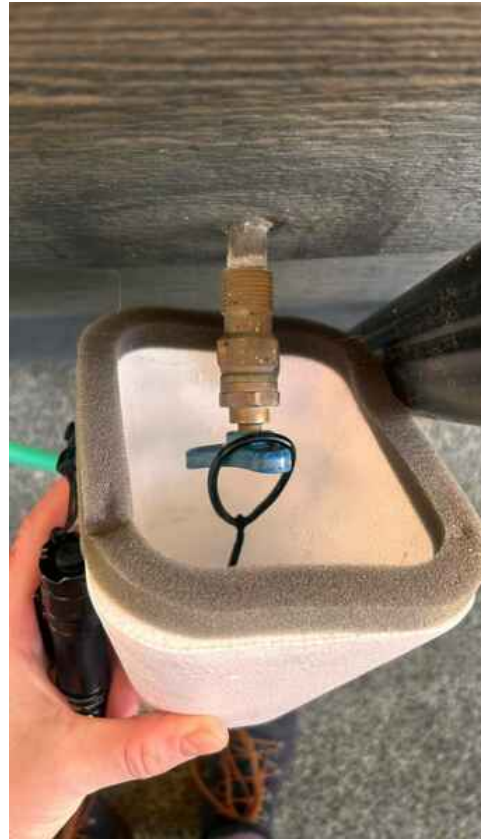
HOSE BIBS NOT FROST RESISTANT

The exterior hose bibs are not frost-free, which can increase the risk of water pipes freezing during colder months. It's recommended to upgrade these to frost-free hose bibs. This modification helps prevent freezing issues and potential water damage in the winter. Consider making this upgrade before cold weather sets in.

Upgrade Hose Bibs

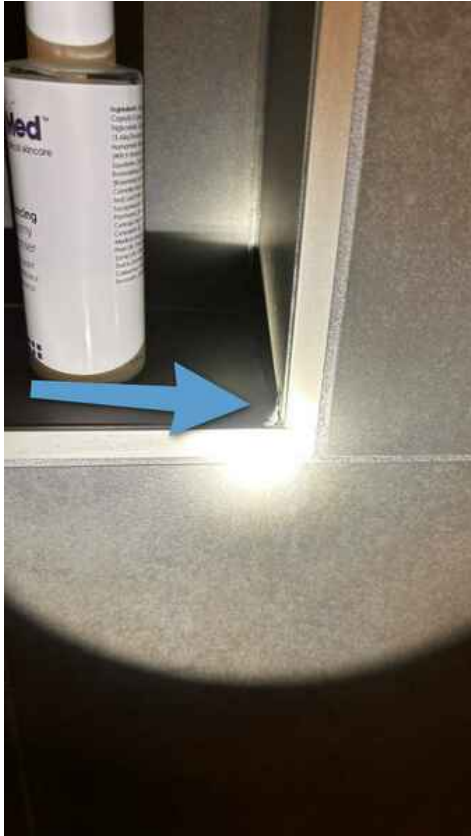
ROUTINE MAINTENANCE FOR SITE-BUILT SHOWER

The site-built shower in the upstairs bathroom requires regular sealing and routine maintenance to ensure its longevity. Particular attention should be paid to level surfaces, such as the soap and shampoo holders, as well as the corners of the shower. These areas should be periodically re-caulked or sealed with silicone to prevent water infiltration and maintain the integrity of the shower. Routine upkeep will help avoid potential issues down the line.

Silicone Maintenance

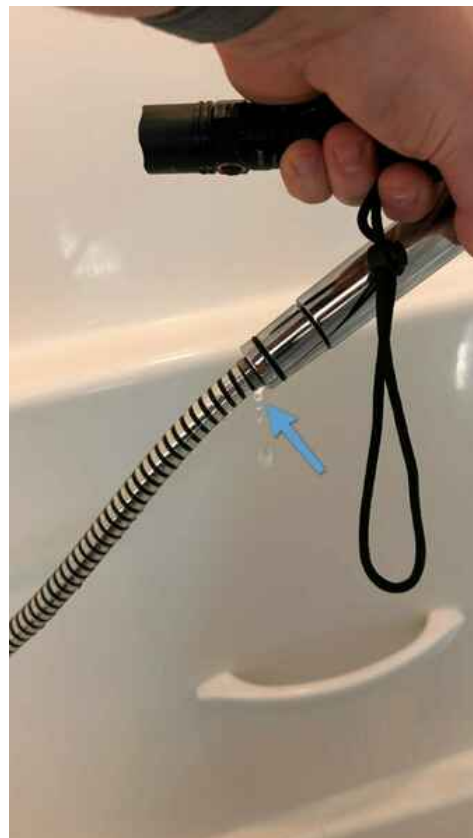
SHOWERHEAD LEAK IN UPSTAIRS GUEST BATHROOM

The showerhead in the upstairs guest bathroom was observed to have a slight leak. While this is not a major issue at the moment, it is recommended to address this upon possession to prevent further leakage and ensure proper functionality of the showerhead.

Showerhead leaking slightly

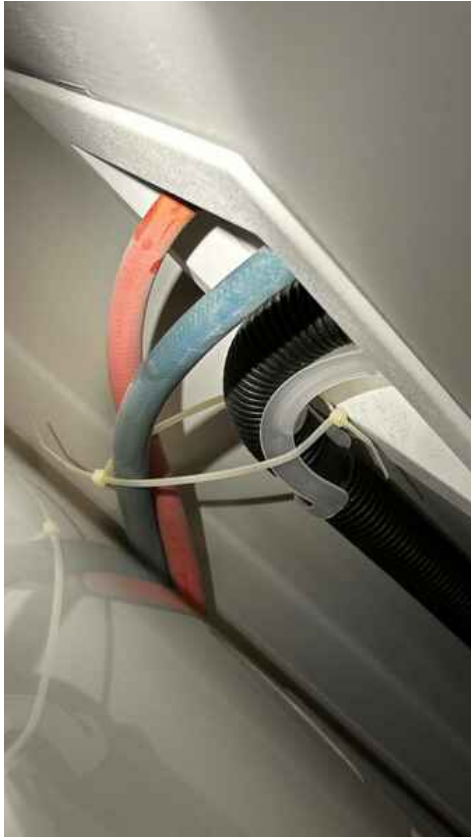
PLASTIC WATER SUPPLY LINES FOR WASHERS

Both washers in the home are connected to plastic piping for their main water supply. It is recommended to upgrade these to braided metal supply lines, which are more durable and less prone to leaks. This upgrade should be considered upon possession to ensure a more reliable water connection and reduce the risk of future water damage.

Upgrade rubber hoses

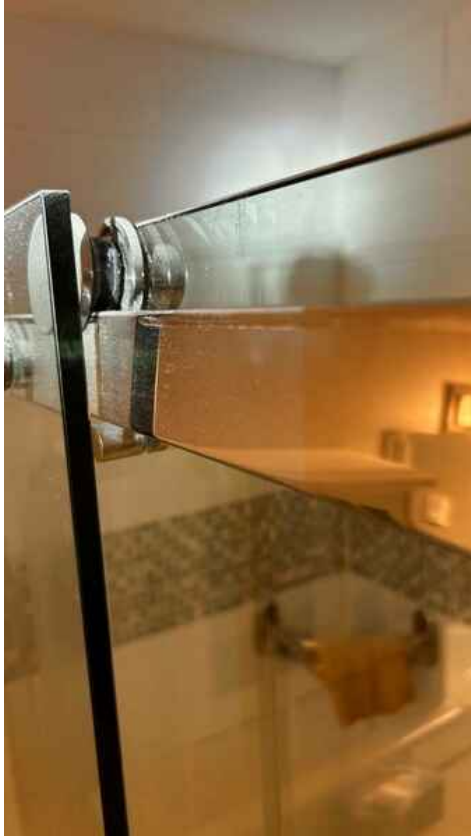
CAULKING AND SHOWER DOOR MAINTENANCE NEEDED IN DOWNSTAIRS SUITE BATHROOM

The glass shower door in the downstairs basement suite bathroom requires caulking maintenance, as it does not fully seal to the tile wall, causing water to leak out. Additionally, the sliding glass door felt uneven and difficult to open and close, likely due to worn wheels on the track. It is recommended to address both the caulking and door mechanism upon possession to prevent further water leakage and ensure smoother operation of the shower door.

Wheels/ Track possibly worn

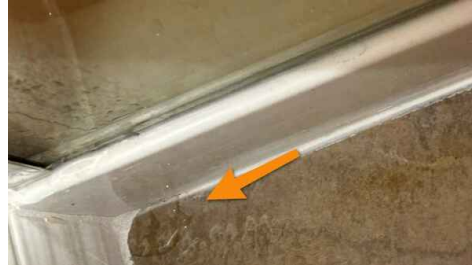
Shower wall not Sealed to tile

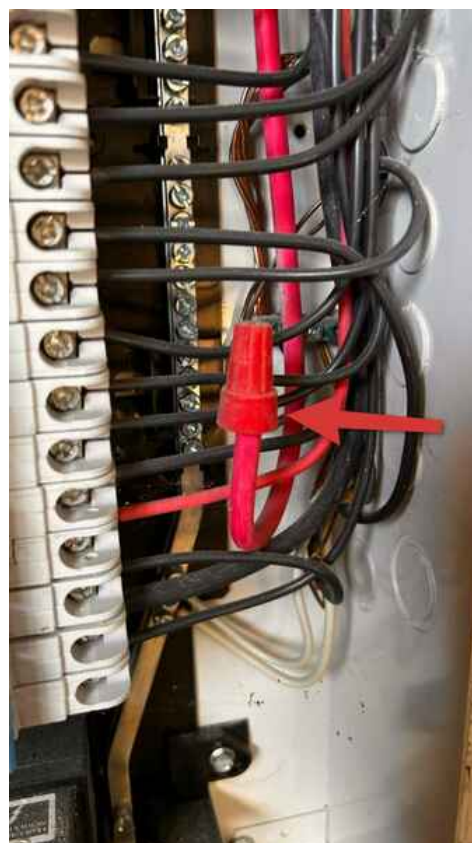
CONDUCTOR TERMINATED WITH WIRE NUT IN ELECTRICAL PANEL

One conductor in the electrical panel has been terminated using a wire nut (Marrette). While this is not an immediate concern and appears to be safely terminated, it is recommended to consult a licensed electrician to confirm its safety. Ideally, the conductor should be removed completely to ensure the panel is properly configured. Addressing this upon possession would be a prudent step.

Terminated Conductor

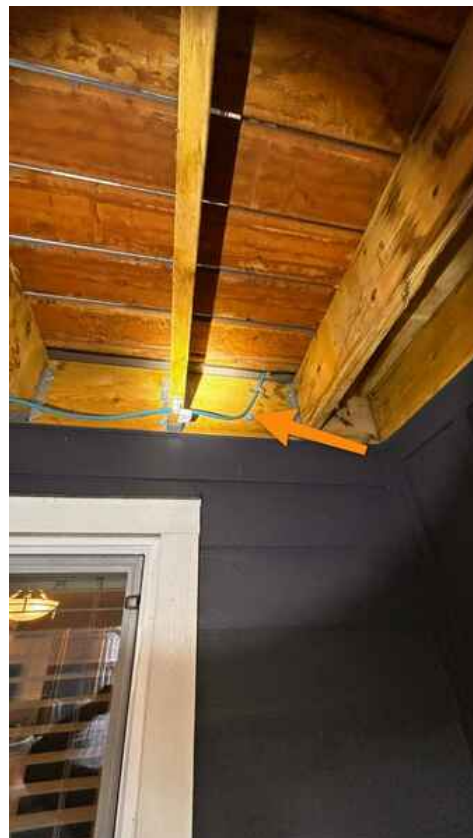
IMPROPER USE OF EXTENSION CORD UNDERNEATH DECK

An extension cord was observed underneath the deck, being used as a permanent wiring fixture. Extension cords are not designed for long-term use in this manner and can pose electrical and safety hazards over time. It is recommended to replace this setup with proper permanent wiring installed by a licensed electrician. This should be addressed upon possession to ensure safety and compliance with electrical standards.

Extension cords not designed to be permanent wiring

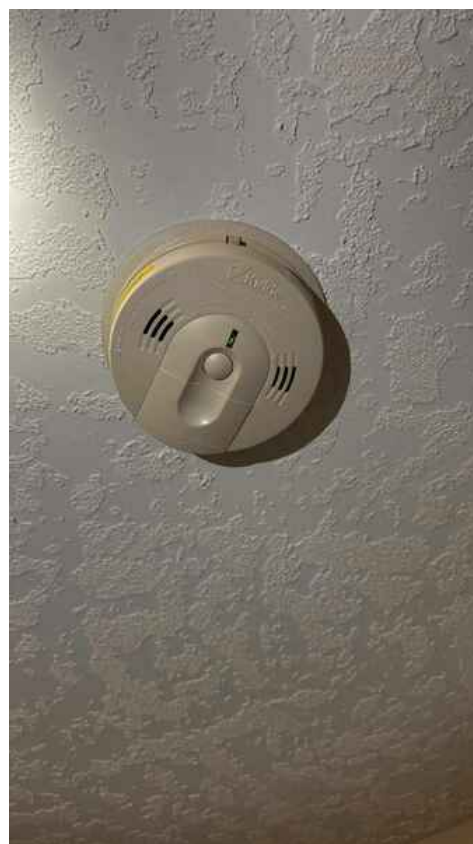
SMOKE AND CARBON MONOXIDE DETECTORS

It is important to note that **smoke detectors should be installed in each room and living space, as well as carbon monoxide detectors on every floor and near appliances that emit CO.** These detectors can help ensure the safety of occupants by providing early warning in case of fire or the presence of dangerous levels of carbon monoxide. It is recommended to test these detectors regularly and replace batteries as needed to ensure they are functioning properly. This is a life safety issue.

Install adequate smoke and CO detectors

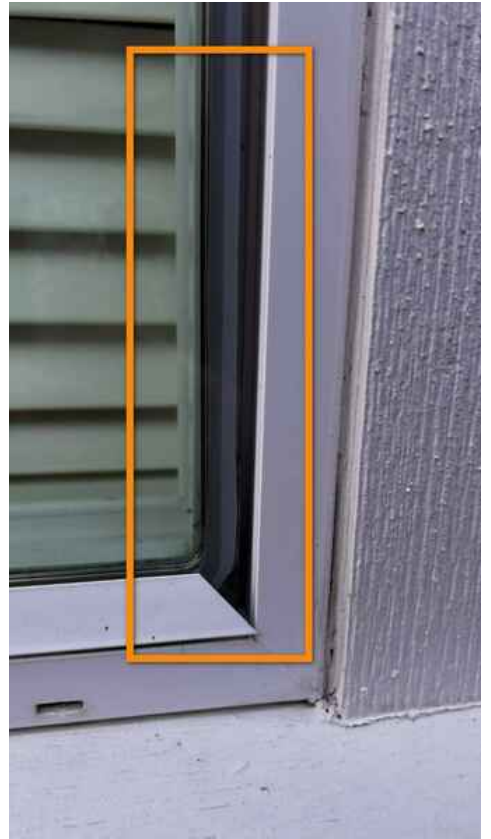
MISSING PLASTIC FLASHING ON DOWNSTAIRS BEDROOM WINDOW

The window on the left side of the house, serving one of the bedrooms in the downstairs suite, is missing a small section of plastic flashing that typically covers the border of the windowpane. This is a minor issue, but it's recommended to replace the flashing to ensure proper sealing and protection against potential moisture intrusion or drafts. This repair should be addressed upon possession.

Replace missing window component

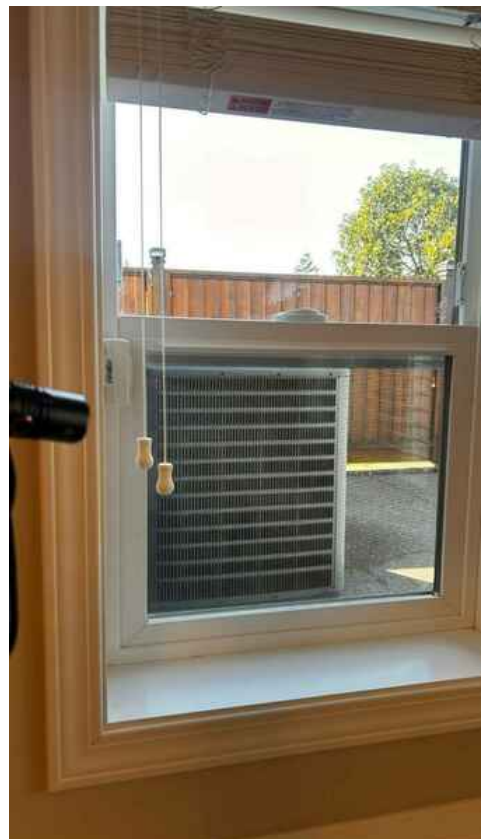
SLIGHTLY STICKY HUNG WINDOW IN DOWNSTAIRS BEDROOM

The hung window in the bedroom of the downstairs basement suite was noted to be slightly sticky when opening and closing. While still functional, it may require a bit more effort to operate. This is a minor issue that can be addressed at your discretion to improve ease of use.

Window slightly Sticky

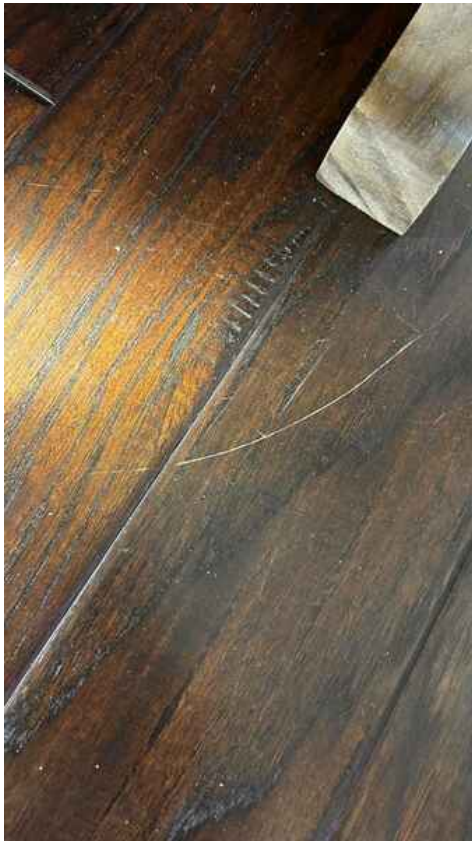
RIP IN LINOLEUM AND MINOR SCRATCHES IN HARDWOOD FLOORING

A small rip and tear were noted in the linoleum near the utility closet in the basement, along with several minor scratches observed in the hardwood flooring throughout the home. While these are cosmetic issues, they should be addressed at your discretion upon possession to maintain the appearance and durability of the flooring.

Small Scratch in wood floor

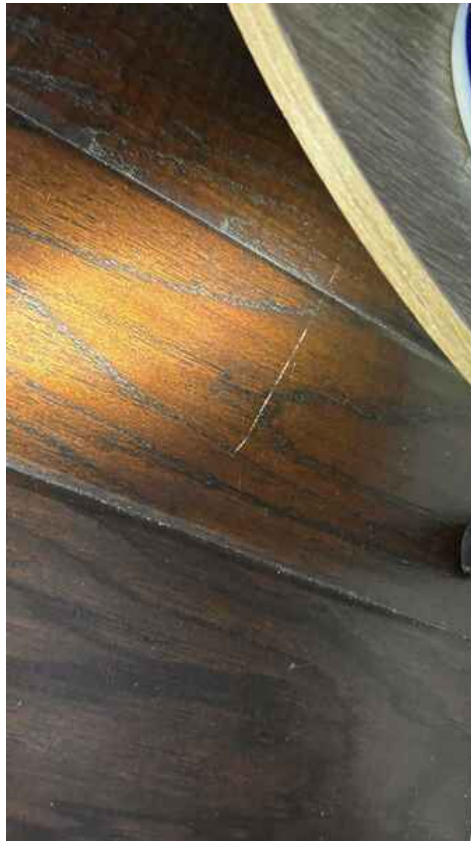
Small Scratch

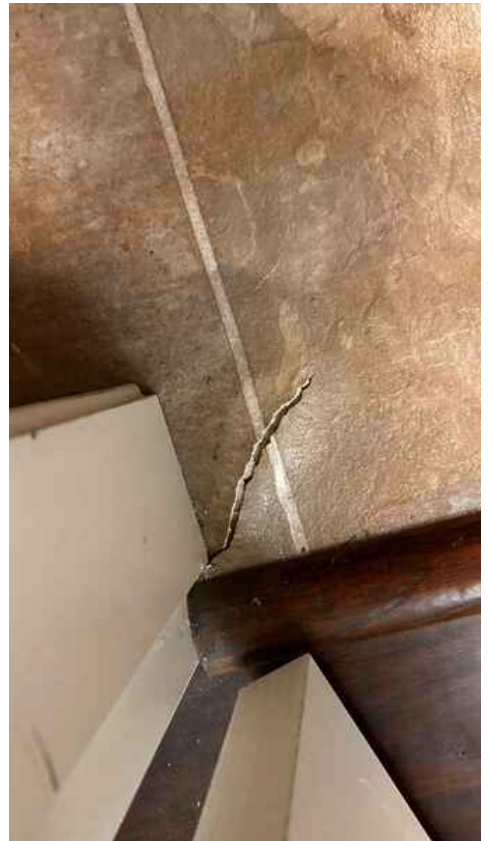
Ripped linoleum

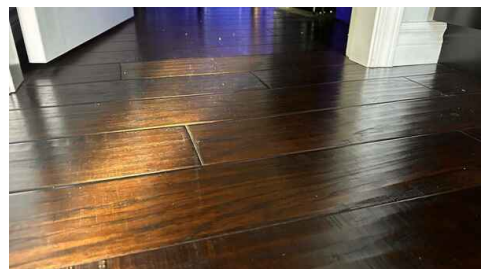
MINOR FLOOR DISPLACEMENT NOTED BETWEEN KITCHEN AND PANTRY

A minor floor displacement was felt between the main area of the kitchen and the pantry. This slight unevenness is common in homes and could be attributed to the subfloor or minor settling. It is barely noticeable and does not currently pose a concern. However, if desired, it can be monitored over time to ensure no further movement occurs.

Very Minor Floor Displacement (hard to capture with camera)

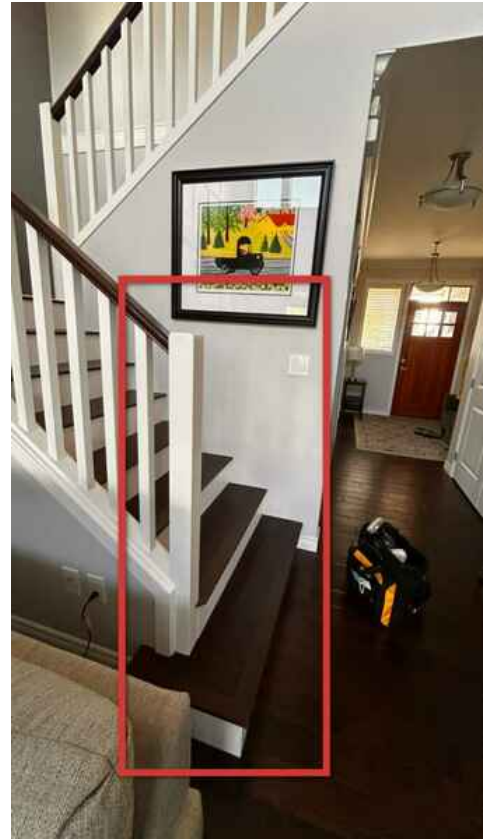
The handrail on the stairway leading to the upstairs does not extend fully to the last step. While this may not pose an immediate issue for most, it is a potential safety hazard, particularly for elderly individuals or those with mobility concerns. It is recommended to extend the handrail to improve safety and ensure full support when using the stairs. This should be addressed upon possession for enhanced safety.

Handrail should extend as far as treads

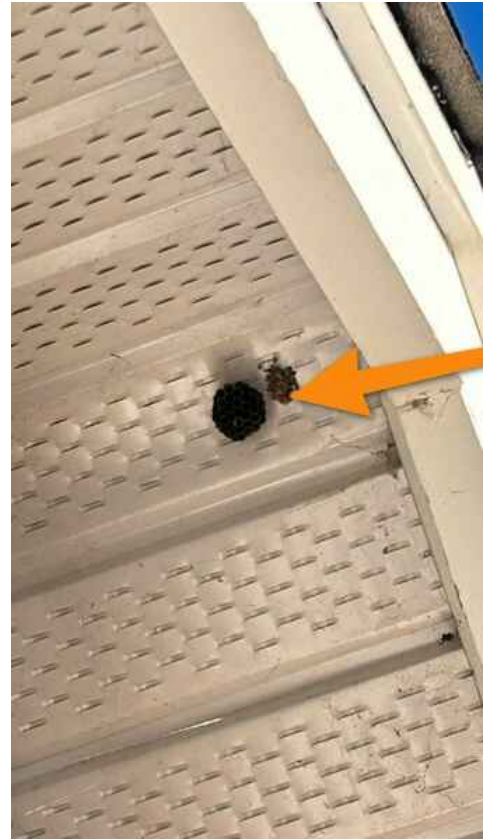
INACTIVE WASP NEST NOTED IN ENTRYWAY SOFFIT

A small, inactive wasp nest was observed in the peak of the entryway soffit. While there are no signs of current activity, it is recommended to remove the nest to prevent any future insect habitation. This can be addressed upon possession for peace of mind and to ensure the area remains pest-free.

Nest in soffit peak

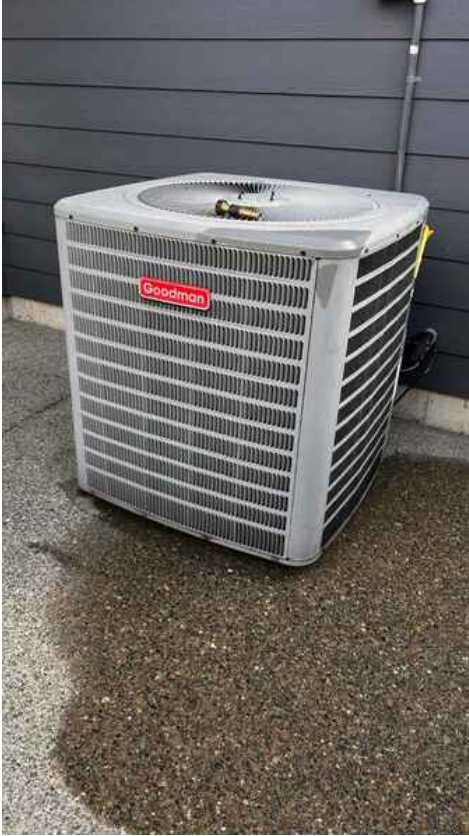
HEAT PUMP SERVICING AND ADEQUATE SIZING

The heat pump appears adequately sized to efficiently heat and cool the upstairs portion of the home, while the downstairs suite relies on electric baseboard heating. It is recommended to have the heat pump serviced + cleaned upon possession to ensure it continues to function effectively and maintains energy efficiency. Regular maintenance will help prolong the lifespan of the system and ensure optimal performance.

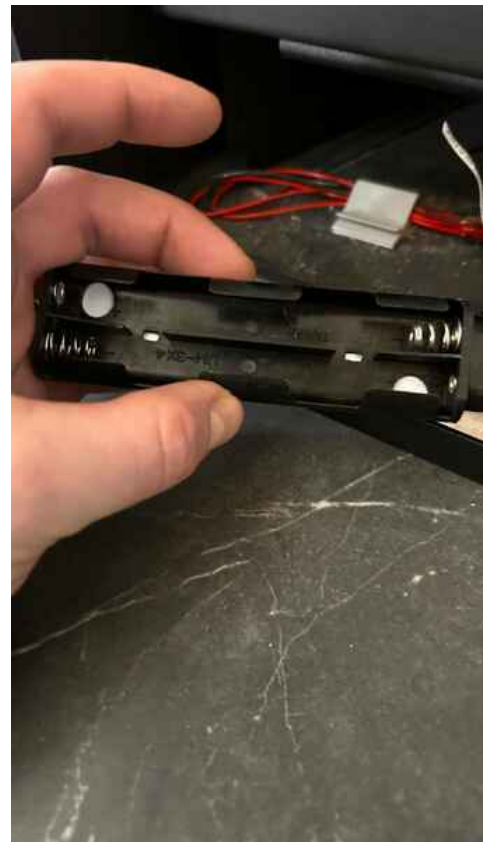
UNABLE TO TEST FIREPLACE DUE TO MISSING BATTERIES

Unable to test the functionality of the fireplace at the time of inspection due to the control unit lacking batteries. It is recommended that the seller provides batteries or instructions for operating the fireplace to ensure proper testing and functionality upon possession.

Missing batteries for fireplace

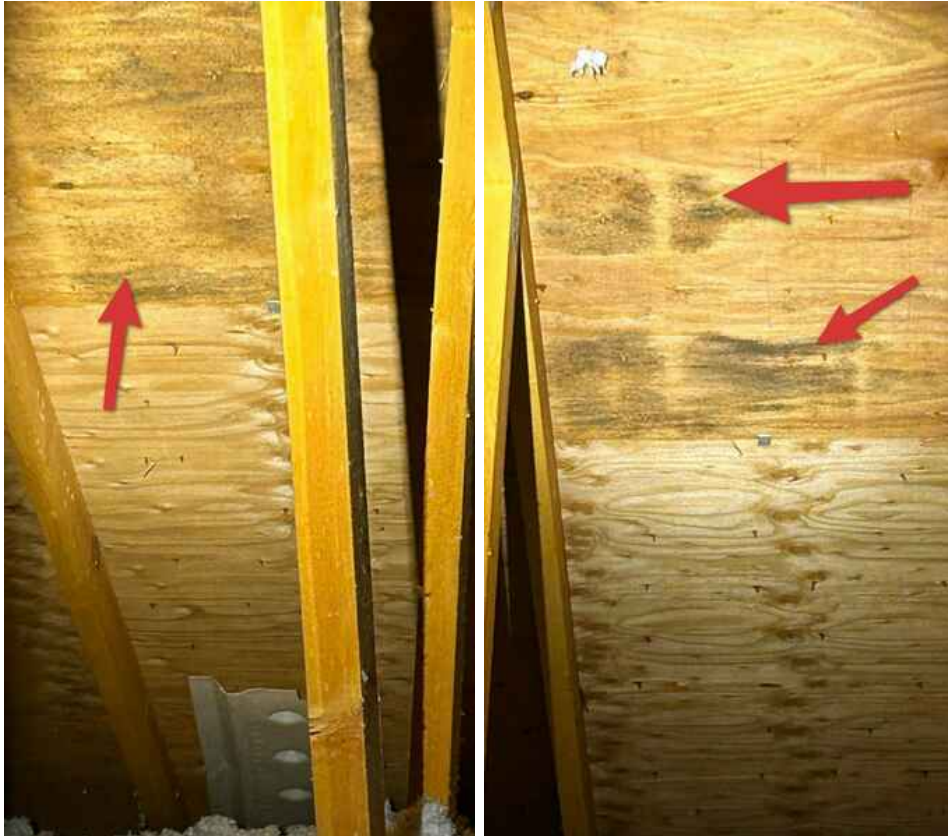
MINOR ATTIC STAINING ON SHEATHING

A small amount of attic staining was observed on the right side of the sheathing. This minor staining could be due to a number of factors, including a potential ventilation issue or simple surface discoloration during construction. While the staining is very minor and not currently a cause for concern, monitoring the area over time is recommended to ensure no further issues arise. If there are any concerns, a ventilation specialist can provide further evaluation.

Minor Attic Staining

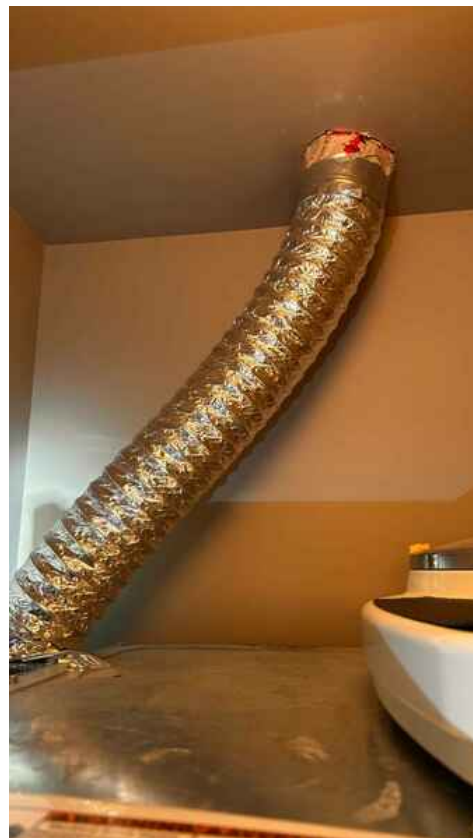
NONMETALLIC CORRUGATED DRYER VENT

The downstairs suite dryer is using a nonmetallic corrugated vent for exhaust, and it is recommended to upgrade this to a smooth metallic vent to improve efficiency and fire safety. The vent for the upstairs dryer was not fully visible without pulling out the unit, but it is recommended to replace this vent with a smooth metallic material upon possession as well. Both upgrades will help ensure proper ventilation and reduce the risk of potential fire hazards.

Upgrade material
