WATCHTOWER
HOME INSPECTIONS

RESIDENTIAL REPORT

7124 Willis Point Road, BC

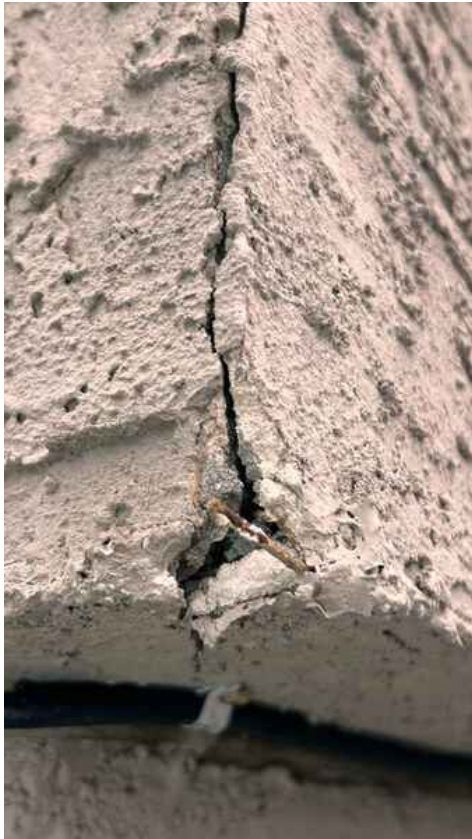
Stucco cracks were observed throughout the property, particularly along the windowsills, with some areas requiring paint, repair, or replacement where pieces have fallen off or are missing. Additionally, some windows require caulking between the frame and window assembly to prevent water ingress and maintain weather resistance. To enhance the property's appearance and reduce potential concerns during buyer inspections, it is recommended that these issues be addressed prior to listing the home for sale.

Seral Crack

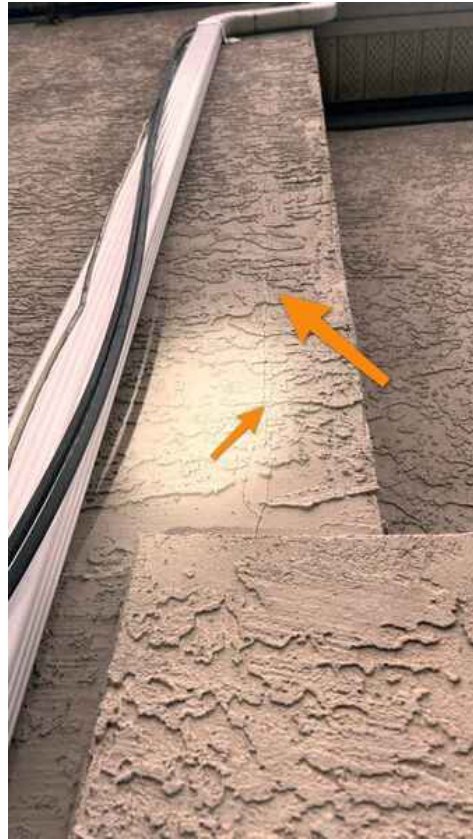
Stucco cracks

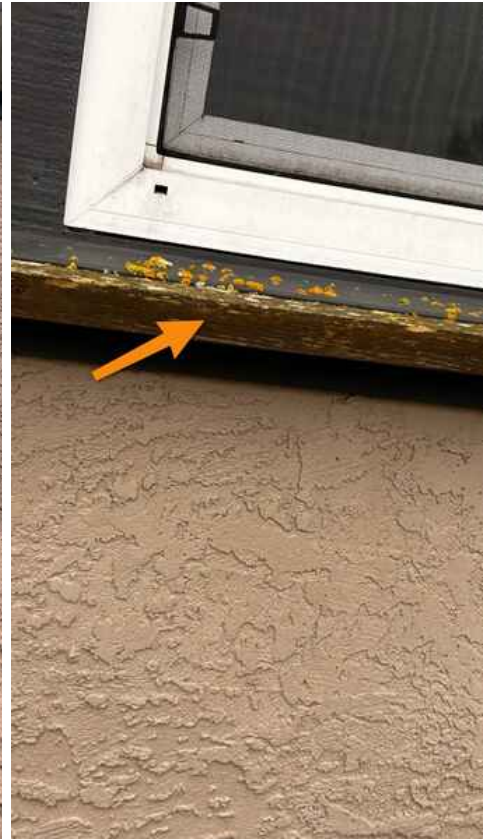
Rotted Sills throughout

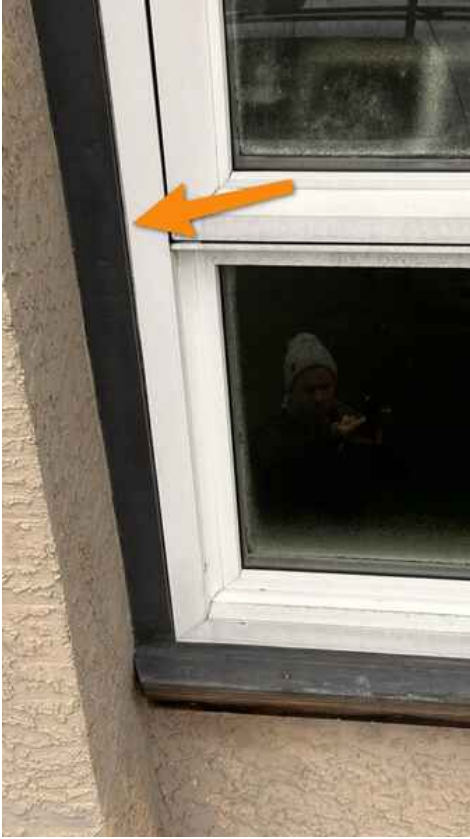
Caulk Gaps

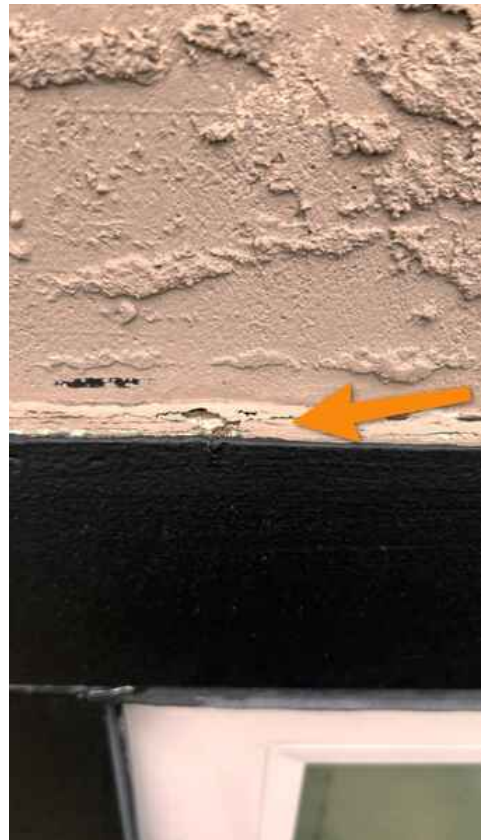
Some windows on the property were missing flashings above the assemblies, relying solely on caulking to prevent water intrusion. In several cases, the caulking was deteriorated and requires maintenance. This presents both a current issue and an ongoing maintenance need to ensure water is properly managed. Recommend repairing or replacing deteriorated caulking before listing the home for sale and advising future owners to perform regular checks.

Maintain Caulk

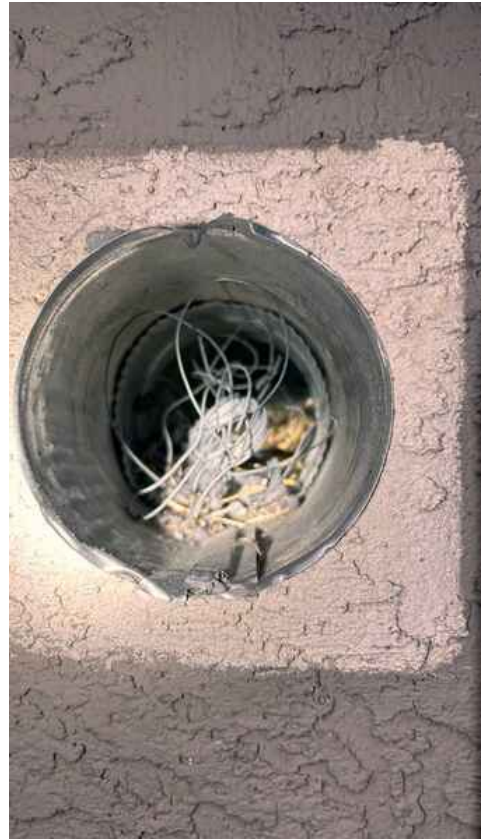
On the right side of the home, an exterior vent was observed to be open and unguarded. Evidence of past pest activity was noted, including straw inside the vent. It is recommended to clean out the vent to remove any debris or potential pest evidence and install an appropriate cover to prevent further intrusion. Addressing this issue upon possession will help maintain the integrity of the vent and deter pests.

Unguarded vent

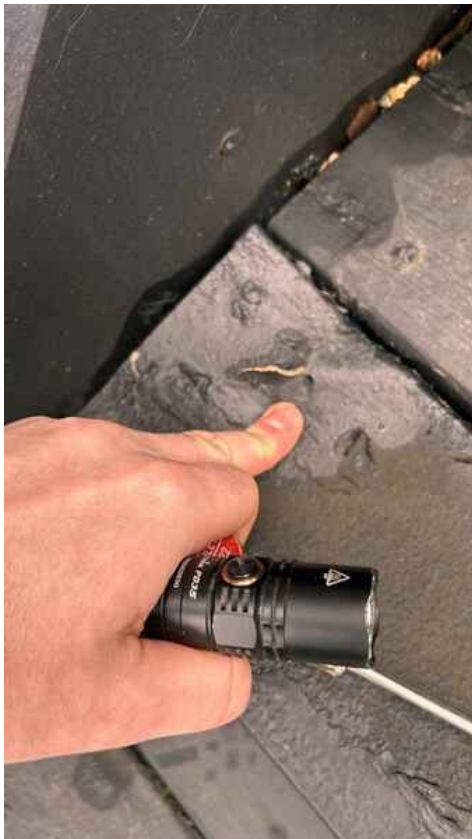
The exterior wood staircases leading to the upper floor units, both covered with stucco, exhibit significant rot and deterioration beneath the structures. The front staircase (Unit A) is particularly affected, with rot extending to the sill plate, which is fully disintegrated, and visible wood decay emerging from behind the stucco. The environment around this staircase is also notably mouldy, further exacerbating the condition. While the rear staircase appears slightly more stable, both structures will likely require full replacement in the near future.

Some stairs present minor trip hazards, and protruding nails, adding to the overall maintenance and safety concerns. Although the staircases are not yet unsafe to use, they are nearing that point, and addressing these issues soon is critical to prevent further structural compromise. This will likely represent a significant expense. Recommend repairs or replacement of the staircases before listing the property to avoid potential buyer concerns.

Rotted Treads

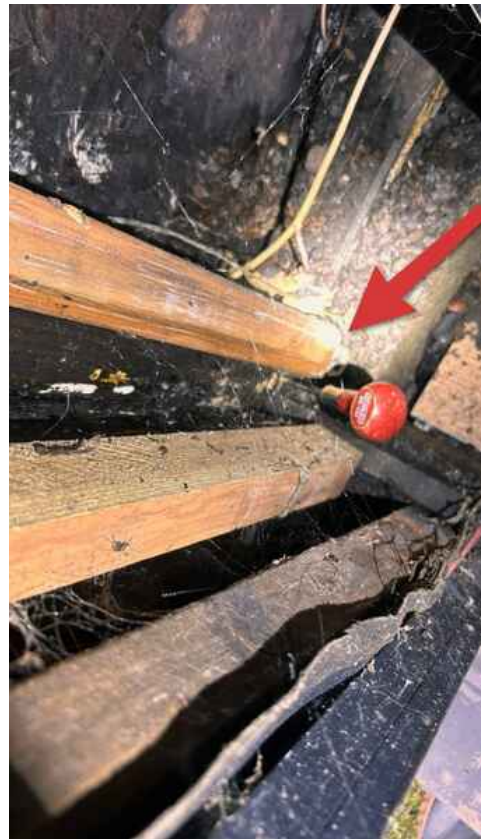
Rotting Sill/ Structure

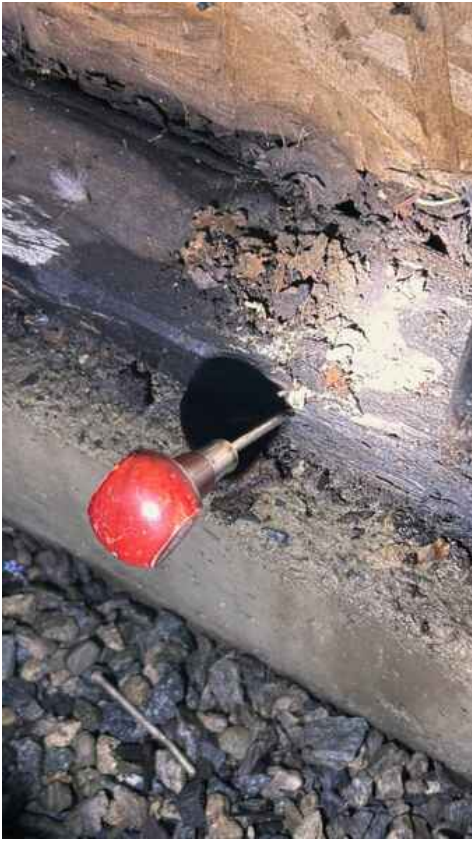
Rotted Sill

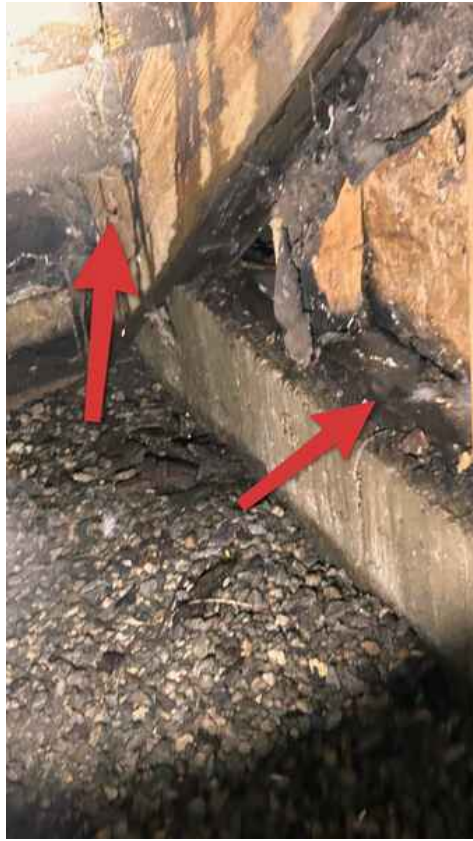
Rotted Stringer, Sill, and Materials

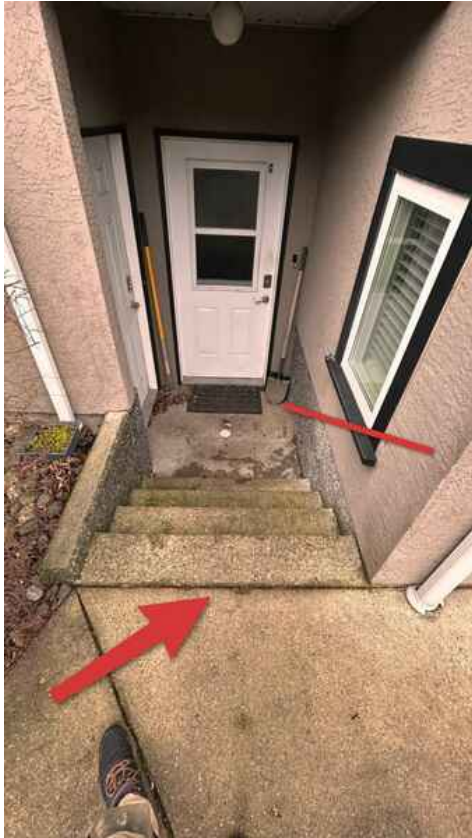
Several trip hazards were observed on the property due to lifted pavers and concrete sections. Additionally, the entryway to the lower unit, which has more than three risers, lacks a handrail. Installing a handrail would significantly enhance safety and reduce the risk of falls. Recommend addressing the trip hazards and installing a handrail before listing the property to improve overall safety and reduce potential buyer concerns.

Missing handrail & Trip Hazard

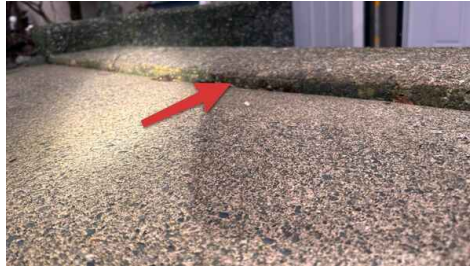
Trip hazard

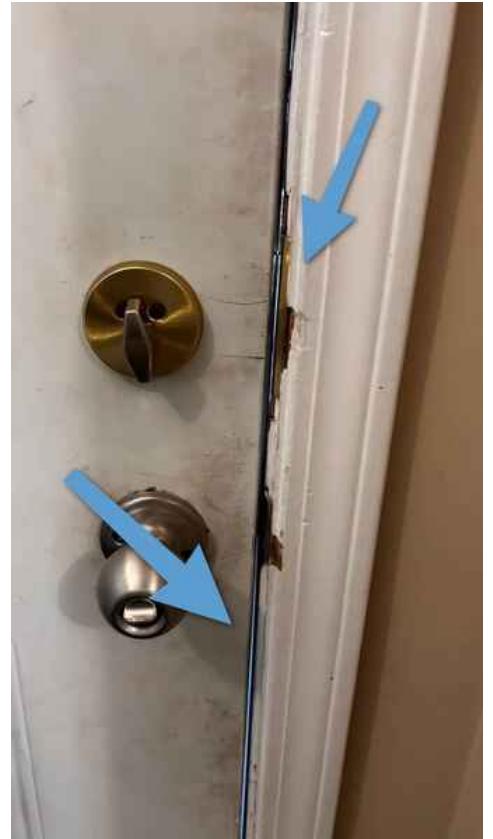
The exterior front door of Unit B has inadequate weatherstripping, allowing exterior light to enter the living space. This could indicate gaps that may lead to drafts and energy inefficiency. Recommend installing or replacing weatherstripping upon possession to improve energy efficiency and comfort.

Renew weather stripping

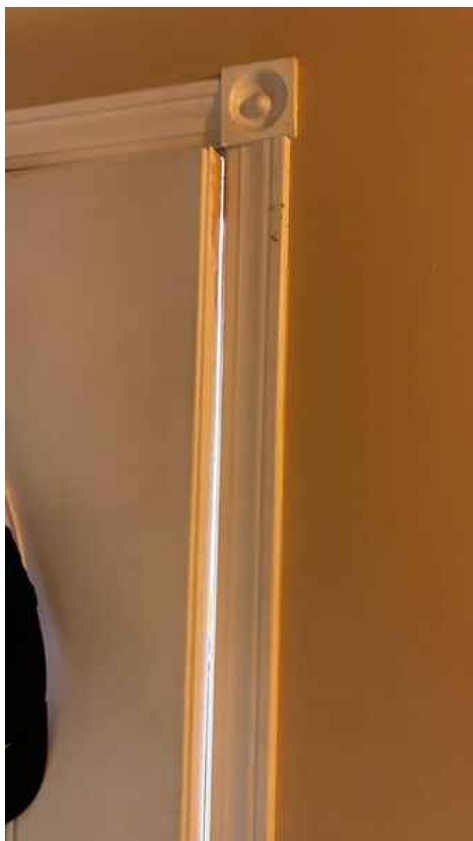
The exterior door in Unit A appeared to be out of alignment and sticky, even after removing a coat rack attachment that was clipped onto the door. The issue may be resolved with a simple hinge adjustment, but further inspection and minor repairs are recommended to ensure proper functionality.

Misaligned Door (unit A)

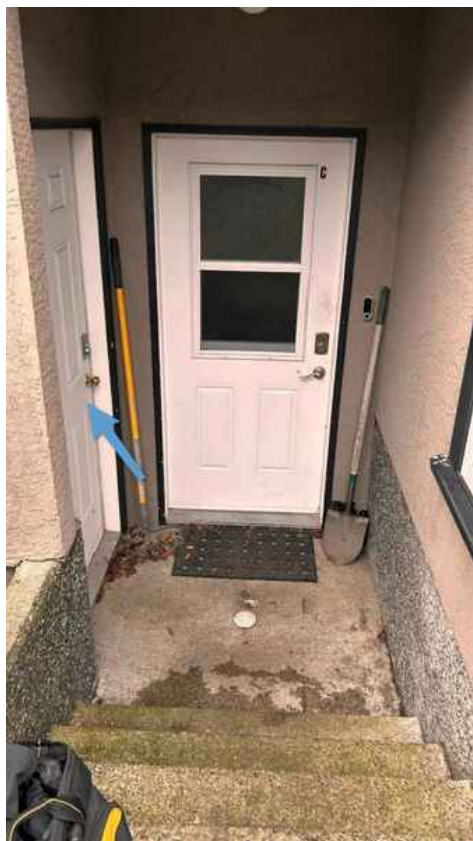
Additionally, the exterior door to the laundry/utility room did not latch properly due to an issue with the strike plate or latch mechanism. Further inspection and repairs are recommended to restore proper operation and ensure security.

Utility room door doesn't latch

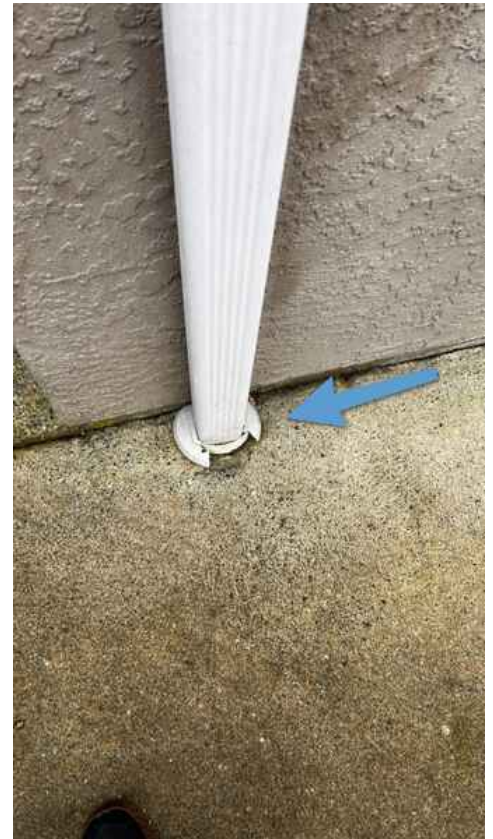
Several perimeter drainage risers were observed with broken or chipped covers, which could allow debris to enter and potentially clog the drainage system. Recommend replacing the damaged covers to maintain proper drainage functionality.

Chipped/ Broken covers

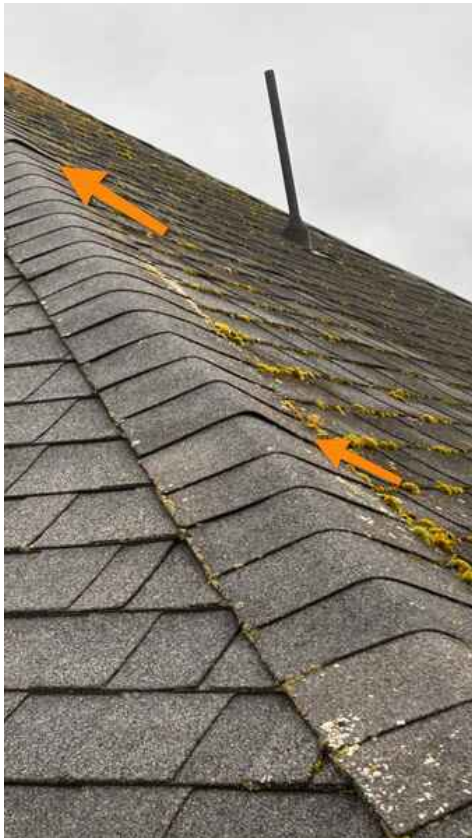
Additionally, a few shingles were uplifted, and one or two small gaps were noted in the step flashing, which could allow wind-driven rain to penetrate. With regular upkeep and maintenance, the roof should last another 10 years. However, it is recommended to have a professional roofer inspect and maintain the roof upon possession to address these issues and ensure the roof's longevity.

Slightly lifted shingles

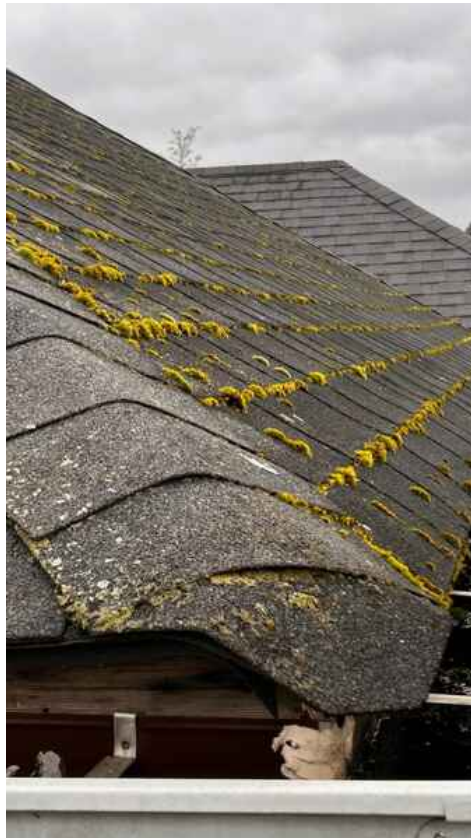
The roof is overall in its mid to later stages of life. Extensive moss growth was observed across the roof surface, which can retain moisture and accelerate wear. Minor granular loss noted on some of the shingles as well. The roof is also missing a drip edge flashing. Installing a drip edge flashing would help prolong the life of the roof sheathing & fascia by improving water runoff management.

Moss covering

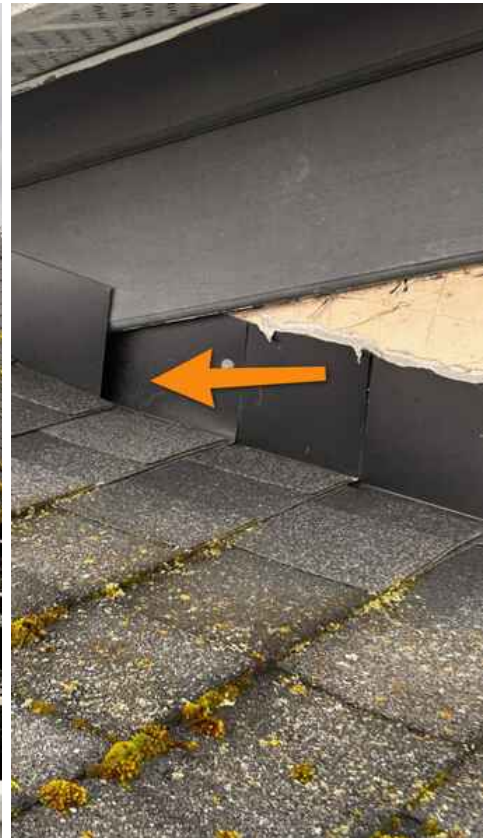
Gap in step flashing

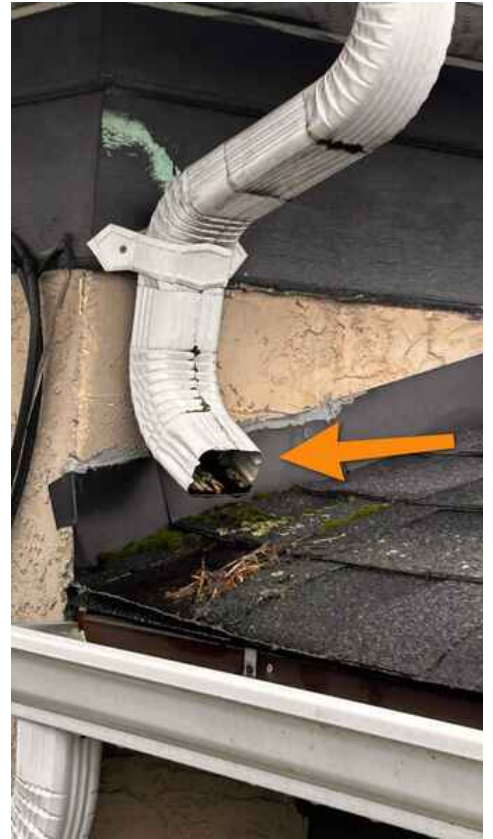
Downspout discharging on to roof surface observed at time of inspection. The large volume of water passing over the lower roof may cause staining and premature wear of the roofing material. Leakage may also result from the large volume of water running along a roof/wall intersection, for example, at a dormer. The flashing details may be severely tested. Recommend a qualified contractor to extend downspout to lower gutter.

Extend downspout to gutter

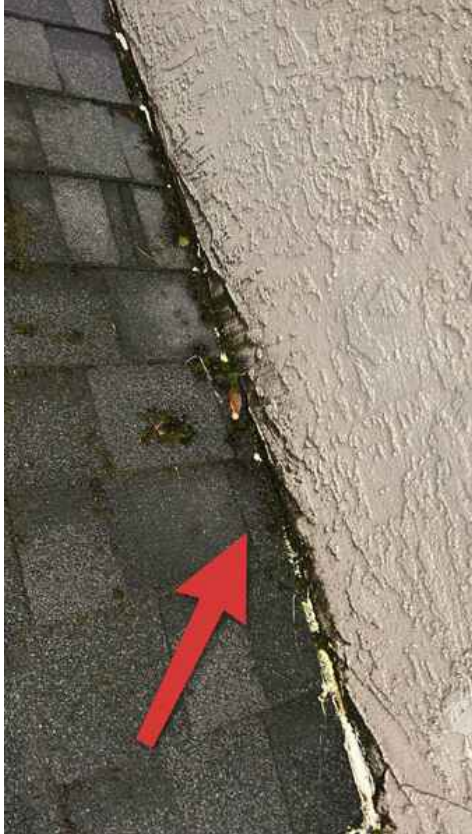
The section of the roof over the entryway to Suite C was missing step flashing on both sides. While some flashing was present, the absence of step flashing has already led to signs of wear and moisture penetration. Fortunately, this roof area is not over a living space, minimizing immediate interior concerns.

Missing step flashing, visible discoloration

However, to prevent further deterioration and ensure proper water management, it is recommended to address the missing step flashing and perform necessary repairs immediately upon possession. Timely action will help maintain the integrity of this section of the roof.

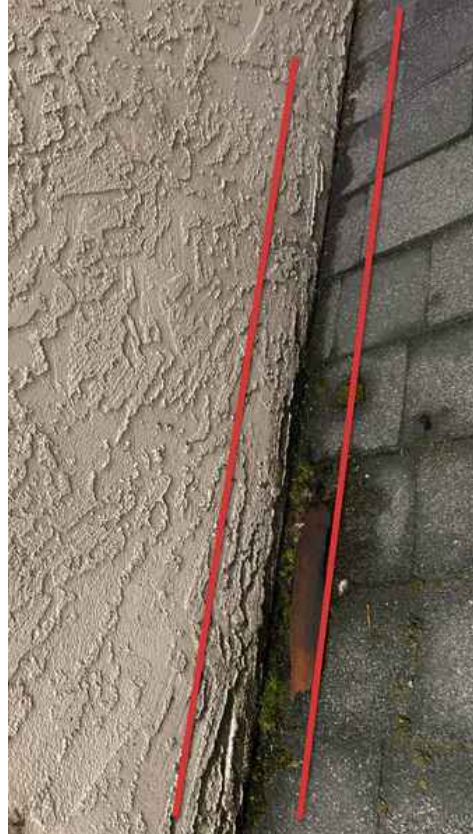
Add step flashing

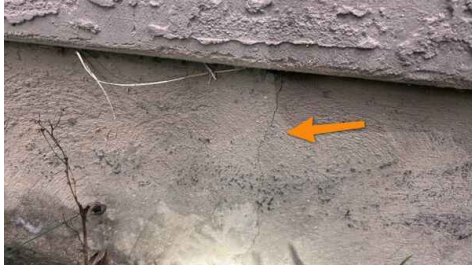
A few small hairline foundation cracks were observed, along with one more prominent crack that is suspected to be a cold shrinkage crack, likely due to a portion of the foundation being poured separately, as indicated by the different appearance of the concrete. While these cracks do not appear structurally significant, sealing all cracks is recommended to prevent water ingress and further deterioration. For added peace of mind, consider obtaining a professional evaluation of the larger crack.

Hairline crack

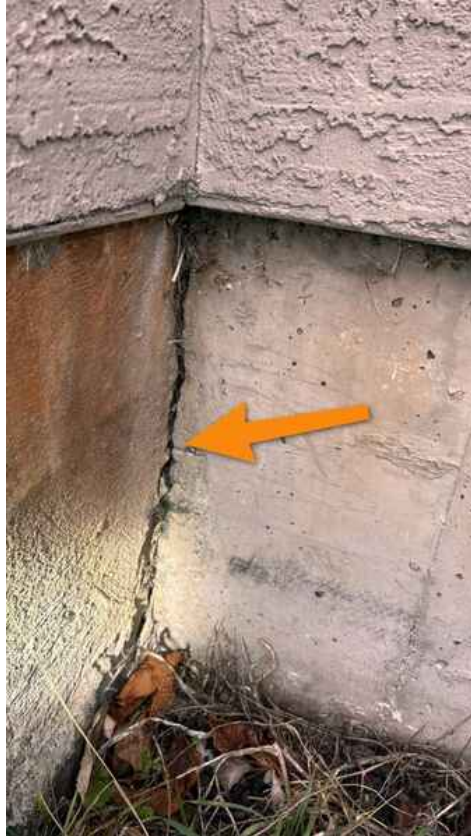
Crack, Differing concretes

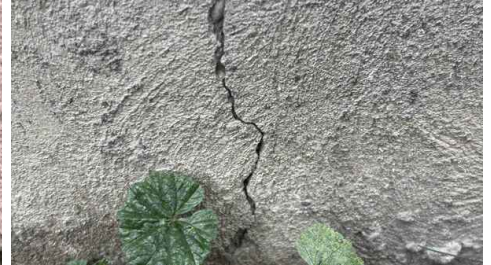
Minor crack

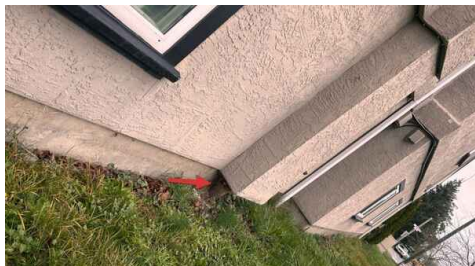
A cast iron drain, waste, and vent (DWV) pipe was observed on the property, including a vent stack on the roof, which appears to be part of the same system leading to the ground on the left side of the home. While cast iron piping was a durable choice in its time, this material is now past its expected service life and may pose risks such as leaks, blockages, or structural degradation. Additionally, its age may result in insurance implications.

Cast Iron Drain & Waste

It is strongly recommended to consult a licensed plumber to evaluate the condition of the DWV system and discuss options for replacement or remediation. Proactive measures can prevent potential failures and bring the system up to modern standards.

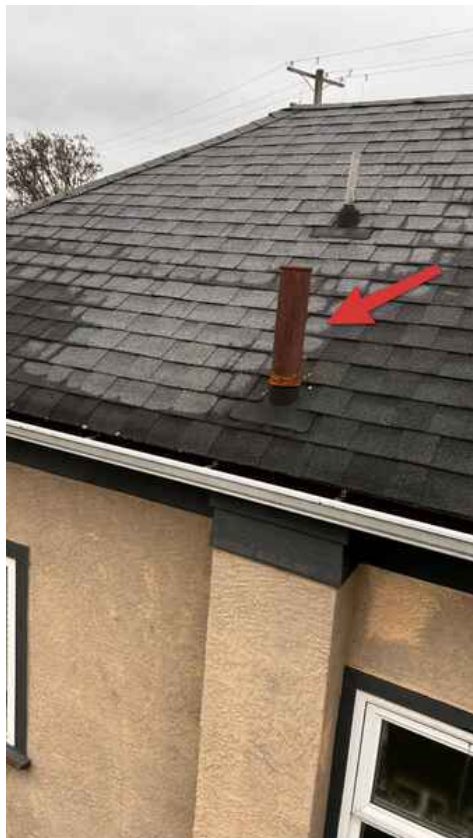
Cast iron Vent

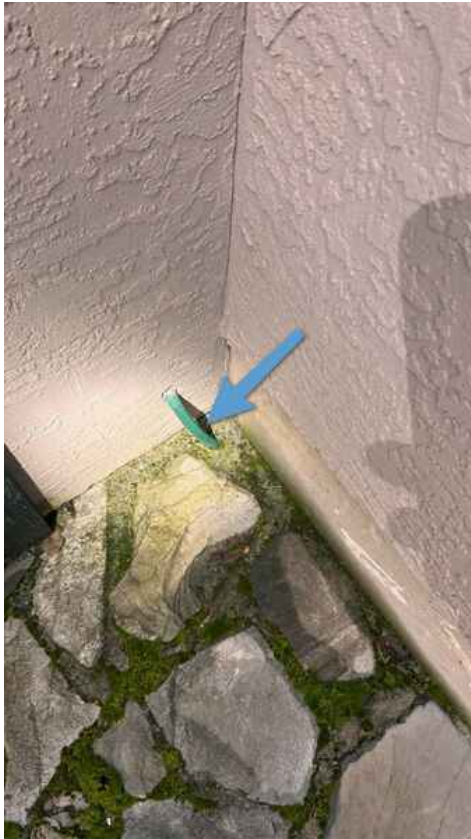
A temporary hose bib was observed on the property, which does not appear to be winterized and is likely at risk of freezing during colder months. Additionally, a standard green garden hose has been run underground around the house and through the front portion of the steps, seemingly to water the edges of the property. This setup poses a potential for leaks and may not be reliable or durable. It is recommended to terminate and remove the garden hose to prevent future issues and ensure proper water management.

Garden hose under grade

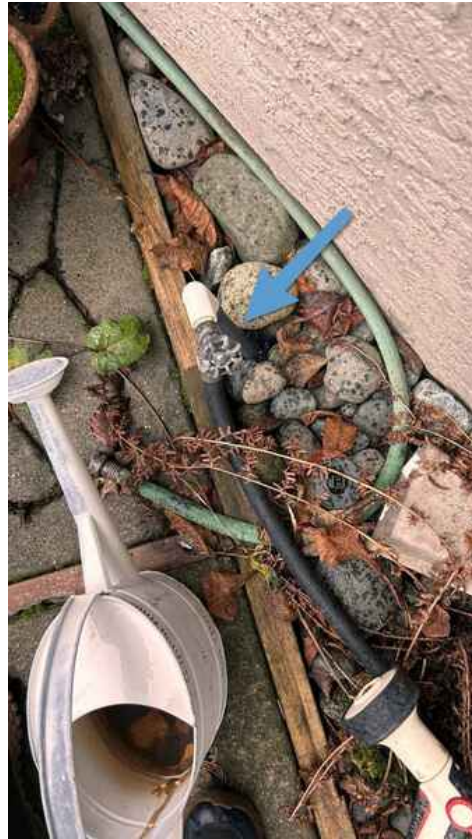
"temporary" hose bib Not winterized

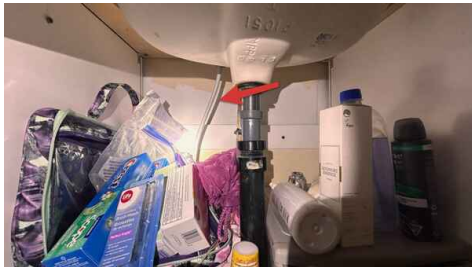
Underneath the bathroom sinks, some supply hoses leading from the copper stub-outs to the faucets were observed to be plastic. One hose appeared to be a gray plastic material, which could potentially be polybutylene (Poly-B)—a recalled material that is a known insurance concern. To avoid future issues or inspection red flags, it is highly recommended to replace all plastic hoses with steel braided hoses.

Possible Poly-B (easy upgrade to steel braided hoses)

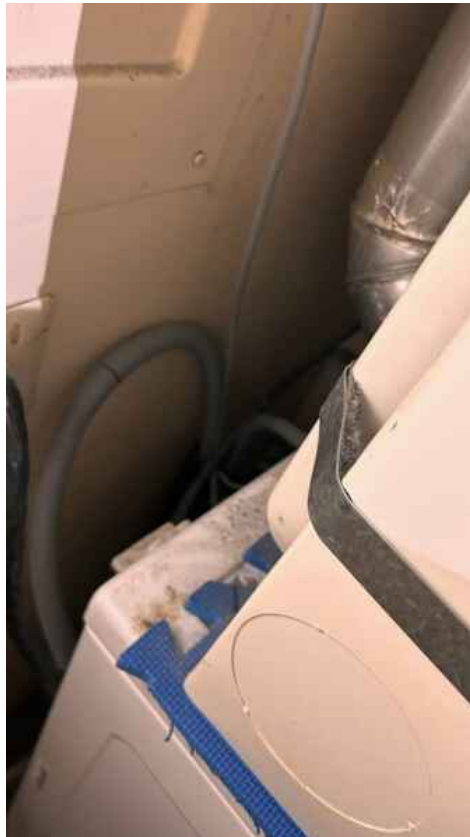
Additionally, the washing machine hoses were also plastic, a type known for its tendency to burst. Upgrading these to steel braided hoses is strongly recommended to reduce the risk of water damage and improve reliability.

Upgrade Laundry hoses to steel braided

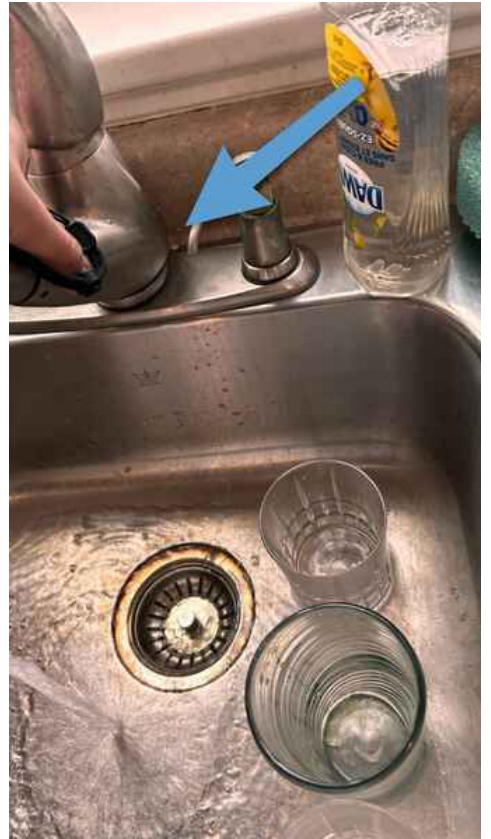
The kitchen faucet in Unit A was observed to be loose. This may affect its functionality and could lead to potential leaks if not addressed. Recommend securing or repairing the faucet upon possession to ensure proper operation.

Loose faucet assembly

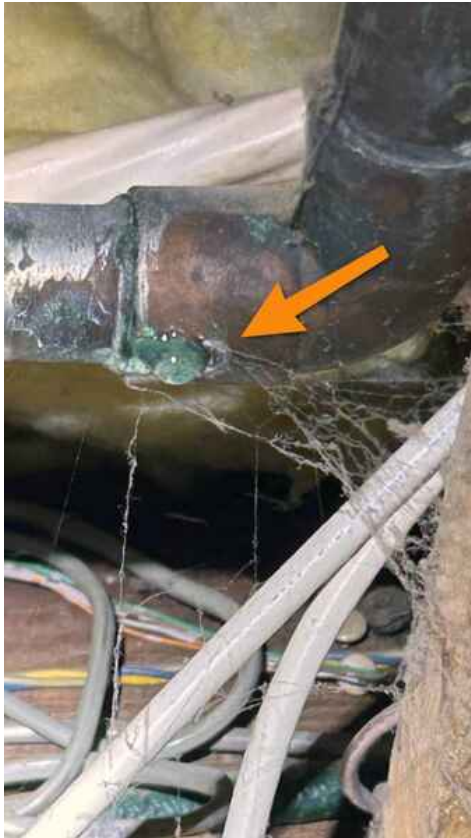
In the utility closet, a slight drip was observed on a pipe, with a single bubble of water present. While no active dripping or water pooling was noted or observed, it is recommended to have a plumber evaluate and address this issue.

Drip

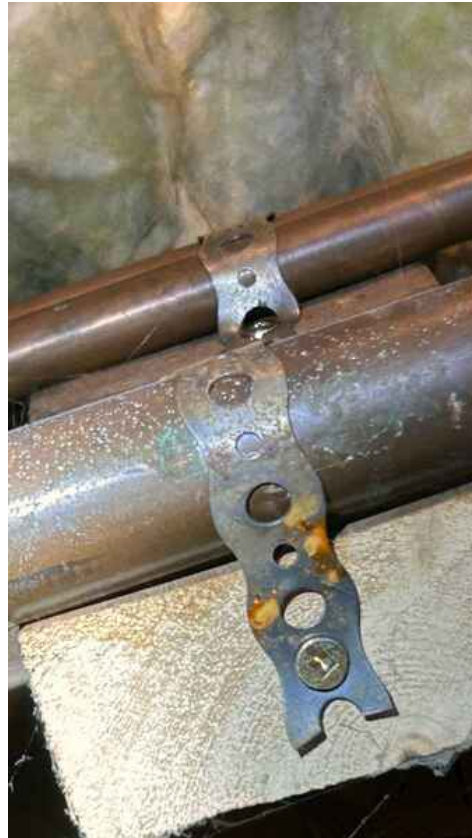
Additionally, a section of copper piping was supported by a stainless steel strap, which could lead to galvanic corrosion over time. Replacing the strap with a copper-compatible support is recommended to prevent metal reactions and maintain the integrity of the piping.

Different metals shouldn't be touching

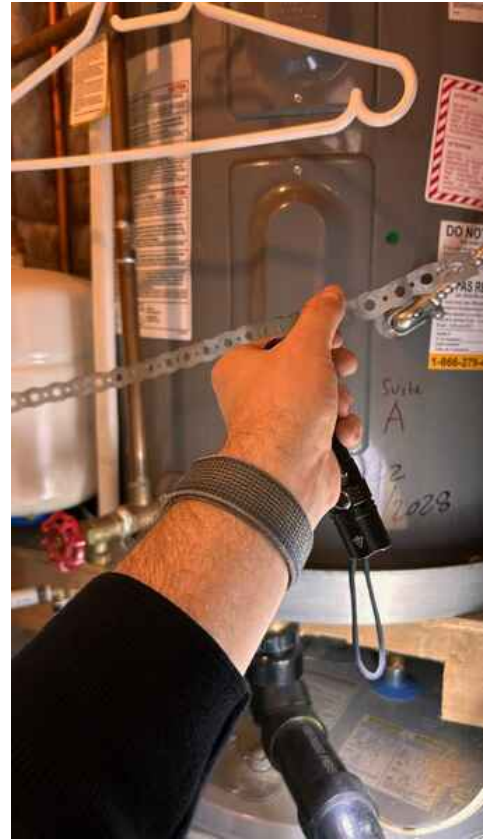
Two of the three hot water tanks were missing seismic straps, with one having a disconnected strap. It is recommended to install or reattach straps to secure the tanks properly.

Unhooked seismic strap

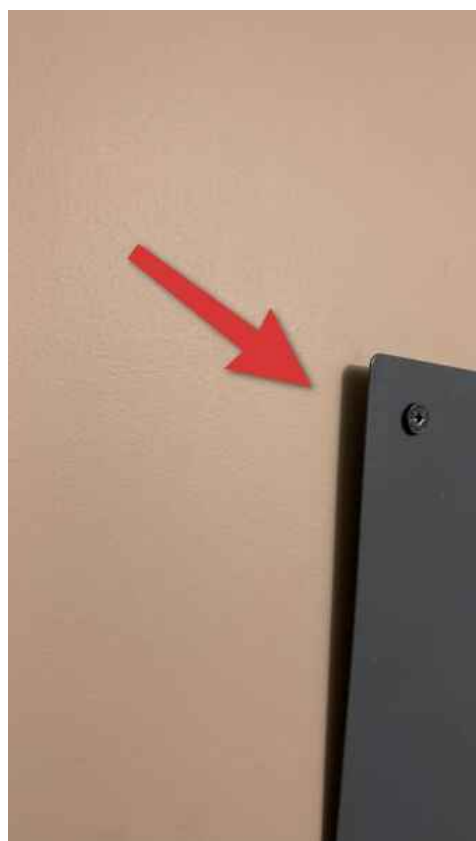
Unit C: The panel cover was observed to have screws that did not tighten securely, leaving the cover ajar in some areas. This could potentially cause the cover to fall off over time. Repairs are recommended to ensure the panel cover is secure and safe.

Cover screws don't hold tight (unit C)

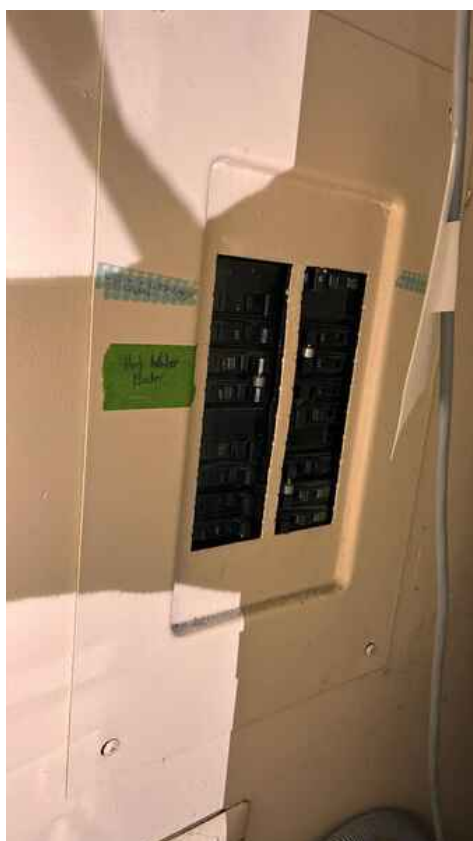
Inaccessible Panel (behind washer and dryer) Unit A

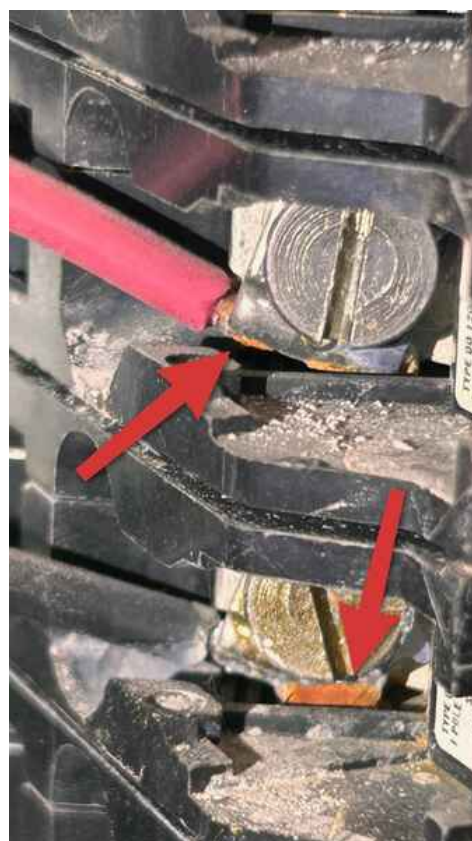
Unit B: The electrical panel showed signs of corrosion on some of the terminal connectors, likely due to humidity. It is recommended to have a licensed electrician assess and address this issue.

Possible corrosion issue (unit B)

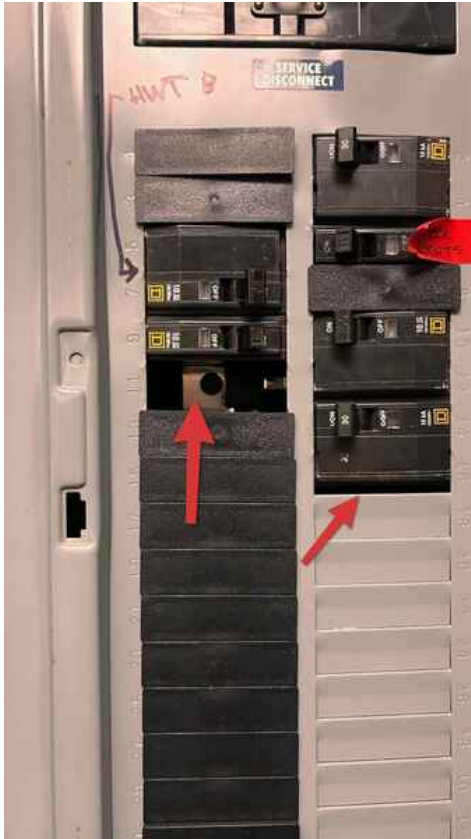
Main Panel (Laundry/Utility Room): The main panel had unprotected openings, compromising its ability to contain a fire as required. It was also missing a screw for the cover, which should be replaced to secure the panel properly.

Panel Openings (main panel)

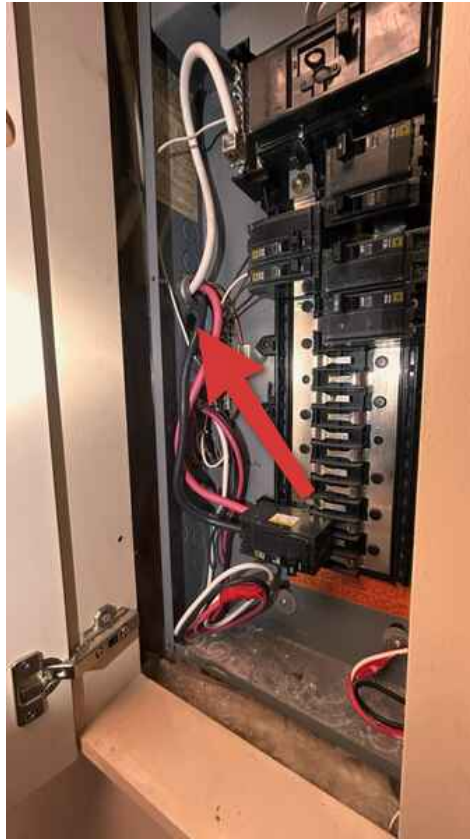
Missing Knock Out

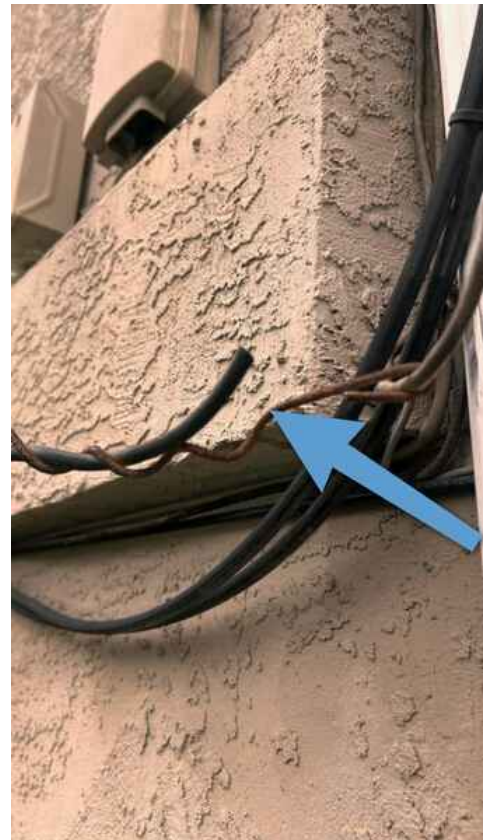
A wire likely belonging to a cable or internet service provider was observed to be improperly terminated and attached to another wire on the house using an old, rusty piece of metal resembling a coat hanger. While this setup is beyond the scope of a home inspection, it appears makeshift and may not meet professional standards. Buyers may want to contact the appropriate service provider to ensure the wiring is safely and properly installed.

Cable Improperly Terminated

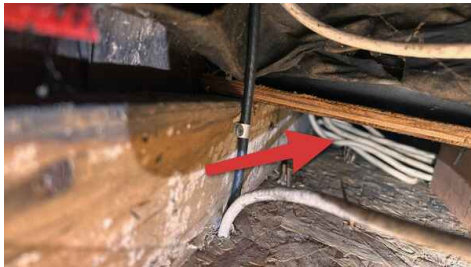
Underneath both sets of exterior stairways, improperly terminated open junction boxes with exposed conductors were observed. Additionally, beneath the rear entry stairway, an outdoor-rated cable was connected to standard Romex wiring, which is not suitable for outdoor use along with a spool of possible live romex. This connection appears to be improper and lacks a proper junction box.

Spool of possible live conductor in an outdoor environment

These conditions pose potential electrical hazards and should be addressed by a licensed electrician as soon as possible to ensure safety and compliance with proper standards. Immediate attention is recommended to prevent potential risks.

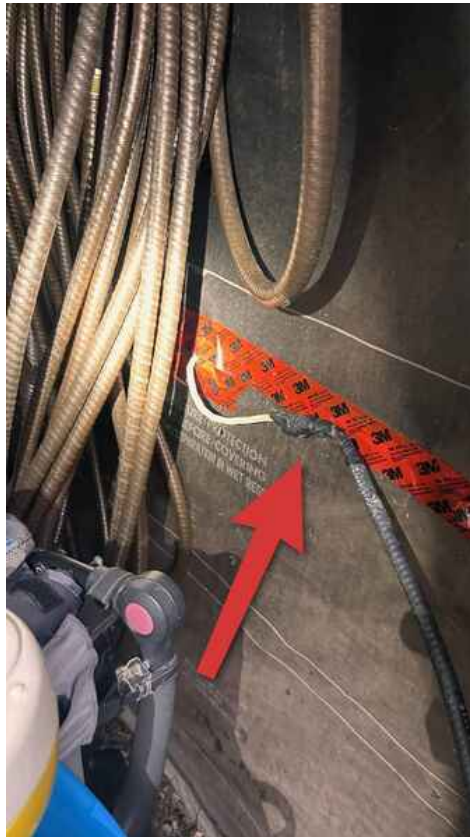
Improper connection

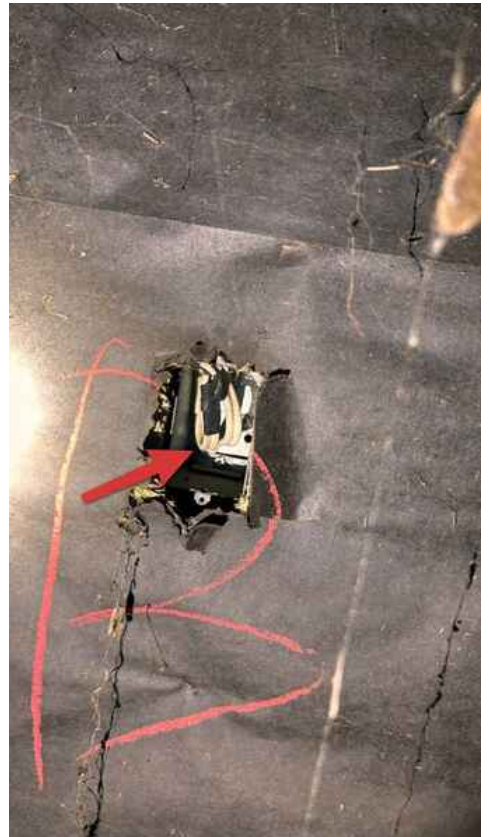
Improper termination

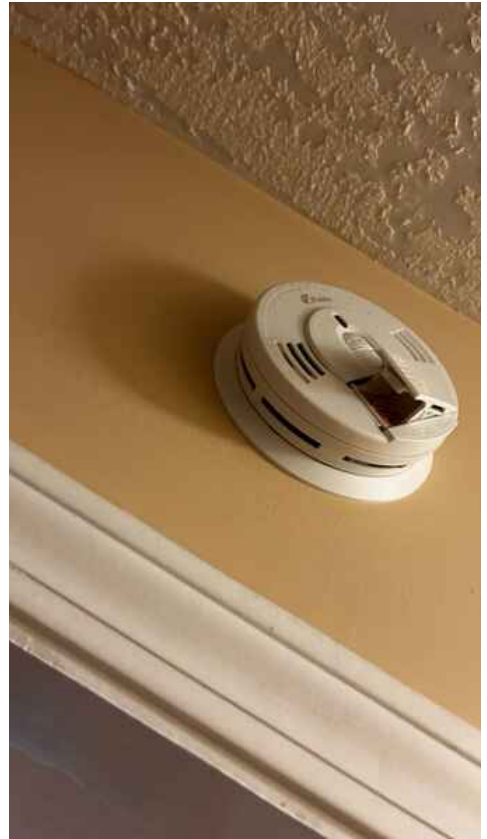
It is important to note that smoke detectors should be installed in each room and living space, as well as carbon monoxide detectors on every floor and near appliances that emit CO. These detectors can help ensure the safety of occupants by providing early warning in case of fire or the presence of dangerous levels of carbon monoxide. It is recommended to test these detectors regularly and replace batteries as needed to ensure they are functioning properly. There was an observed smoke detector without a battery in unit A. This is a life safety issue.

Smoke detector with removed battery (unit A) Very Dangerous!

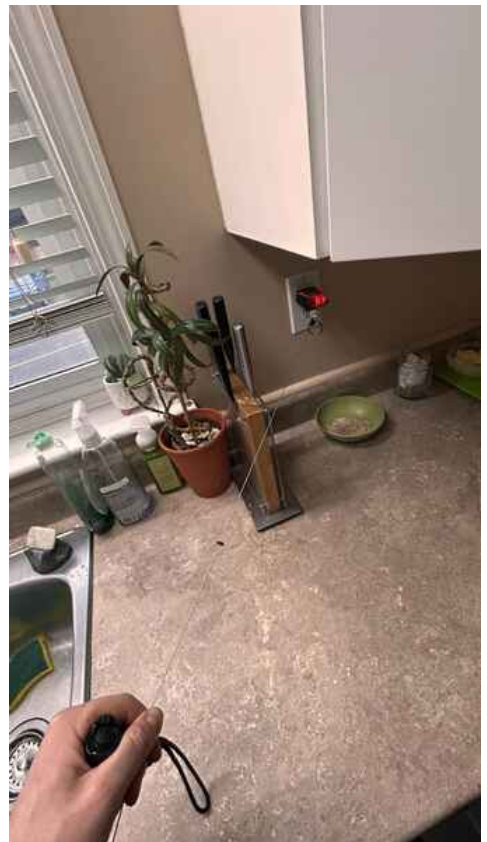
None of the kitchen outlets near sinks or other water sources in any of the units were GFCI protected, which is a recommended safety feature to reduce the risk of electrical shock. However, all bathroom outlets were equipped with GFCI protection. It is advised to have a licensed electrician install GFCI outlets in the kitchens, particularly near water sources, to enhance safety and bring the property in line with modern standards.

Kitchen not GFCI protected

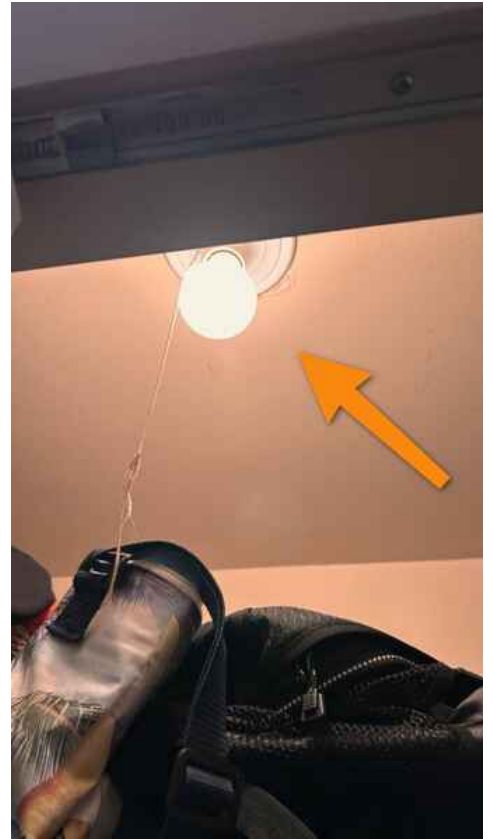
Most closets in all units were observed to have exposed lightbulbs. As a safety measure, it is recommended to install protective cages around the lightbulbs to prevent mechanical damage and reduce the risk of broken glass. This is a simple upgrade that enhances safety and minimizes potential hazards.

Unprotected Bulbs

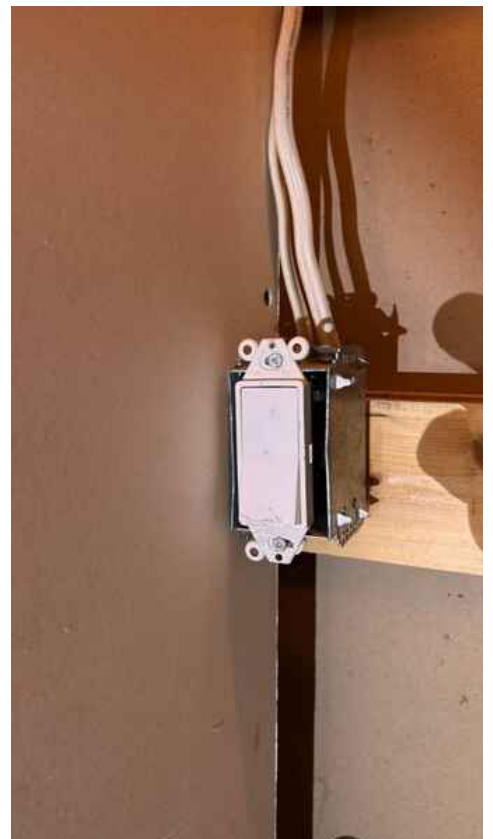
The light switch in the utility closet housing the hot water tanks was missing a cover plate, leaving the junction box and switch exposed. This poses a minor electrical safety hazard. It is recommended to install a cover plate to ensure safety and compliance with electrical standards.

Needs proper cover

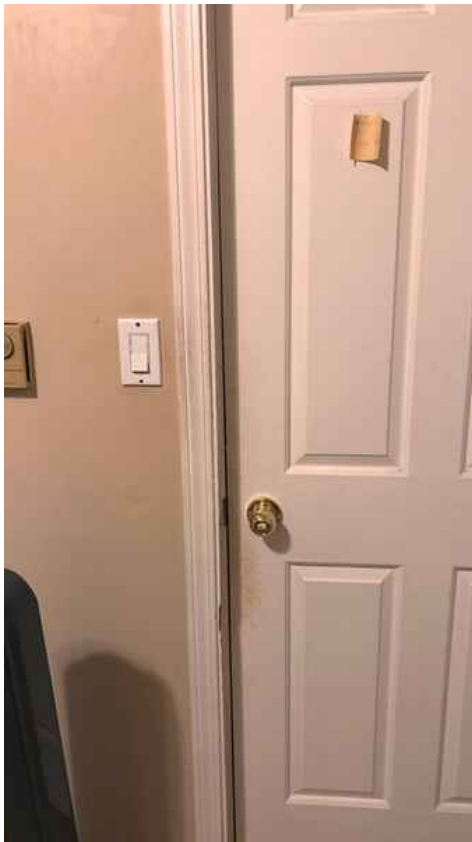
A few closet doors throughout the property were observed to be either completely off their tracks or close to falling off. Along with a bedroom door in unit B that seemed to be out of alignment. These doors will require adjustment or repair to restore proper functionality.

Unit B Bedroom door misaligned

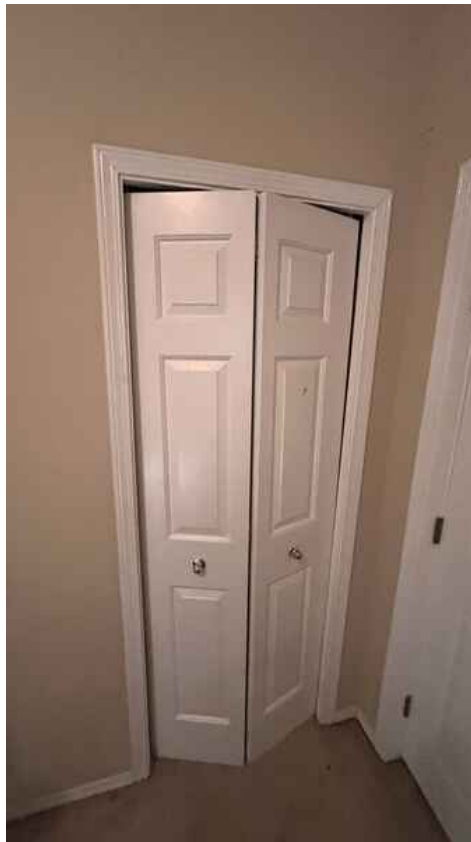
Closet (very full, damaged)

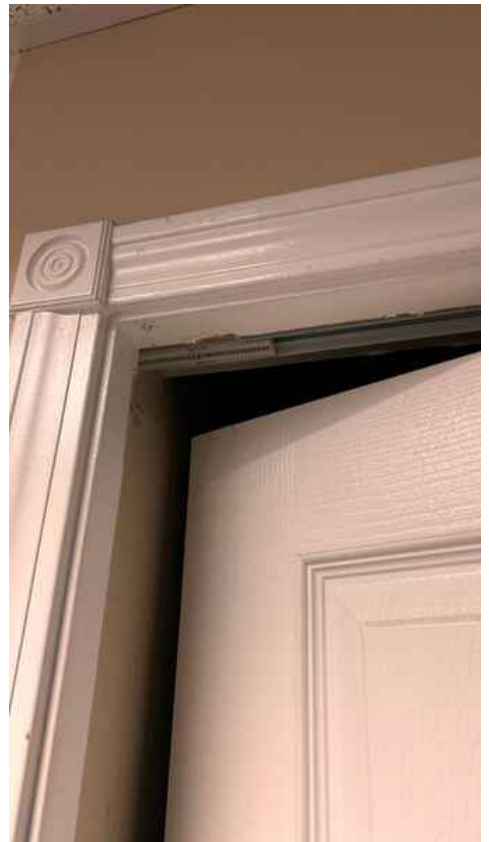
Utility closet off track
