WATCHTOWER
HOME INSPECTIONS

RESIDENTIAL REPORT

7124 Willis Point Road, BC

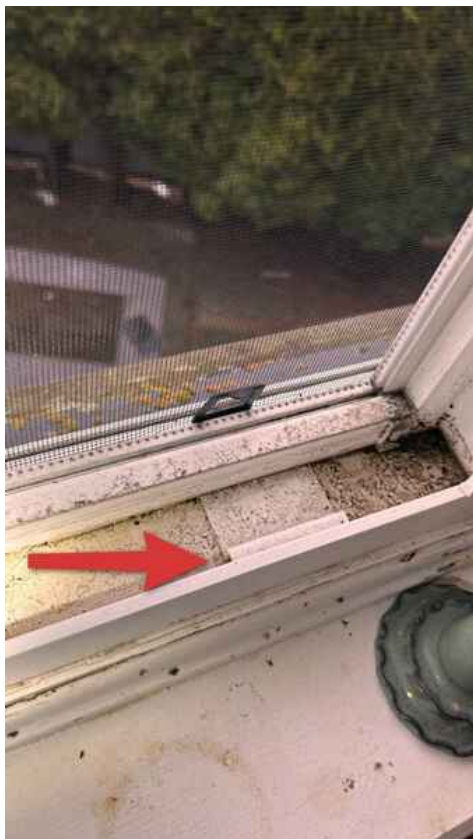
Several windows throughout the property, particularly in Unit B, exhibited moisture inside the window tracks. In one case, the moisture was significant enough to form pooling. The exact cause of the moisture is undetermined and could be due to internal humidity or potential exterior water intrusion. Further evaluation by a professional is recommended to identify the source and address any necessary repairs or adjustments. This could be contributing to the mold issue noted in the Environment section of this report.

Water pooling in track

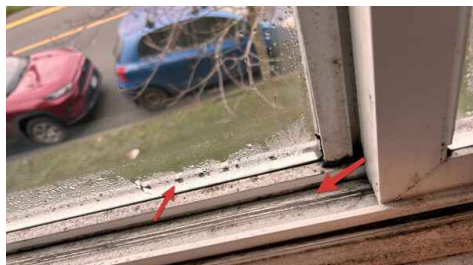
Moisture

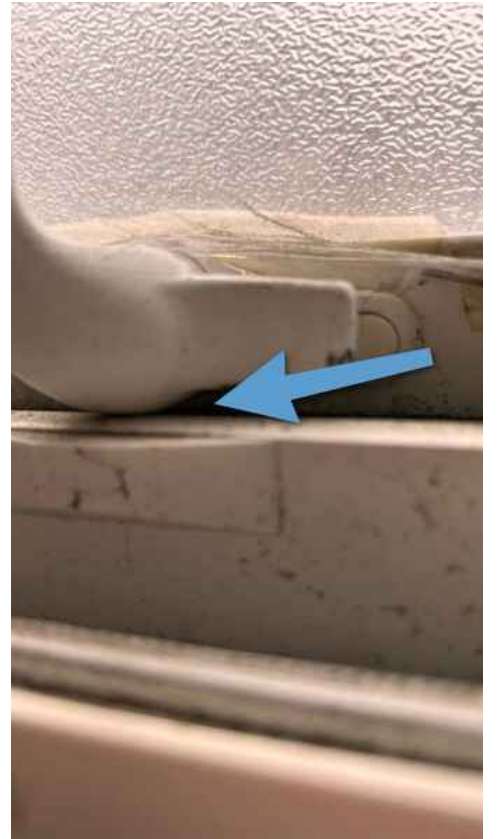
The bathroom awning window in Unit C was observed to be out of alignment, causing it to hit the handle when opened and closed. Adjusting the window alignment is recommended to restore smooth operation.

Hadle hitting frame

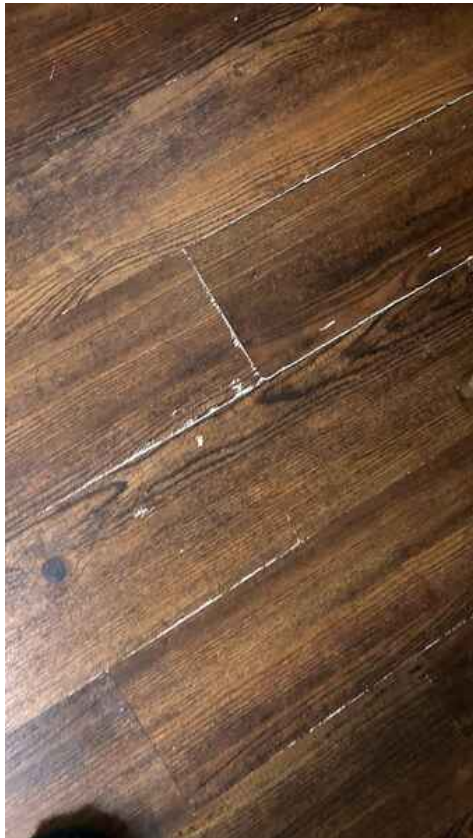
Several cosmetic issues were noted throughout the property, including heavily stained carpets in one of the bedrooms in Unit B, misaligned cabinets, and scuffed laminate flooring. While these items are beyond the scope of a standard home inspection, they are mentioned here as a courtesy. Buyers should be aware that additional cosmetic concerns may exist and are encouraged to evaluate these as part of their own assessment.

Worn laminate

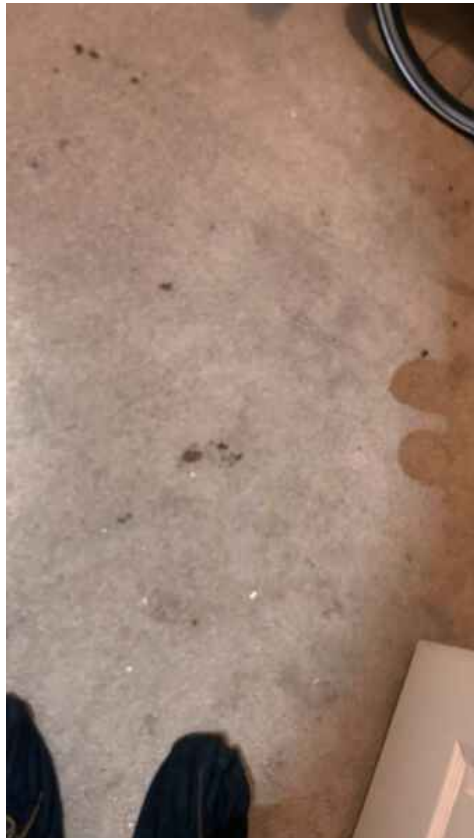
Stained Carpet

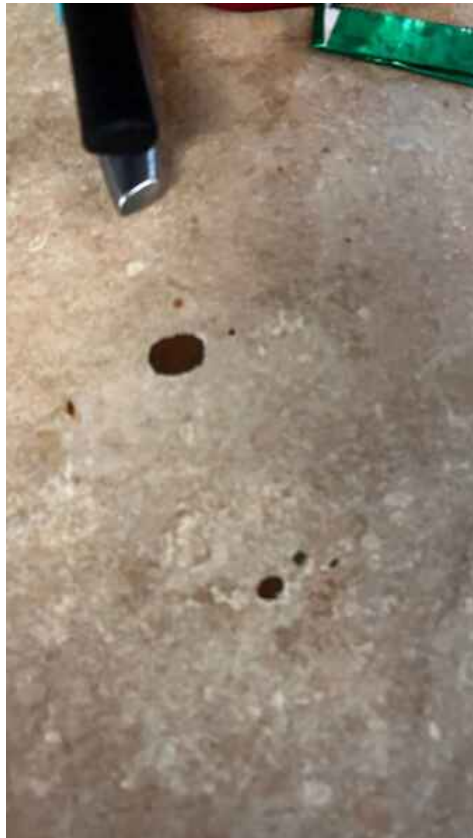
Counter top scuffs

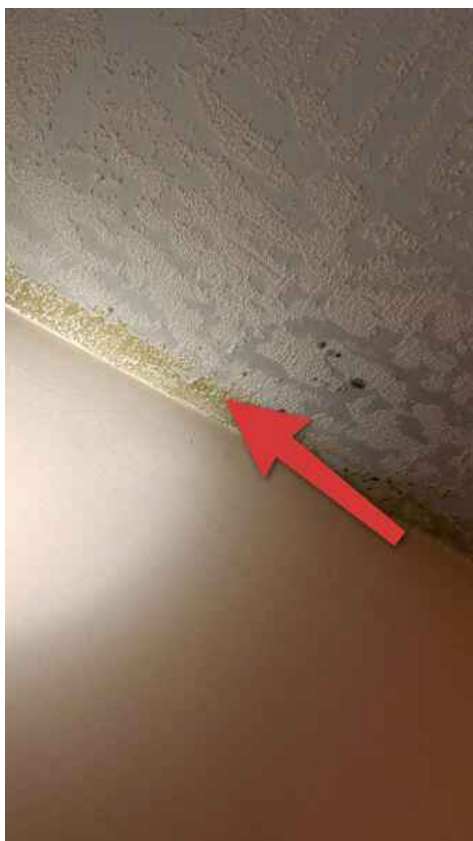
One of the bedrooms in Unit B exhibited what appeared to be mould/ discolouration on the edge of the ceiling. A thermal camera scan indicated this area was slightly colder than the rest of the ceiling (typical for the edge of any room/ceiling). While a moisture meter test showed dry readings, this result is inconclusive. Further evaluation is strongly recommended due to potential environmental hazards and the inability to access the attic for a more thorough assessment.

Ceiling Stain

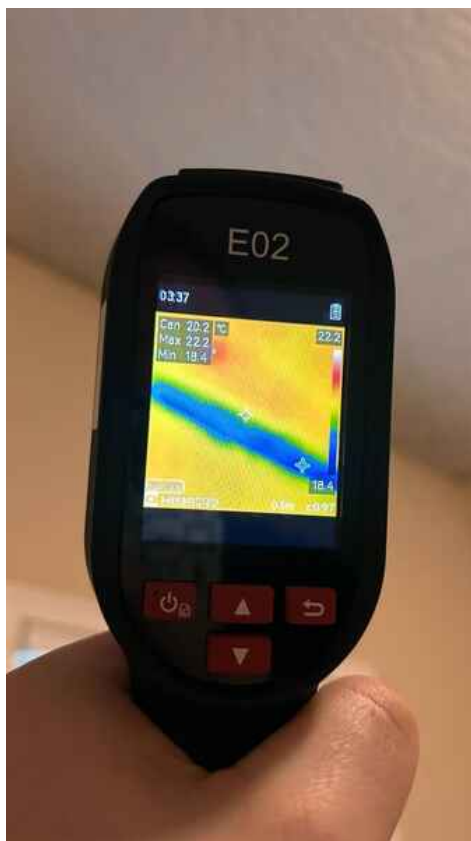
Thermal image of ceiling (cold spot tested dry)

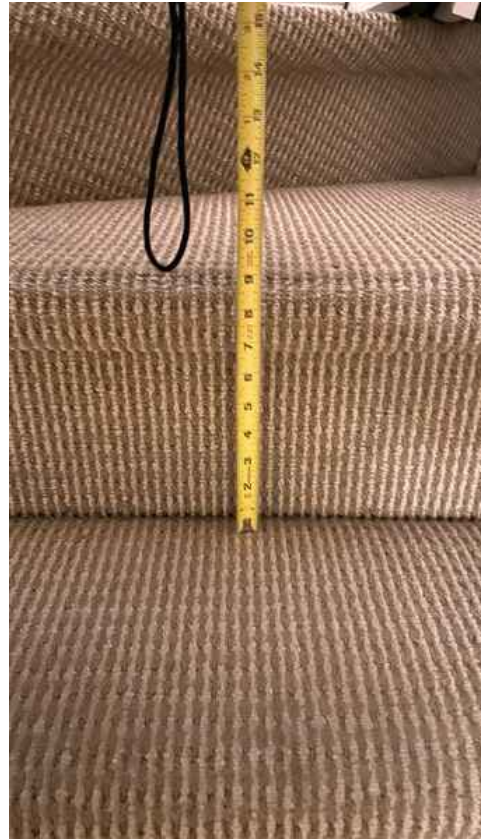
The stairs leading down to the bedroom in Unit A were observed to be non-uniform, with a height variance of approximately one inch. This could pose a potential trip hazard. While repairing the stairs may not be practical, being aware of the issue is important for safety.

This step was 9 inches, Rest were 8 inches

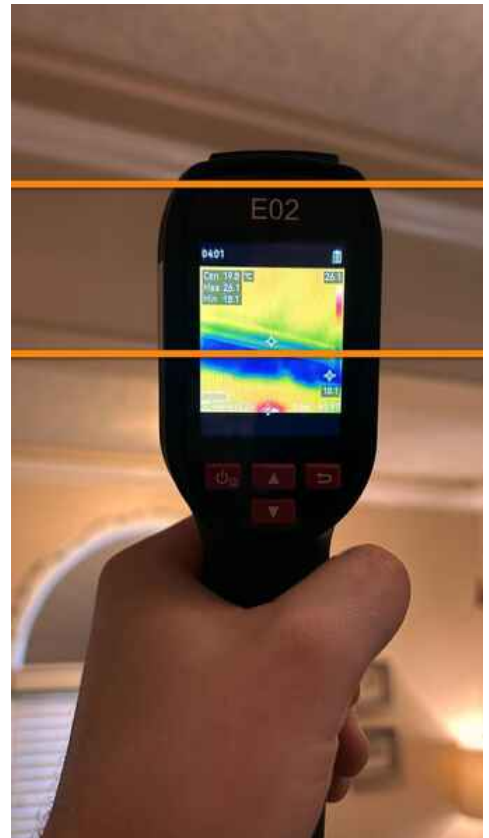
Cold spot is 18 while the rest of the room is 26

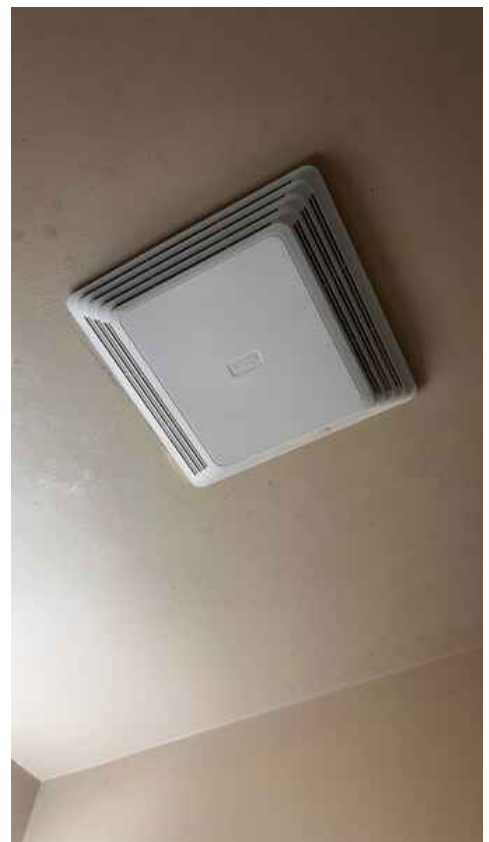
Inefficient Bathroom Fans

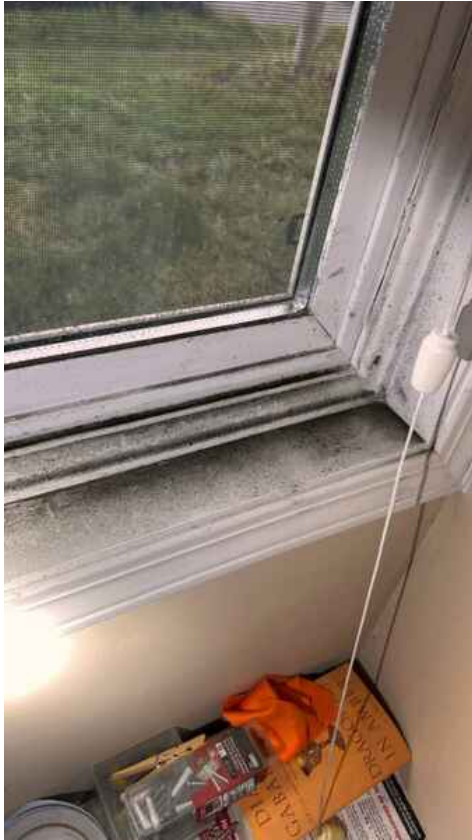
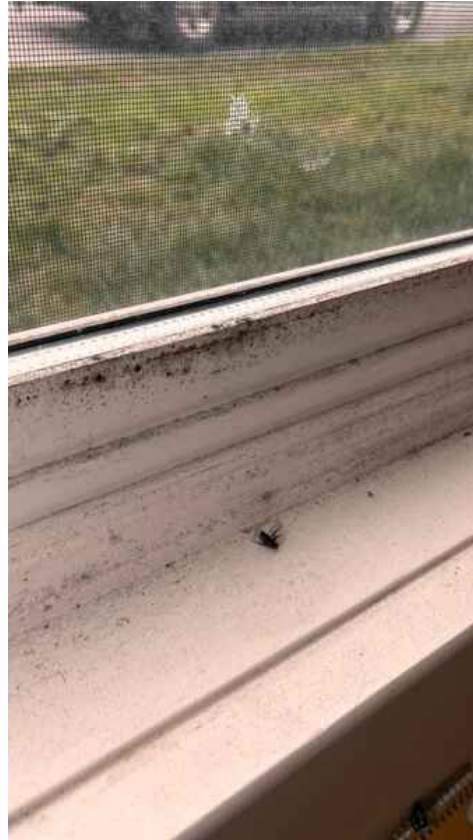
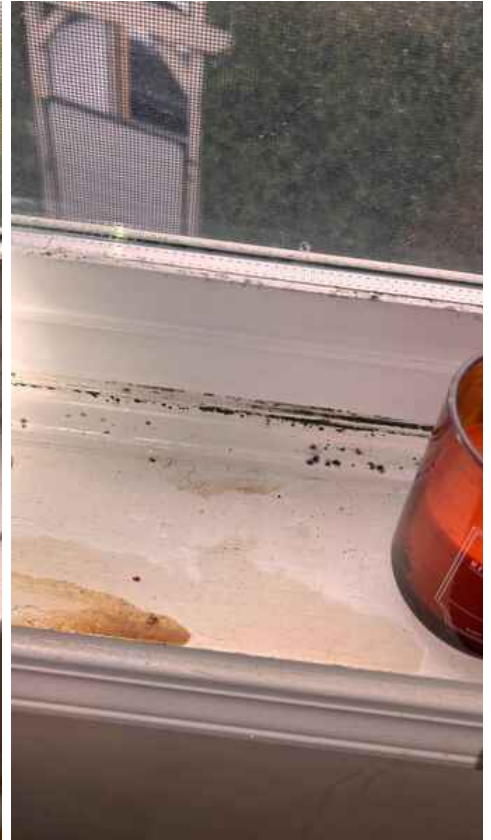
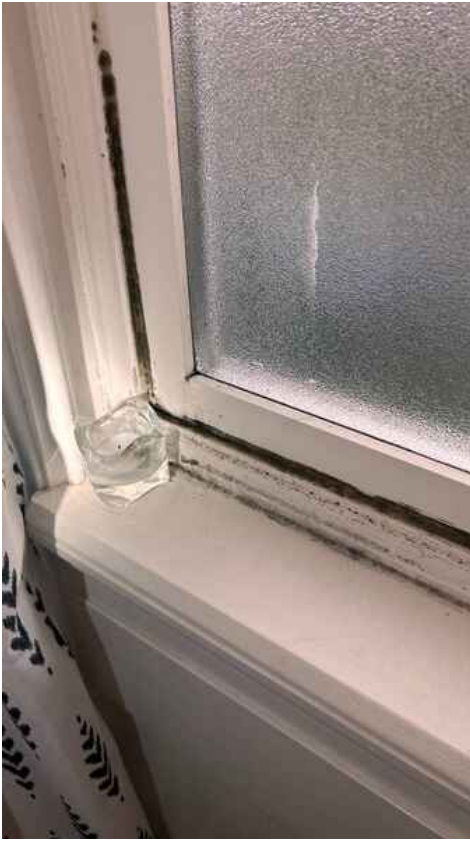
Suspected mold growth was observed throughout the property, particularly on window frames in all three units. In Unit B, significant suspected mold was noted along the edges of the ceiling in one of the rooms. This condition indicates possible issues with moisture control or ventilation and poses a potential health risk to occupants. Recommend further investigation by a qualified mold remediation professional to determine the extent of the issue and perform appropriate remediation. At a minimum, a professional cleaning team is recommended. Address prior to subject removal to ensure the cause of the moisture is resolved, and necessary repairs are completed.
