**WATCHTOWER**  
HOME INSPECTIONS

## RESIDENTIAL REPORT

7124 Willis Point Road, BC

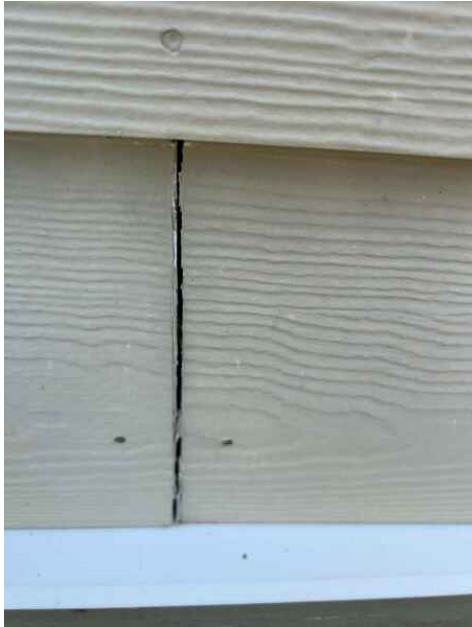
Routine caulking maintenance is recommended around the exterior of the property, including around windows and in small gaps in the siding. Proper caulking helps prevent moisture intrusion and ensures the home's exterior remains well-sealed. It is advised to inspect and reapply caulking where needed upon possession to maintain the home's integrity.

Caulk Gap in siding

Caulk trim

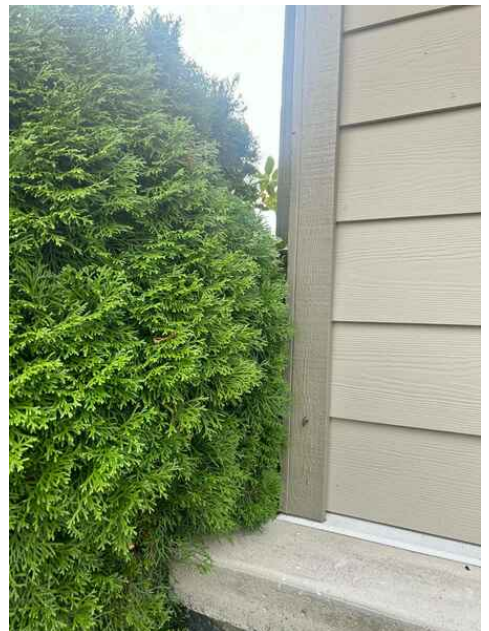
Vegetation was observed to be too close to the siding and structure of the home. This can trap moisture and potentially lead to damage or pest intrusion. It is recommended to trim the vegetation back to maintain at least a 3-foot clearance from the home. Address this upon possession to help protect the siding and foundation.

Trim back all vegetation 3 feet

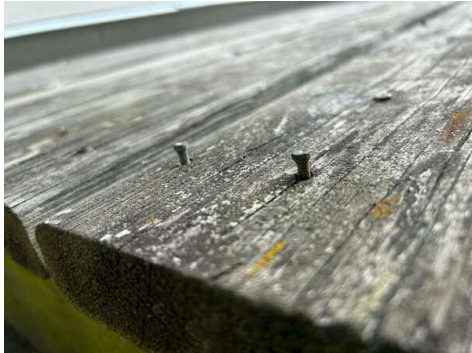
The step/platform leading to the rear entry French doors on the back patio is poorly constructed, showing signs of rot, exposed and proud nails, and an uneven step pattern. This poses a safety hazard. It is recommended to replace the current step/platform with a professionally built set of stairs to ensure safety and durability. Address this upon possession to prevent potential injuries.

Proud Nails

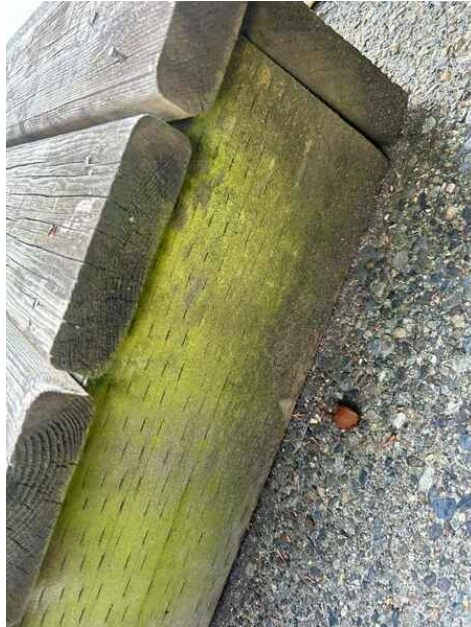
Signs of rot/decay

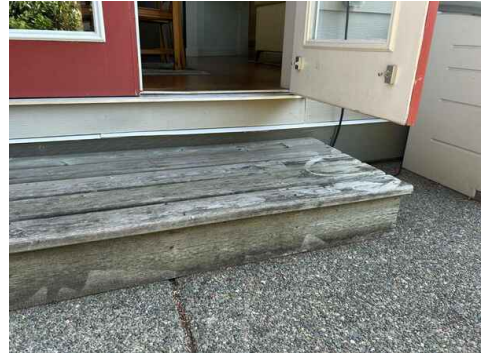
Un-uniform Risers (steps)

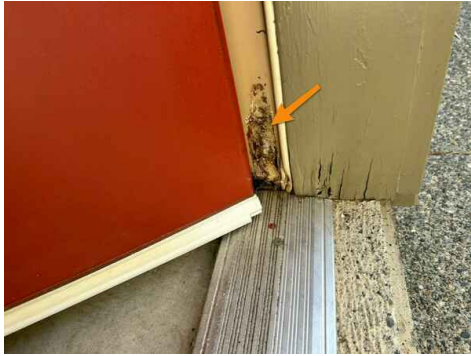
The garage man door leading to the exterior on the left-hand side of the property was showing slight signs of rot in the inside trim of the door frame, and daylight is visible from the interior, which could allow pests and weather to enter. The source of moisture is currently unknown. It is recommended to have this area inspected and repaired to prevent further deterioration. Investigating and addressing the moisture source upon possession will help prevent additional damage and improve weatherproofing.

Door Frame Damage

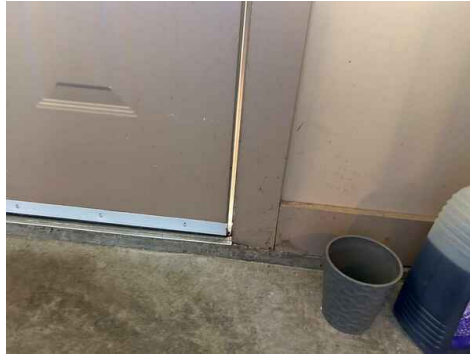
Visible Light through weather stripping

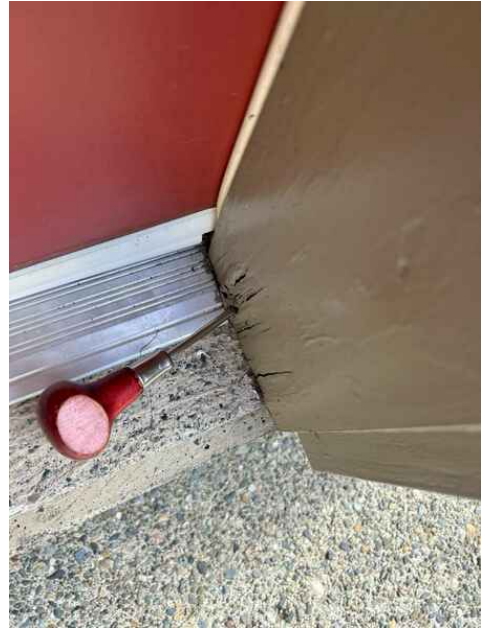
Trim Rot

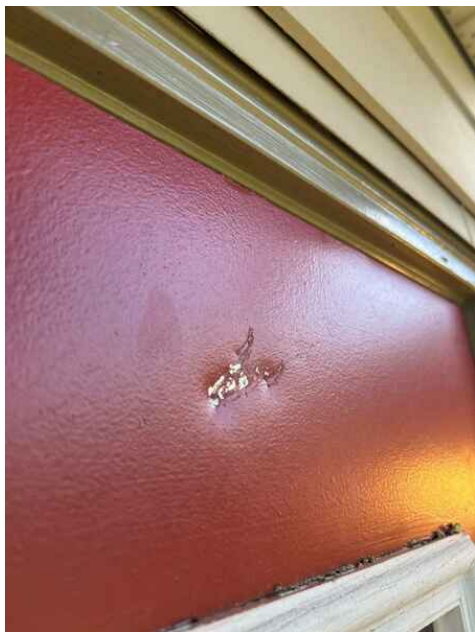
One pane of glass in the French doors at the rear entry of the home has a lost seal, and the bottom lock on the other door would not engage during the inspection. It is recommended to repair or replace the glass pane to prevent further deterioration and address the lock issue to ensure proper security. The surface of the door was also dented due to swinging and hitting the light fixture. These repairs should be made upon possession to restore both functionality and security.

Dented Door

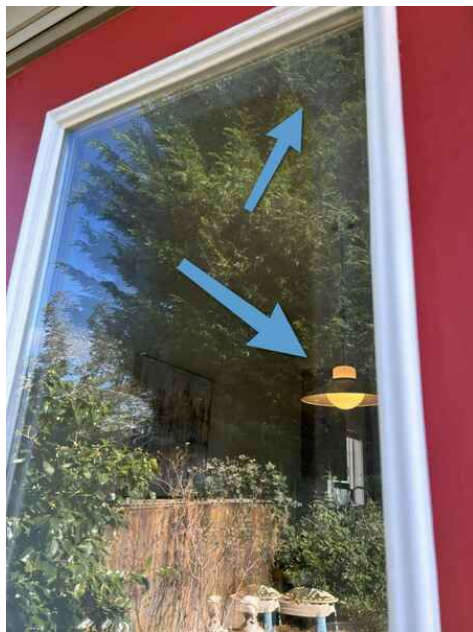
Lost seal

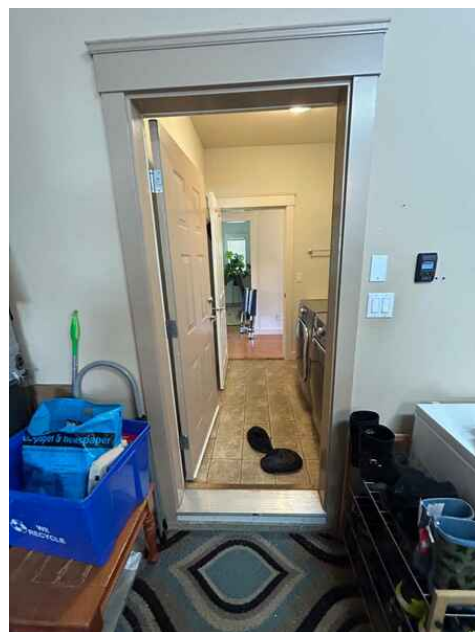
The man door from the garage leading into the living space is not self-closing, which is important to prevent exhaust fumes from vehicles entering the home. It is recommended to install or repair a self-closing mechanism on the door to ensure safety. This is a life safety issue. Address this upon possession for improved safety and air quality.

Man door needs to self close

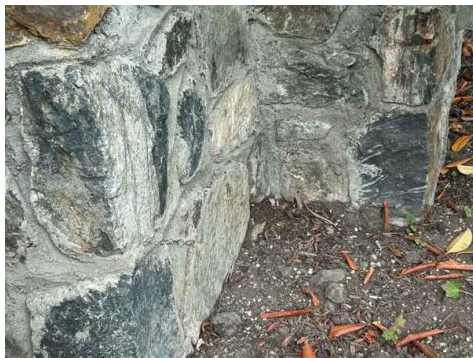
Several areas in the front of the property, including the stone veneer, were observed to be too close to grade. The general slope of the front lawn is slightly leaning toward the house in areas, which could cause water to collect near the foundation or enter the garage. A portion of the garage trim was showing signs of rot because of contact with grade.

Stone veneer, in particular, can act like a hard sponge and absorb water if too close to the ground. A few spots on the left side of the house were also noted to be too close to grade. It is recommended to adjust the grading or take other measures to prevent potential water damage to the home.

Stone Veneer touching Grade

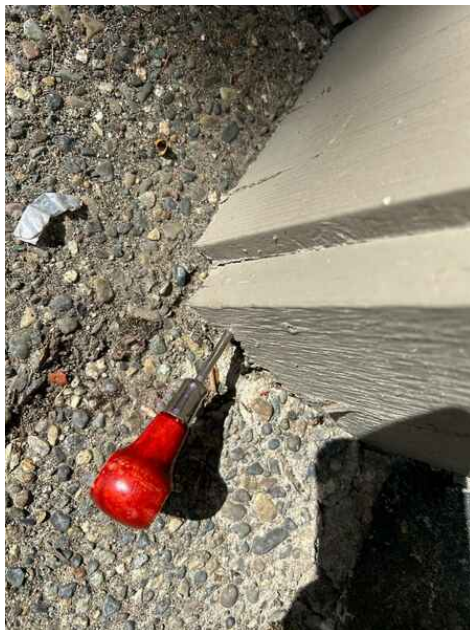
Garage Trim Slightly Rotting

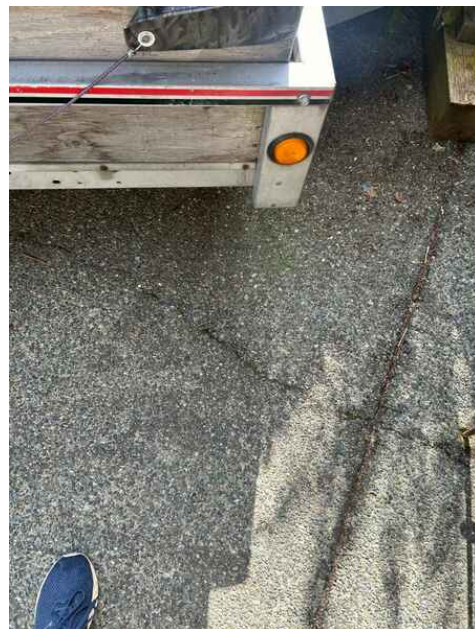
Small cracks were observed in the walkway around the house and the patio. These are common in exterior concrete and do not pose immediate concerns. However, it is recommended to monitor the cracks and seal them if they begin to widen, to prevent further deterioration.

Cracks

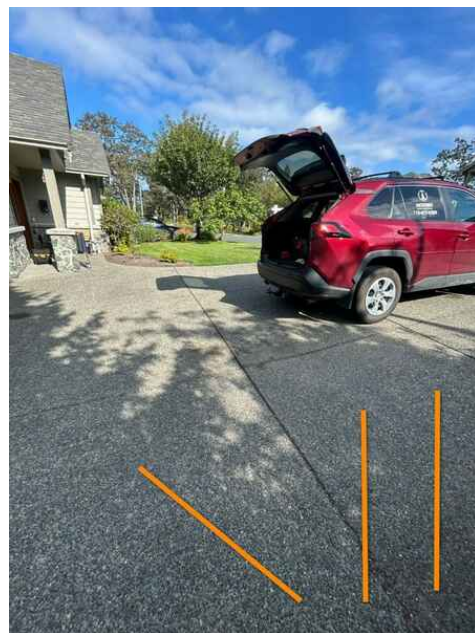
There is no visible drain on the left front portion of the driveway leading to the back gate, which could result in water pooling against the retaining wall during heavy rainfall. It is recommended to ask the seller about any history of water pooling during intense rain periods. Adding a proper drain in this area may be necessary to prevent potential water accumulation.

Path of water could cause pooling

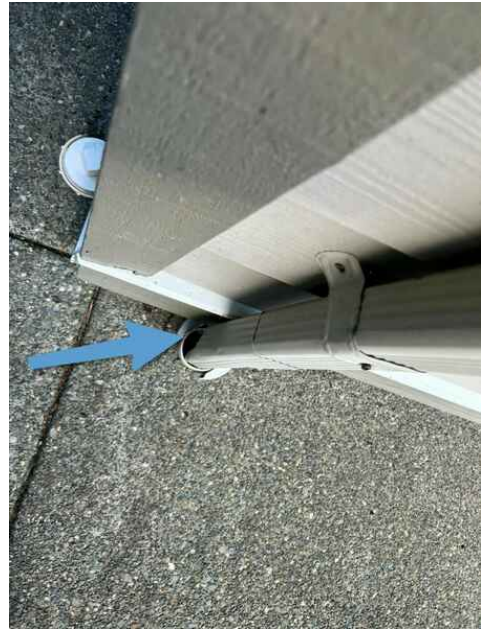
Throughout the property, the risers for the perimeter drainage were slightly exposed. It is recommended to cover these risers and ensure that the downspouts are fully directing water into the perimeter drainage system. This will help protect against potential water accumulation and ensure proper drainage. Address this upon possession to maintain effective water management.

Add cover

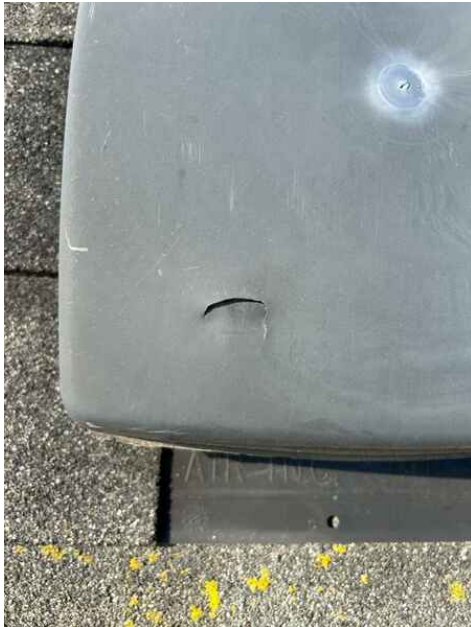
The roof is showing signs of wear and moss build up, including granular loss on certain sides depending on the roof's orientation, cracked shingles, missing drip edge flashing and kick-out flashings, and a few shingle bulges. Exposed fasteners were also observed, with one fastener penetrating through a shingle. Additionally, a crack was noted in one of the box vents. At a minimum, roof maintenance/ clean up upon possession is essential. A roofing expert should assess the roof to provide a better estimate of its remaining lifespan and recommend any necessary repairs.

Cracked Roof Vent

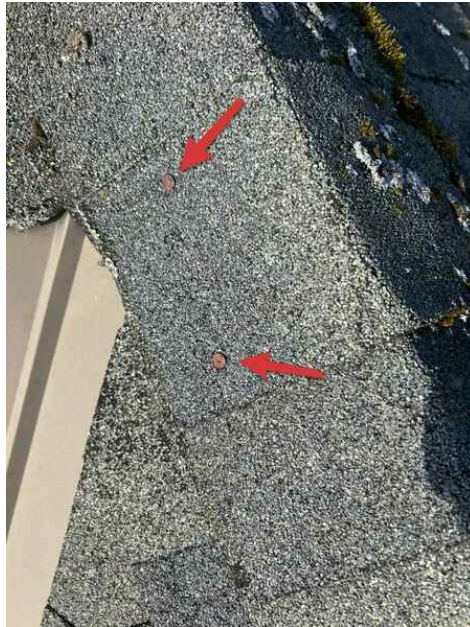
Exposed Fasteners

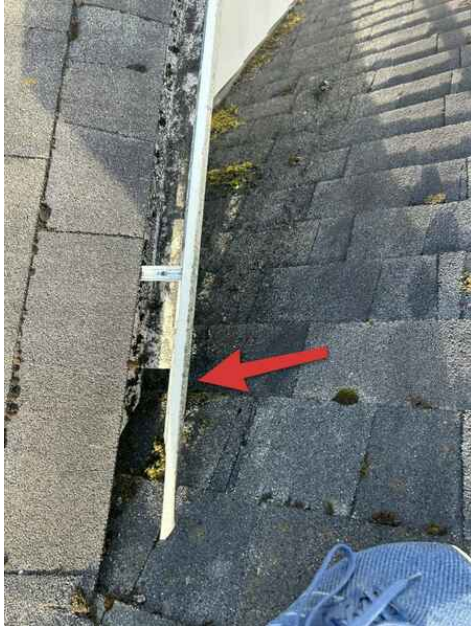
Gutter draining directly onto roof surface

Add downspouts

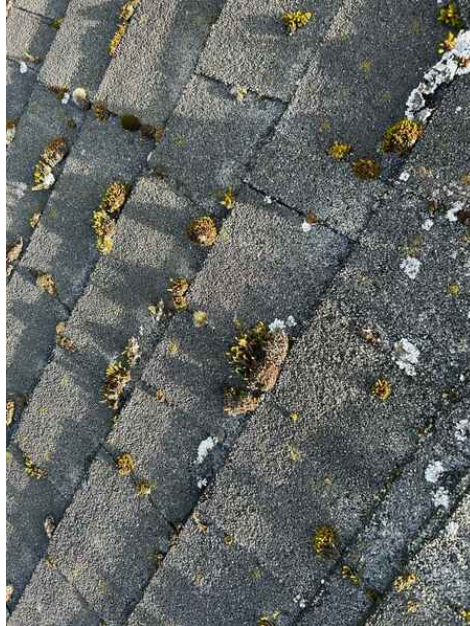
Moss build up

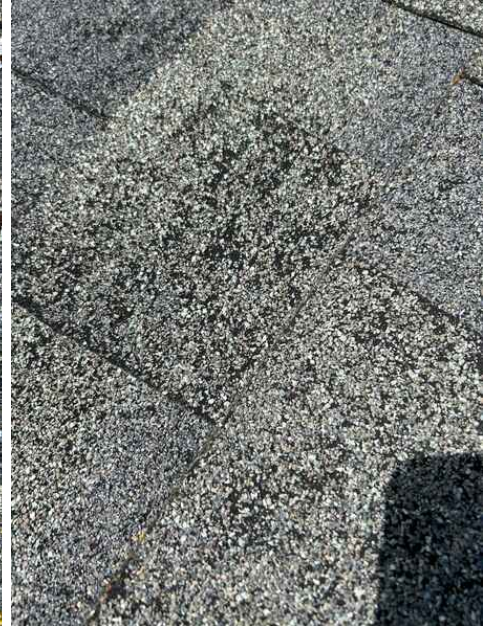
Granular loss

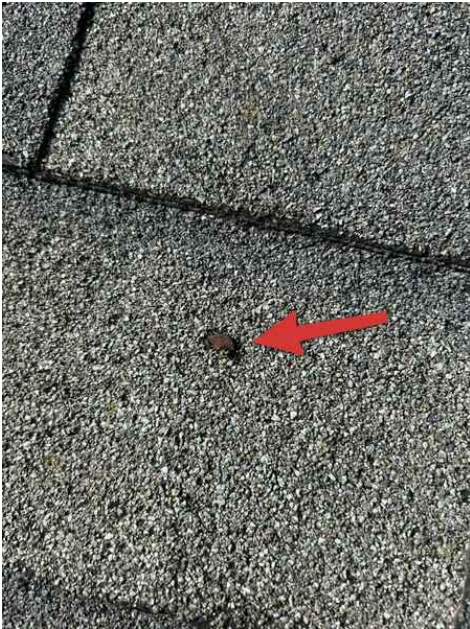
Penetrated Fastener

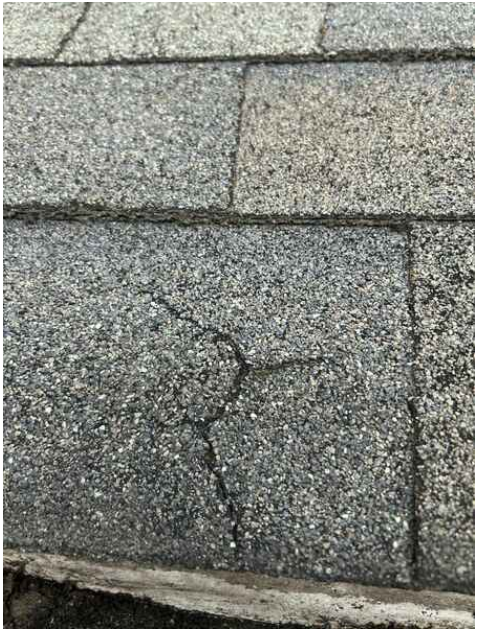
Bulging Shingle

Cracked Shingle

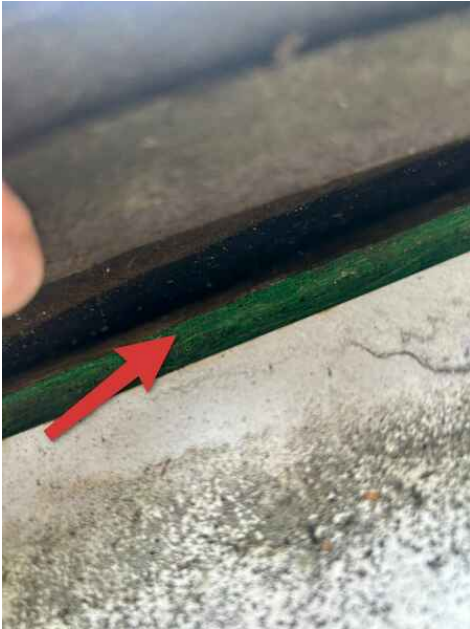
Missing Drip Edge Flashing

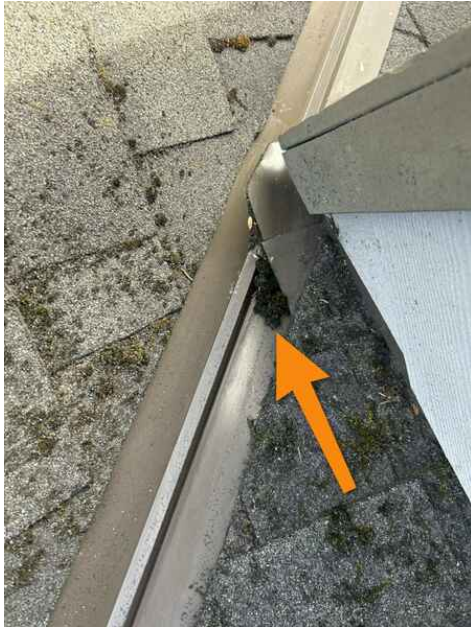
The roof design has an area where a valley flashing is exposed through the step flashing of a dormer. Additionally, many gutters are draining directly onto the roof surface, which can lead to premature shingle wear. It is recommended to add downspouts during the next major roof replacement to improve drainage and extend the life of the shingles. Addressing these issues will help prevent unnecessary wear and maintain the roof's integrity over time.

Valley Flashing Running Through Step Flashing

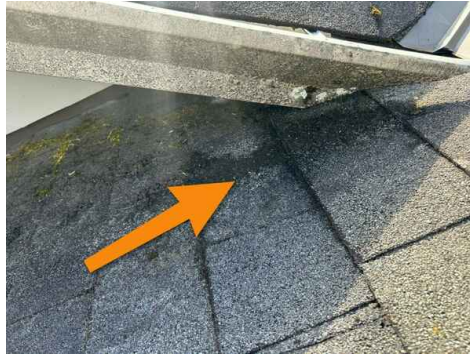
Premature Shingle Wear, Add Downspout

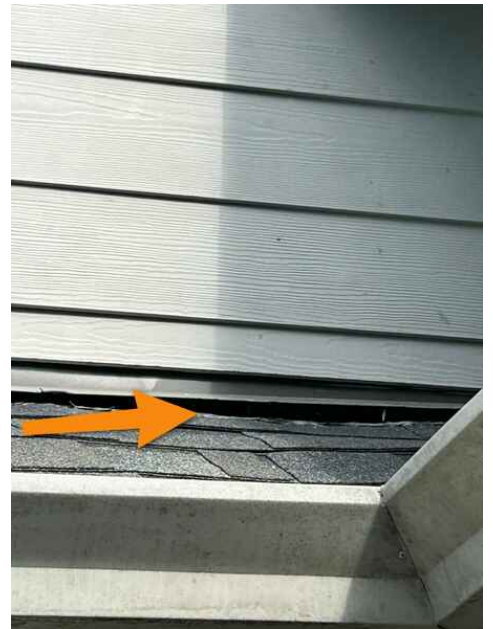
One of the lap flashings on the left side of the home was observed to be slightly uplifted, which could allow wind driven water to penetrate and potentially cause moisture damage. It is recommended to have a roofing professional secure the flashing upon possession to prevent any future water intrusion issues.

Uplifted Flashing

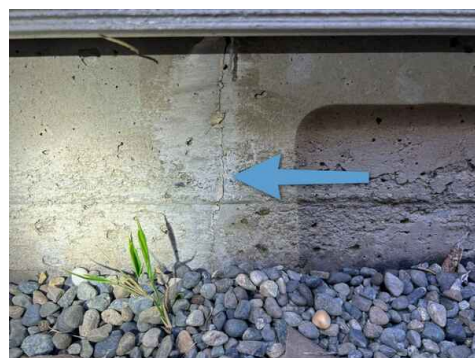
A very minor foundation crack was observed on the right side of the home, and it has already been sealed. This appears to be a routine repair, and no further action is required at this time. However, it is recommended to periodically inspect the area to ensure the seal remains intact.

Minor Shrinkage Crack

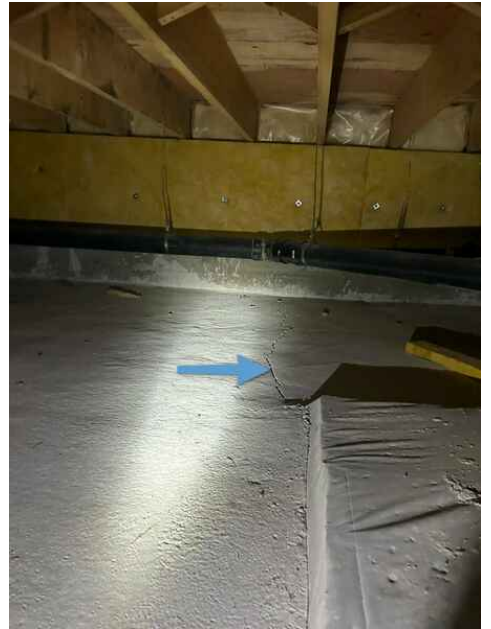
Several small cracks were observed in the crawlspace slab. However, the overall condition of the crawlspace is clean and well-insulated. These minor cracks are typical and not currently a concern, but it is recommended to monitor them over time to ensure they do not worsen. No immediate action is required.

Small Cracks

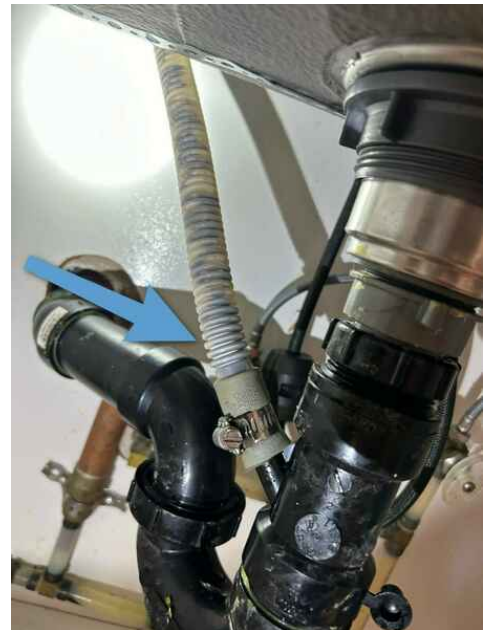
The dishwasher drain hose, where it connects to the tailpiece just before the P-trap, shows a significant amount of waste buildup. It is recommended to have the drain hose flushed, cleared, or cleaned to ensure proper drainage and prevent potential backups. Addressing this upon possession will improve the dishwasher's performance.

Clean Drain

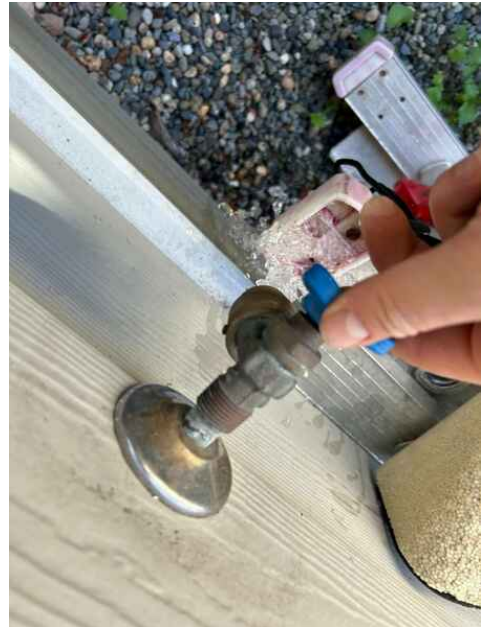
The exterior hose bibs are not frost-free, which can increase the risk of water pipes freezing during colder months. It's recommended to upgrade these to frost-free hose bibs. This modification helps prevent freezing issues and potential water damage in the winter. Consider making this upgrade before cold weather sets in.

Upgrade Bibs

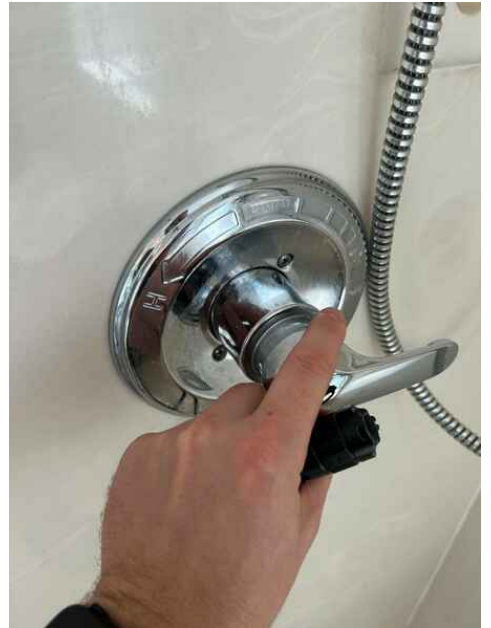
The shower and faucet controls in the master bathroom were found to be loose. It is recommended to have them tightened to ensure proper function and prevent potential leaks. This can be addressed upon possession for convenience and maintenance.

Faucet Control Was loose

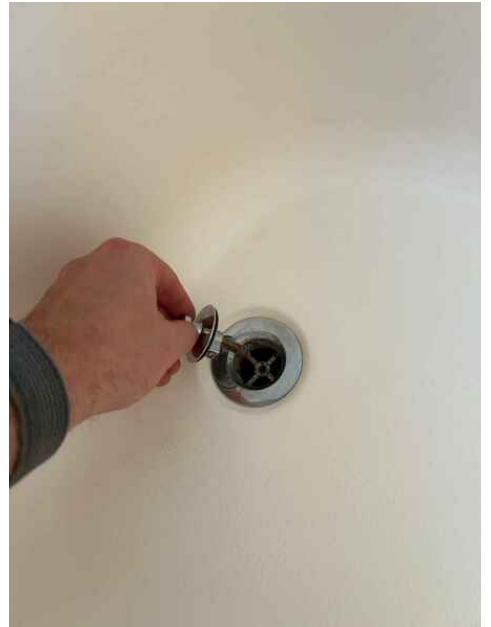
The tub stopper in the guest bathroom hallway was not working or appears to be unattached. It is recommended to repair or replace it at your discretion for proper functionality.

Tub stop not attached

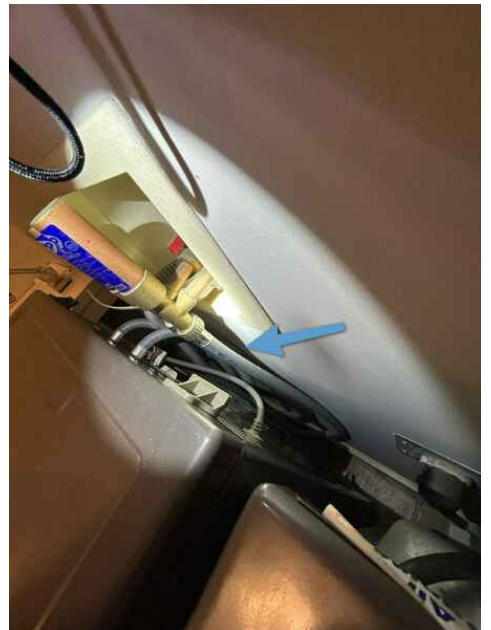
The hoses feeding the washing machine are not the metal braided type, which provides better durability and protection against leaks. It is recommended to upgrade to metal braided hoses for improved safety. Address this upon possession to prevent potential water damage.

Upgrade to Metal Braided Hoses

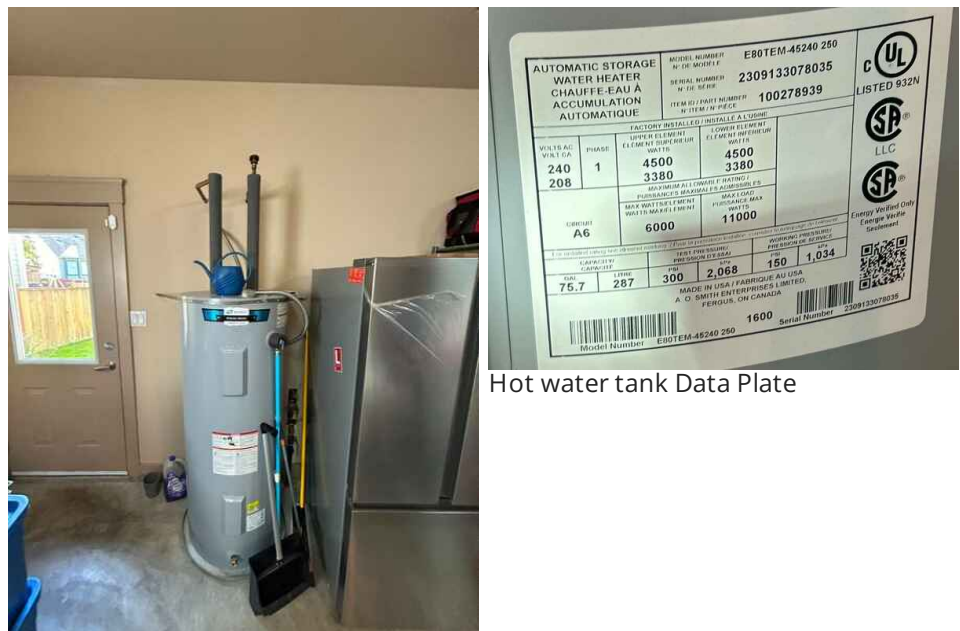
The hot water tank, which appears to be new, is missing an expansion tank and has only one seismic strap. It is recommended to inquire with the seller about any remaining warranty on the hot water tank. Additionally, adding a second seismic strap and an expansion tank would improve safety and ensure proper installation. Address these items upon possession for optimal performance and compliance with local standards.

Add additional seismic strap

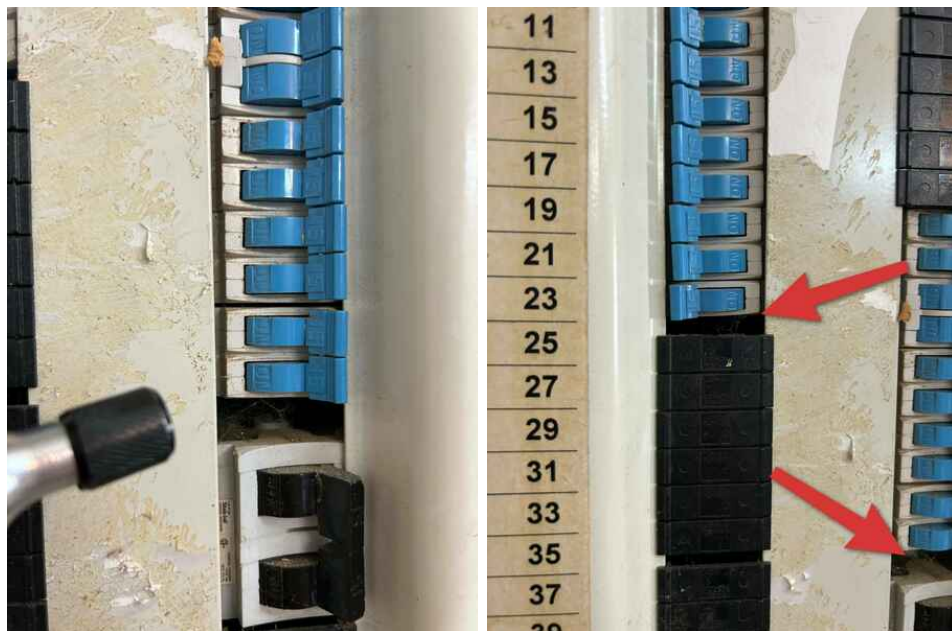
The electrical panel had several gaps in the breaker rows, and the breakers were not flush with the panel cover, which could pose an electrical safety hazard. It is recommended to have an electrician assess the panel, realign the breakers, and close off the gaps to ensure safe operation. This should be addressed upon possession to prevent potential electrical issues.

Breakers not flush with cover

Gaps in breaker row

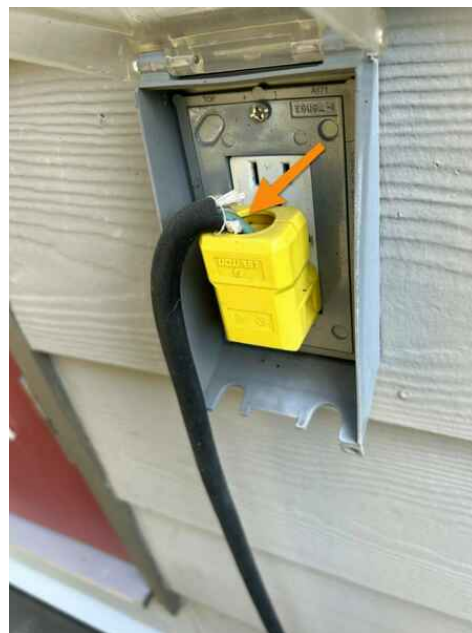
The irrigation system is using an (slightly damaged) extension cable as a permanent wiring solution, which is not appropriate for long-term use. It is recommended to have the system properly wired by an electrician to ensure safety and compliance with electrical standards. This should be addressed upon possession to prevent potential hazards.

Damaged Cable

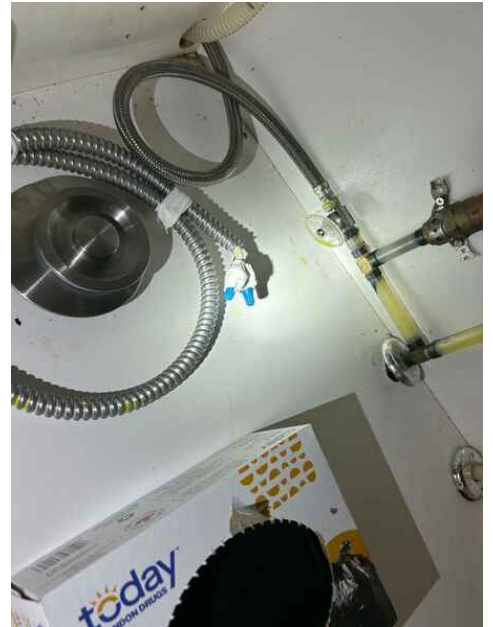
An open electrical connection was found in an armoured BX cable underneath the kitchen sink, likely powering a garbage disposal unit. This poses a safety hazard and should be properly terminated or removed by an electrician. It is recommended to address this upon possession to ensure electrical safety.

remove unused conductors

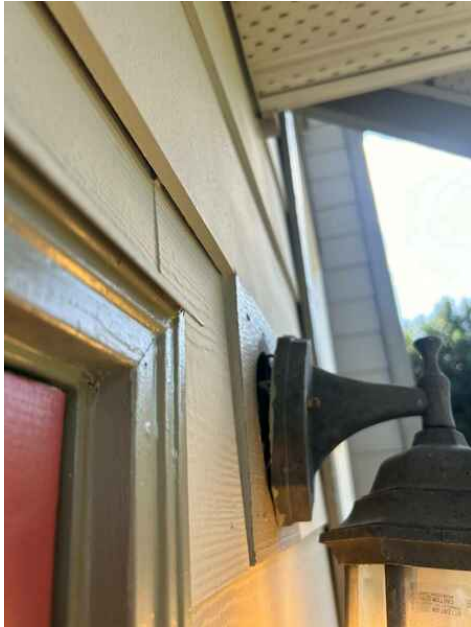
On the left side of the home, the telecom box was found to be damaged and exposed, which could allow water intrusion. Additionally, the exterior light at the rear entrance was damaged, likely caused by the swing of the French door, exposing the electrical components. It is recommended to repair both the telecom box and the exterior light to prevent water damage and ensure electrical safety.

Light fixture exposed

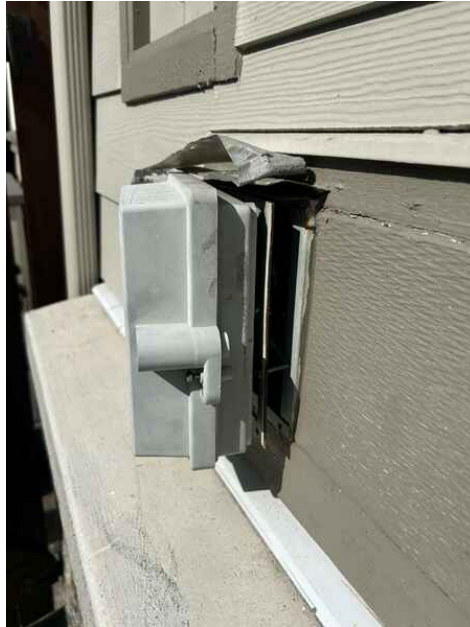
Damaged Telecom box

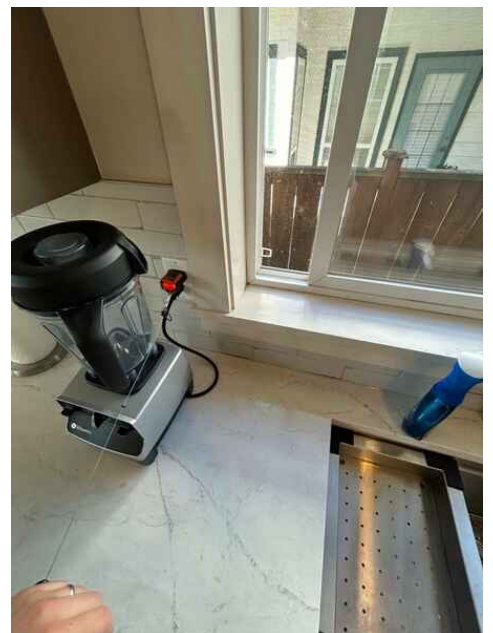
The receptacle near the kitchen sink is not GFCI protected, which is a safety concern in areas with potential water exposure. It is recommended to have an electrician install a GFCI receptacle to reduce the risk of electrical shock. Address this upon possession for improved safety.

Receptacle Not GFCI

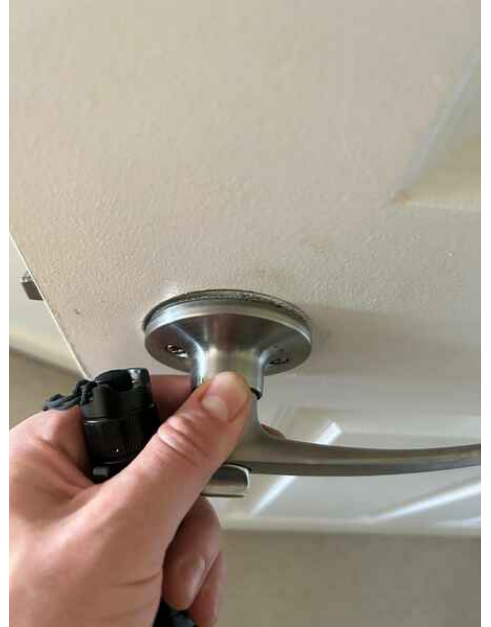
The door hardware in the master bedroom is slightly loose, and the pocket door to the master bathroom is a bit sticky and may need some track maintenance. Repair at your own discretion.

Loose Hardware

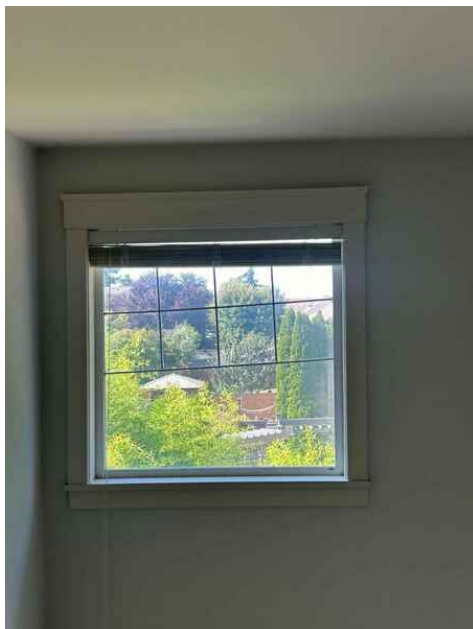
Several (most) windows throughout the property, approximately 20 years old, are exhibiting what appear to be manufacturing defects. The spacers between the panes show signs of deterioration, but most window seals appear to remain intact, so replacing them may not significantly improve energy efficiency. Additionally, many of the decorative muntins are crooked, which affects the aesthetic appeal. While the windows are still functional, it is recommended to obtain several quotes to assess the scope of work, as prices may vary. Consider repairs or replacements based on preference and budget.

Crooked Decroitive Muntins

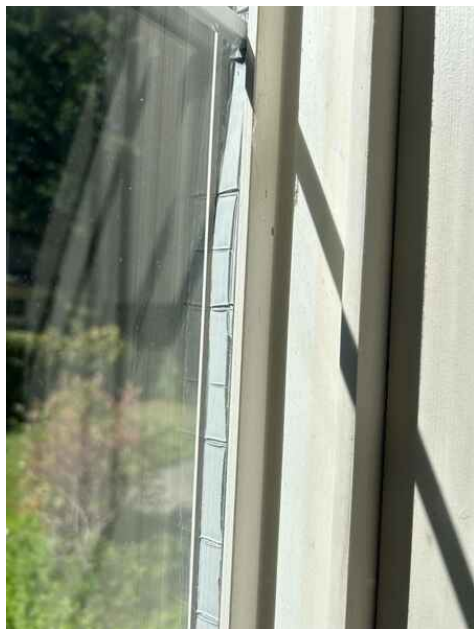
Spacer Damage

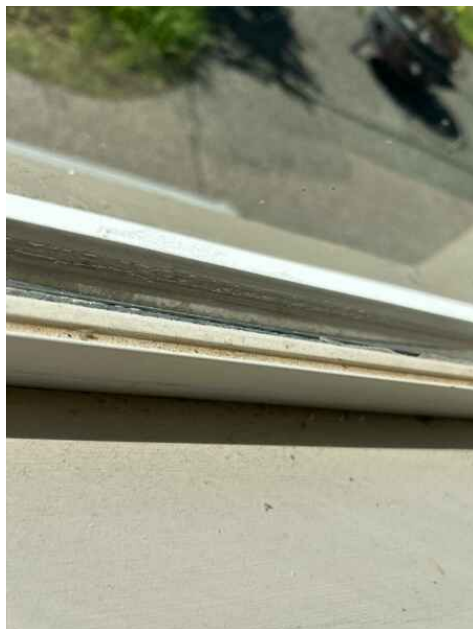
Spacer Deterioration

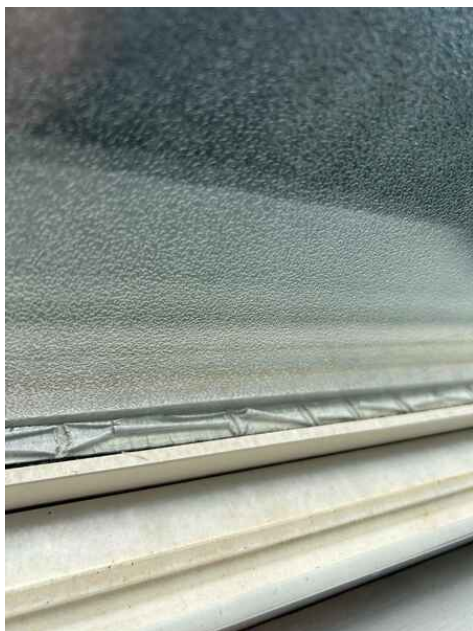
Peeling Spacer Material

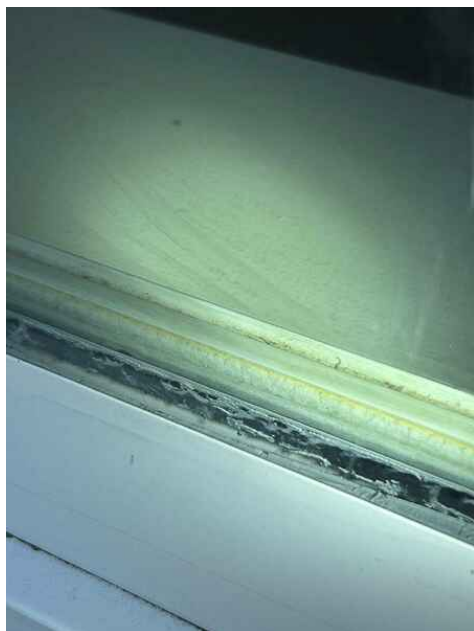
Spacer Sunk

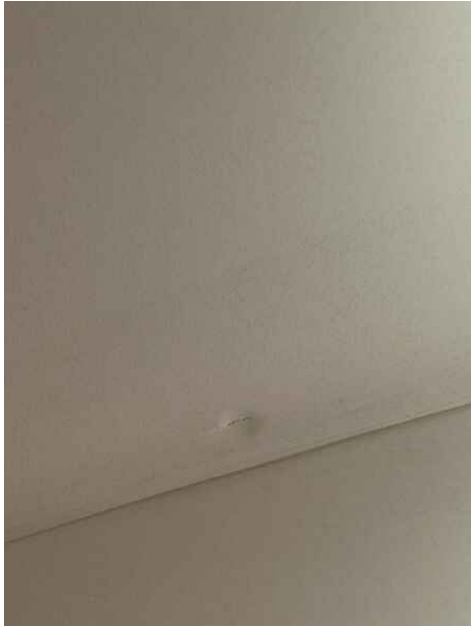
A small amount of scuffing on the hardwood and some nail pops were noted. Additionally, the crown moulding in the dining room/living room is slightly separated from the ceiling. These are general cosmetic issues and are typically beyond the scope of a home inspection. Addressing these is at your discretion for aesthetic purposes.

Nail Pop

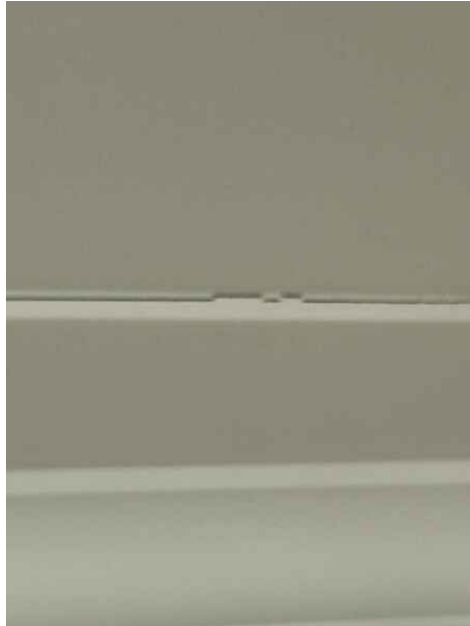
Crown Moulding Separated

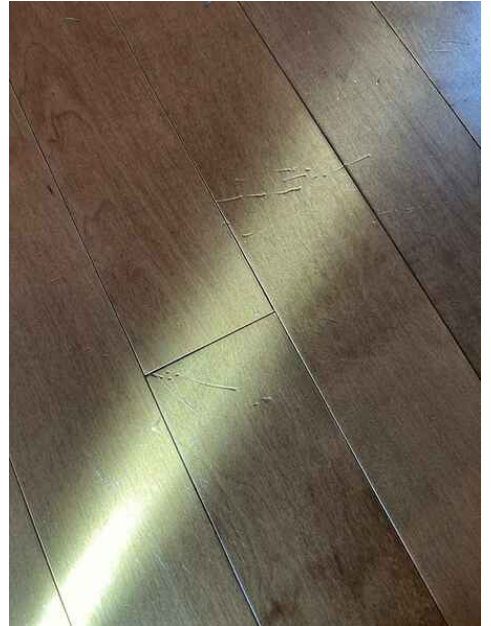
Scuffs

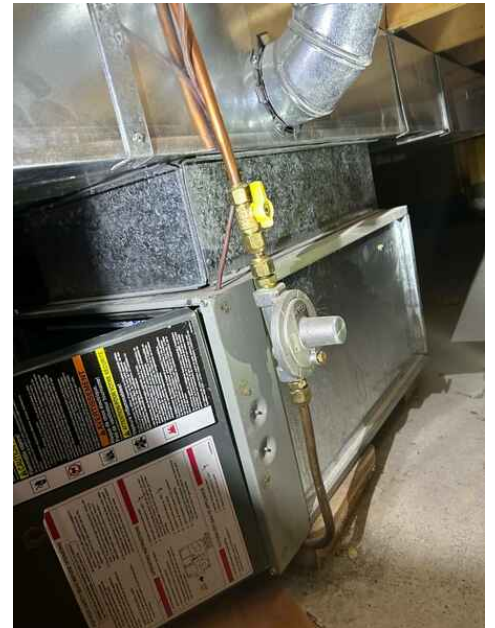
No drip leg was observed on the gas line entering the mid efficiency furnace. This component catches particulate in the gas supply. It is recommended to have the furnace and gas fireplace serviced/cleaned and inquire with the technician whether a drip leg is necessary. If so, adding one during routine maintenance is advisable. Regular scheduled maintenance should be established to ensure ongoing efficiency and safety.

Missing Drip Leg

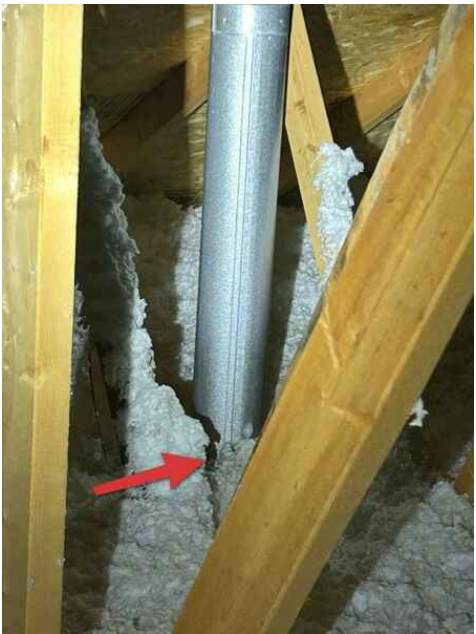
The metal B-vent exhausting the gas-fired furnace is in close contact with the blown-in fiberglass insulation in the attic, likely due to previous work that displaced the insulation. Typical B-vent installation requires a 1-inch clearance from insulation to prevent potential fire hazards. It is recommended to have the insulation adjusted to maintain proper clearance. This should be addressed upon possession to ensure safe operation of the vent system.

B-Vent requires 1 inch of clearance

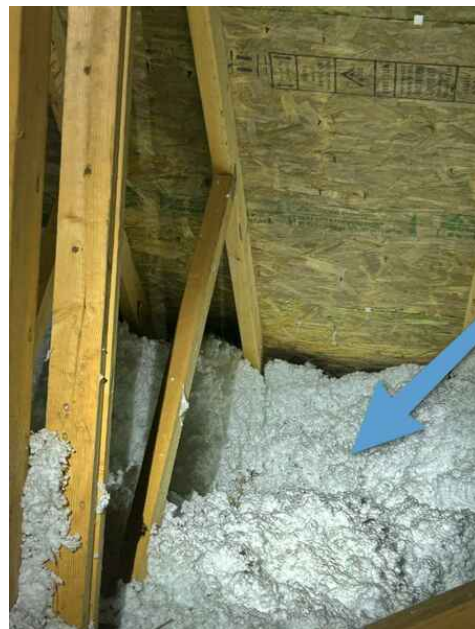
The blown-in fiberglass insulation in the attic appears to be slightly displaced, likely due to someone running low-voltage wiring or performing other work. This is an easy fix—have someone re-fluff or evenly spread the insulation to ensure proper coverage and maintain energy efficiency. Addressing this upon possession is recommended for optimal insulation performance.

Displaced/Uneven Insulation

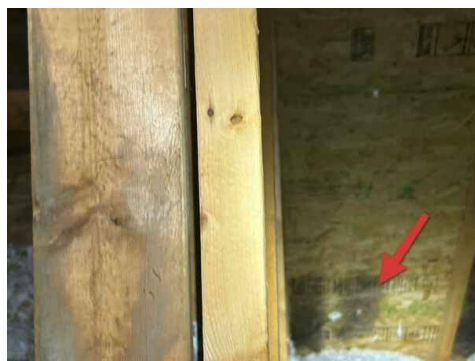
Slight staining was observed in the attic space accessed by the hallway ceiling hatch, which is common in this climate and isolated to a small area of the attic. It is recommended to have the area inspected by an insulation or ventilation expert to prevent any potential for further staining. Addressing this upon possession will help maintain the attic's condition and ensure proper ventilation.

Small Staining

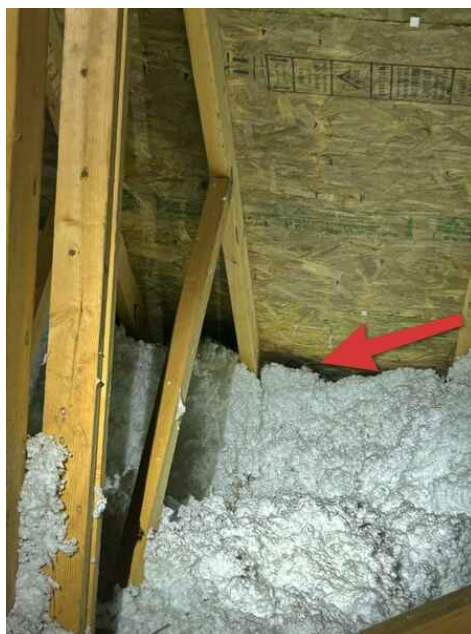
Staining

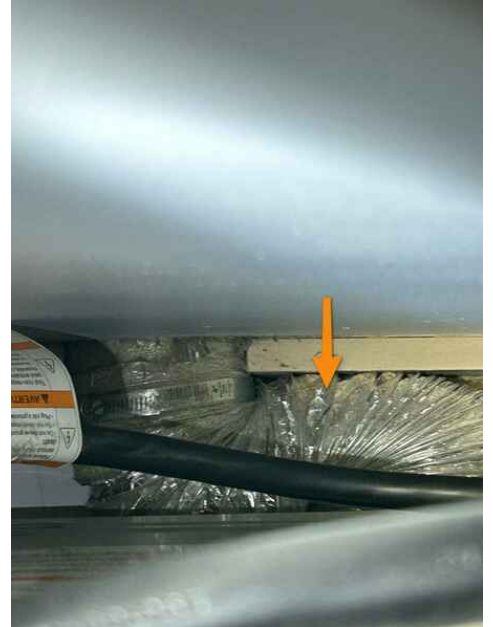
The dryer vent is made of corrugated, nonmetallic material and appears to be squished by the dryer, which can restrict airflow and pose a fire hazard. It is recommended to replace it with a smooth metal vent for better airflow. Additionally, as part of routine maintenance, the dryer vent should be cleaned annually to prevent lint buildup and ensure proper ventilation. Address this upon possession for optimal safety.

Squished dryer vent

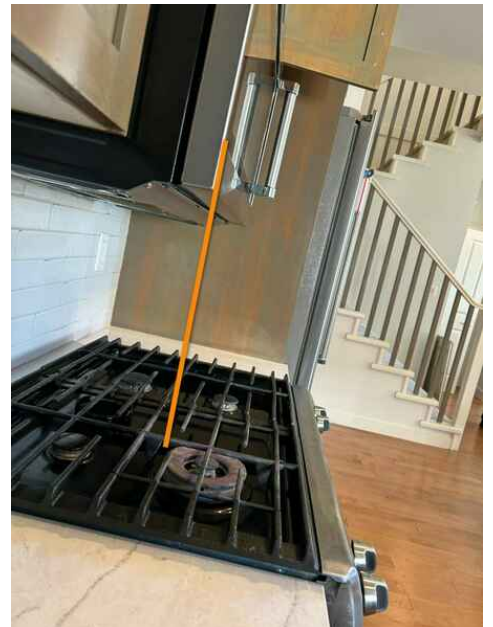
The microwave unit venting the gas range appears to be positioned a little too close to the surface of the range, making it quite warm to the touch after just a few minutes of use. Additionally, the microwave does not fully cover the range's surface, which may allow humidity and combustion products to enter the living space. While a carbon monoxide test did not detect any harmful levels, indicating the fan is functioning, the microwave may be inadequate for proper venting with this range. This is something to be aware of for long-term performance and safety.

Microwave unit may not be ideal

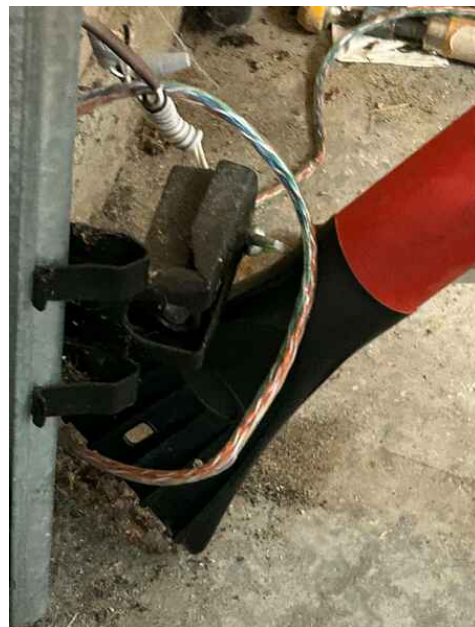
The safety sensor for the garage door was not functioning properly in all areas. It worked near the sensors, but not in the middle of the garage door path, indicating the need for adjustment or realignment. It is recommended to have the sensors properly adjusted to ensure safe operation of the garage door. This should be addressed upon possession to prevent any potential safety hazards.

Adjust Safety Sensors

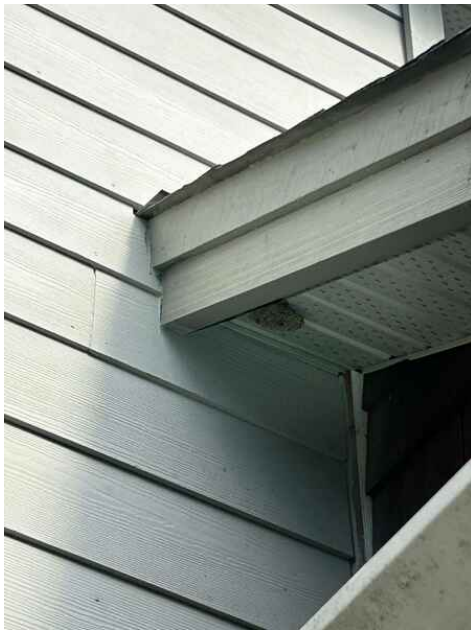
A few areas on the exterior of the home were found to have wasp nests, as well as in the attic under one of the box ventilation vents. Additionally, an insect or wasp nest was observed in the attic accessible via the hallway door. It is recommended to have these nests professionally removed upon possession by a pest expert to prevent any potential infestations or damage to the home.

Wasp nest on soffit

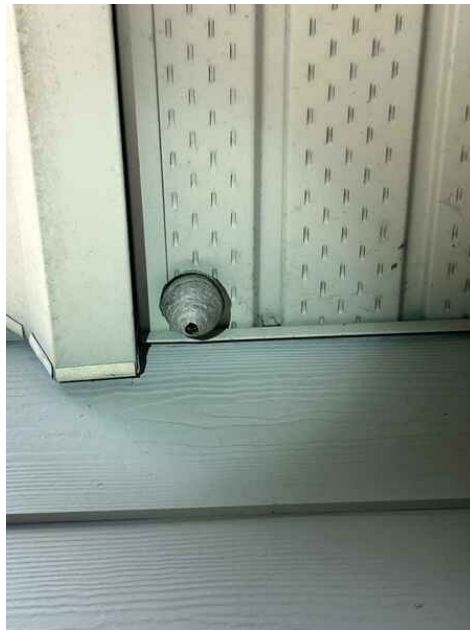
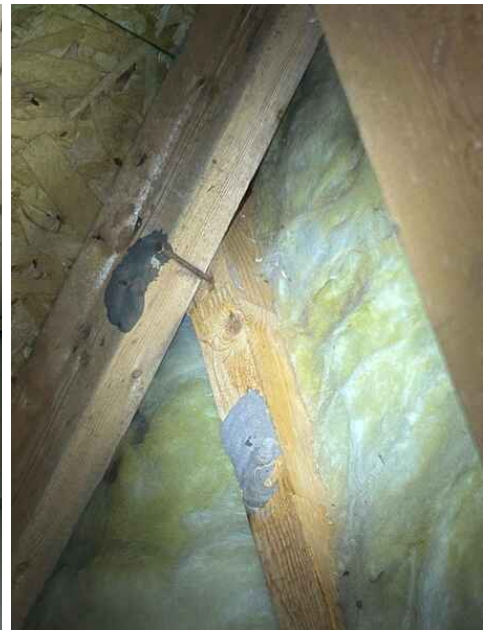
Insect nest

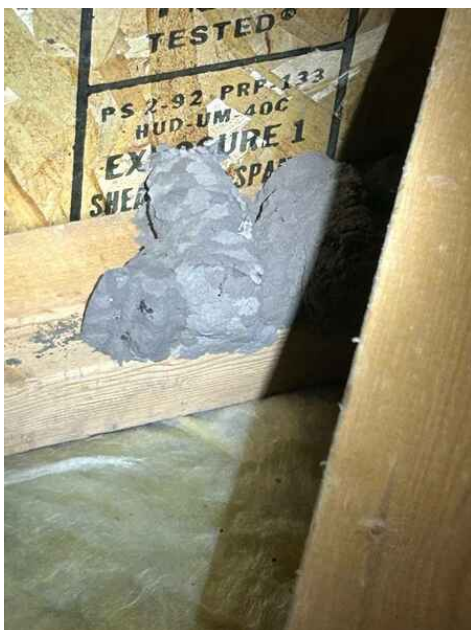
Wasp nest in attic space
