WATCHTOWER HOME INSPECTIONS

RESIDENTIAL REPORT

7124 Willis Point Road, BC

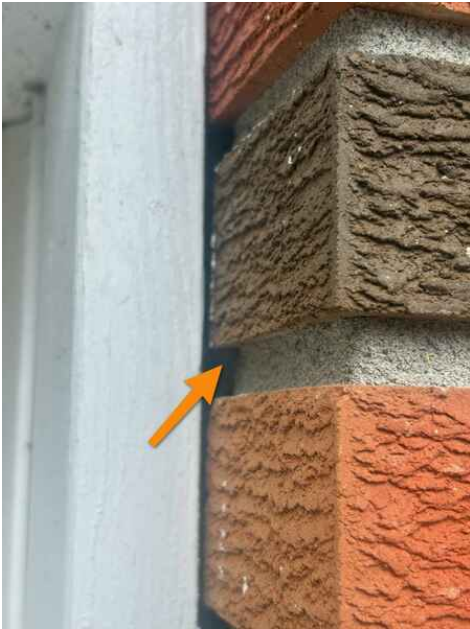
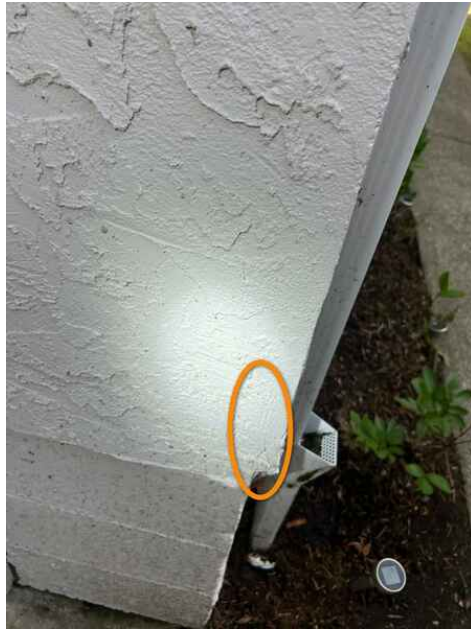
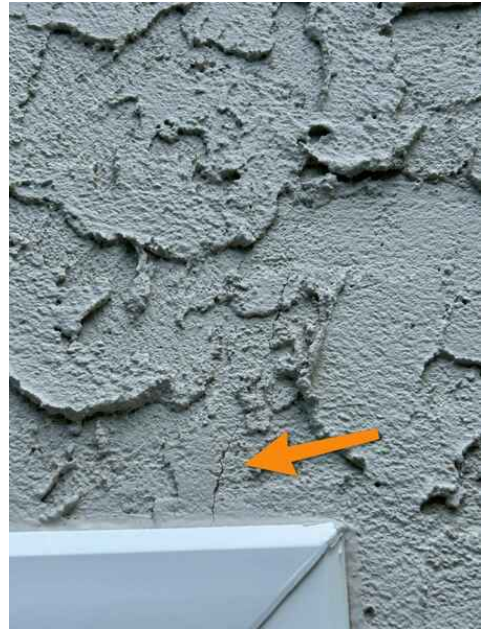
STUCCO CRACKS AND VOIDS IN EXTERIOR WALLS + CAULKING MAINTENANCE

Stucco cracks and voids where the brick veneer meets other materials throughout the exterior walls, and exterior caulking needing touch ups were found during inspection. These issues can lead to water intrusion, moisture damage, and aesthetic concerns if left unattended. Recommend sealing and repairing the stucco cracks and voids to prevent further deterioration and maintain the structural integrity and appearance of the property's exterior upon possession.

Fill Void

Patch Cracks

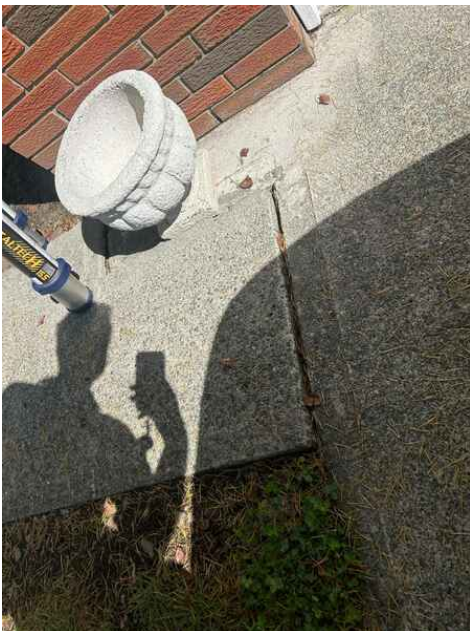
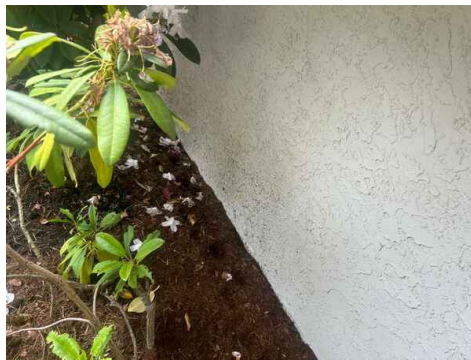
EXTERIOR SIDING PROXIMITY TO GROUND

Some sections of the brick veneer and stucco siding were found to be too close to the ground during the inspection. This proximity increases the risk of moisture infiltration, insect infestation, and structural damage. It is recommended to address this issue by increasing the clearance between the siding and the ground to mitigate potential issues and maintain the integrity of the exterior cladding.

Brick siding too close to grade

Stucco Touching Grade

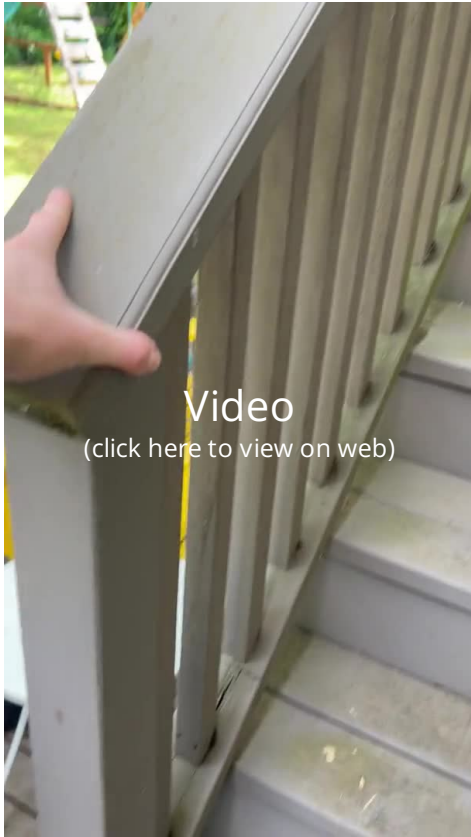
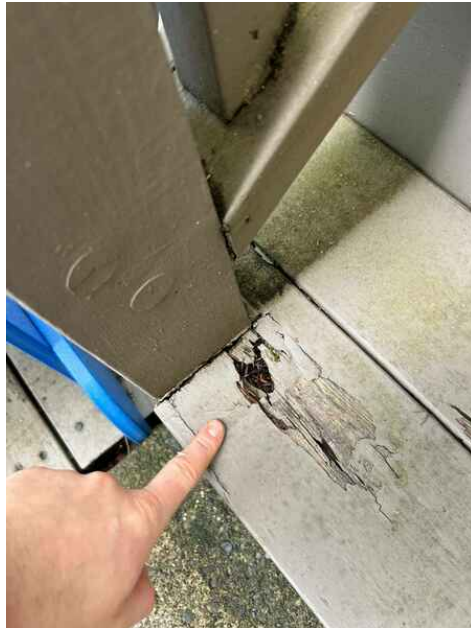
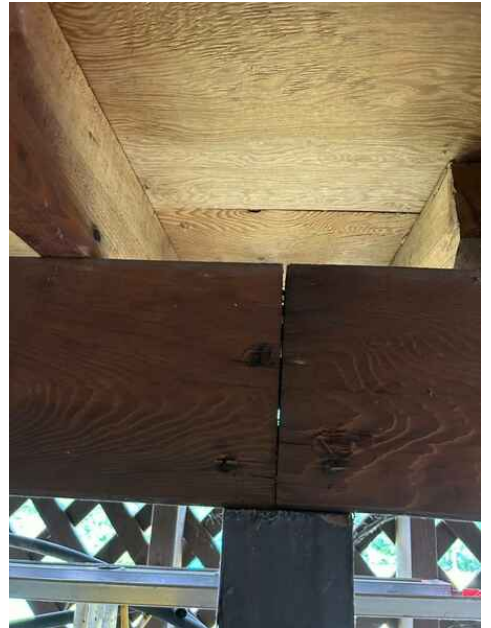
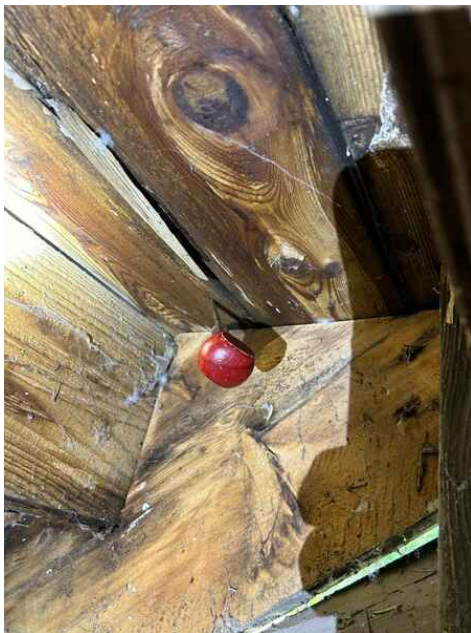
DEFICIENT DECK CONSTRUCTION

Multiple deficiencies were noted in the construction of the deck, including the absence of proper ledger bolts and joist hangers, as well as signs of rot and improper building techniques in various areas. These issues compromise the structural integrity and safety of the deck, posing potential hazards to occupants. It is imperative to address these deficiencies promptly by engaging a qualified contractor upon possession to rectify the construction shortcomings, ensure structural stability, and mitigate safety risks.

Rotted Treads and Members

Insufficient Overhang

Rot Throughout

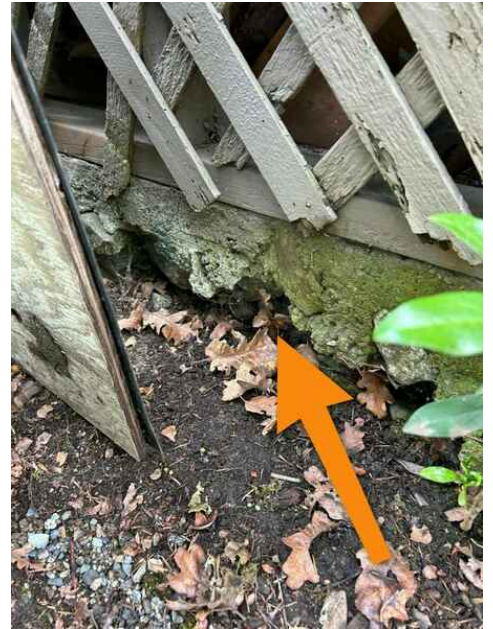
The concrete slab under the deck is being undermined as a result of property grading issues. This undermines the stability and integrity of the patio, potentially leading to structural problems and safety hazards. It is recommended to address the grading issues to prevent further undermining and stabilize the patio slab. Engaging a qualified contractor to assess and rectify the grading problems is advised to ensure the long-term structural integrity of the patio area upon possession.

Undermined Patio Slab Due to Grading

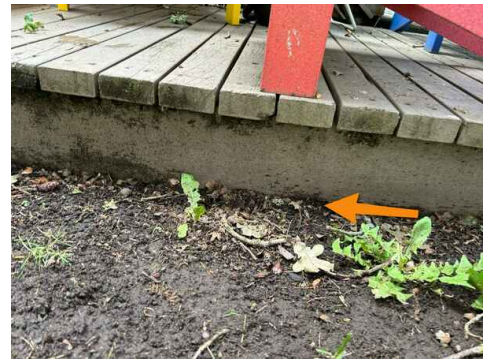
The wood patio addition exhibits poor construction practices, with its base directly in contact with the ground. This setup can lead to issues such as wood rot and uneven settling. It is advisable to address these concerns promptly by raising the patio base above grade and ensuring proper construction methods are employed to enhance durability and longevity.

Wood Grade Contact

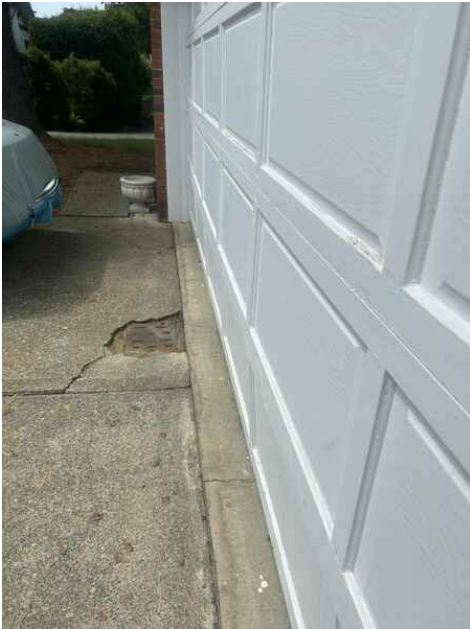
During the inspection, signs of bowing were noted on the garage door, although it continues to function adequately. While the current functionality is satisfactory, monitoring and potential reinforcement may be advisable to prevent further deterioration or operational issues in the future. Regular maintenance and periodic assessments can help ensure the continued reliability of the garage door.

Bowed Garage Door

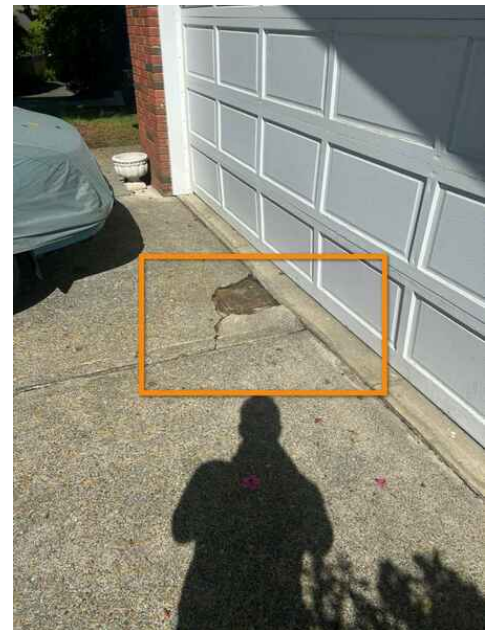
UPGRADE DRIVEWAY DRAINAGE FOR PROPER WATER DIVERSION

Driveway sloping toward the garage and home, posing potential water ingress issues. Recommend upgrading the old drain to a slot drain system to effectively divert water away from the property's foundation upon possession. This upgrade will help prevent moisture-related damage and enhance the longevity of the driveway and surrounding structures.

Upgrade old drain to a slot style drain\

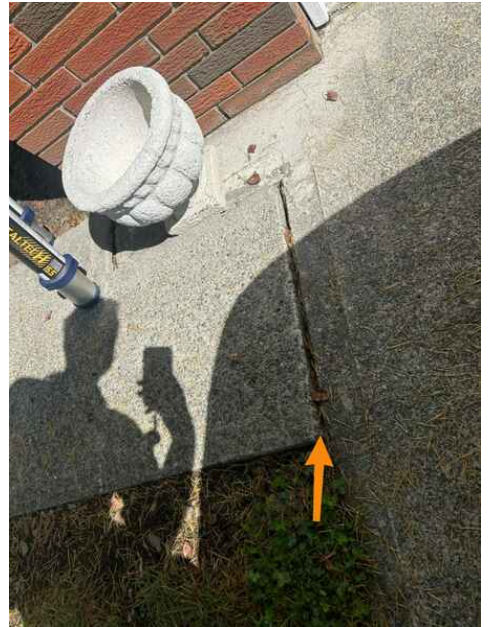
TRIP HAZARDS IN DRIVEWAY AND WALKWAYS

Noted trip hazards/ cracks scattered throughout the driveway and walkways during inspection. These hazards pose risks of accidents and injuries and should be promptly addressed. Recommend repairing or levelling uneven surfaces to ensure safe passage for residents and visitors. Taking action to mitigate these hazards will enhance the safety and usability of the property's exterior pathways.

Trip Hazard

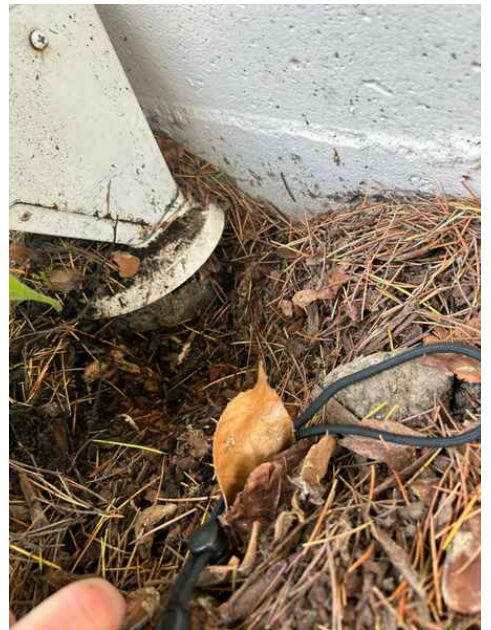
PERIMETER DRAINAGE SCOPE

It is recommended to conduct a perimeter drainage scope to assess the condition of the concrete perimeter drainage system surrounding the property before the removal of subjects. This proactive measure can provide valuable insights into the effectiveness of the drainage system in managing rainwater runoff and preventing moisture-related issues such as foundation damage or water infiltration. By identifying any potential drainage issues early on, appropriate measures can be taken to address them and safeguard the property against water damage.

Concrete tile drain

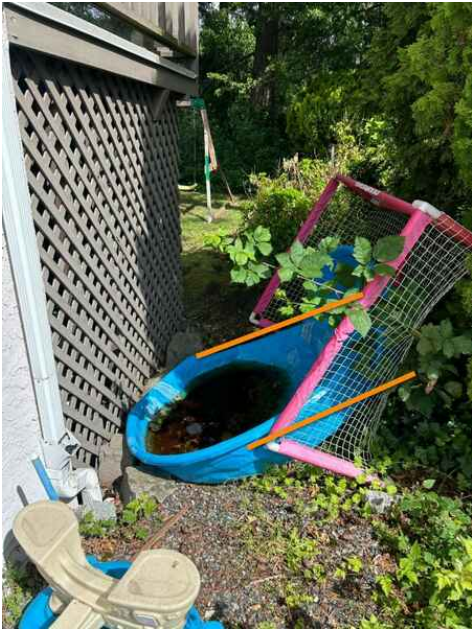
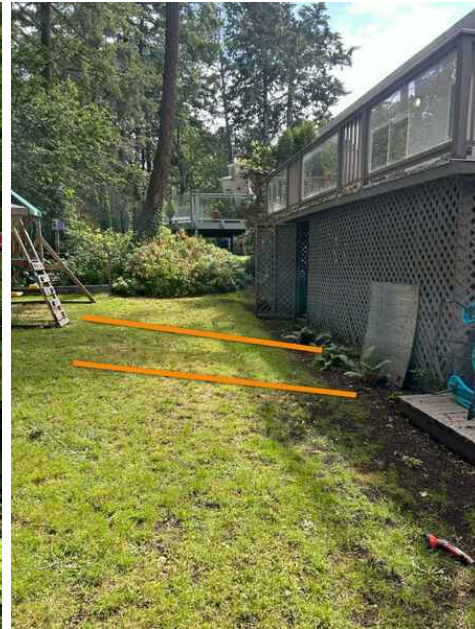
The current grading configuration near the home does not effectively direct rainwater away from the structure, posing potential moisture infiltration risks during heavy rainfall. Proper grading should slope away from the home, with a recommended 6-inch drop in elevation over the first 10 feet. Flat or negative grading can lead to soil saturation and potential water infiltration through foundation walls. Evaluation and repairs by a qualified contractor are advised to ensure proper rainwater runoff management and mitigate moisture-related issues.

Grade slopes toward home

Address grade sloping toward home

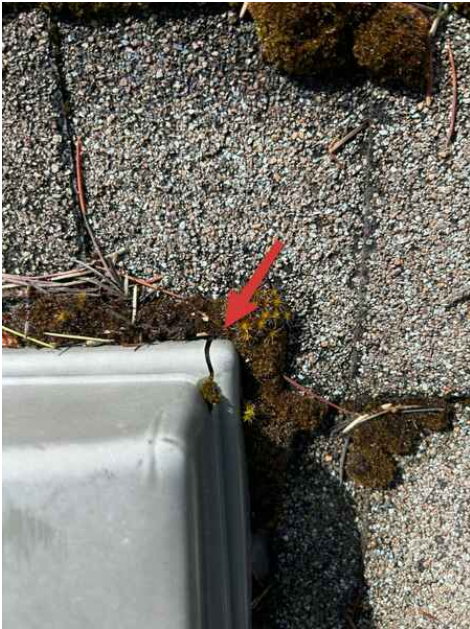
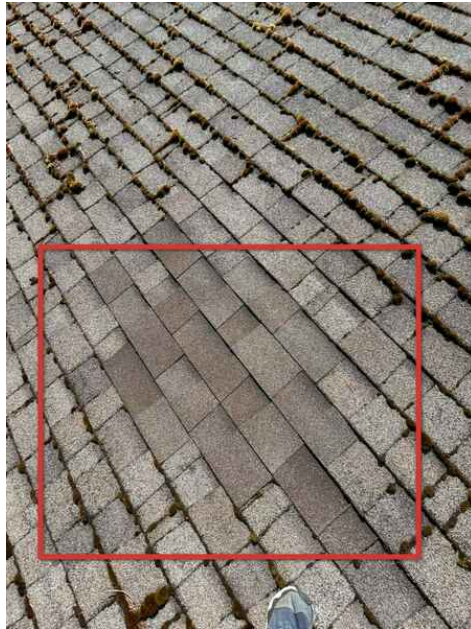
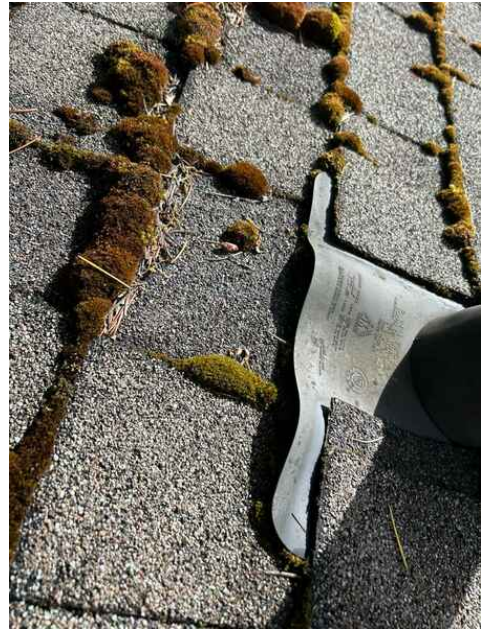
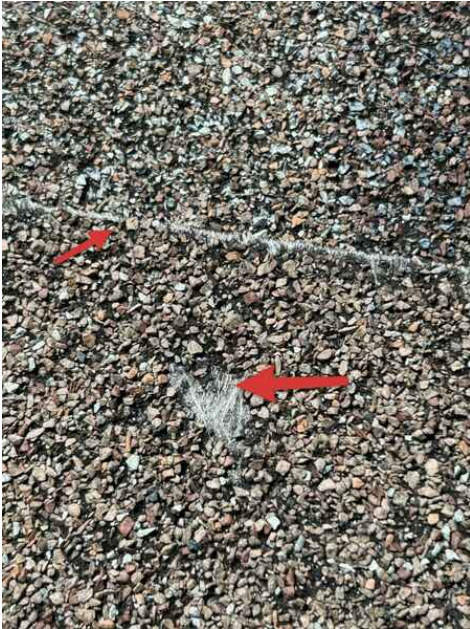
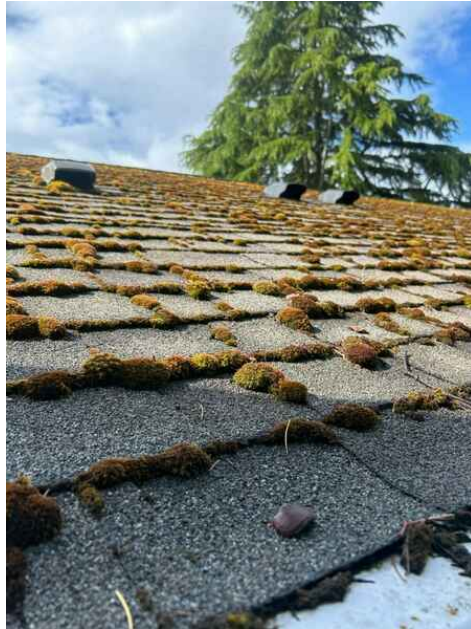
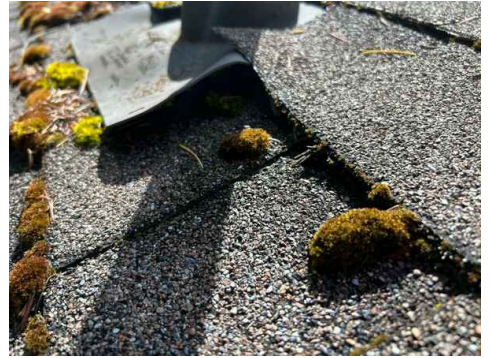
ROOF PAST EXPECTED SERVICE LIFE

The roof inspection revealed several issues including granular loss, exposed fiberglass matting, exposed fasteners, extensive moss growth, damaged gutter guards, warped plumbing stack boots, cracked vent boxes, soft spots in areas, and evidence of previous patch jobs. These issues collectively indicate that the roof is past its life expectancy and in need of significant attention or total replacement. Recommend immediate inspection and repair by a qualified roofing professional to address these issues and prevent further deterioration or water damage to the property.

Cracked Vent Casing

Evidence of a previous patch

Warped Vent stack boot

Fiberglass matt showing

Severe moss

Lifted shingle

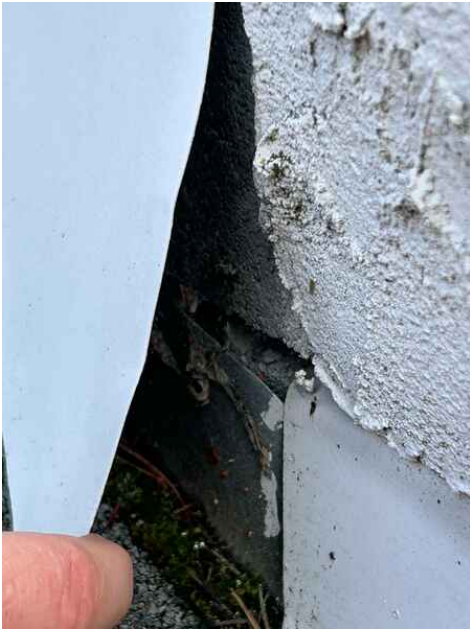
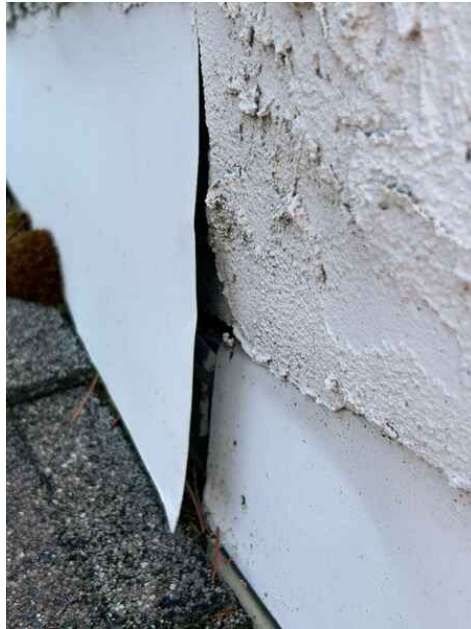
Chimney counter flashing was exposed, potentially allowing wind-driven rain to infiltrate the base flashing. This exposure poses a risk of water damage and should be addressed promptly to prevent further deterioration. Recommend sealing or repairing the chimney counter flashing to ensure proper protection against moisture intrusion and maintain the integrity of the roof structure.

Wind driven rain could enter

Counter Flashing bent

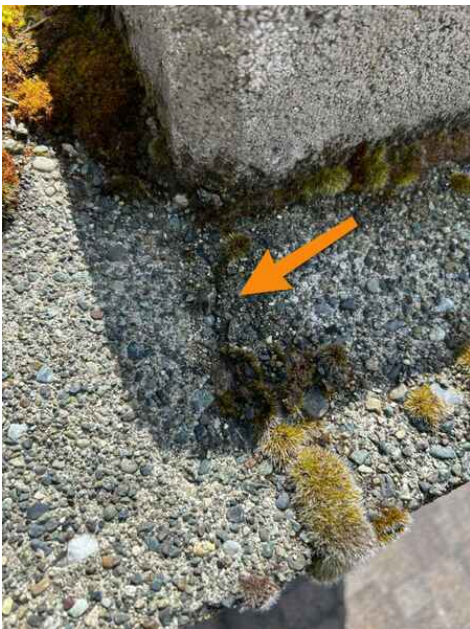
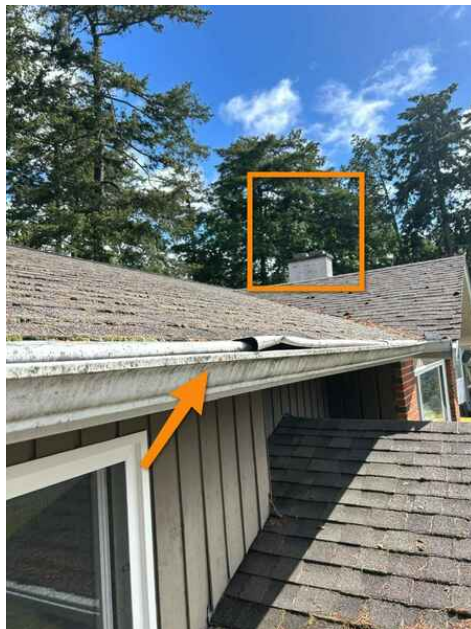
CHIMNEY MAINTENANCE RECOMMENDATIONS

Cracked chimney crown and the absence of a rain cap on the chimney. These issues expose the chimney to potential water damage, debris entry, and structural deterioration. Recommend repairing the cracked chimney crown and installing a rain cap upon possession to prevent moisture infiltration and prolong the lifespan of the chimney. Regular chimney maintenance is essential to ensure its functionality and longevity.

Cracked Crown

Missing rain cap + Damaged Gutter/
gutter guard

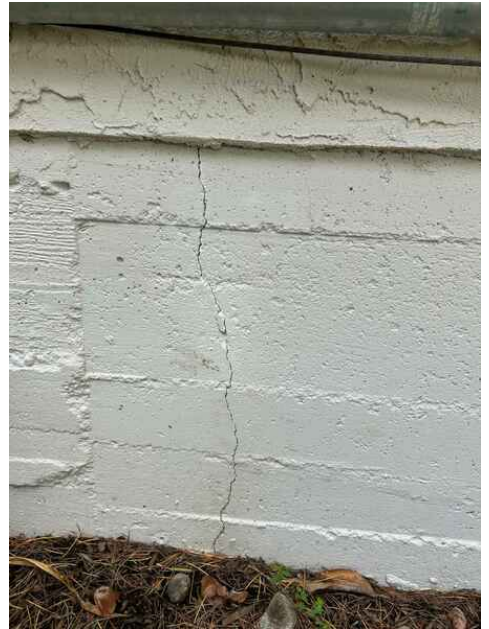
MINOR FOUNDATION CRACKS DETECTED

Two minor cracks were identified in the foundation. These cracks should be closely monitored for any signs of expansion. It is advisable to consult with a foundation specialist to assess the severity and recommend appropriate repairs. Additionally, sealing the cracks is recommended to prevent potential water infiltration and further deterioration upon possession.

Foundation Crack

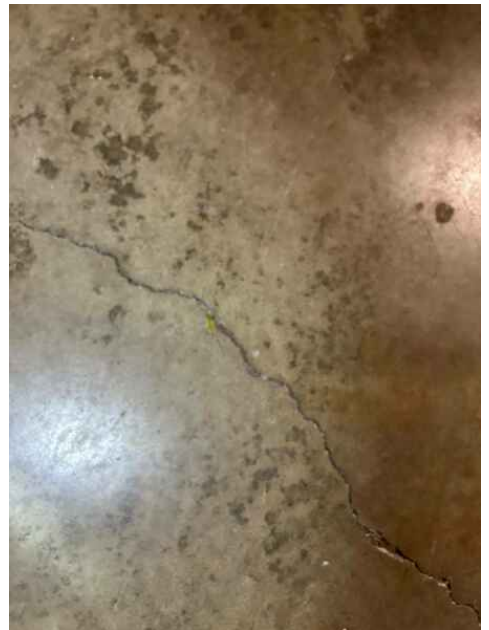
MINOR CRACKS IN GARAGE SLAB

Minor cracks were observed in the slab of the garage. While these cracks are currently minor and not posing immediate structural concerns, they should be monitored yearly for any signs of expansion. It is recommended to seal the cracks to prevent moisture infiltration and further deterioration over time. Regular maintenance and monitoring of the garage slab can help prevent larger issues in the future.

Cracks in Garage Slab

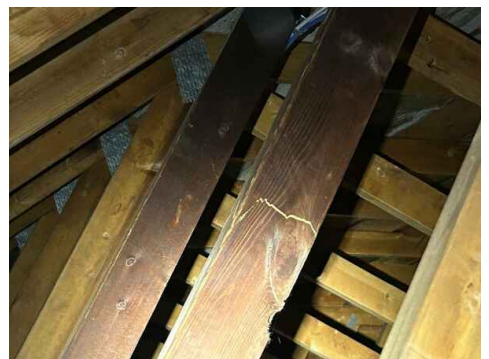
ATTIC TRUSS EVALUATION RECOMMENDED

A cracked truss member was identified in the attic during the inspection. To ensure the structural integrity of the roof system, it is advisable to seek further evaluation by a qualified structural engineer and obtain scope of work before removal of subjects. This assessment will provide valuable insights and recommendations for appropriate repairs or reinforcement measures.

Cracked Truss Member

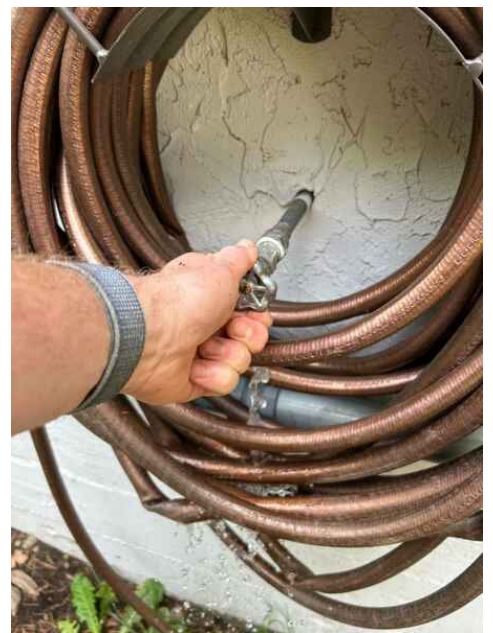
HOSE BIBS NOT FROST RESISTANT

The exterior hose bibs are not frost-free, which can increase the risk of water pipes freezing during colder months. It's recommended to upgrade these to frost-free hose bibs upon possession. This modification helps prevent freezing issues and potential water damage in the winter. Consider making this upgrade before cold weather sets in.

Hose bib not frost resistant

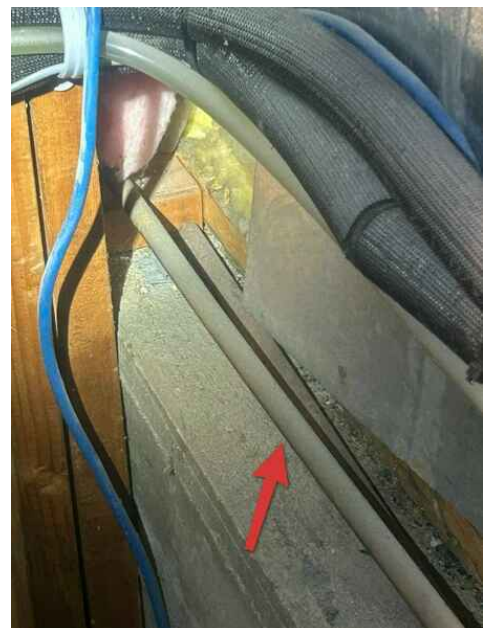
Copper pipes generally have a life expectancy of 40-70 years. Due to the age of the home, it is advantageous to be aware of this condition. Most of the plumbing has been upgraded to Pex on the last renovation there is still sections of piping that is left over such as the hose bibs and possible concealed piping.

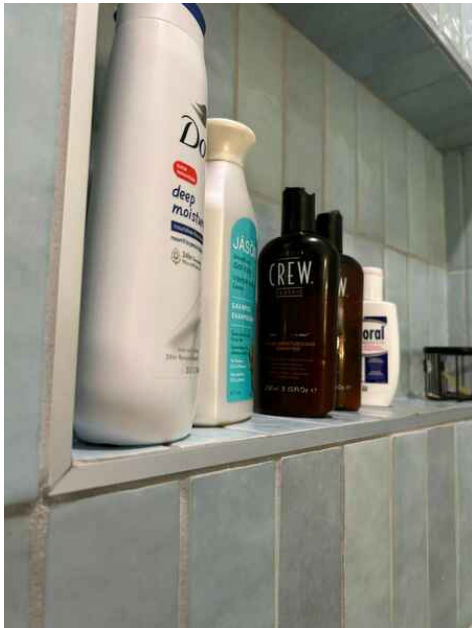
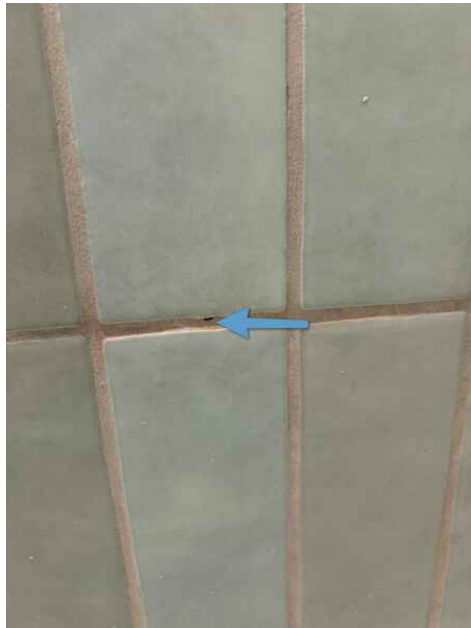
Pinhole was detected in the grout of the master shower, posing a risk of water seepage. Additionally, each shower featured a curb shelf, demanding meticulous maintenance due to numerous joints on a horizontal surface, prone to water ingress over time. Regular inspection and upkeep of these areas are advised to prevent moisture-related issues, ensuring the longevity and integrity of the shower enclosures.

Flat Sections hold Water

Pin hole in grout

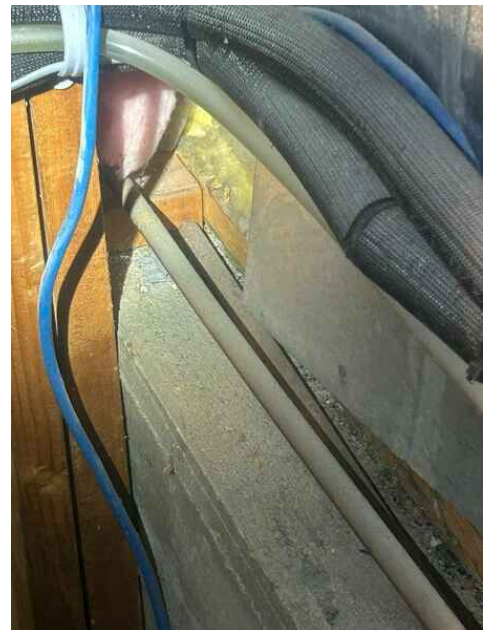
In the utility room, a section of copper piping is observed to be unsecured. This lack of secure attachment poses a risk of movement or damage to the piping system, potentially leading to leaks or other plumbing issues. Securing the copper pipe with appropriate fasteners or supports is recommended to ensure the integrity and stability of the plumbing infrastructure within the utility room.

Pipe in utility room needs to be secured

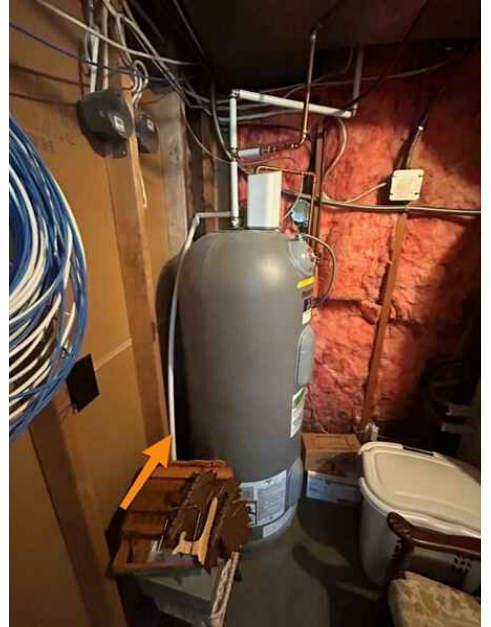
The hot water tank needs a few safety upgrades for optimal performance. Installing seismic straps, a drip pan, an expansion tank, and extending the TPR valve 6-8 inches from the ground will enhance safety and protect against potential leaks or damage. These simple additions ensure smooth operation and peace of mind. Recommend to install with the next hot water tank.

Extend TPR Valve

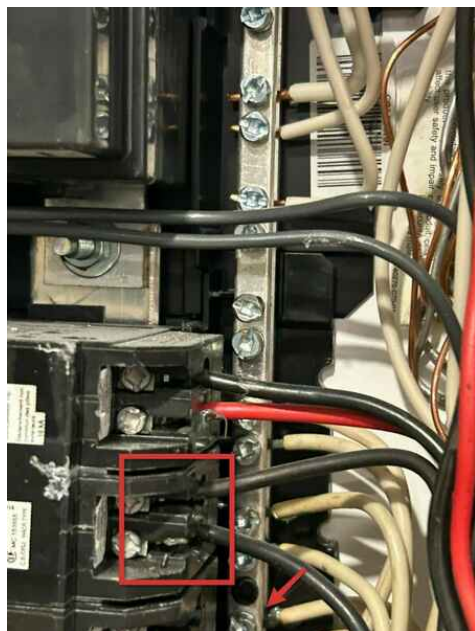
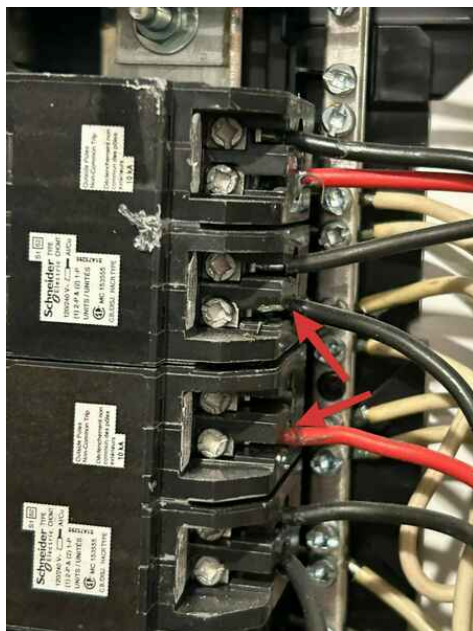
Aluminum wire appears to be installed on roughly 50% of the branch electrical circuits in the subject premises. These single strand, branch circuit aluminum wires were used widely in houses during the mid 1960s and 1970s. Insurance companies are taking a harder position over this feature and may require a full rewire, regardless of the condition of the existing material. It's worth noting that anti-oxidant paste was observed at the connections in the panel, and pig tailing was observed at a proportional amount of outlets inspected, which helps mitigate corrosion and expansion/ contraction issues. You must contact your insurer and a qualified electrical contractor before subject removal, to ensure you are in full possession of the facts and costs.

Aluminum Wiring

Aluminium Wiring with Anti Ox Paste

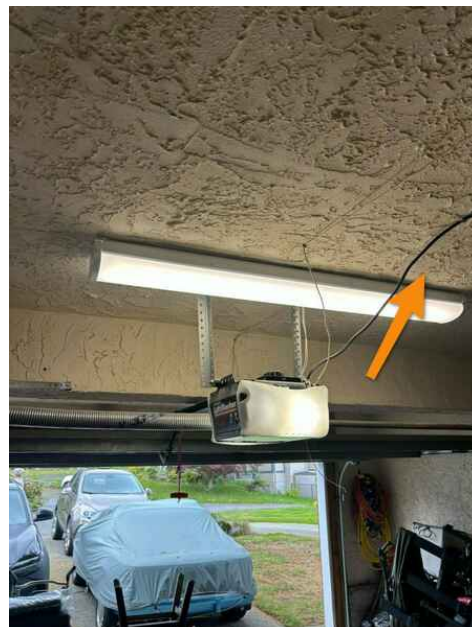
The garage door motor was found to be connected to an extension cord, which is not recommended for permanent wiring. The heat pump drain pan also had what is suspected to be a heat cable attached to an extension cord fed through the exterior wall. This practice poses a safety risk and may lead to electrical hazards. It is advised to have a qualified electrician install proper wiring to ensure the safe and reliable operation of the garage door motor and heat pump drain tray.

Garage motor plugged into extension cord

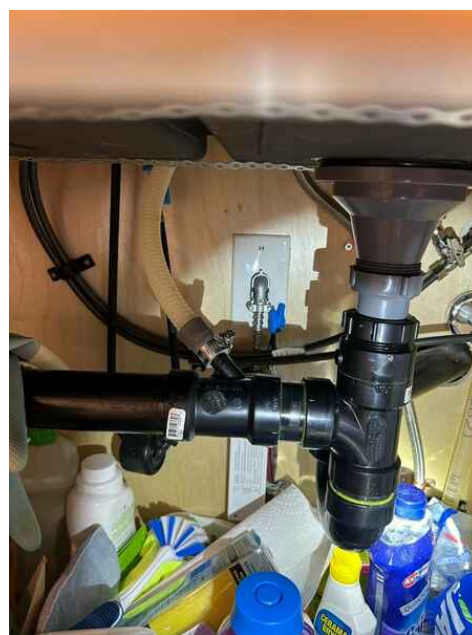
An exposed electrical connection was found under the sink, posing a safety hazard. It is recommended to enclose it within a junction box to mitigate the risk of electrical shock or fire. Immediate attention to this issue upon possession of the property is advised to ensure a safe living environment.

Put open connection in junction box (high humidity area)

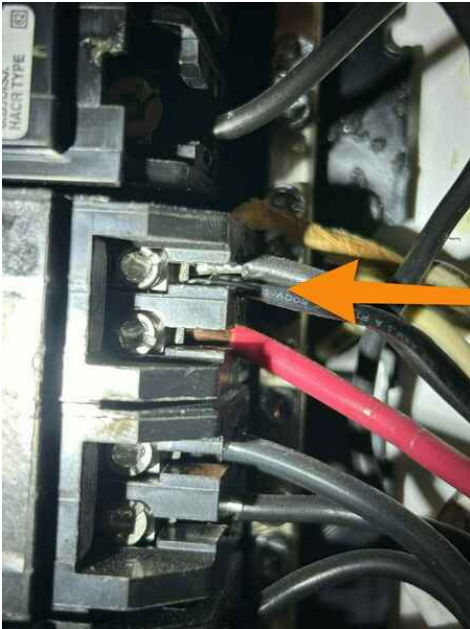
During the inspection of the main electrical panel, a double tap was identified. A double tap occurs when two or more wires are connected to a single circuit breaker terminal designed for a single wire. This practice is not compliant with electrical safety standards and can lead to overheating and potential fire hazards. It is recommended to have a licensed electrician correct the double tap upon possession to ensure the safety and proper functioning of the electrical system.

Double tap (both aluminium)

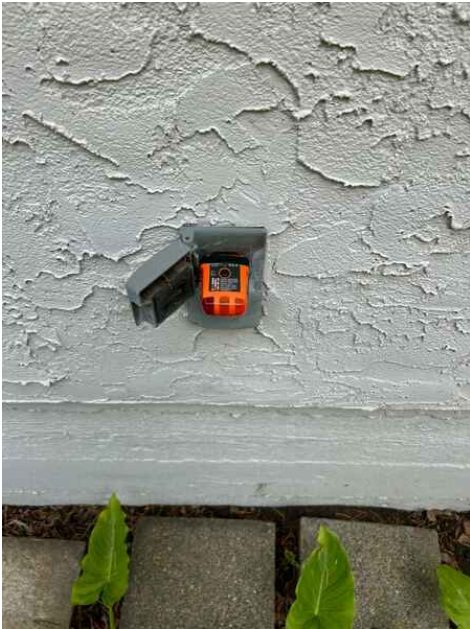
Only one of the outdoor outlets is equipped with GFCI protection. This presents a safety concern, as all outdoor outlets should be GFCI protected to mitigate the risk of electric shock. It is recommended to install GFCI outlets or retrofit the existing outlets with GFCI protection to ensure compliance with safety standards and minimize electrical hazards.

Majority of exterior outlets not GFCI protected

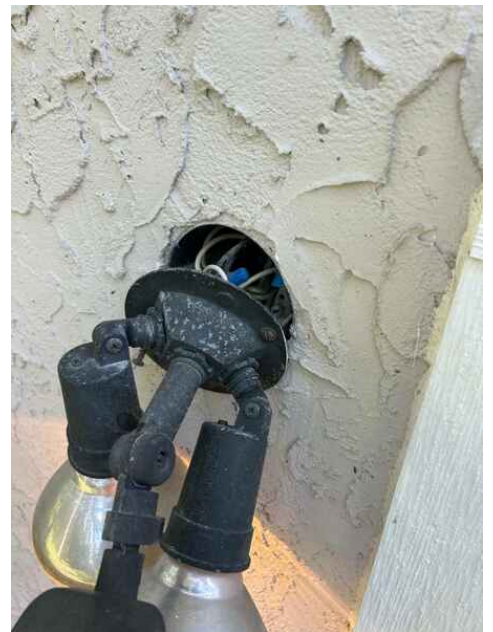
The exterior light at the rear entry to the basement was observed to be fully exposed to the outdoor elements. This exposure increases the risk of damage to the light fixture and compromises its functionality over time. To prevent potential issues such as water damage or electrical hazards, it is recommended to install a weatherproof cover or enclosure for the exterior light fixture, providing essential protection against the elements upon possession.

Fix light fixture

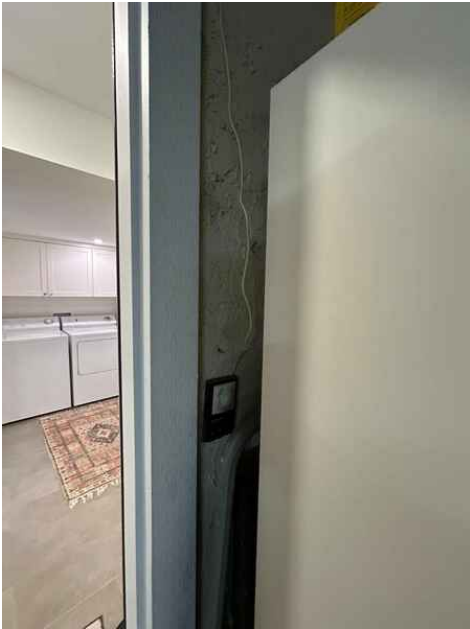
An unsecured low voltage wire was observed at the garage door controls, posing a potential safety hazard. Securing the wire with appropriate fasteners or conduit is recommended upon possession to prevent accidental damage or exposure. This measure ensures the reliable operation of the garage door controls and minimizes the risk of electrical hazards.

Secure Wire

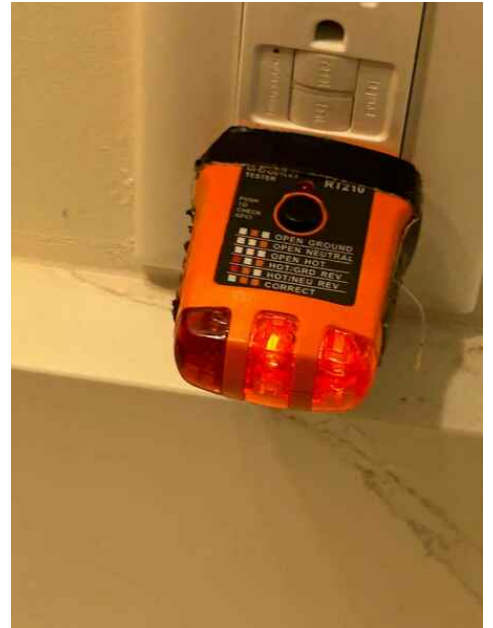
The GFCI outlet in the upstairs hallway bathroom is wired on the same circuit as the lights, resulting in an inconvenience where tripping the GFCI disrupts the functionality of the lights. This configuration can pose inconvenience and safety concerns, particularly during power outages or when troubleshooting electrical issues. It is recommended to have the GFCI outlet rewired to a dedicated circuit to ensure uninterrupted access to lighting and compliance with electrical safety standards upon possession.

Outlet on same circuit as ligts

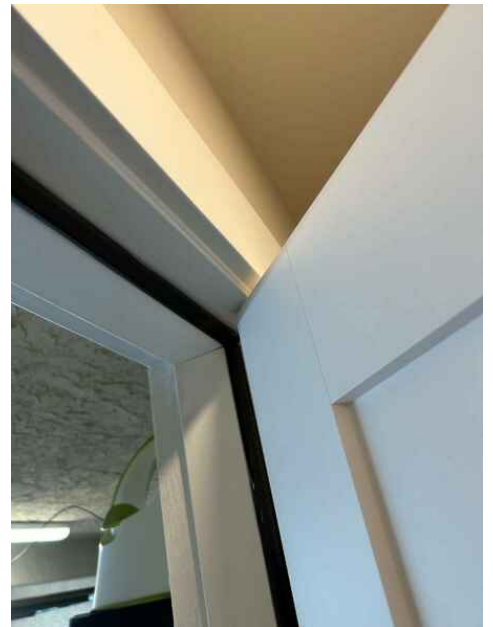
The man door leading to the garage lacks self-closing functionality, which is essential for gas proofing purposes. This feature ensures that potentially hazardous gases, such as carbon monoxide, are contained within the garage space. It is recommended to adjust the door mechanism to enable self-closing functionality, promoting safety and compliance with gas proofing standards.

Install self closing hinge

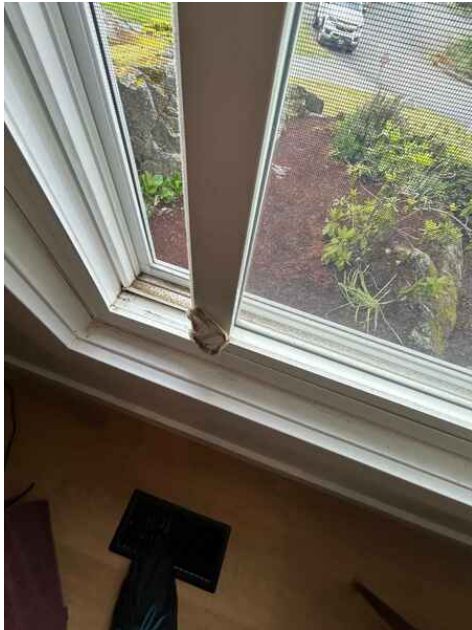
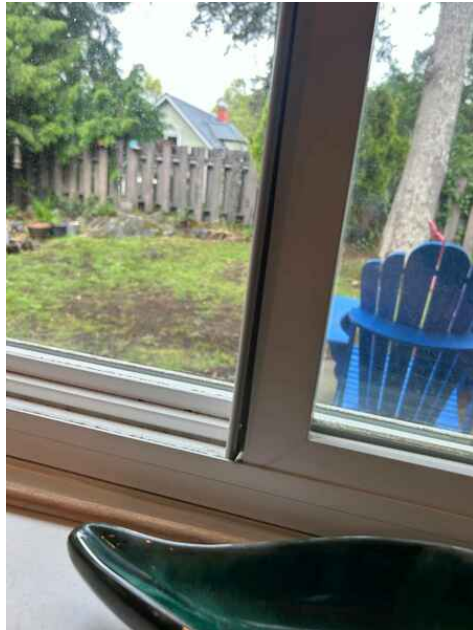
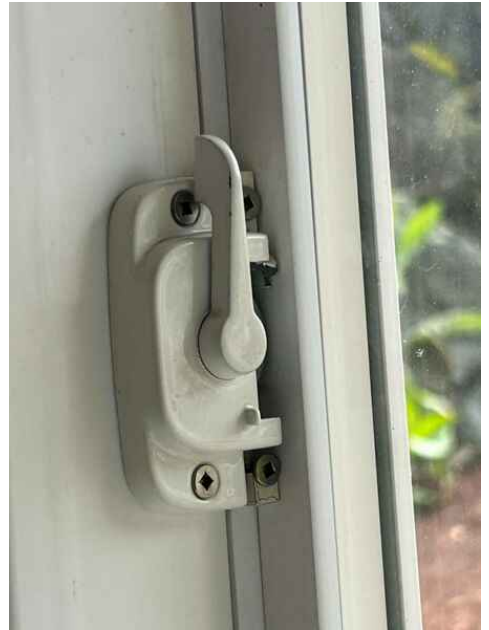
Several windows in the home exhibited issues such as stickiness, missing components like locks, or damaged weather stripping. These issues can impact functionality and energy efficiency. It is recommended to address these issues promptly upon possession to ensure smooth operation and proper sealing against the elements, enhancing both comfort and security in the home.

Weather stripping broken/ Sticky window

Broken/ worn component

Broken lock

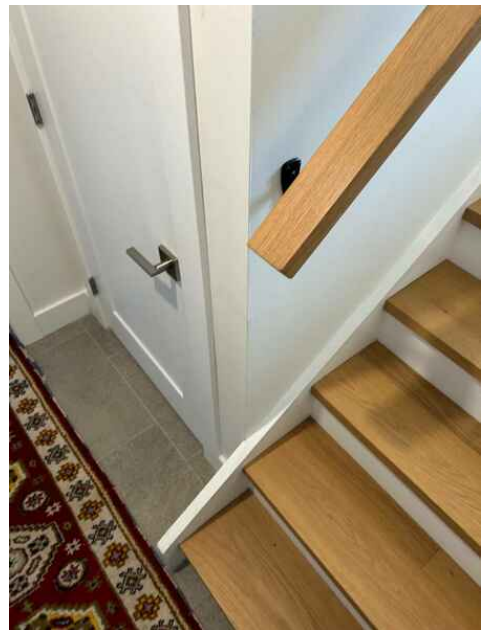
The handrail on the stairs exhibits an accessibility concern as it does not extend down to the full length of the stairs and is slightly oversized, making it difficult to grasp for children and individuals with smaller hands. This issue may pose a safety risk, particularly in emergency situations or for those with mobility limitations. Consideration should be given to adjusting or replacing the handrail to ensure it meets accessibility standards and promotes safety for all occupants upon possession.

Hand rail doesn't extend

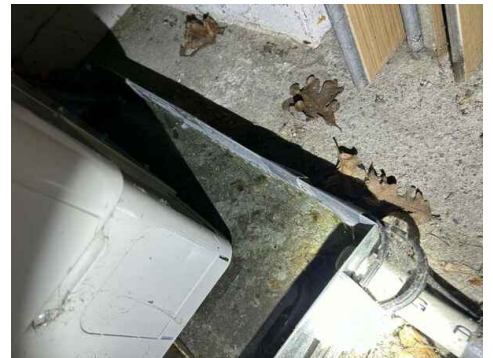
The drip pan beneath the heat pump is holding water and appears to have a heat cable connected to an extension cord, likely for freeze prevention. However, this setup poses potential safety hazards and is not ideal for proper drainage. It is recommended to address the water accumulation issue and ensure the heat cable is safely and appropriately installed by a qualified professional to mitigate risks and optimize the functionality of the heat pump system.

Permanently flooded pan

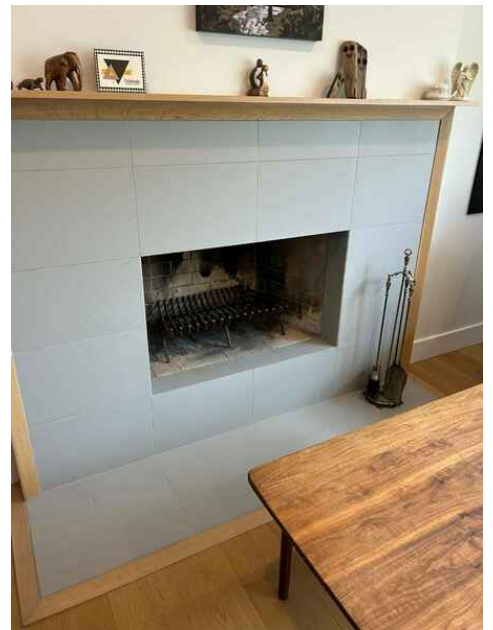
WETT inspection required

Inspector recommends a WETT (Wood Energy Technology Transfer) inspection for all wood burning appliances/ fire places and that the appropriate home owners insurance is obtained prior to use.

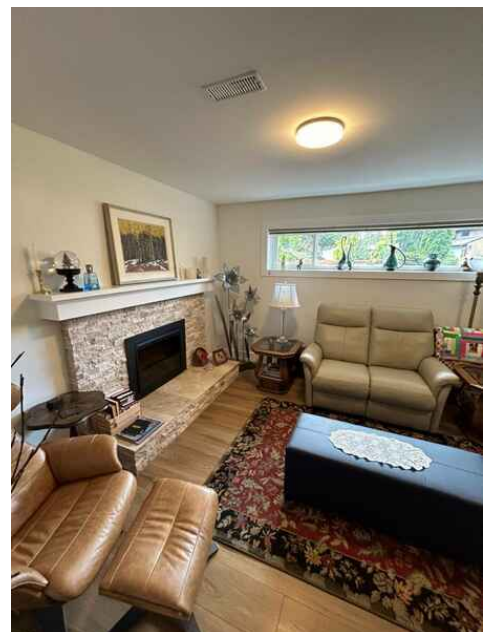
The electric fireplace exhibits a rattle, more of an inconvenience than a serious issue. While this doesn't affect its functionality, it may warrant further examination to identify and address the source of the noise for improved comfort and enjoyment.

Rattling fireplace

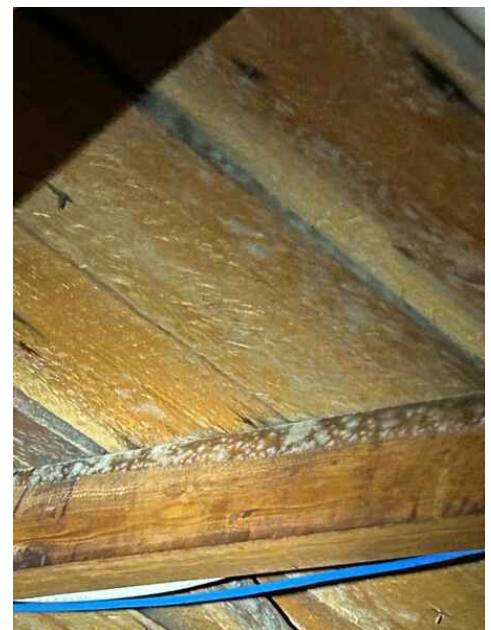
During the inspection, slight discoloration was observed on the attic decking and wood surfaces. While this may indicate moisture exposure or aging, further investigation by a qualified professional is recommended upon possession to assess the extent of the issue and determine any necessary remediation or maintenance measures.

Staining on attic structural members

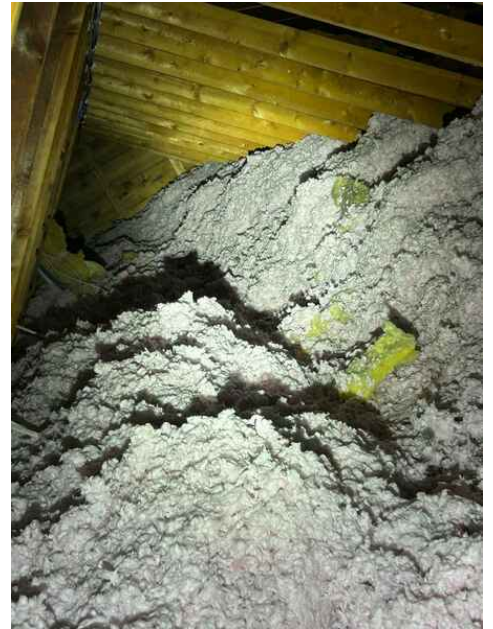
It was observed that the blown-in loose-fill insulation in the attic was compressed in certain areas, likely as a result of previous renovations. This compression reduces the insulation's effectiveness, potentially leading to energy loss and temperature inconsistencies. It's recommended to address this issue by redistributing or adding insulation to ensure optimal energy efficiency and climate control in the attic space.

Compressed insulation

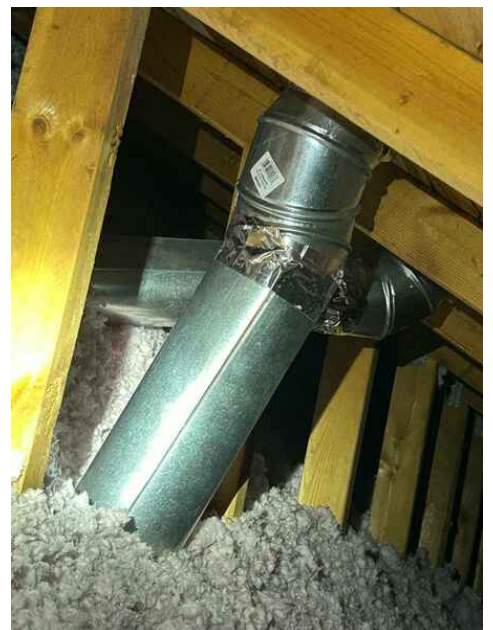
Uninsulated vents

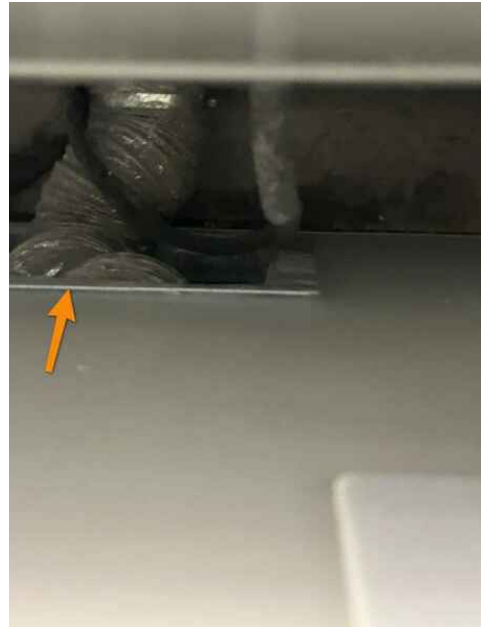
KEEP DRYER VENT CLEAR OF LINT FOR FIRE SAFETY + DRYER VENT MATERIAL

It is important to keep the dryer vent clear of lint to ensure fire safety. The dryer vent is made of corrugated aluminum material. While aluminum vents are commonly used, corrugated vents can pose risks of lint buildup and potential blockages over time. Lint buildup in the dryer vent can cause the dryer to overheat and ignite a fire. Regularly cleaning the lint filter and the dryer vent will help to prevent lint buildup and ensure that the dryer is functioning safely. We recommend cleaning the lint filter after each use and having the dryer vent professionally cleaned at least once a year, or more often if you notice any signs of lint buildup or reduced airflow. Regular maintenance of the dryer and its venting system is crucial to prevent dryer fires and ensure the safety of your home and its occupants.

Corrugated material

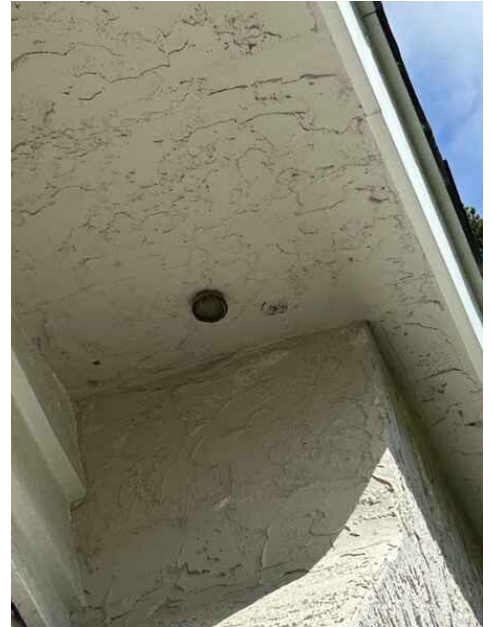
An inactive wasp nest was sighted on the soffit. While currently dormant, it's essential to monitor for any signs of activity and take preventive measures to discourage future nest-building. Inspection and potential removal by a pest control professional can ensure the safety and comfort of the property.

Inactive wasp nest
