**WATCHTOWER**  
HOME INSPECTIONS

## RESIDENTIAL REPORT

APRIL 4, 2024

7124 Willis Point Road, BC

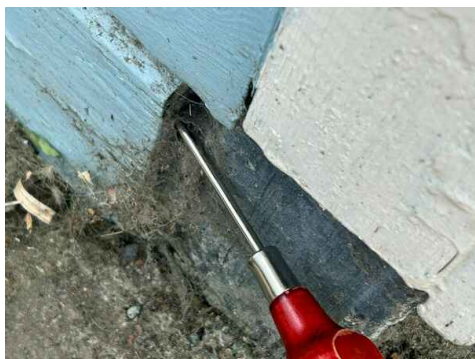
Deterioration and rot have been observed on the siding throughout various exterior areas of the home, raising concerns about moisture infiltration into the wall system. This condition could lead to further structural damage and may attract pests. It is advisable to consult with a siding contractor to assess the extent of the damage and consider repairs or replacement. For those concerned about potential expenses, obtaining a quote before closing can help in budget planning. Ideally, any necessary work should be scheduled upon possession of the home to ensure the property's exterior is adequately protected against future damage.

Siding boards showing signs of rot

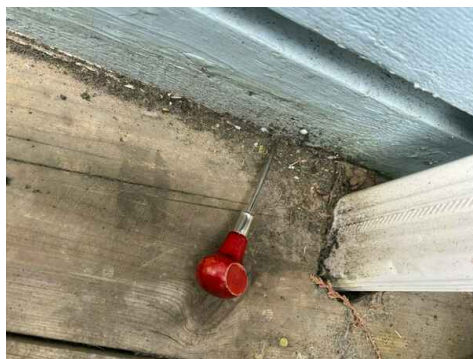
Soft wood noted near car park area

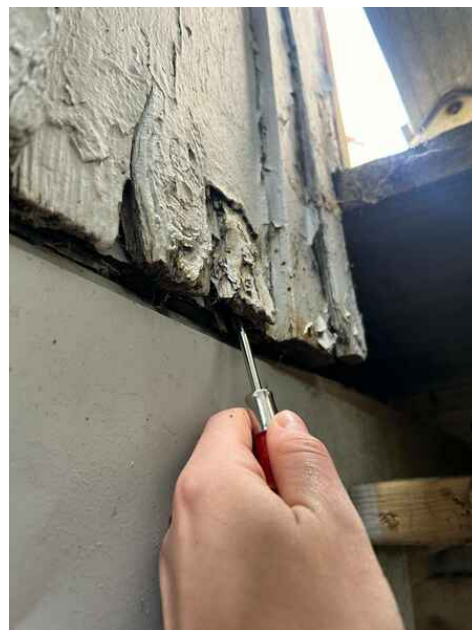
Severe Rot on Right lower siding

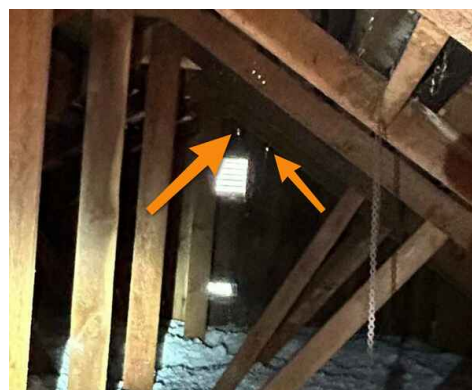
During the inspection, sections of the attic were observed to have light coming through on both the face and back of the house, suggesting potential issues with the siding. Light penetration in these areas typically indicates gaps or deterioration in the siding, which could lead to water intrusion, pest entry, and compromised insulation. It is crucial to address these siding vulnerabilities promptly to prevent further damage to the home's structure and interior. A thorough evaluation and repair of the siding by a professional upon possession are recommended to ensure the home's exterior is properly sealed and protected.

Penetration of light near gable vents

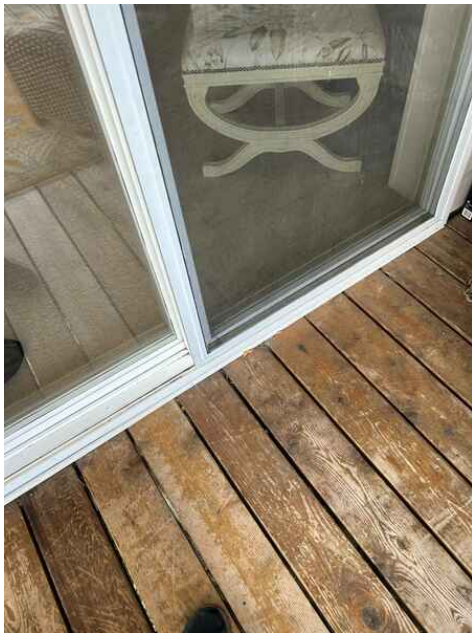
There was no flashing observed at the connection between the back deck and the home. Flashing is crucial in this area to prevent water from infiltrating the space between the deck and the house, which can lead to structural damage over time. It's recommended to have a professional install appropriate flashing to ensure the longevity of both the home and deck by preventing potential water damage and wood rot.

No flashing observed

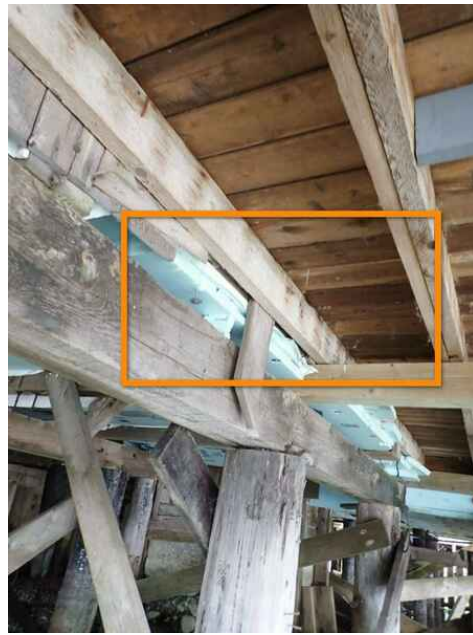
Missing flashing underneath deck, will lead to water ingress of the insulation assembly

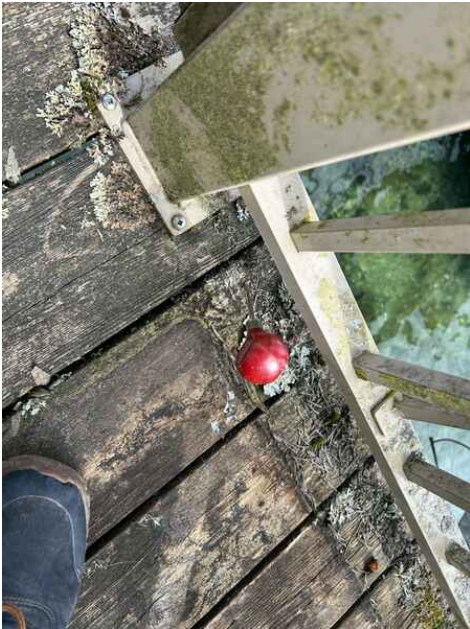
While the deck structure itself appears to have been constructed with greater care than the rest of the home's foundation, it still relies on the same piers and foundation also noted in this report for their deteriorating condition. Additionally, signs of wear are evident on many of the deck boards, and there are instances of protruding (proud) nails that pose a safety hazard. Notably, a section of the deck is totally missing its railing, temporarily replaced by a doggy gate, which does not provide adequate safety or support and poses a significant safety hazard.

Wearing deck boards

Given the array of issues, from the reliance on a compromised foundation to the makeshift safety measures and structural instability, it is strongly advised to have these outdoor structures thoroughly assessed by a professional. Corrective actions, including proper railing installation, securing or replacing deteriorated deck boards, addressing the proud nails, and ensuring the stability and safe attachment of the walkway to the deck, are imperative. Taking these steps will enhance the safety, functionality, and longevity of the deck and walkway, making them secure for use. It is advised that children are not allowed on the deck until all these concerns are addressed.

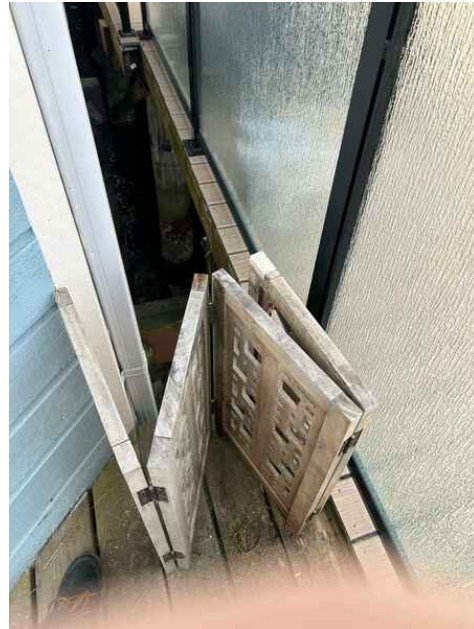
Missing gate replaced by doggy gate

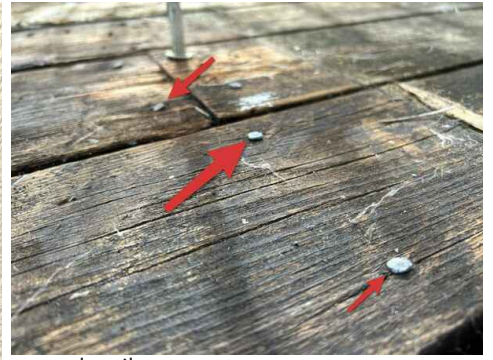
proud nails

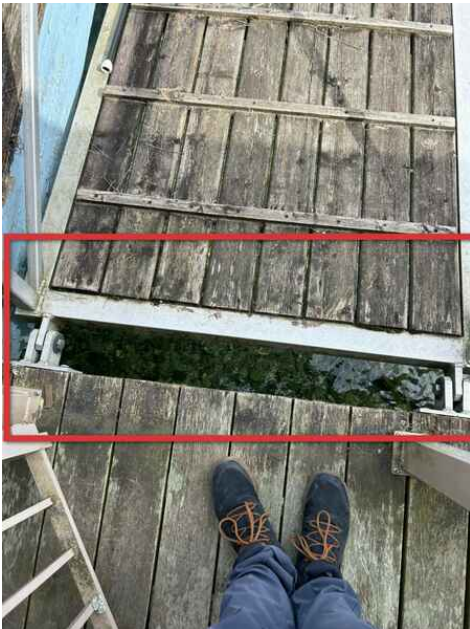
Large gap to walkway (fall hazard)

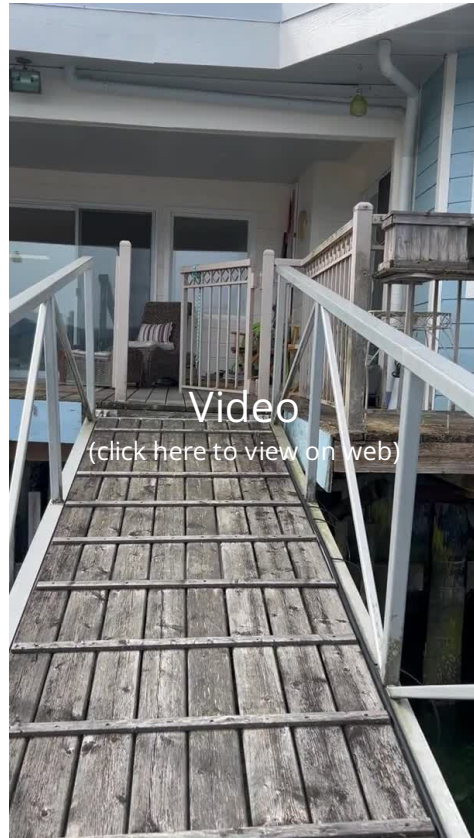
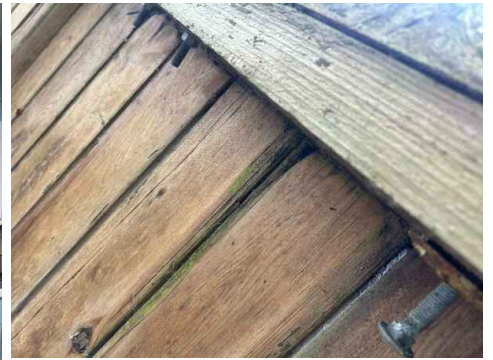
Hardware insufficiencies for walkway

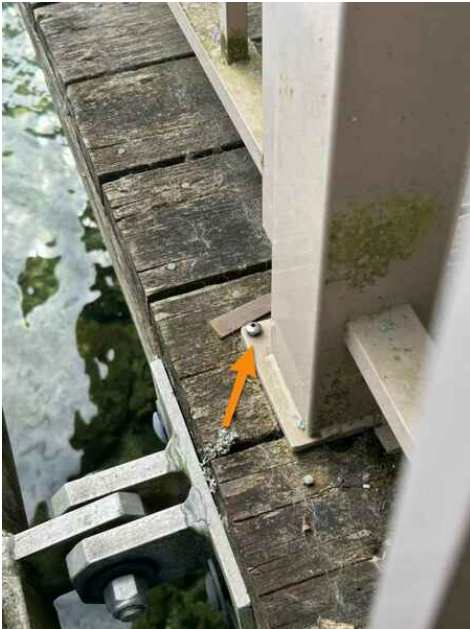
The deck railing is mounted directly onto the deck's surface, creating a vulnerability to accelerated deterioration from water ingress around the hardware. This configuration facilitates the collection of water, promoting wood rot and potentially undermining the railing's stability. To counteract this, applying mastic to the railing's hardware is advised. This action will serve as a waterproof barrier, significantly reducing water ingress and helping preserve the wood's integrity, thereby prolonging the railing's lifespan and maintaining its stability.

Hardware drilled into surface

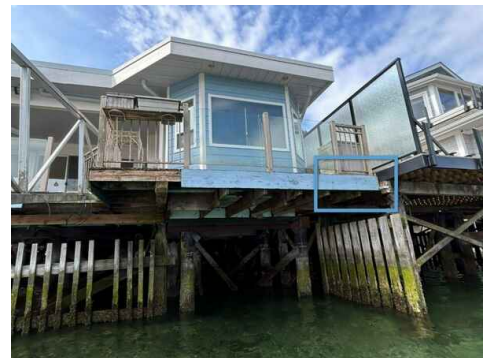
The aesthetic fascia board on the deck is exhibiting splitting, indicating potential weather-related wear or material deterioration. While primarily a cosmetic concern, if left unaddressed, it could lead to further damage or moisture ingress. Addressing this issue promptly by repairing or replacing the split fascia will maintain the deck's appearance and integrity.

Section of fascia falling off

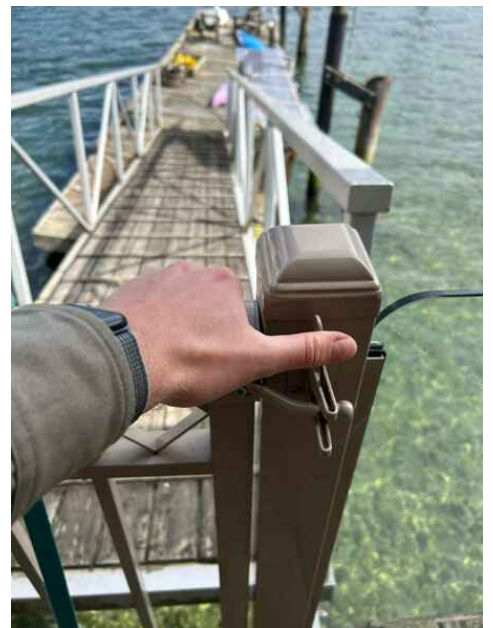
The deck gate is currently out of alignment due to mounting issues, resulting in sections that are wobbling and lack sturdiness. This condition not only affects the functionality and safety of the gate but also poses a risk of further damage if not promptly addressed. Correcting the mounting and ensuring the gate is securely fastened will restore its proper alignment and stability, enhancing the deck's overall safety and usability.

Gate and latch out of alignment

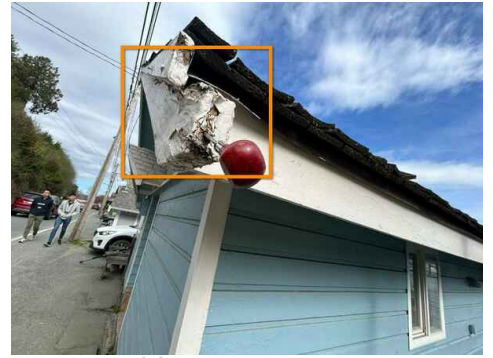
Throughout the home's exterior, rot has been identified multiple fascia boards. This deterioration can compromise the home's structural integrity, aesthetics and lead to further damage if not addressed promptly. To maintain the property's condition and prevent additional issues, such as water ingress into the roof or attic space or further rot, replacing or repairing the damaged fascia boards is recommended upon taking possession of the home.

Very rotted fascia

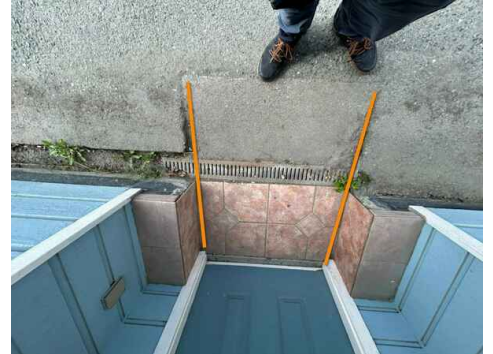
The front entrance exhibits a low threshold with negative grading directing towards it, highlighting the importance of the existing drainage system. The drain positioned here is essential for preventing water ingress into the home, particularly during heavy rainfall. Its efficiency in diverting water away from the entrance is crucial in safeguarding the interior against potential water damage.

Grade towards home and low threshold on entry door

It's advisable to discuss with the seller how the front entrance and its drainage perform under intense rain conditions. This conversation can shed light on any past issues with water pooling or entry and confirm the drain's capacity to handle significant rainfall. Ensuring that this drain is functioning correctly is key to maintaining the home's integrity and preventing moisture-related problems at the front entrance.

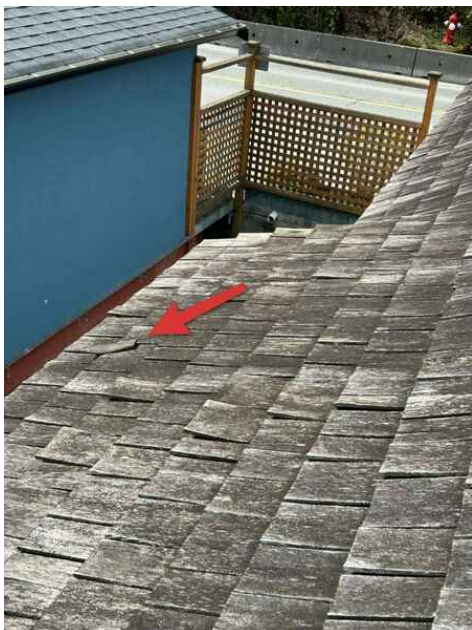
The wood shake roof of the home exhibits significant wear and damage, including cupping and splitted shakes, lifted shakes, missing shakes, and multiple damaged ridge sections. While wood roofs are renowned for their durability and longevity with proper care and maintenance, the current state of this roof indicates neglect and necessitates extensive maintenance to restore its condition and functionality. The observed damage points to potential underlying issues that could compromise the home's defense against the elements.

Broken loose and missing sections

Given the extensive nature of the required repairs, it is strongly advised to have this roof thoroughly assessed by a roofing professional who specializes in wood shingle/shake roofs. Such an assessment will not only provide a detailed overview of the necessary repairs but also offer insight into the ongoing maintenance needed to prolong the roof's lifespan. It's essential to address these concerns promptly upon taking possession of the home to avoid further deterioration and potential leaks.

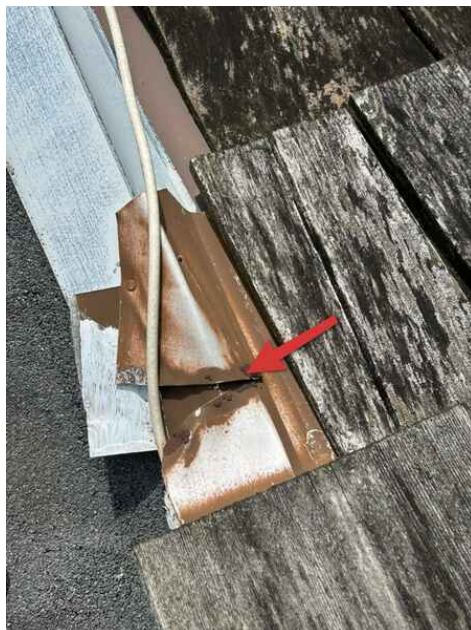
Voids and deteriorated flashings throughout

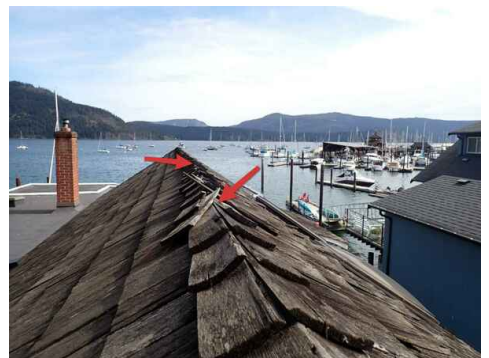
Ridge line damaged

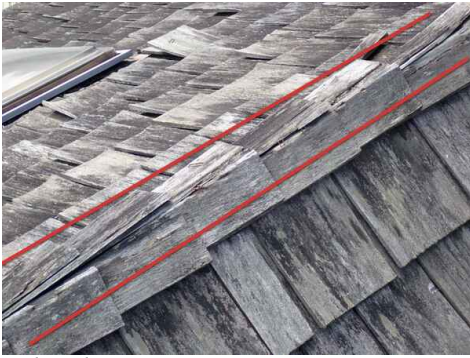
Ridge damage

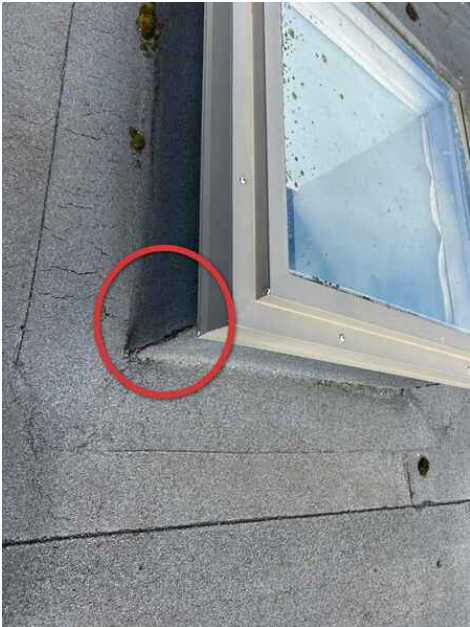
The modified bitumen section of the roof shows significant wear, notably alligatoring—a pattern of cracks indicating aging—and pooling, where water collects due to poor drainage, risking leaks and structural damage. Soft spots suggest potential deck damage beneath.

Compromised flashing, with missing or rusted hardware, especially near the skylight, exacerbates leak risks.

Split material on skylight curb

Immediate evaluation and repair by a professional familiar with modified bitumen roofing are crucial. Homeowners should understand that alligatoring and pooling signify serious issues that need prompt attention to prevent further damage.

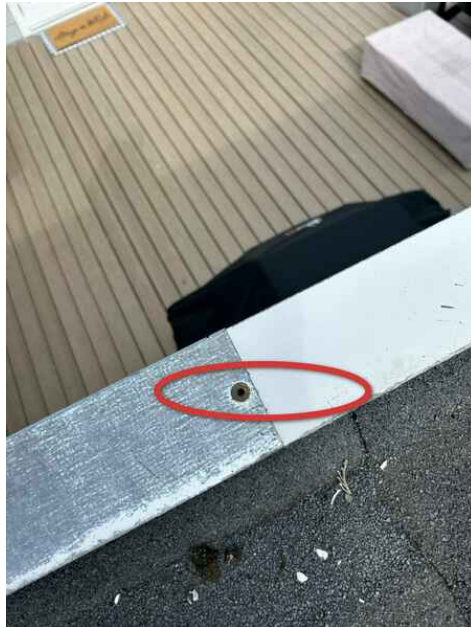
Rusted exposed hardware

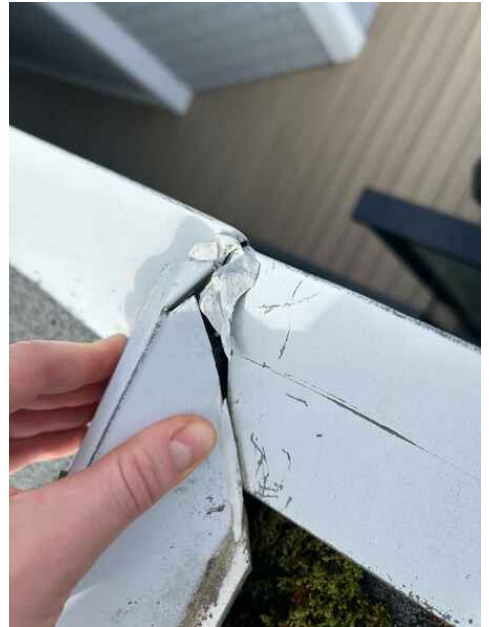
Void in flashing

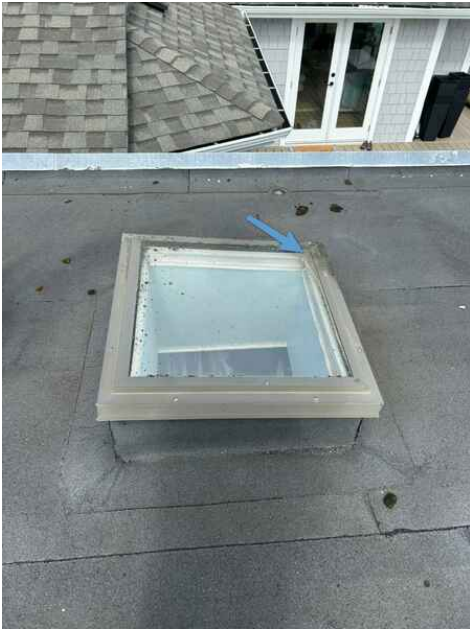
During the inspection, the skylights exhibited no signs of leakage, which is positive. However, it's important to note the variance in their installation techniques, which could impact future maintenance needs. One skylight is well-constructed on a site-built curb, offering a robust seal against water intrusion. In contrast, another is installed almost flush with the roof surface, making its step flashing less visible and potentially more susceptible to issues if not properly maintained.

evidence of pooling on skylight

Maintaining all skylights, including the two additional ones located on the modified bitumen section of the roof, is crucial for their longevity and effectiveness. The skylights on the mod-bit section, previously noted for lacking mastic on the hardware, particularly underscore the need for regular checks and upkeep. Consistent maintenance is key to ensuring these features remain leak-free and continue to enhance the home's natural lighting without causing water damage concerns. Regular inspection and prompt repair of seals, flashing, and hardware can prevent future issues, safeguarding the integrity of both the skylights and the roof.

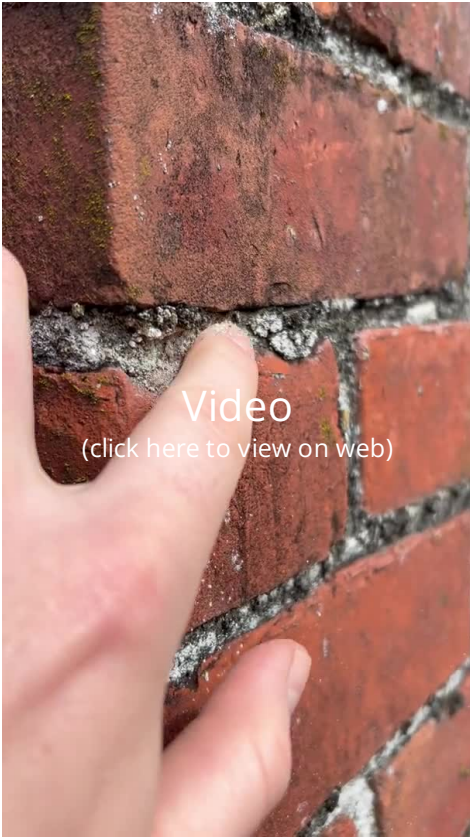
The chimney exhibits signs of spalling and deteriorating mortar, indicating a need for repointing to restore its structural integrity and prevent further damage. Additionally, the current chimney cap is virtually non-existent, likely allowing significant water ingress, which can lead to internal damage and potential leakage into the home. It's crucial to address these issues promptly by engaging a professional to repoint the chimney and install a new, durable cap. These steps will not only prevent water damage but also ensure the chimney's safety and functionality. Hidden damage is possible. Advised to obtain a quote before close.

Repoint of mortar and possible rebuild needed

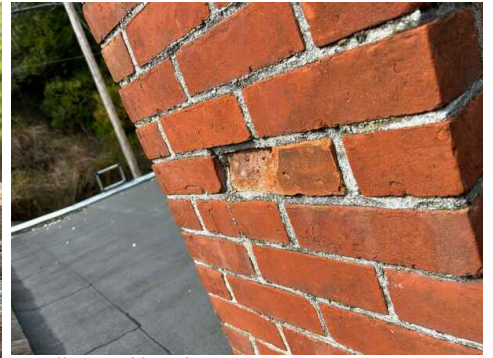
Spalling of bricks

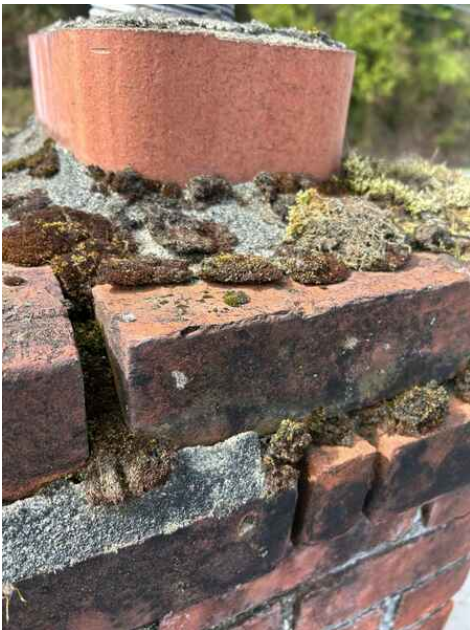
Missing cap and serious voids

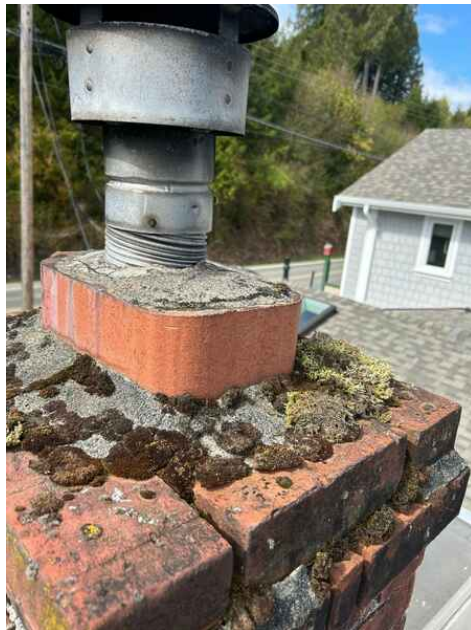
Missing cap increasing water ingress

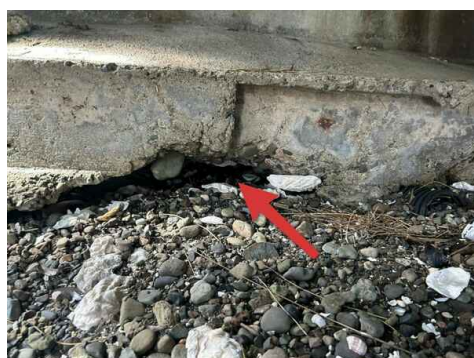
Several piers and pillars are exhibiting rot at the points where they meet their footings, a condition that compromises their stability and integrity. Additionally, numerous footings are either being undermined by the environment or show extensive signs of deterioration, further accentuating the potential risk to the home's safety and durability. Observations also revealed that a few posts are noticeably out of plumb, multiple posts using shims, or have significant space between the surface and beam, indicating uneven settling or shifting that could affect the structure's overall balance.

Compounding these issues, the concrete slab that underpins a portion of the house is experiencing undermining effects, which could lead to significant structural failures if left unaddressed. Furthermore, there are beams with inadequate overhang, currently one only secured by a joist hanger, a method that may not provide sufficient long-term support given the environmental challenges posed by the marine setting.

Undermined footing

Obtain quote before closing.

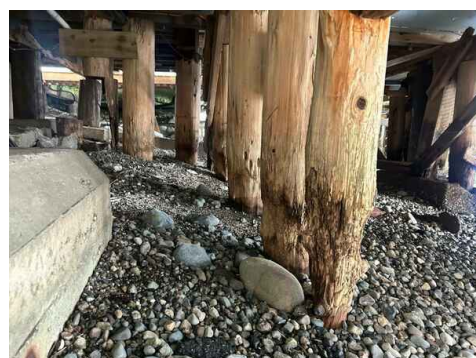
Deteriorated posts

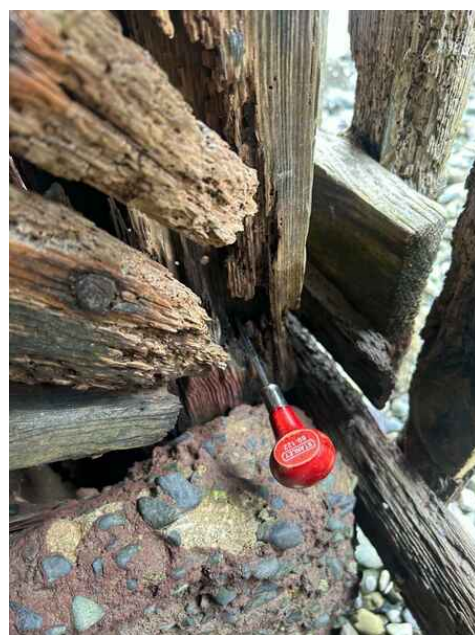
Severely rotten posts in degraded footings

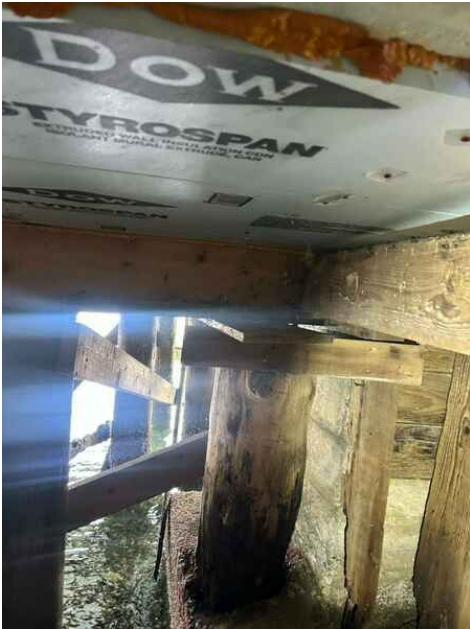
Shims used over post log in a deteriorated footing

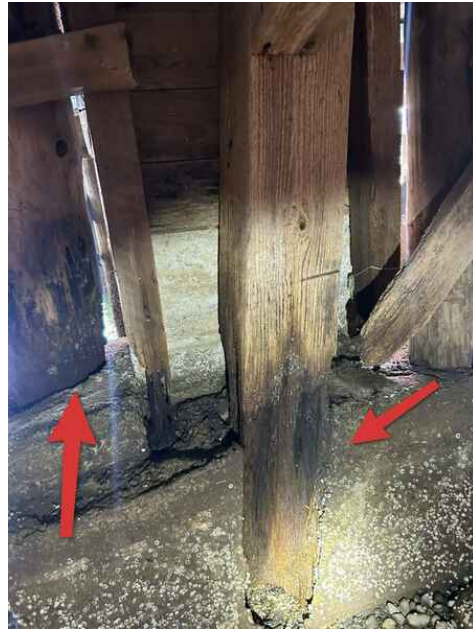
Severe rotted support post in disappearing footing

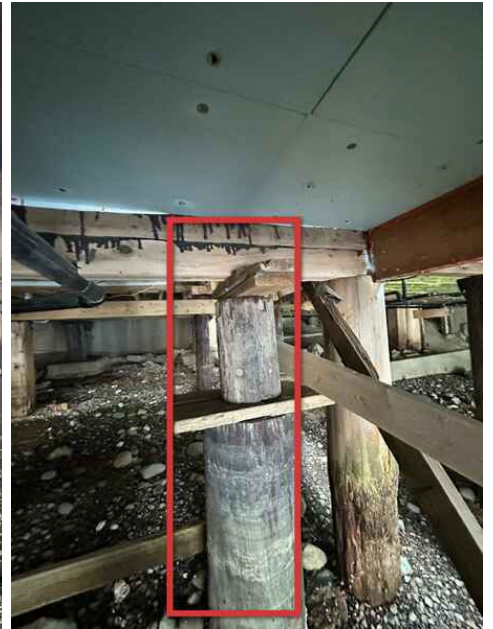
Improper building practices, Log to shim to log to shim

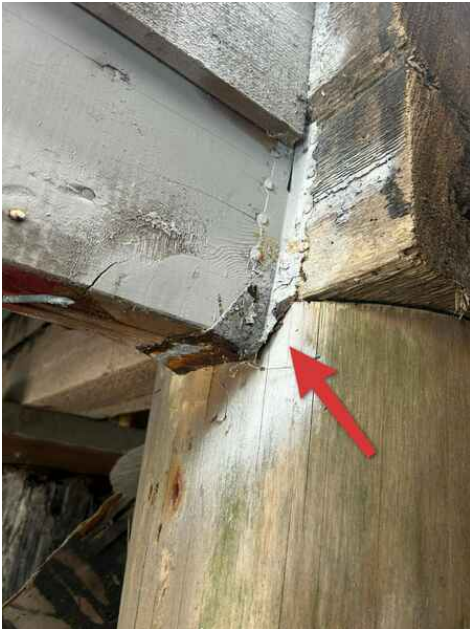
Beam used with joist hanger, insufficient end bearing

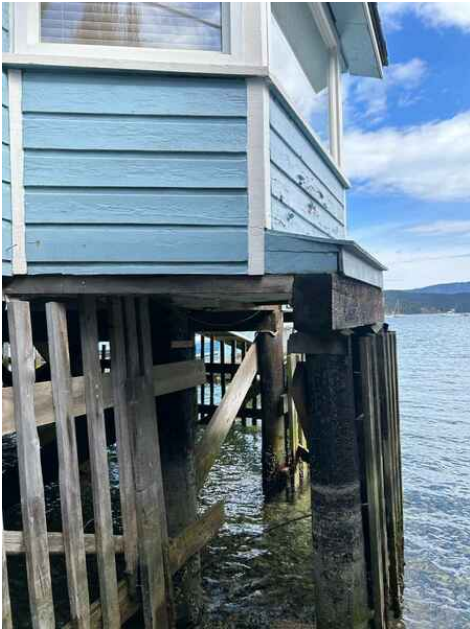
Floor displacement observed throughout the living area suggests underlying foundation or subfloor issues, such as settling or moisture damage, which could affect the home's structure and safety. A structural specialist's examination is crucial to pinpoint the exact cause and determine the necessary repairs. Addressing this promptly will help ensure the home's stability and prevent further damage, maintaining its safety and value.

Section of home is obviously displaced inside

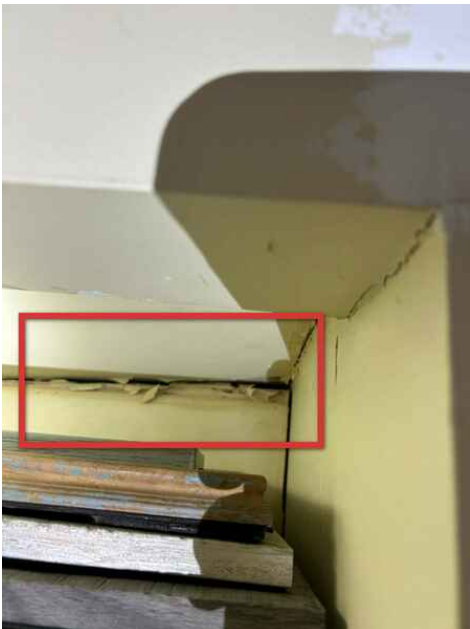
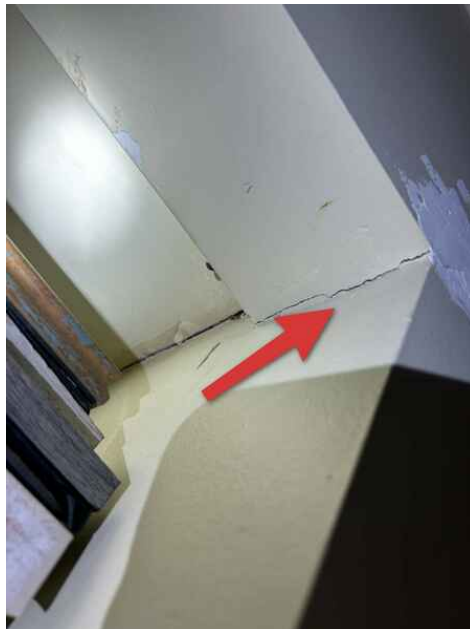
Moderate to severe cracking observed on the guest bedroom wall and cubby area indicates potential structural stress or foundation issues. These cracks necessitate an urgent evaluation by a structural engineer to assess their severity and underlying causes. Timely intervention is essential to address any structural concerns, ensuring the safety and integrity of the space.

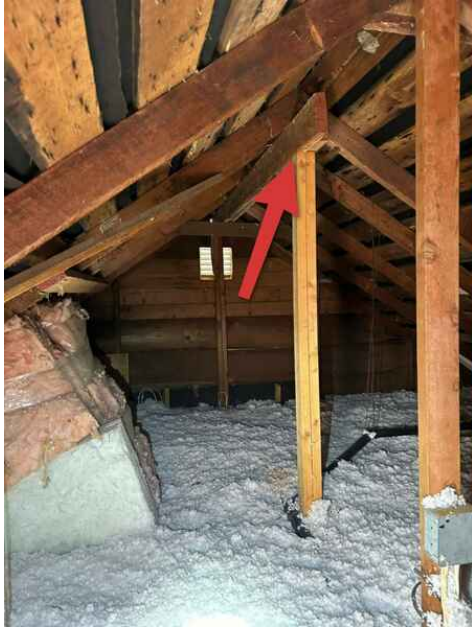
The attic inspection revealed irregular spacing between the rafters, with noticeable variation throughout. Additionally, in the front portion of the home, it appears that rafters were removed to accommodate a skylight installation. Efforts have been made to redistribute the load to a new wood member in lieu of the removed rafters. However, given the structural implications of such modifications, it is essential to have these changes assessed by a structural engineer. This professional evaluation will determine if the current approach adequately supports the roof's load and complies with building standards, ensuring the home's structural integrity and safety.

Rafters taken out and attempted replaced load

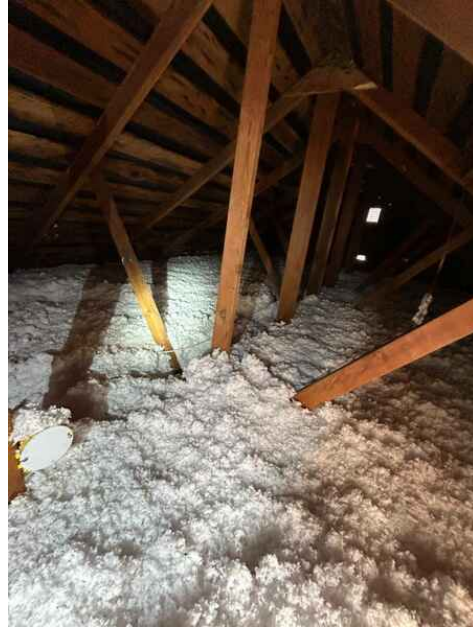
Irregularly spaced rafters

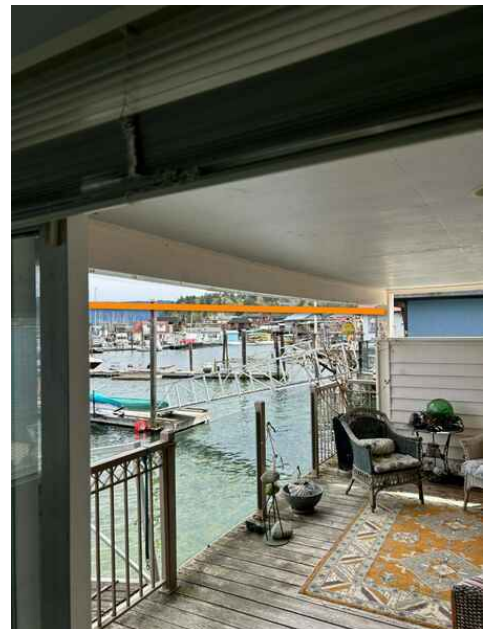
The beam supporting the rear portion of the roof above the back deck shows significant sagging at time of inspection. This is a structural concern and requires assessment by a structural engineer before the close of the sale to determine the cause and necessary corrective measures.

Beam has obvious sag

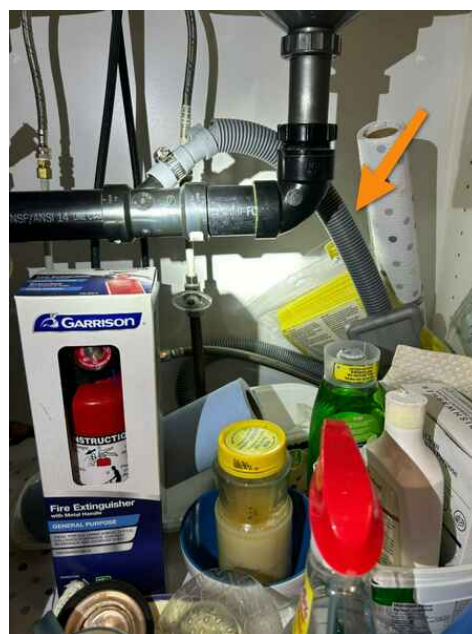
The dishwasher drain hose is positioned too low under the sink, posing a risk of backflow into the dishwasher. This setup can lead to contaminated water returning to the dishwasher, potentially affecting the appliance's performance, hygiene and dirty water mixing with potable. To prevent backflow, the drain hose should be looped to a higher point under the sink before connecting to the drainage system, creating a high loop that prevents backflow. Adjusting the hose's placement or installing an air gap device is recommended to ensure proper drainage and maintain the dishwasher's efficiency and cleanliness.

Hose should be fixed higher to prevent backflow of waste water

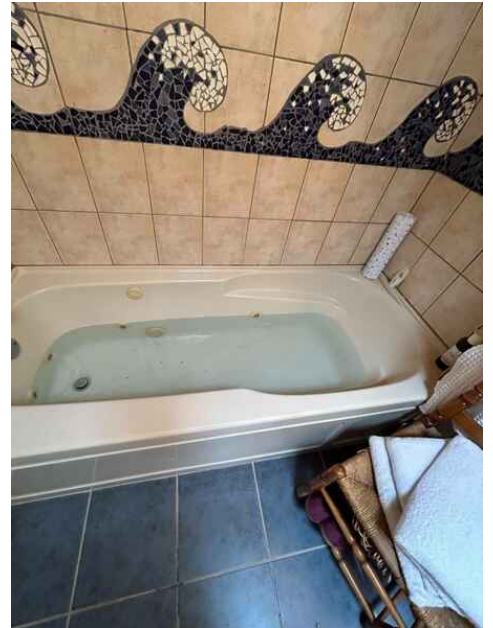
The master bathtub exhibits slow drainage, indicating a potential blockage or plumbing issue. A professional cleaning or plumbing inspection is recommended to restore efficient drainage upon possession.

Tub has slow drain

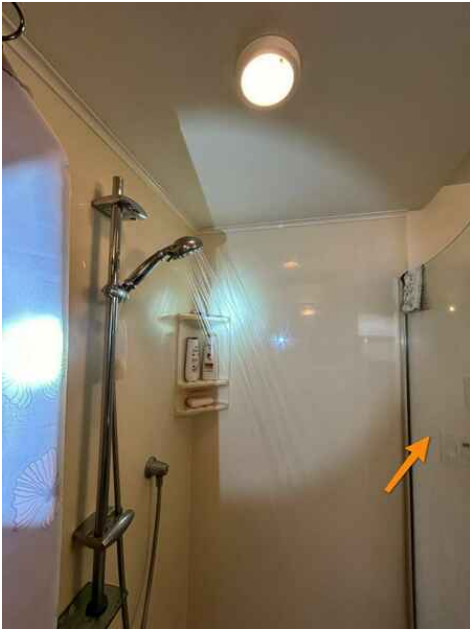
The glass wall of the shower appears to be leaking, allowing water to pass onto the other side of the glass. This issue can lead to water damage on the bathroom floor and potentially affect the surrounding areas if not promptly addressed. Sealing or repairing the glass wall, focusing on the areas where the seal may have failed, is recommended to prevent further leakage. In general keeping up with regular maintenance of the grout and caulking is recommended. A professional evaluation upon possession will determine the best course of action to ensure the shower is watertight and to avoid any long-term moisture problems.

Glass partition leaking

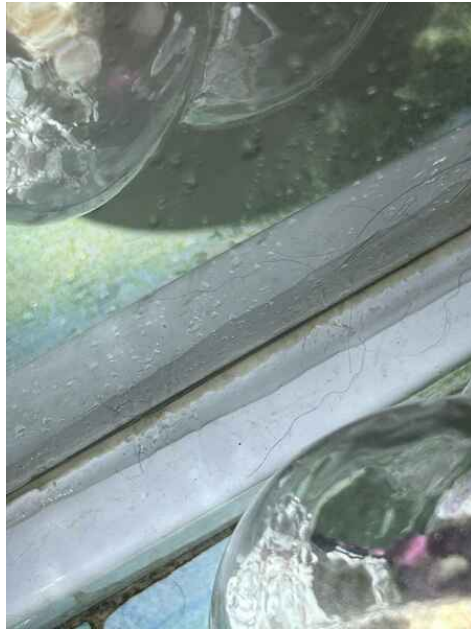
Needs caulking maintenance

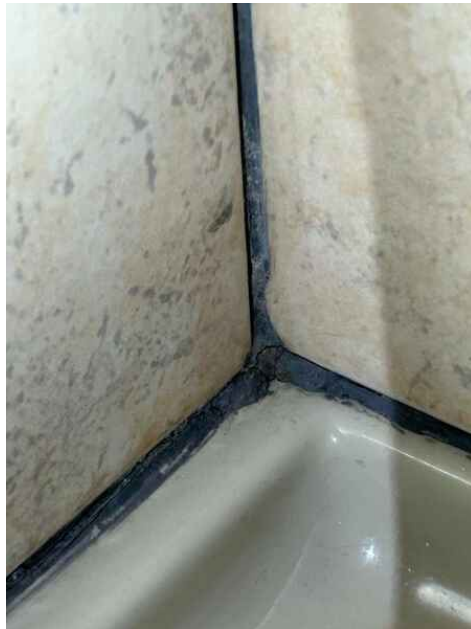
Missing caulk/ silicone

Re silicone upon possession

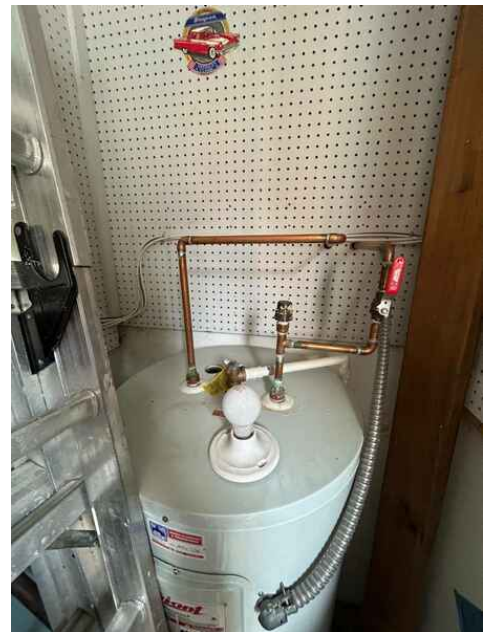
No expansion tank was present. Expansion tanks allow for the thermal expansion of water in the pipes. These are required in certain areas for new installs. Recommend a qualified plumber evaluate and install upon getting a new tank.

Missing expansion tank

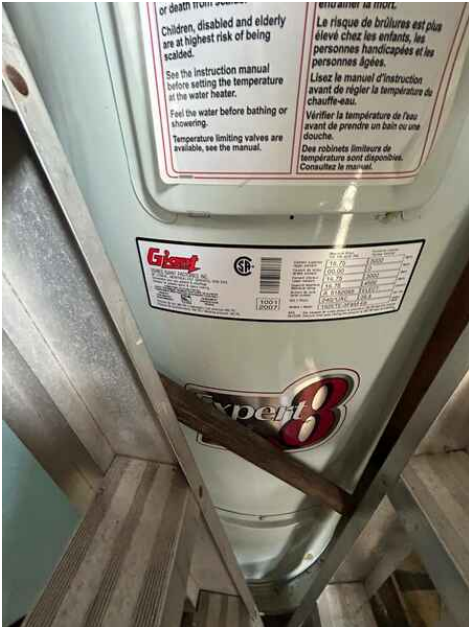
No seismic straps

Recommend upon possession a qualified professional to add seismic straps to secure the tank and to protect from plumbing damage during seismic movement. Typically, one strap at the top third of the tank, and one at the bottom third.

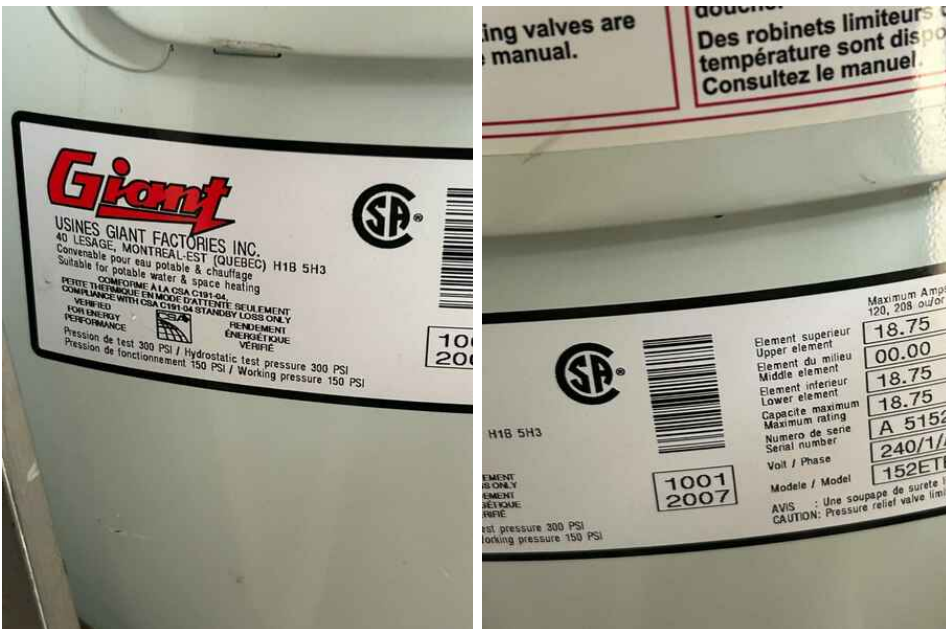
The water heater in the home dates back to 2007/2008. Given the typical lifespan of water heaters ranges from 7-10 years, this unit is at the end of its effective service life. Ageing water heaters can become less efficient, more prone to breakdowns, and may even pose a risk of leaks or water damage. It's advisable to have a qualified professional assess its current condition and consider planning for its replacement to ensure reliable and efficient hot water supply in the home.

Water heater well past life expectancy

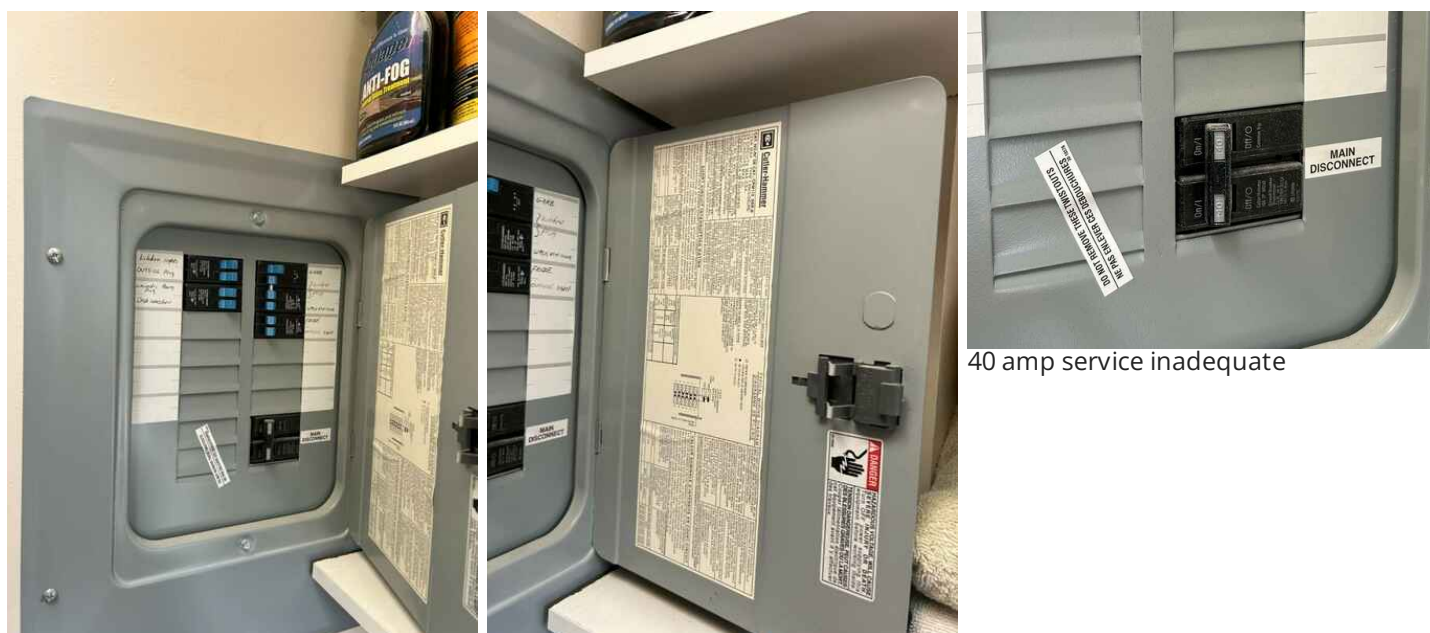
40 amp service inadequate

Inquiring about the cost of such upgrades is essential, as it can impact the overall investment in the property. Ensuring the electrical system can accommodate current and future needs is crucial for a safe and functional home environment.

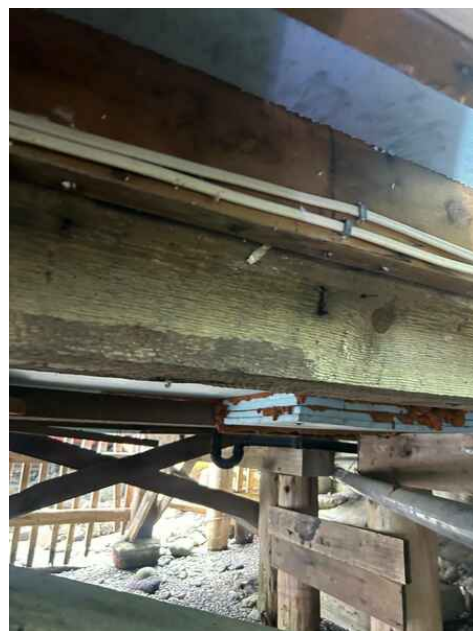
The electrical wiring used outside the home is not suitable for exterior conditions, posing concerns about durability and electrical safety. Without proper weatherproofing or conduit, such wiring is vulnerable to the elements, potentially leading to electrical hazards. It's recommended to promptly replace this wiring with materials rated for outdoor use by a licensed electrician to ensure safety and compliance with electrical standards.

Interior wiring used outside

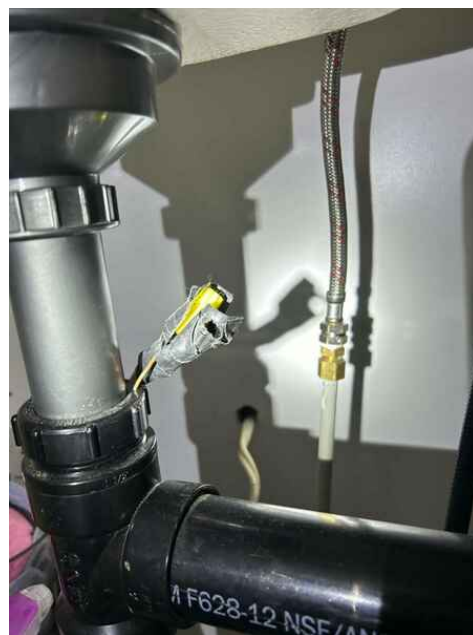
There's improperly terminated electrical wiring under the sink, which needs attention and be properly removed. While currently posing no immediate harm due to not being a hot wire, correcting this by having a licensed electrician secure or appropriately redirect or terminate the wiring is advisable upon possession. Proper handling will eliminate any potential risks and ensure the area is safely set up, aligning with electrical safety practices.

Wiring should be completely removed

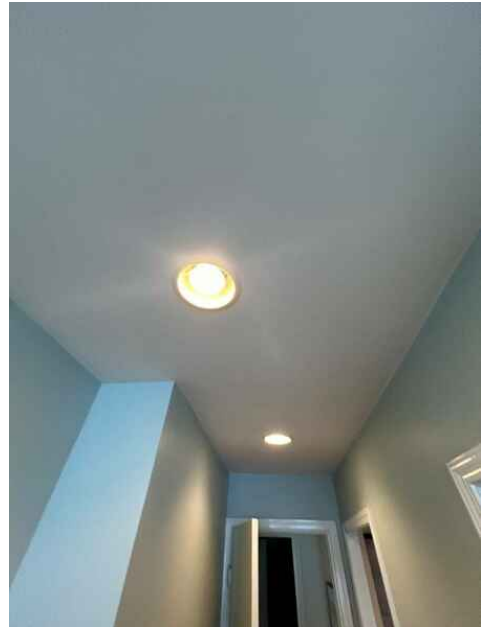
It is important to note that smoke detectors should be installed in each room and living space, as well as carbon monoxide detectors on every floor and near appliances that emit CO. These detectors can help ensure the safety of occupants by providing early warning in case of fire or the presence of dangerous levels of carbon monoxide. It is recommended to test these detectors regularly and replace batteries as needed to ensure they are functioning properly. This is a life safety issue.

Both bedrooms missing Smoke/CO detectors

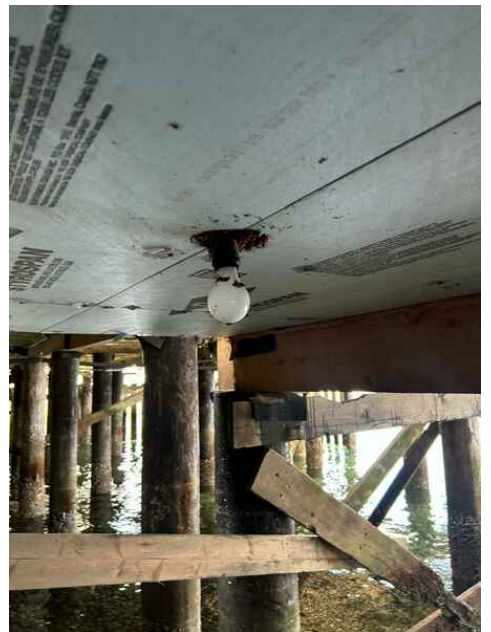
An interior light fixture installed outside under the home, especially in a marine environment, is unsuitable and poses safety risks due to exposure to moisture and salt air. Such conditions can damage the fixture, increasing the likelihood of electrical hazards. Immediate replacement with an exterior-rated fixture designed to withstand marine conditions is advised, ensuring safety and compliance with electrical standards.

Light fixture not appropriate for marine location

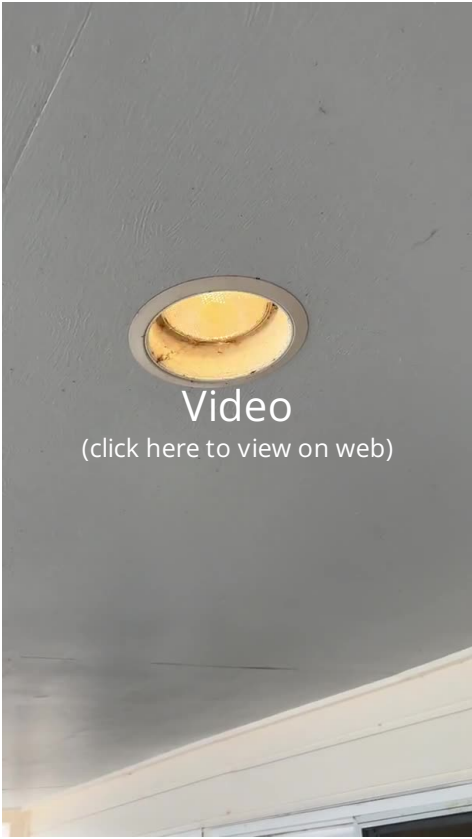
The dimmer switch for the exterior light on the deck was found to be malfunctioning during the inspection. This issue may stem from the switch not being rated for outdoor use, which can affect its performance and durability when exposed to outdoor conditions. To ensure safety and proper functionality, it's recommended to replace this switch with a model that is specifically rated for exterior use. This adjustment will help prevent future malfunctions and ensure the lighting system's reliability on the deck.

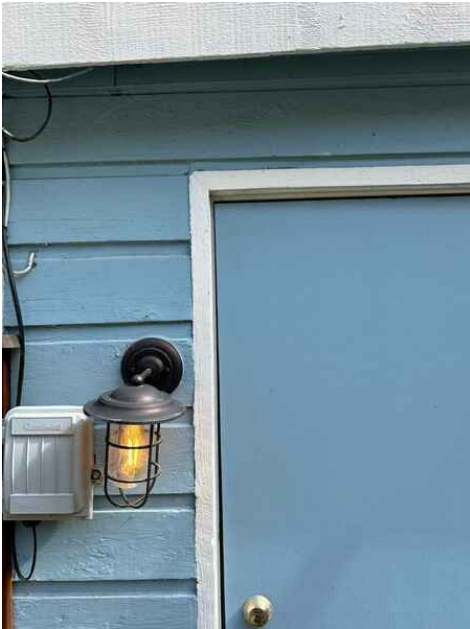
Several doors and a window within the home have been found to be challenging to open or close, suggesting they may not be properly aligned. This condition can often indicate house movement, where shifts in the foundation or structural framing cause changes in how door and window frames fit. Monitoring these symptoms and seeking an evaluation from a structural engineer is advisable to ascertain the home's stability and address any underlying structural concerns, ensuring ongoing safety and integrity.

Misaligned door

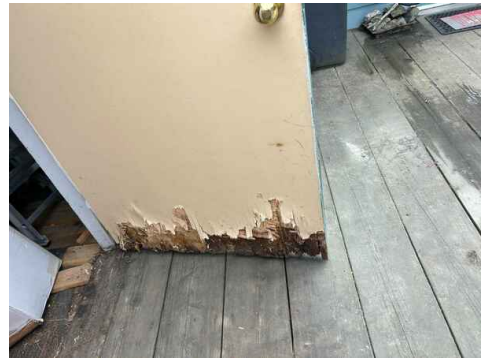
The bottom of the door leading to the utility/storage closet exhibits severe damage, along with significant rot on the lower portion of the door frame and jamb. This deterioration could compromise the door's functionality and potentially allow for pest entry or further damage to the space it protects. Hidden damage is likely. Addressing this issue promptly by repairing or replacing the damaged door and assessing the frame is recommended to maintain the integrity and security of the closet and wall/frame assembly, ensuring it continues to serve its intended purpose effectively.

Door damage

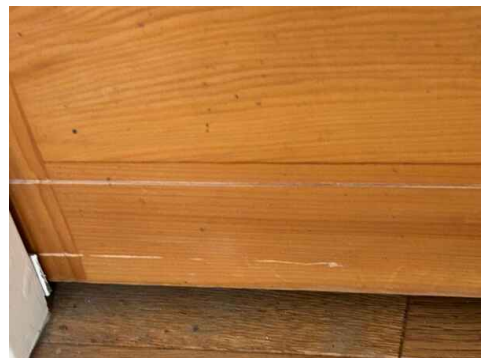
The pocket door to the coat closet is experiencing scraping, indicating it may be off its track or misaligned. This friction can damage the door or its frame over time and hinder smooth operation. A proper adjustment or realignment by a professional, upon possession is recommended to resolve the scraping, ensuring the door functions smoothly and remains in good condition.

Pocket door to coat closet is scraping
