**WATCHTOWER**  
HOME INSPECTIONS

## RESIDENTIAL REPORT

APRIL 4, 2024

7124 Willis Point Road, BC

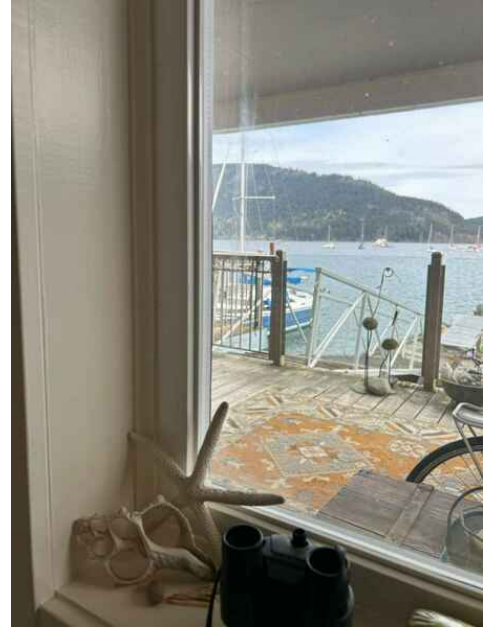
Observed condensation between the window panes on multiple windows, which indicates a failed seal. Recommend qualified window contractor evaluate & replace as needed.

Failed seal rear windows

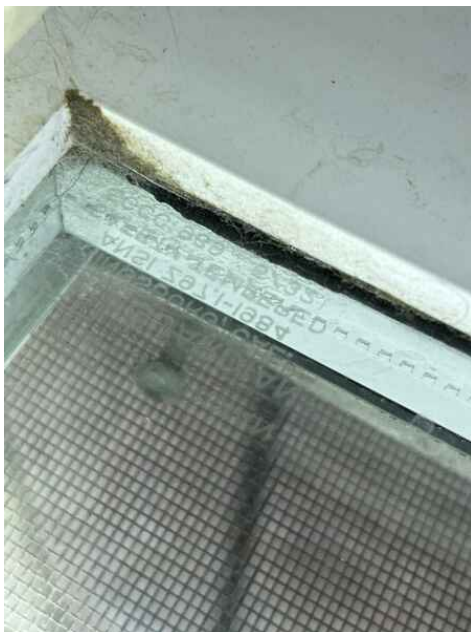
The windows in the home, based on indications from several units, appear to date back to 1999 (1996 in spare sleeping room and 1984 main rear sliding glass door), making them approximately 25 years or older. While windows of this age can still function adequately, it's common for them to gradually lose their seal and become more challenging to operate over time. Regular maintenance can help prolong their usability, but it may be beneficial to consider the condition and efficiency of these windows as part of the home's overall maintenance plan. This doesn't pose an immediate concern, but being aware allows for informed decisions regarding potential future updates or replacements to enhance the home's comfort and energy efficiency. This is a summary item purely due to the costs involved of replacing windows as they tend to be expensive.

sliding glass door from 1984

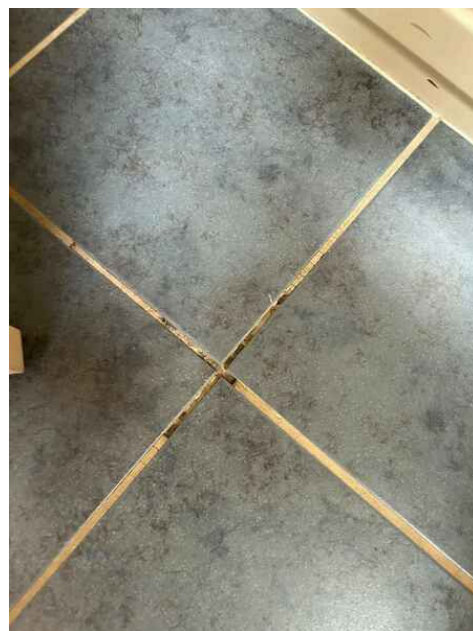
There are areas within the master bathroom's tile floor where grout is missing. Addressing this by re-grouting affected areas upon possession will prevent water penetration and maintain the floor's durability and appearance.

Missing grout

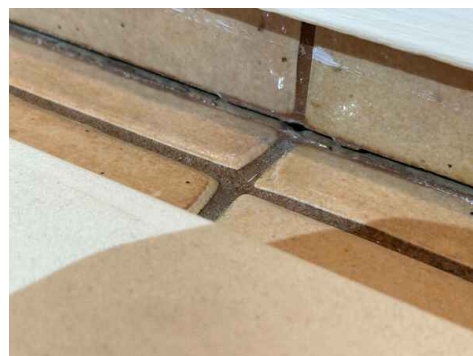
The caulking behind the kitchen sink is either missing or has worn out, potentially allowing water to seep through gaps and cause damage to the countertop or under-sink cabinetry. Reapplying caulking in this area is a straightforward maintenance task that can prevent water damage and maintain the kitchen's cleanliness and appearance. Apply upon possession.

Behind kitchen sink needs caulk/silicone

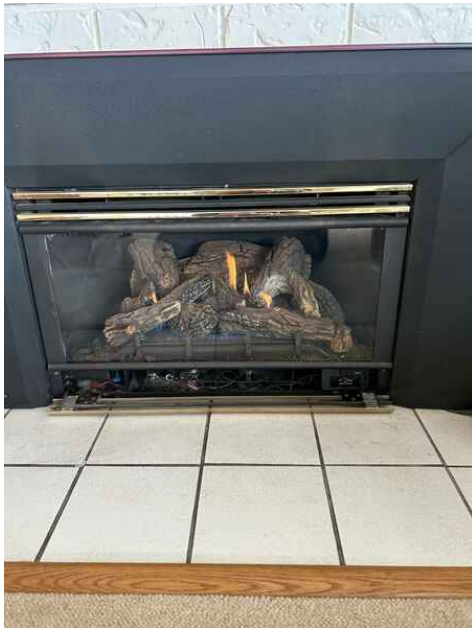
Fireplace functional

Upon taking possession of the home, it is recommended to service the gas fireplace to ensure its safe and efficient operation. It was also noted that there is no gas shut-off valve directly at the unit. Installing a shut-off valve is crucial for safety, allowing for quick disconnection of gas supply in case of emergencies or for routine maintenance. This service and installation of a shut-off valve should be carried out by a qualified professional to enhance the functionality and safety of the gas fireplace.

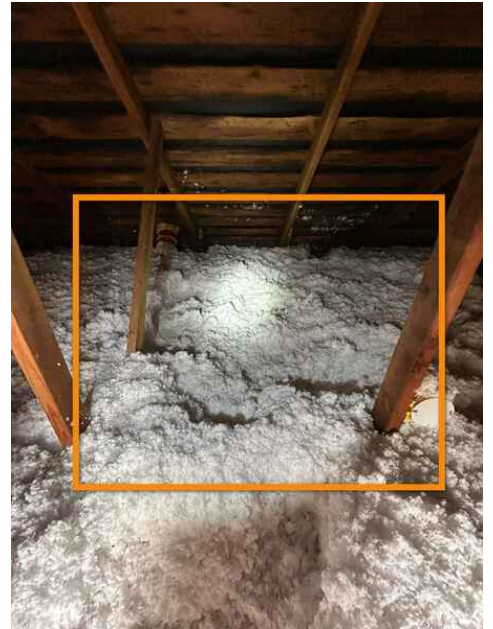
In several areas of the attic, the blown-in fiberglass insulation was observed to be compressed or compacted, likely as a result of work performed in the attic space. Compaction of insulation can significantly diminish its effectiveness in providing thermal resistance, potentially leading to increased energy costs and reduced comfort within the home. It is advisable to have a professional assess and possibly rejuvenate or replace the compacted insulation to restore its proper function and ensure the attic is adequately insulated.

Compacted insulation in attic due to work

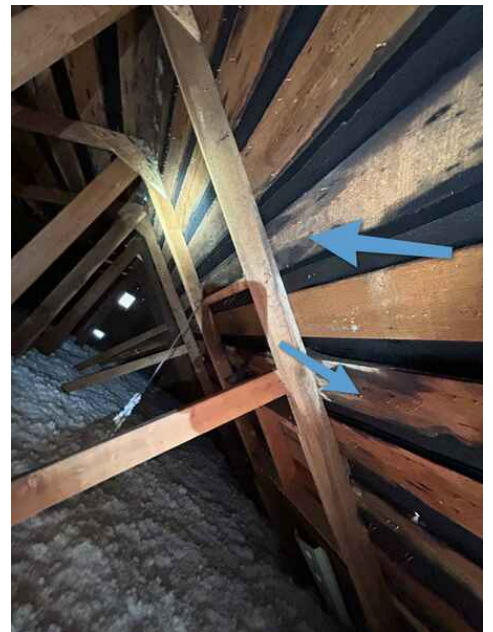
Slight discoloration was observed on the decking (the wood surface to which the shingles are nailed) during the inspection. This change in color could stem from the wear and exposure associated with previous roofing materials. While discoloration can sometimes indicate moisture exposure or aging materials, its presence alone, especially if attributed to past roofing, may not necessarily signify current damage or concern. However, to ensure the roofing system's integrity, it is advisable to monitor these areas yearly for any signs of worsening condition or moisture issues in the future. The attic space was found to have sufficient air flow and ventilation.

Decking discoloration

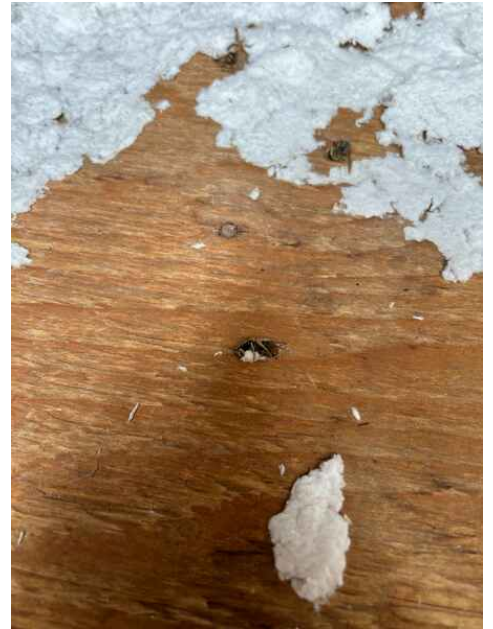
The inspection revealed no visible vapor barrier in the attic space other than on a sky light channel. A vapor barrier is crucial for preventing moisture from passing into the attic insulation and structure, which can lead to mold growth, wood rot, and reduced insulation effectiveness. The absence of a visible vapor barrier raises concerns about potential moisture management issues within the attic. It is advisable to have a professional assess the need for and possibly install a suitable vapor barrier. This measure will help ensure proper attic ventilation and moisture control, contributing to the overall health and longevity of the home.

No visible vapor barrier

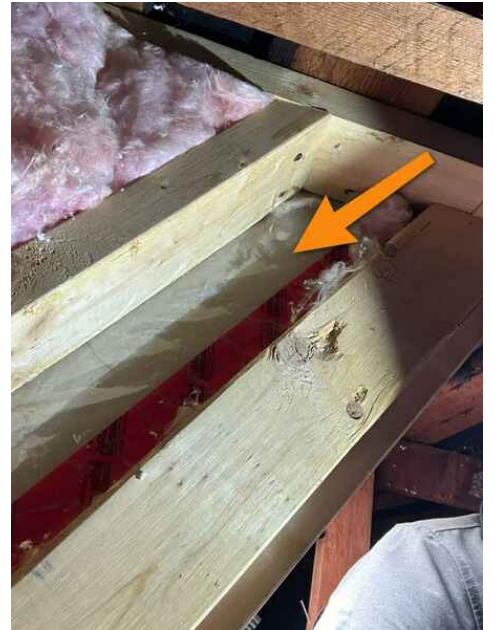
A section of insulation was observed to be missing along the skylight channel. This absence can lead to thermal inefficiency, allowing heat to escape during the winter and enter during the summer, potentially affecting the home's overall energy efficiency and comfort levels. Addressing this gap by installing appropriate insulation around the skylight channel is recommended to restore thermal integrity and ensure consistent indoor temperatures throughout the year.

Add insulation

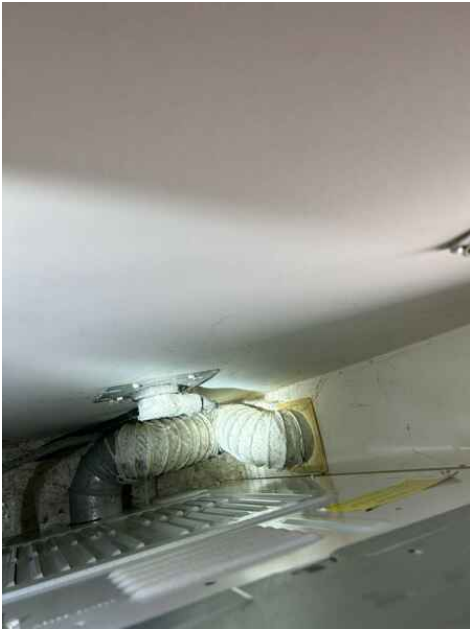
The dryer vent is made of plastic corrugated material, which can lead to restricted airflow, increased lint buildup, and potential fire hazards. To address this, replace it with a rigid metal or semi-rigid aluminum vent pipe for improved safety and efficiency. Prioritize this replacement promptly for optimal dryer performance.

Non metallic corrugated tubing is unsafe

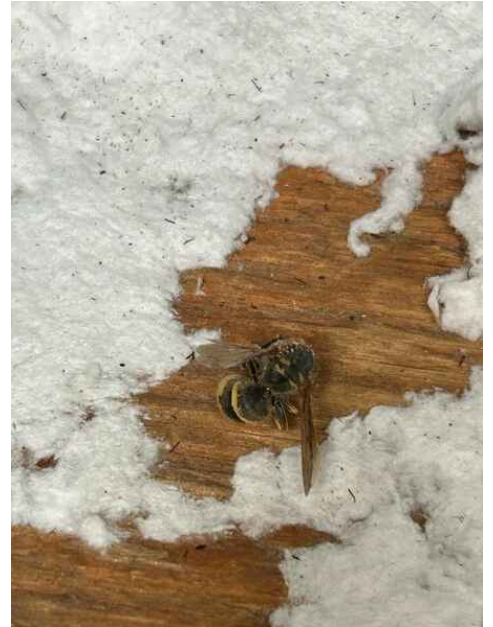
Evidence of wasp nests was found in the attic. Engage a pest control professional upon possession to safely remove these nests. Additionally, inspecting for and sealing any potential entry points for wasps around the chimney and garage can help prevent future infestations. Regular monitoring and maintenance are advised to ensure these areas remain free of pests.

Multiple dead wasps in attic
