WATCHTOWER
HOME INSPECTIONS

RESIDENTIAL REPORT

7124 Willis Point Road, BC

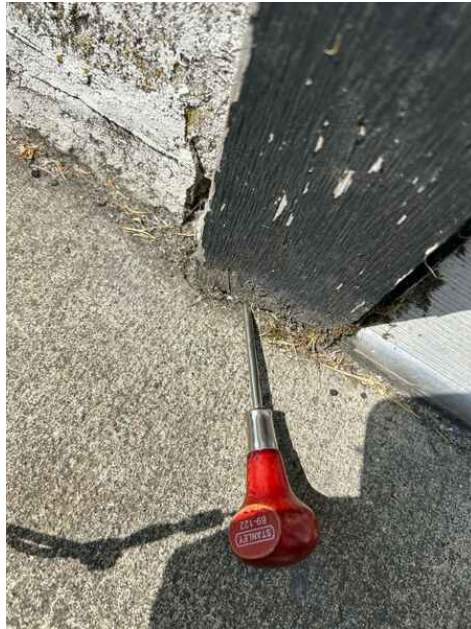
The window frames and trim need paint and upkeep, especially the window sill that is negatively graded toward the window assembly. It is recommended to repaint and properly maintain the window frames and correct the grading of the window sill to prevent water ingress and prolong the life of the windows. This maintenance should be completed upon possession to ensure the windows remain in good condition.

Trim decaying due to contact with grade

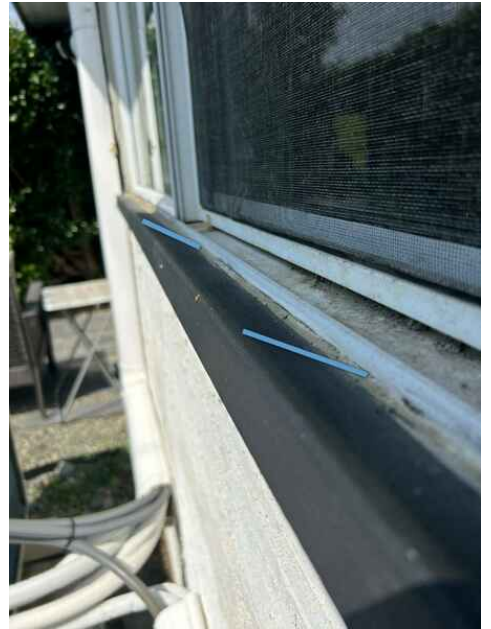
Negative sloped sill

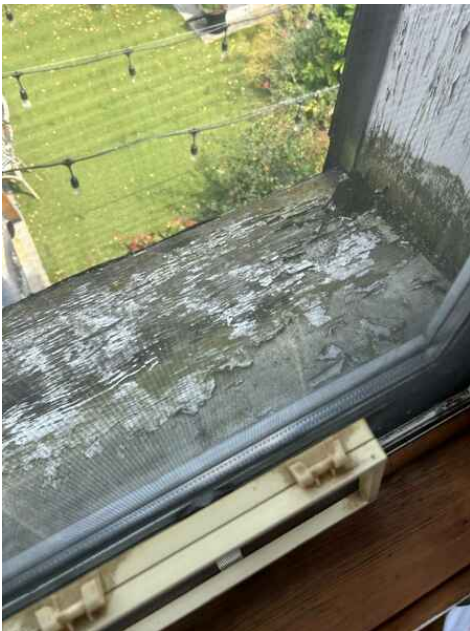
ADDRESS ROTTING AND DAMAGED WINDOW SILLS

Two window sills in the master bedroom upstairs exhibit severe rot, as they are the only sills not utilizing aluminum and instead relying on paint and wood. The likelihood of hidden damage is high, and it may be necessary to consult multiple professionals/ contractors due to the scope of work. Additionally, other window sills show signs of needing paint and flashing adjustments to prevent wind-driven rain from getting behind the siding. The design of the deep sloped sills contributes to these issues. It is recommended to obtain quotes for the necessary repairs before closing, as fixing the damage in the wall system may be expensive. Addressing these concerns upon possession will ensure the windows and surrounding structure are protected.

Severely Rotted Sill

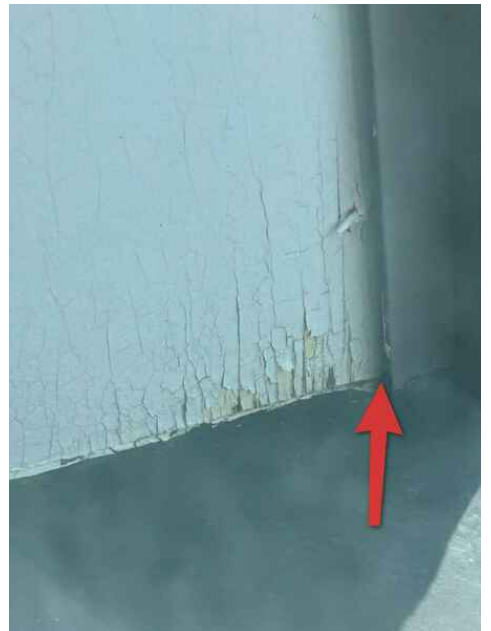
Possible entry point for water due to deep window well design

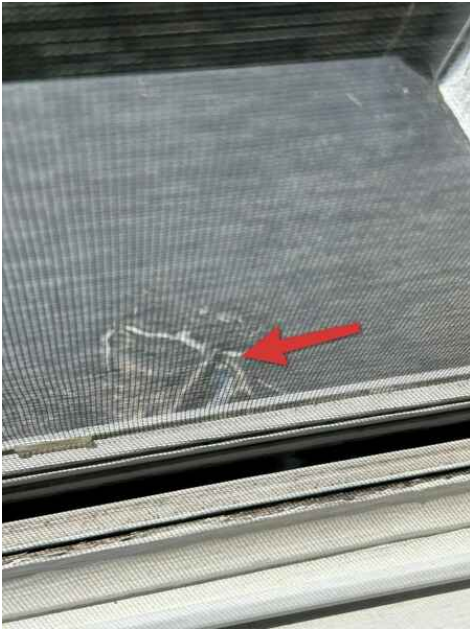
Paint and upkeep recommended

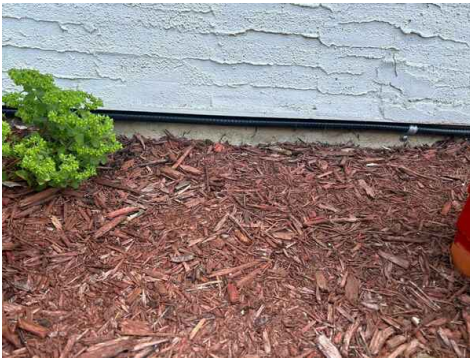
The siding throughout the property is too close to grade, causing damage to the stucco in areas. It is recommended to adjust the landscaping where possible to ensure the siding is not touching the ground. Additionally, repair any damaged stucco to prevent further deterioration. These actions should be taken upon possession to protect the exterior surfaces and maintain the integrity of the home.

Siding too close to grade

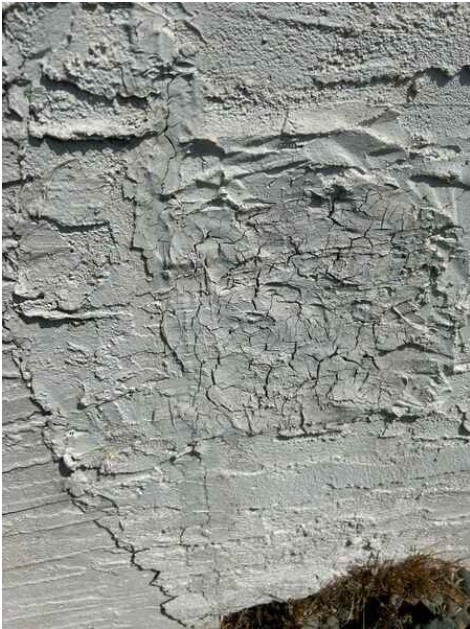
General stucco cracks were observed around the home. The chimney, which is attached to the home, has a several stucco cracks likely due to settling differently than the rest of the structure. It is recommended to patch and seal these cracks to maintain the integrity of the siding and prevent water ingress. These repairs should be completed upon possession to ensure the home's exterior remains in good condition.

Cracked patch

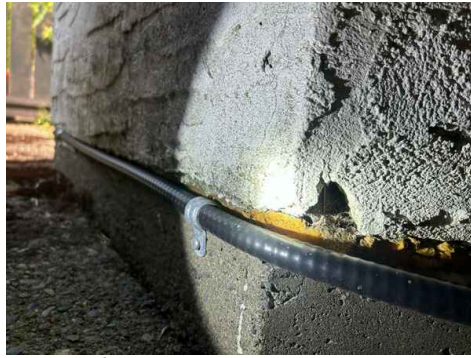
Stucco deterioration

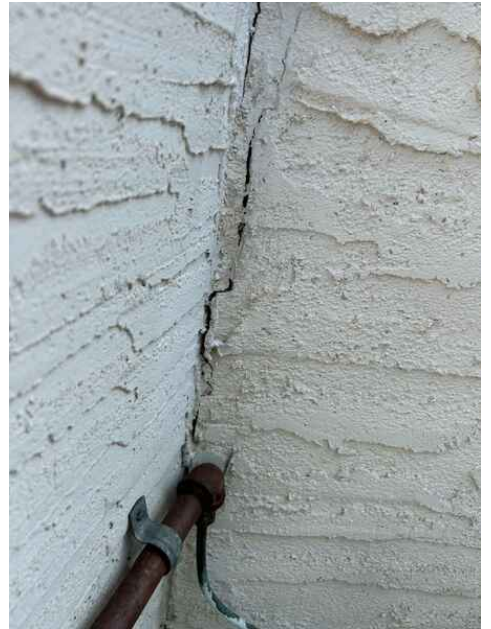
Cracking near chimney

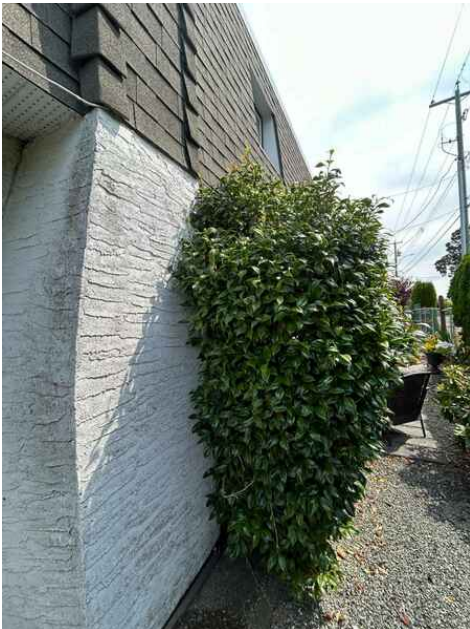
Vegetation is too close to the siding and the base of the tree/shrub is very close to the slab. It is recommended to trim back the vegetation to at least 3 feet from the siding for proper airflow and drying, and to consider removing the tree/shrub to prevent potential damage. This should be addressed upon possession to protect the siding and slab.

Trim or remove vegetation

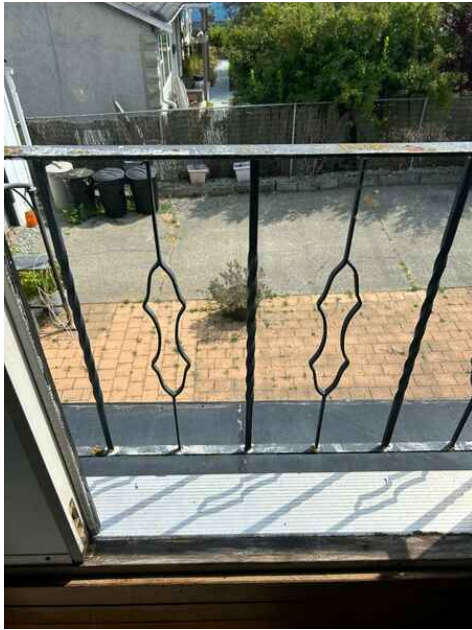
Both the French doors leading to the back patio and the Juliet balcony doors in the master bedroom were difficult to operate, with only one door of each set able to open without risking damage. Additionally, the Juliet balcony guard rail poses a safety risk (particularly for children) due to its height and the spacing of the balusters. It is recommended to repair the doors for proper functionality and address the guard rail to ensure safety. These improvements should be made upon possession to enhance usability and safety.

Wide Balusters, Short Guard Rail

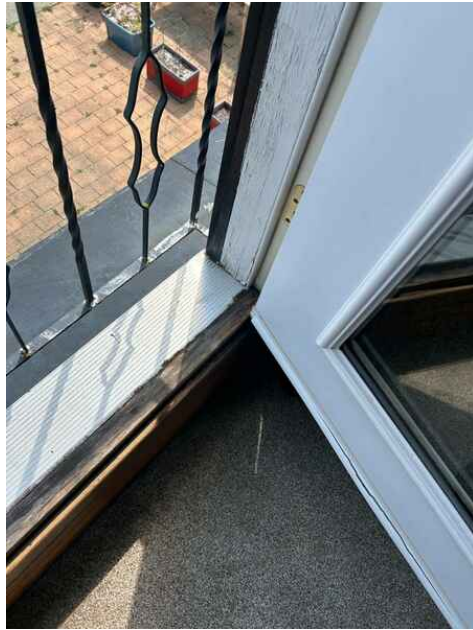
Difficulty opening juliet doors

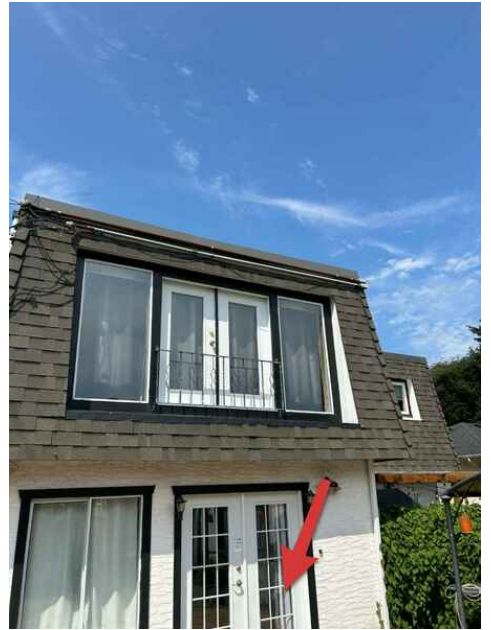
Unable to open 1 french door lock

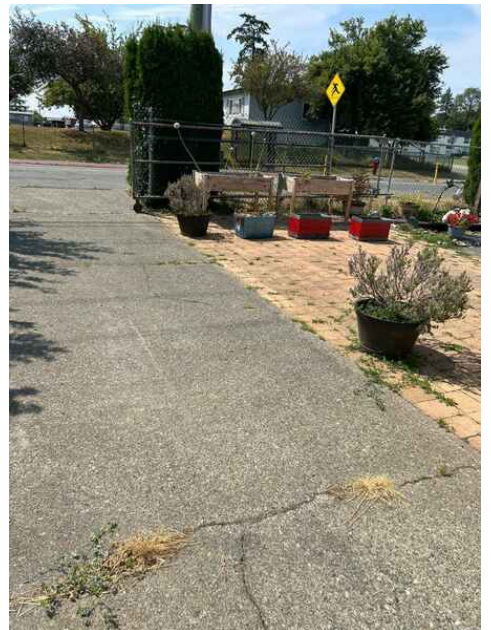
Minor cracks were observed in the driveway, which is typical for a home of this age. It is recommended to monitor these cracks and perform routine maintenance and repair as needed to prevent further deterioration.

Minor Cracking

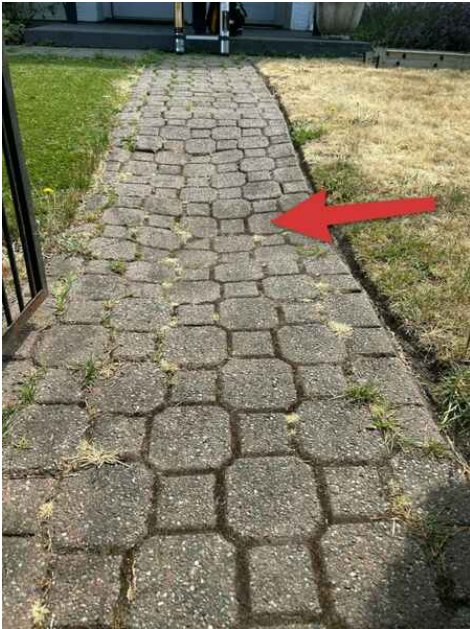
Trip hazards were noted throughout the property, particularly on the front entry pathway made of pavers. This presents a liability risk due to public use for mail and deliveries. It is recommended to level and secure the pavers and address other trip hazards to ensure safety. These repairs should be completed upon possession to reduce the risk of accidents and liability.

Paver trip hazard

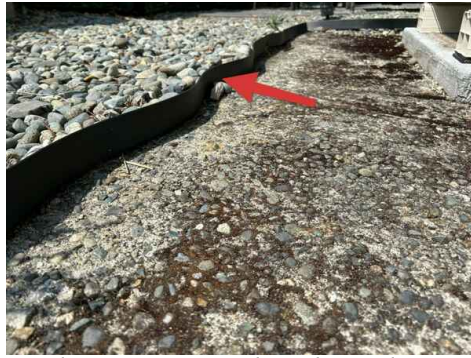
Landscaping material trip hazard

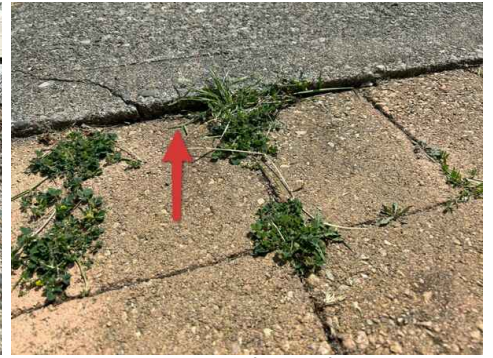
Concrete/Paver trip hazard

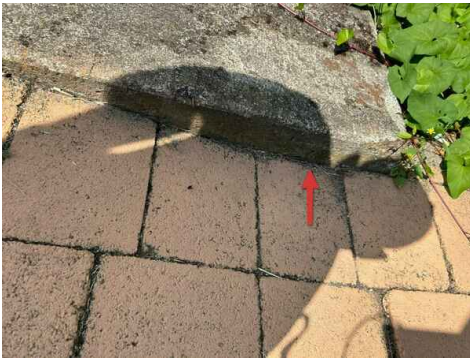
non uniform patio platform

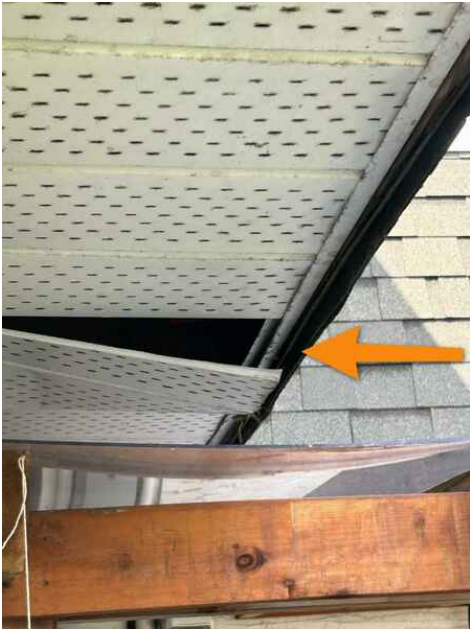
Multiple gaps were noted in the perforated soffits, creating entryways for pests. It is recommended to seal these gaps to prevent pest intrusion and maintain the home's integrity. This should be done upon possession to ensure a pest-free environment.

Major Gap in Soffit

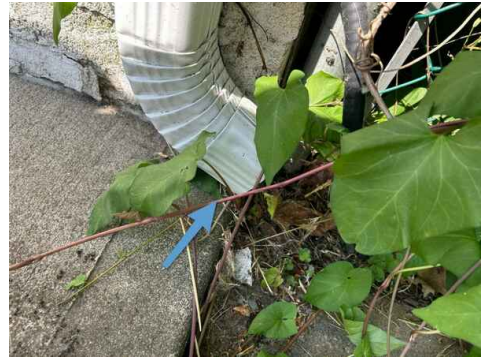
The downspout near the back patio needs to be extended to direct water away from the structure. This should be done upon possession to prevent potential water damage and maintain the integrity of the patio area.

Extend downspout

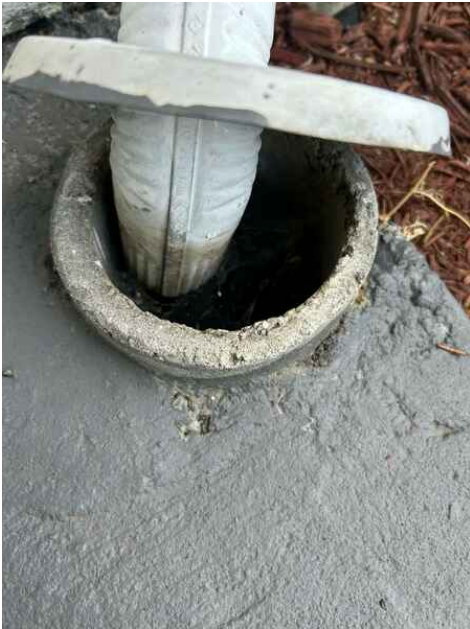
A perimeter drainage scope is recommended due to the materials of the risers (concrete and Big O). These materials can be prone to issues such as blockages, collapse and deterioration over time. It is advised to have a qualified professional assess the perimeter drainage system to identify any potential problems and ensure proper function. This should be completed before subject removal to maintain effective drainage and protect the property's foundation and landscaping.

Concrete Riser

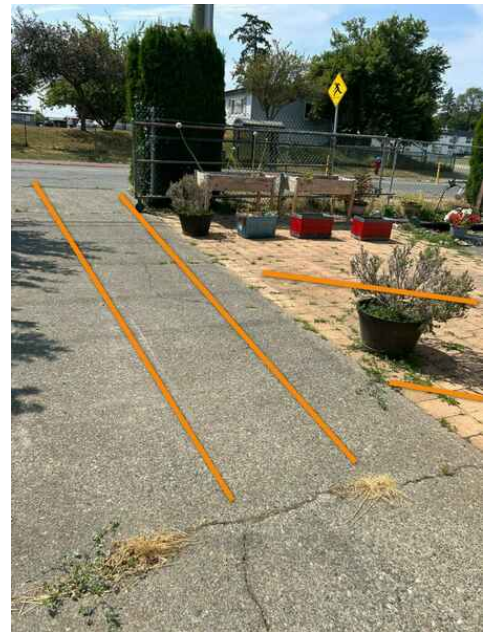
The grade of the driveway leading to the garage and possibly the property itself is a concern. It is crucial to manage water flow to ensure it drains away from the structures effectively. The existing gravel slot drain may not be sufficient. It is recommended to ask the seller about the property's history with intense rain and consider additional drainage solutions if necessary. This should be addressed upon possession to prevent potential water damage.

Very important to manage water, ask seller history

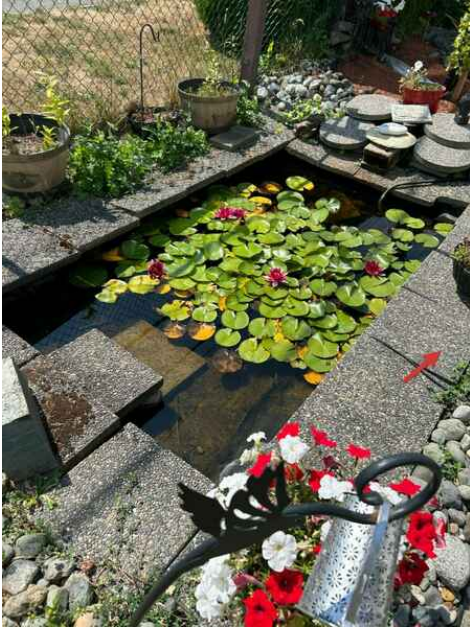
The decorative pond and surrounding pavers near the pond present safety concerns. The pond poses a danger to children, and the loose pavers create a trip hazard. It is recommended to secure the pavers and consider safety measures for the pond to ensure a safe environment. These actions should be taken upon possession to prevent potential accidents.

Loose paver, add guard rail or remove pond

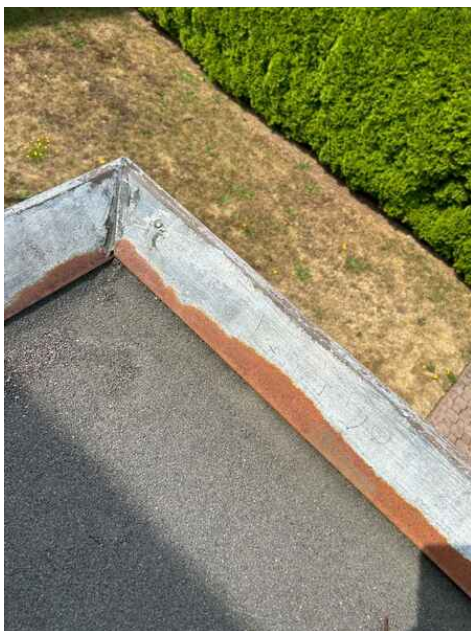
The overhang of the entryway is made of a modified bitumen product and was not updated when the roof was. It is showing signs of granular loss, ponding and rusted flashing. While this is not too concerning as it is not over a living space, it is recommended to monitor it during heavy rains to ensure it is effectively expelling water away from the structure and not holding water after periods of rain. Regular monitoring will help maintain the overhang's condition and prevent potential issues.

Rusting flashing

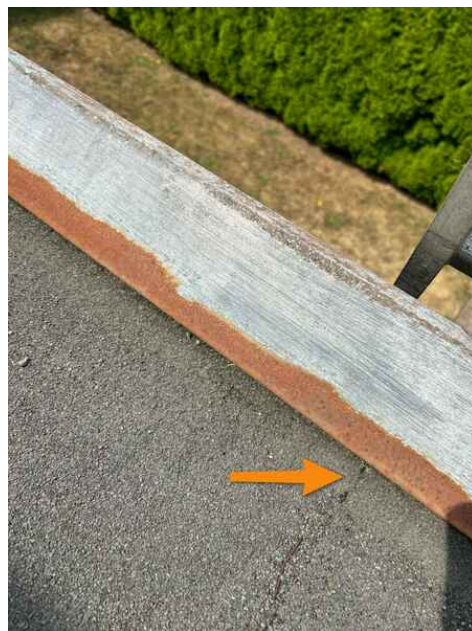
signs of granular loss and pooling

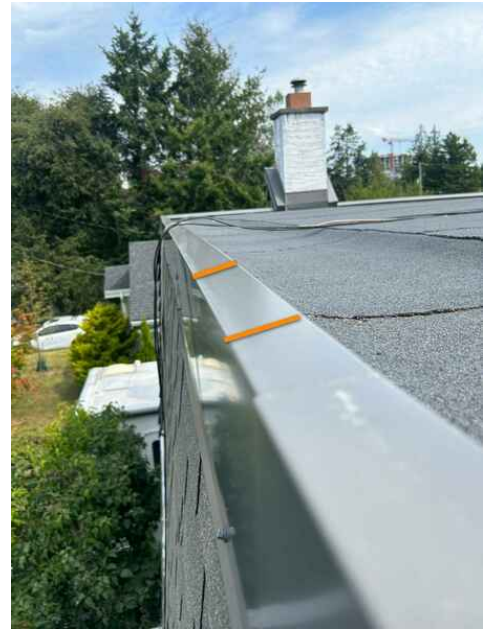
The parapet wall flashing around the perimeter of the roof has some sections where the slope directs water away from the roof rather than towards it. Ideally, parapet flashings should direct water onto the roof surface to prevent drips around the home and siding. While the flashing and roof are very new and in great condition, it is recommended consult with a roofer to adjust the slope of the flashing upon the next maintenance call to ensure proper water flow. This adjustment will help maintain the integrity of the home's exterior.

Some sections of parapet flashing are sloped incorrectly

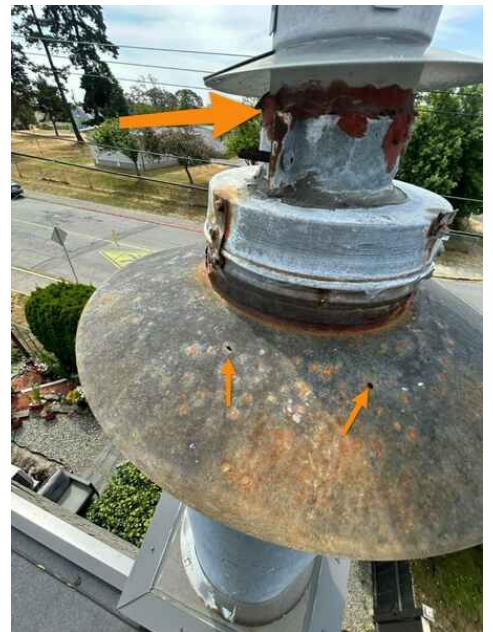
The metal chimney cap shows signs of rusting and pitting, which could potentially lead to water entering the system. It is recommended to patch or replace the chimney cap/vent to prevent water ingress and ensure the chimney's proper function. Addressing this issue upon possession will help protect the chimney system and maintain its integrity.

Rusting and pitted rain guard

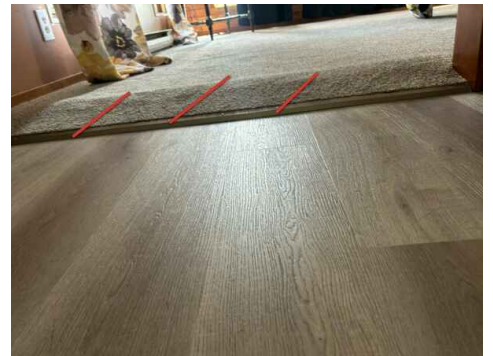
There is significant floor displacement in the master bedroom between the vinyl and carpeting. While it may not be practical to change or address it immediately, be aware that the inconsistency presents a trip hazard. Exercise caution in this area to prevent potential accidents.

Large Floor Transition

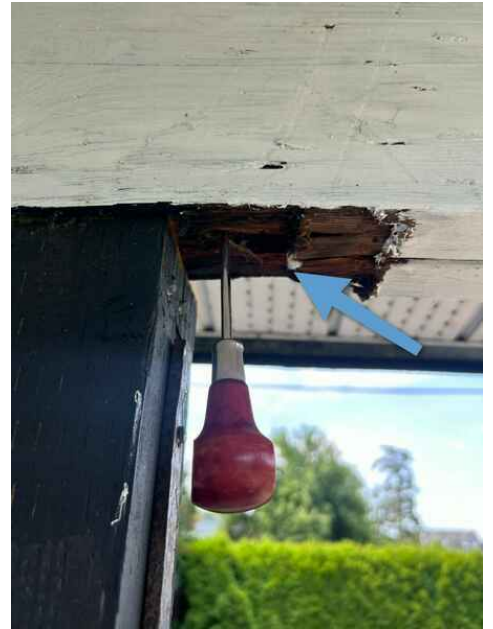
The beam of the entry overhang is showing signs of decay, though the rot is not extensive. It is recommended to paint the beam to prevent further deterioration. This maintenance should be completed upon possession to protect the beam and extend its lifespan.

Paint exposed beam

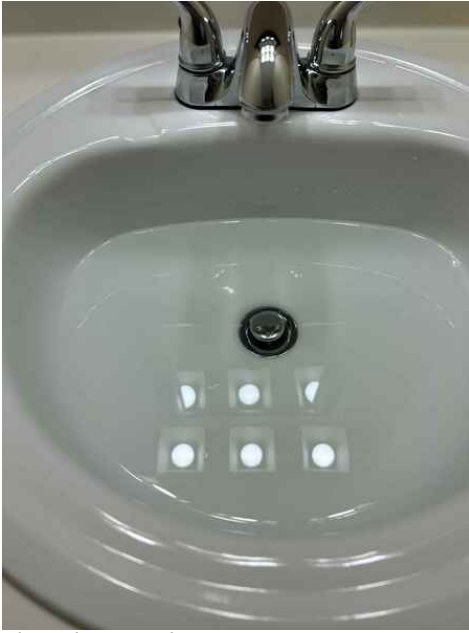
The tub and the downstairs powder room sink were very slow draining. This could be due to hair and debris blockages, but it could also indicate a ventilation issue. It is recommended to have a qualified plumber investigate and address the cause to ensure proper drainage if snaking them doesn't solve the issue. This should be done upon possession to maintain efficient plumbing and to prevent frustration.

Slow draining basin

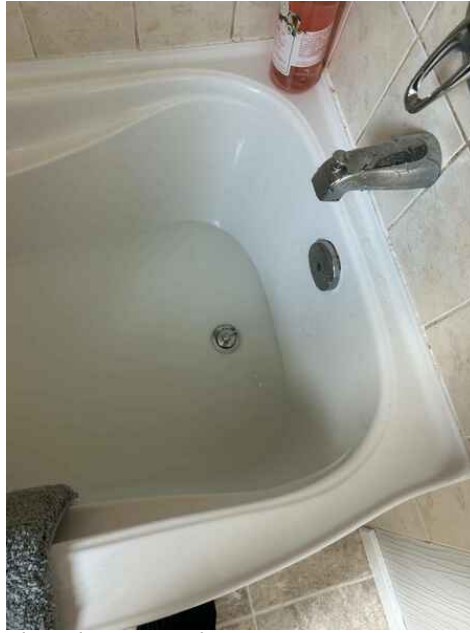
Slow draining tub

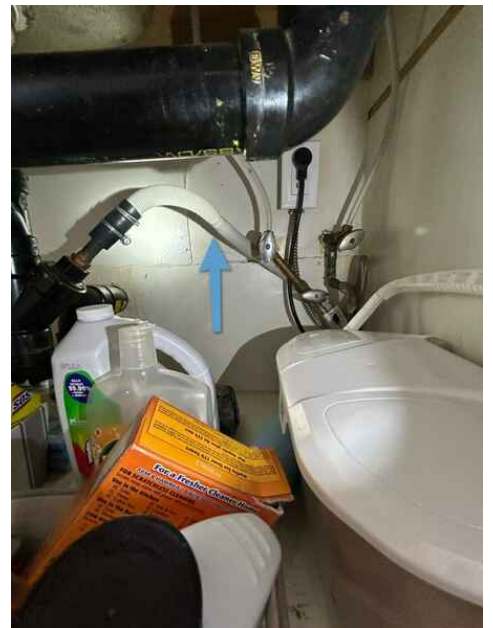
A "high loop" or "air gap" was not present or not installed properly for the dishwasher drain line at visible portions. A high loop or air gap prevents wastewater from siphoning back into the dishwasher during operation. The proper installation of the dishwasher drain line, incorporating a proper high loop, is recommended to be conducted by a licensed plumber or other qualified person upon possession.

Hose should loop higher

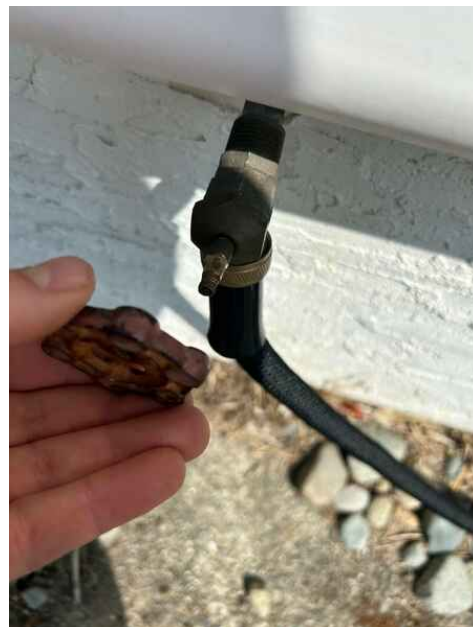
The exterior hose bibs are not frost-free, which can increase the risk of water pipes freezing during colder months. Both hose bibs also had missing or damaged spout controls. It's recommended to upgrade these to frost-free hose bibs. This modification helps prevent freezing issues and potential water damage in the winter. Consider making this upgrade before cold weather sets in.

Upgrade bib

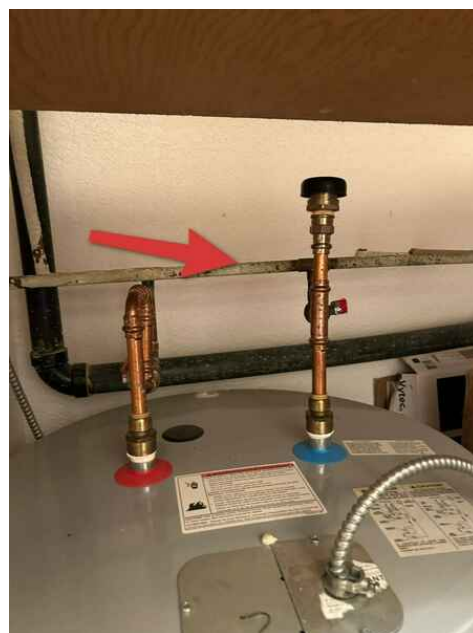
Due to the age of the home, it is important to be aware that the copper pipes are approaching 50 years old. While some copper pipes are known to last 70+ years, they have been known to fail at 35-50. Regular monitoring for any signs of wear or corrosion is advisable. This awareness will help in maintaining the plumbing system and planning for future maintenance.

Ageing copper pipes throughout home

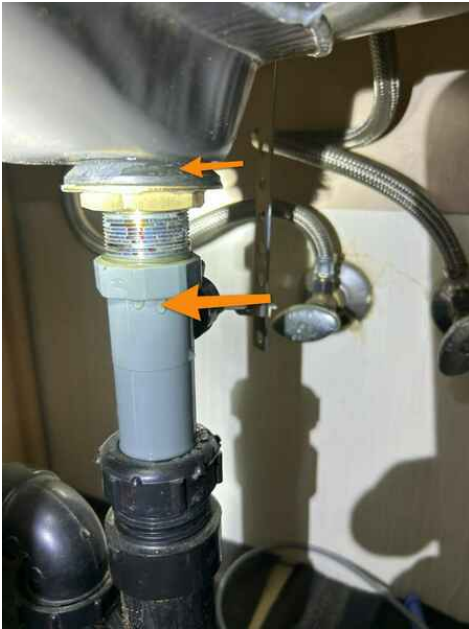
A small leak was observed in the upstairs bathroom basin where the draining material (ABS) meets the basin. It is recommended to have a qualified plumber repair this leak to prevent water damage and ensure proper functionality. This repair should be completed upon possession to maintain an efficient plumbing system.

Leaking basin

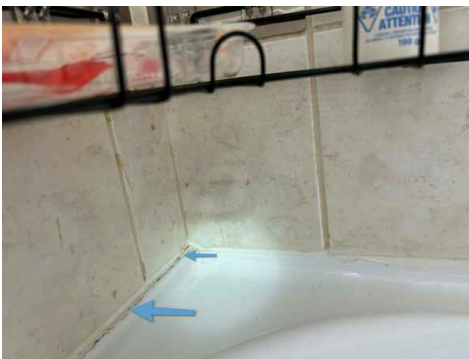
A cracked tile was observed in the bathroom wall area, and silicone maintenance is needed. It is recommended to repair or replace the tile and reapply silicone to prevent water infiltration and maintain the bathroom's aesthetic. These repairs should be completed upon possession to ensure the integrity of the bathroom wall.

Silicone maintenance

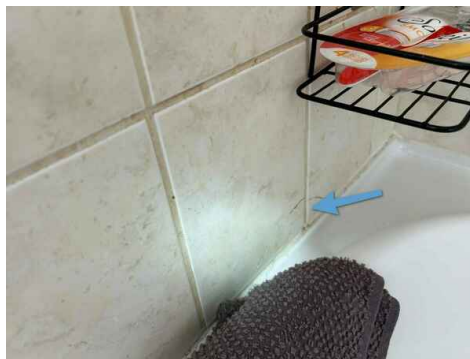
Cracked tile

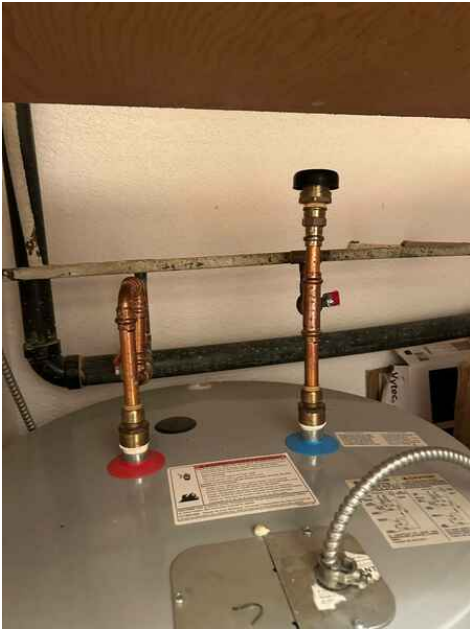
The hot water tank is missing seismic straps, a drip pan, and an expansion tank. It is recommended to install these safety features during the next replacement of the tank to ensure compliance with safety standards and prevent potential water damage.

Missing expansion tank

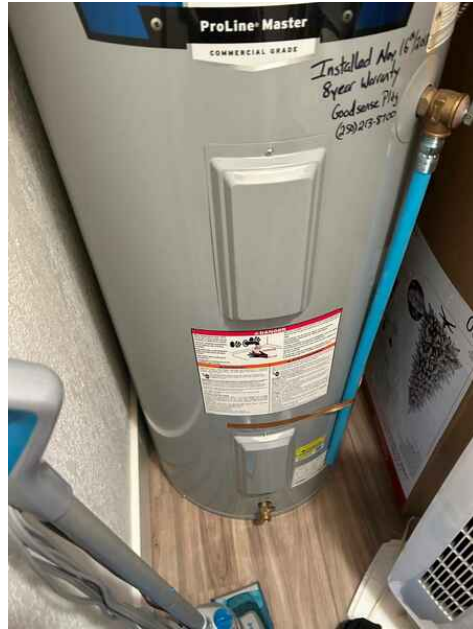
No seismic straps/drip pan

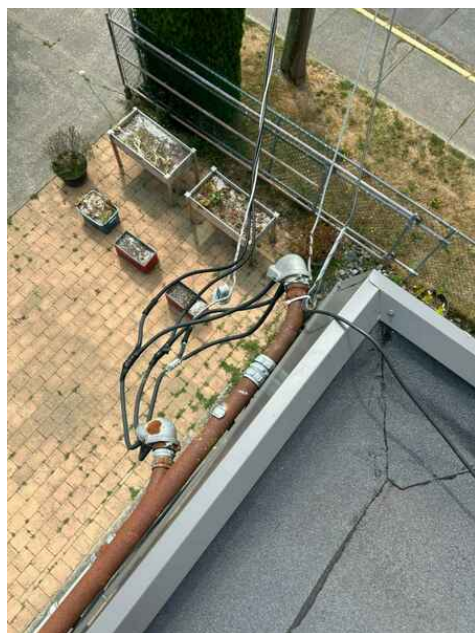
The electrical service lines are not properly secured to the home, as evidenced by the securing hardware hanging in the air. It may be necessary to contact the service provider to address this issue and ensure the lines are securely attached. This should be completed upon possession to maintain safety and compliance.

Secure lines to structure

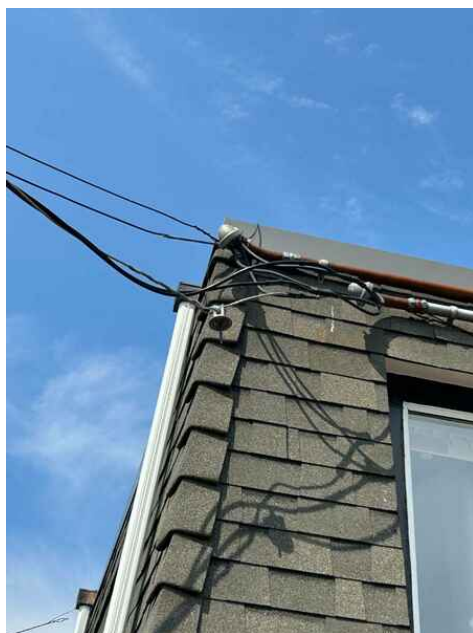
Other occupants of duplex are also responsible

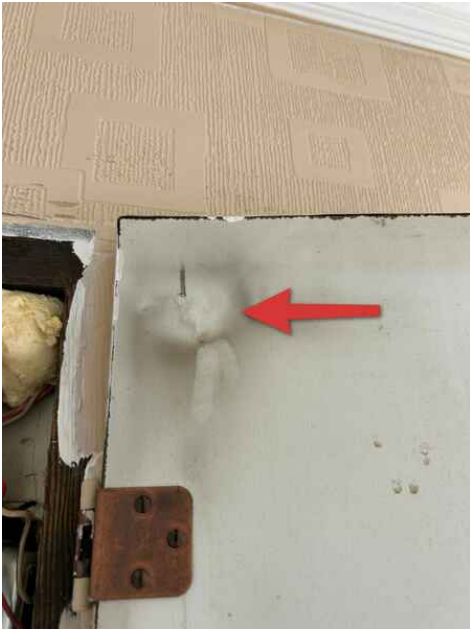
The Federal Pioneer Stab Loc electrical panel and breakers are notorious for not tripping during electrical overloads, which can lead to fires. While not officially recalled, there have been numerous instances of fires. Additionally, there is a double tap in the panel, signs of scorching around the panel cover, an opening in the panel, and sharp-tipped screws securing the cover, all of which present hazards. Panels need to be fully enclosed to contain a fire. It is recommended to obtain a quote for the possible full replacement of the panel before closing the real estate deal.

Scorching on panel cover

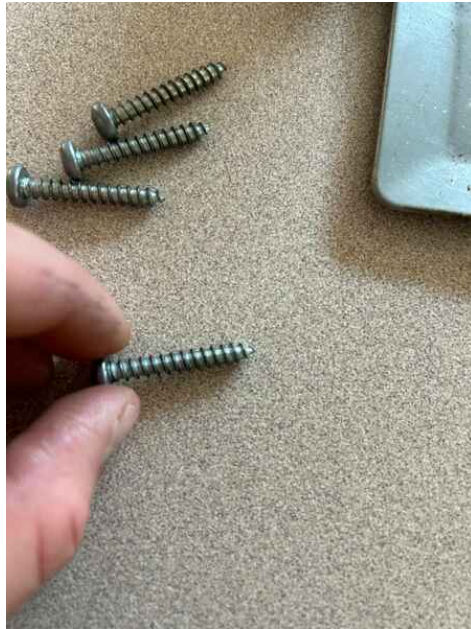
Improper screws securing panel (sharp tipped)

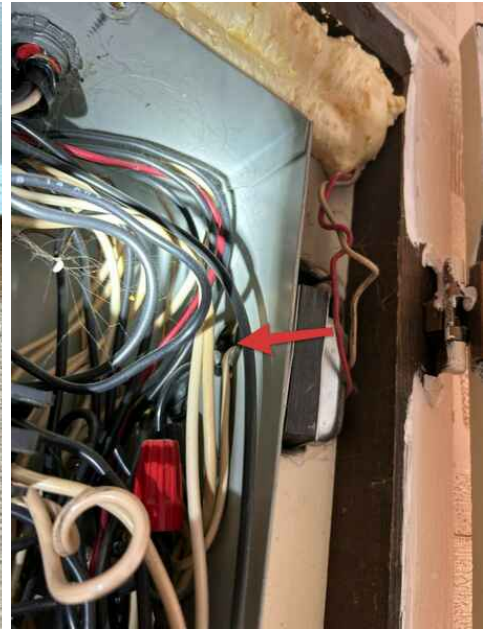
opening in panel (needs to be able to contain fire)

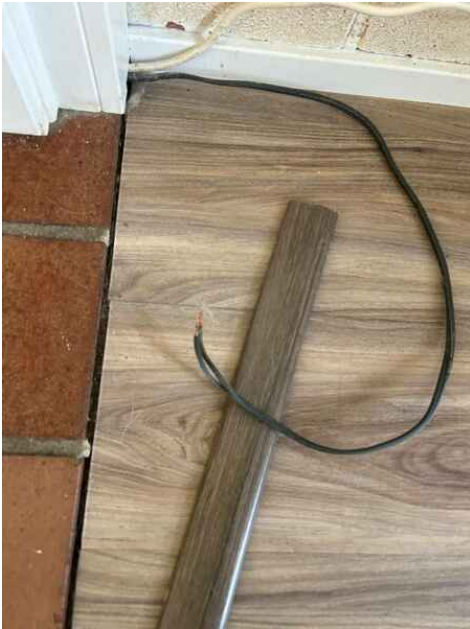
Electrical wires near the fireplace and underneath the sink should be either properly terminated or removed to prevent potential safety hazards. It is recommended to have a qualified electrician address these issues upon possession to ensure a safe home environment.

Stray conductor near fireplace (tested dead)

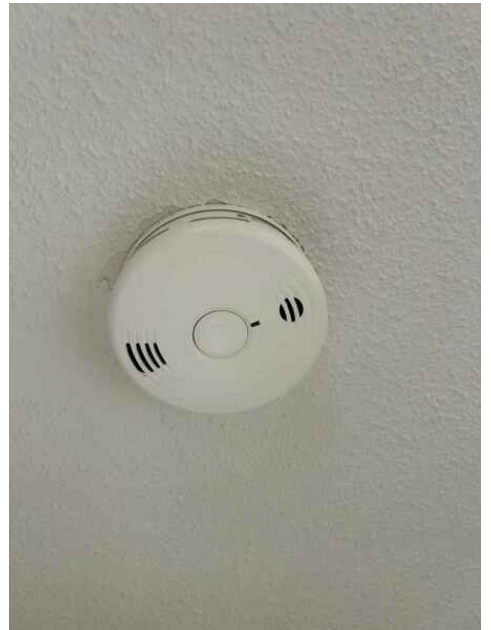
It is important to note that smoke detectors should be installed in each room and living space, as well as carbon monoxide detectors on every floor and near appliances that emit CO. These detectors can help ensure the safety of occupants by providing early warning in case of fire or the presence of dangerous levels of carbon monoxide. It is recommended to test these detectors regularly and replace batteries as needed to ensure they are functioning properly. This is a life safety issue.

Ensure up to date detectors

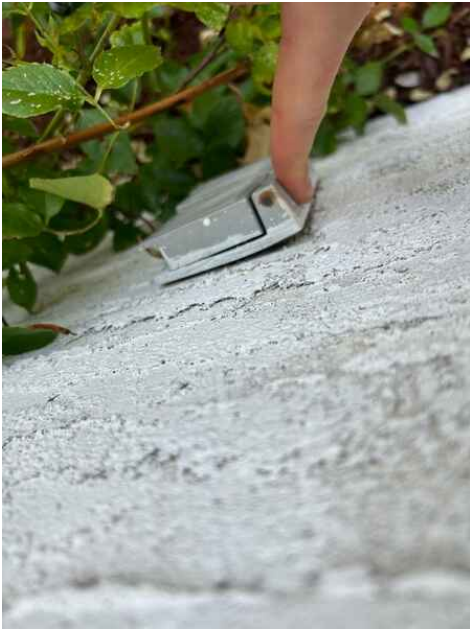
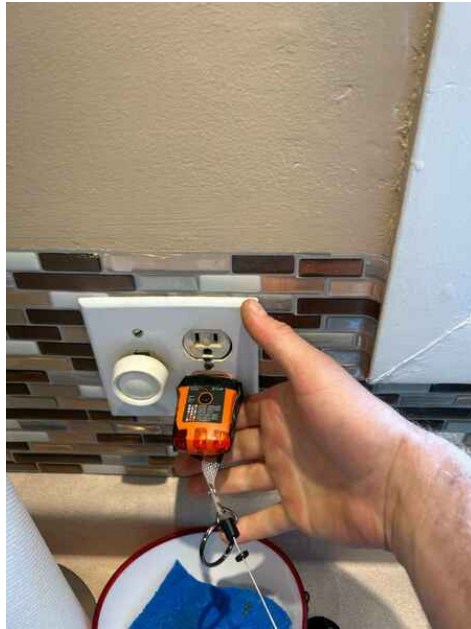
Several outlets, both outside and inside the home, were not GFCI protected where required (near water source). Additionally, the exterior receptacles are showing signs of brittleness and cracking/ ageing. This condition results in a higher chance of electrical shock to the occupants. It is recommended to have a qualified electrician upgrade these outlets to ensure GFCI protection and replace any aging exterior receptacles. These upgrades should be completed upon possession to enhance safety and ensure compliance with electrical standards.

Exterior aged outlet not GFCI protected Kitchen receptacle near sink not GFCI

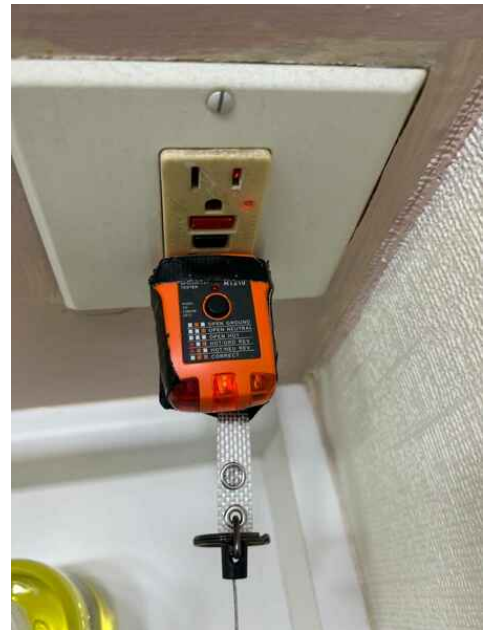
An open ground receptacle was found in the downstairs powder room. It is recommended to have a qualified electrician correct this issue to ensure electrical safety and proper grounding. This should be addressed upon possession to prevent potential electrical hazards.

Outlet tester reads open ground

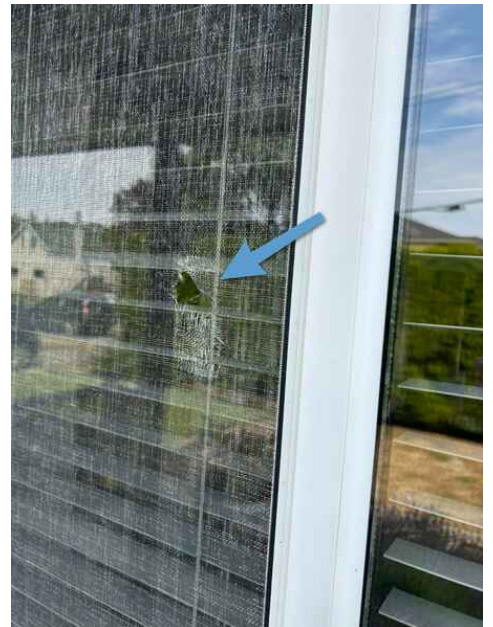
The front window has a torn screen. It is recommended to repair or replace the screen to maintain the window's functionality and appearance. This small repair should be completed upon possession.

Torn Screen

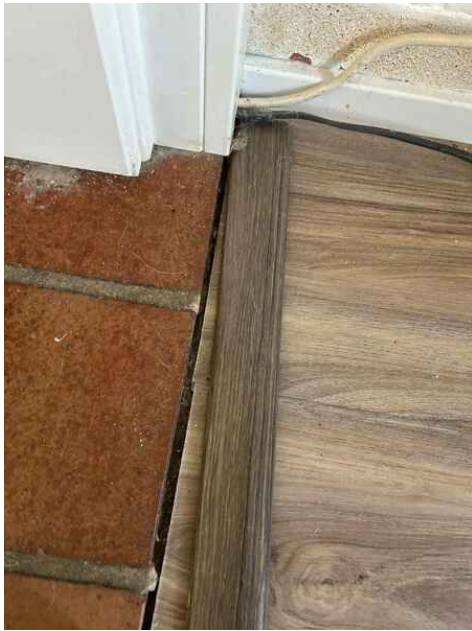
BASEBOARD BROKEN AT FIREPLACE, AND MISSING BASEBOARDS IN SPARE ROOM CLOSET

Loose baseboard

Repair/ Install as desired.

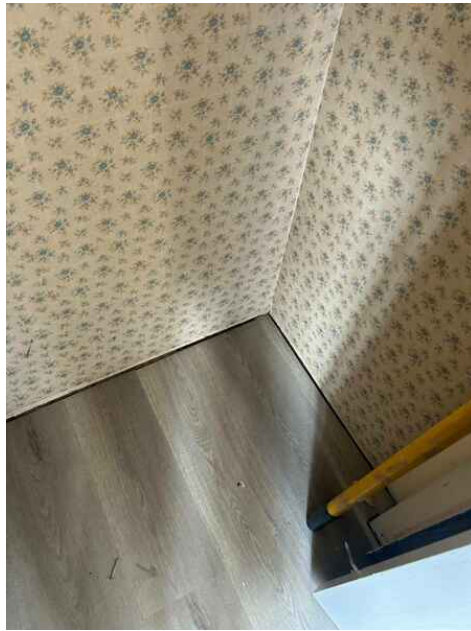
Missing baseboard

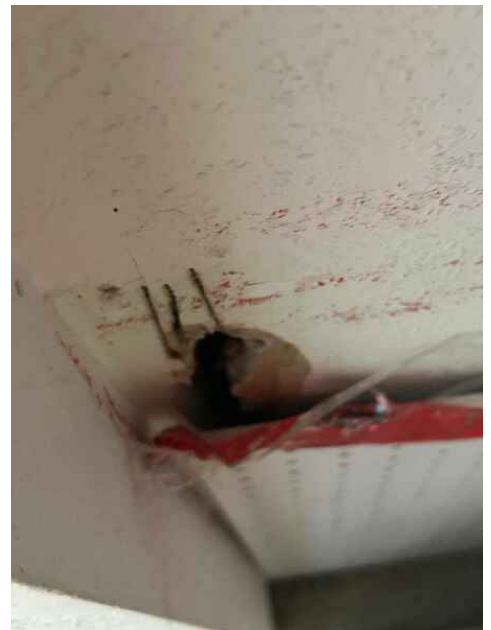
The upstairs hallway closet has an intentional hole in the drywall, taped up with a material likely to access the bathroom plumbing. The craftsmanship is very shoddy. It is recommended to have a professional repair the drywall properly to ensure a neat appearance and maintain the integrity of the closet wall. This repair should be completed upon possession.

Hole in closet wall

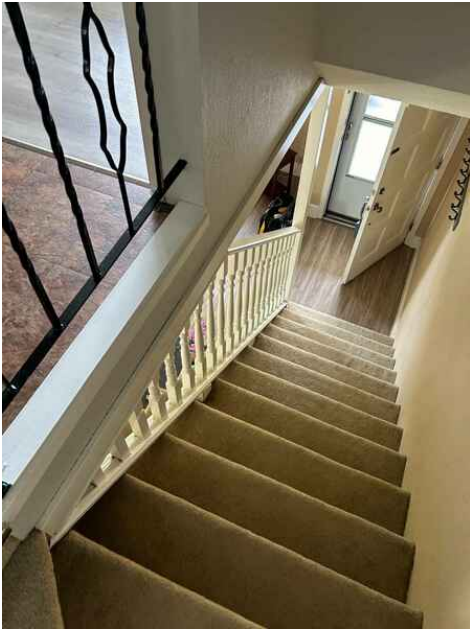
The stairway leading upstairs lacks a handrail for the entire run, and the guard rail at the top of the stairs is not very sturdy. The balusters are quite wide, and the decorative metal could be a climbing apparatus for children. It is recommended to install a continuous handrail, reinforce the guard rail, and consider safety modifications to the balusters. These improvements should be made upon possession to ensure safety and functionality.

No continuous hand rail

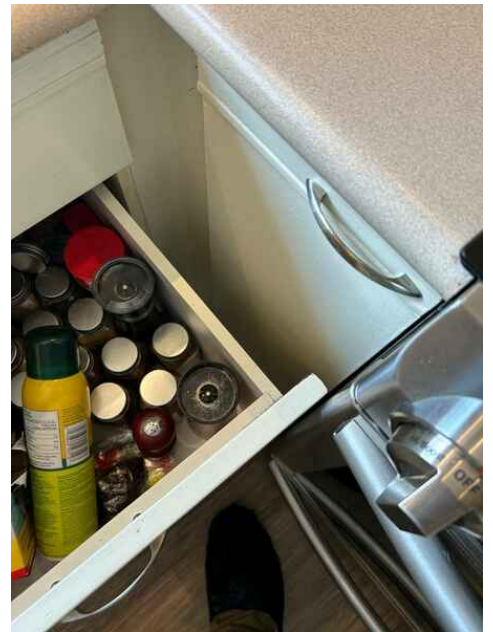
The kitchen drawers do not open fully due to the new oven unit, which can be frustrating. While this is not a critical issue, it may impact the usability of the kitchen space. Consider this when planning for any future kitchen adjustments or renovations.

Drawer hits oven

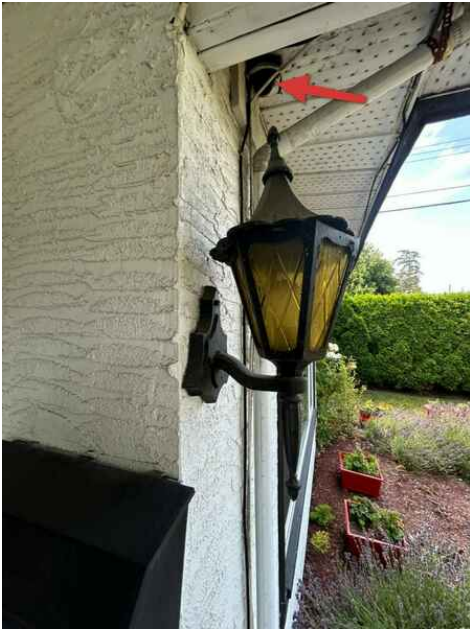
A wasp nest was noted in one of the landscaping light fixtures, and signs of rodents and rodent control were observed in the living space. It is recommended to have a pest control professional remove the wasp nest and address the rodent activity. These actions should be taken upon possession to ensure a safe and pest-free environment.

Steel Wool used as deterrence

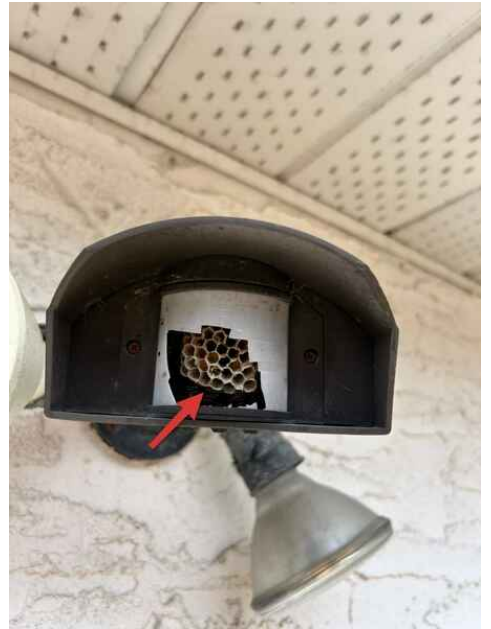
Inactive wasp nest

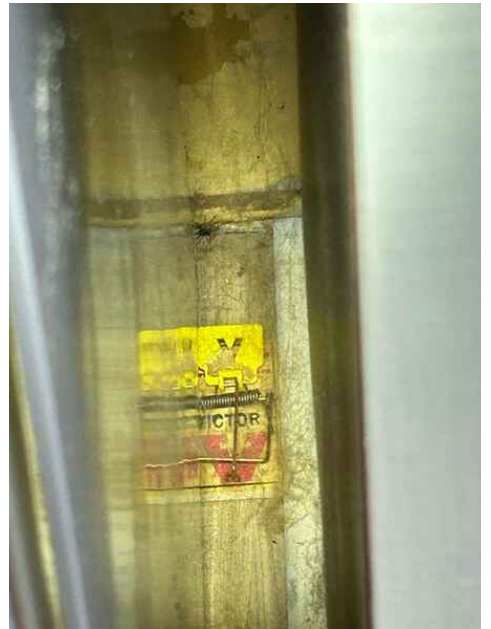
Mouse trap near fridge

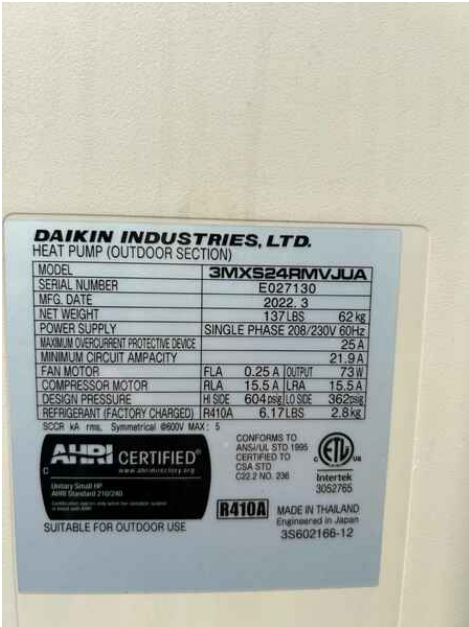
Heat pump data plate

The HVAC condensate drain is discharging very close to the house and siding. It is recommended to extend the drain or divert it elsewhere as drip may be annoying.

Additionally, the heat pump should be cleaned and serviced upon possession, with regular maintenance scheduled thereafter. A qualified HVAC contractor should be engaged to maximize the unit's efficiency and ensure proper operation. Reach out to seller to obtain warranty information.

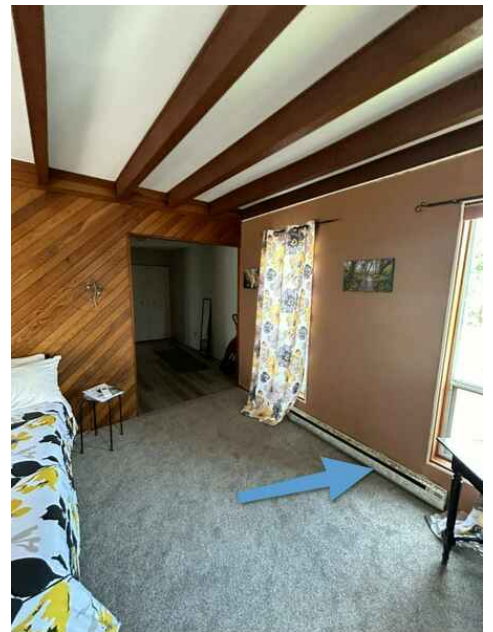
The baseboard heater in the master bedroom is loose. It is recommended to secure or remove the heater properly to ensure safe operation and prevent potential damage. This should be done upon possession to maintain safety and functionality.

Baseboard heater very loose

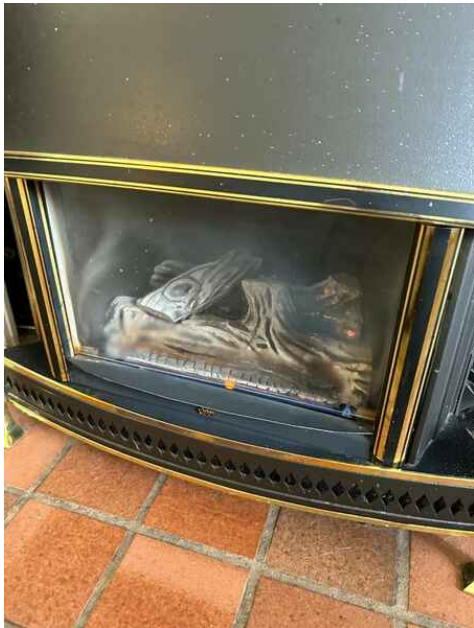
It is recommended to service the gas insert fireplace and determine if there is a sole shut-off valve accessible at the unit. Ensuring proper maintenance and easy access to a shut-off valve will enhance safety and functionality. This should be done upon possession to maintain the fireplace in good working order.

Service gas insert

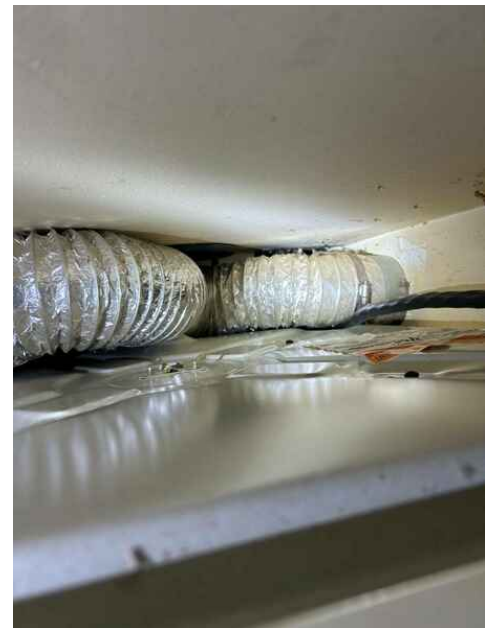
The dryer vent material is corrugated and very long with many turns and twists, which can trap exhaust and lint, posing a fire hazard. It is recommended to upgrade to a smooth, rigid vent material to ensure efficient airflow and reduce the risk of lint buildup. This upgrade should be completed upon possession to maintain safety and improve dryer performance.

windy dryer vent material

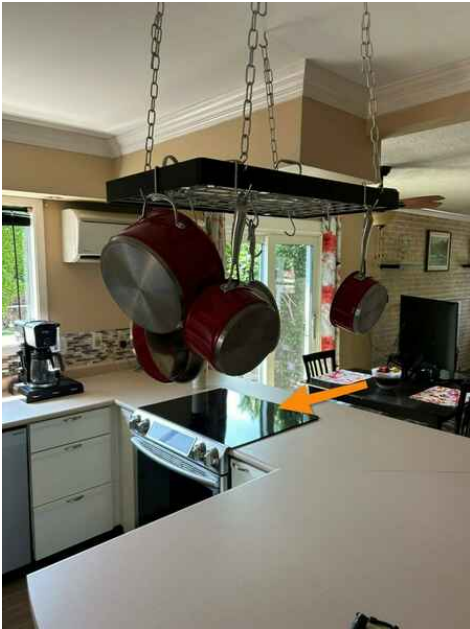
The kitchen lacks an exhaust fan, and the placement of the mini-split system may blow cooking products/ moisture throughout the home. While it may not be practical to install or change the mini-split, be aware that the heat pump will help to dehumidify the air and manage moisture from cooking, though it is not a practical replacement for a kitchen exhaust fan. Consider a proper exhaust fan eventually.

Lack of kitchen exhaust
