WATCHTOWER
HOME INSPECTIONS

RESIDENTIAL REPORT

7124 Willis Point Road, BC

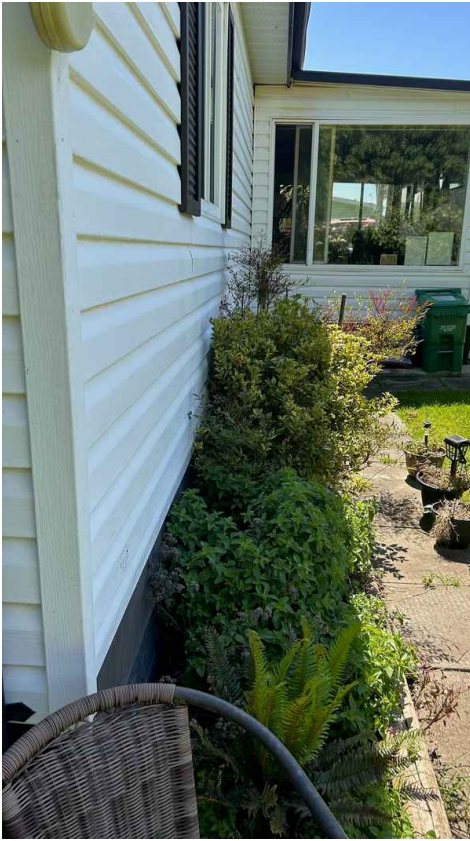
VEGETATION IN CONTACT WITH SIDING

Vegetation was observed touching the siding on the left side of the home. This can trap moisture against the exterior surface and limit airflow, potentially accelerating wear or inviting pests. It is recommended to trim back vegetation by at least three feet upon possession to promote proper drying and help preserve the building envelope.

Vegetation touching siding

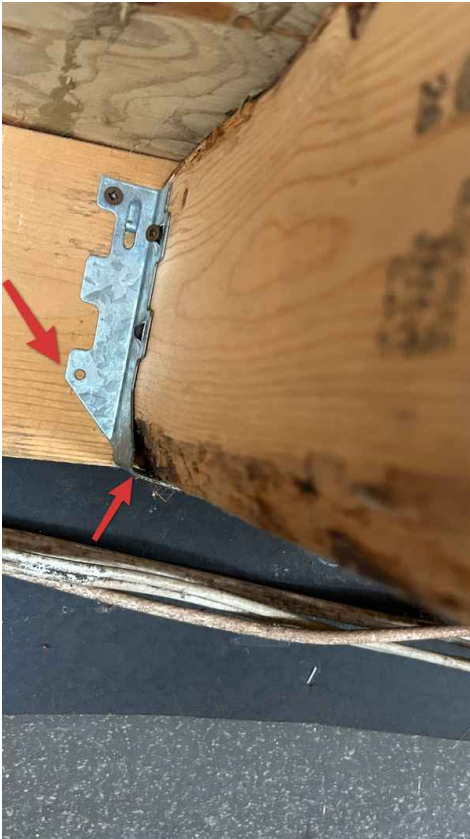
REAR DECK SUPPORTED BY TEMPORARY FOOTINGS AND IMPROPER CONNECTIONS

The rear deck was observed to rest on temporary footings, which are not considered a permanent or structurally reliable support method. In addition, several joist hangers were missing required fasteners, and some joists were not fully seated within their hangers. The deck also appeared to rely on attachment to the manufactured home for support along one side. As noted elsewhere in this report, additions to manufactured homes must be independently supported and freestanding. Evaluation and correction by a qualified contractor is recommended prior to subject removal to ensure the deck is safe, properly supported, and compliant with appropriate construction standards.

Missing Fasteners

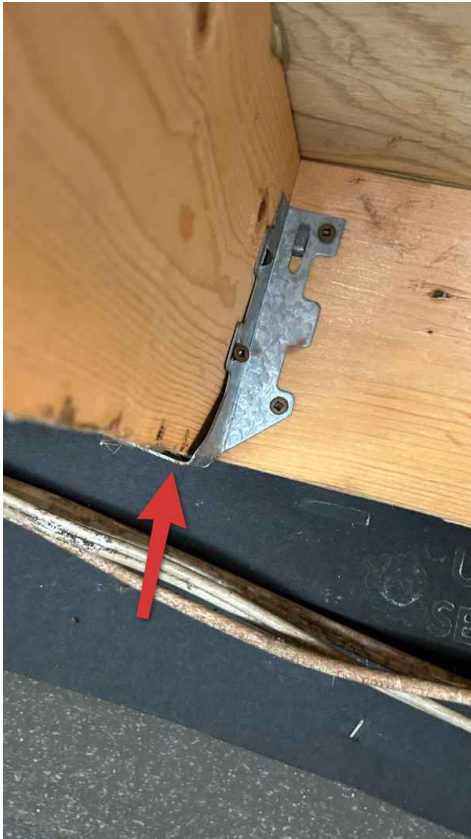
Floating Joist

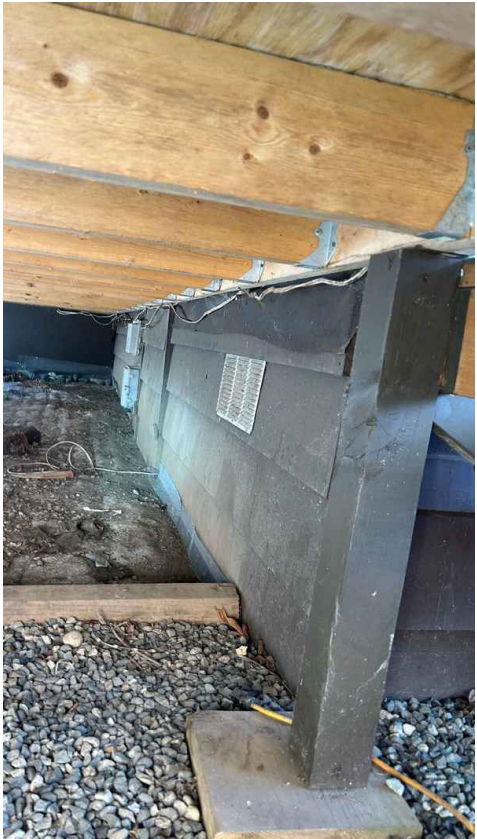
Deck Attached to Manufactured Home

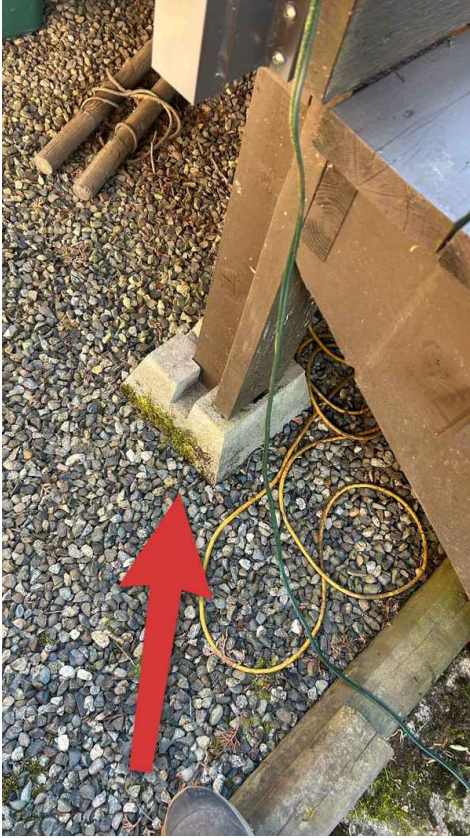
Temporary Footings

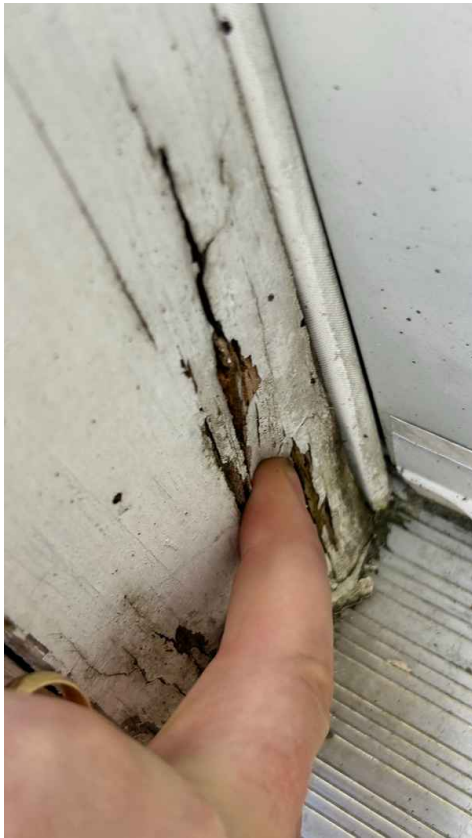
ROTTING NOTED AT REAR DECK ENTRY DOOR FRAME

The exterior lower portion of the door frame at the rear deck entry—leading into the pantry addition—was observed to be significantly rotted. Deterioration of the frame can lead to reduced structural integrity, moisture intrusion, and pest entry. Hidden damage is possible. Repair or replacement of the affected section is recommended upon possession to maintain proper enclosure and prevent further damage.

Wood Rot

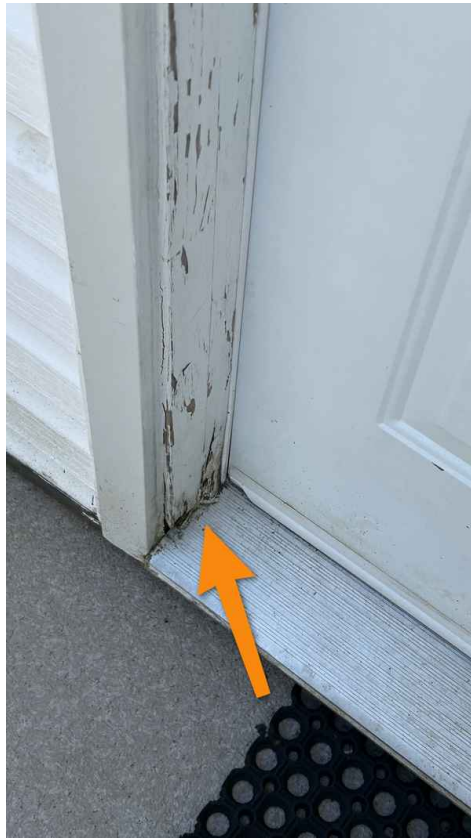
Back Door Frame Rotting

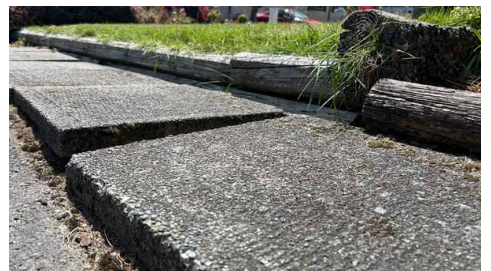
TRIP HAZARDS NOTED AROUND PROPERTY

A few minor trip hazards were observed around the property, including misaligned pavers and uneven walking surfaces. While not structurally significant, these conditions could pose a risk for slips or trips during regular use. Adjustments or levelling are recommended upon possession to improve safety and ease of movement around the exterior.

Trip Hazard

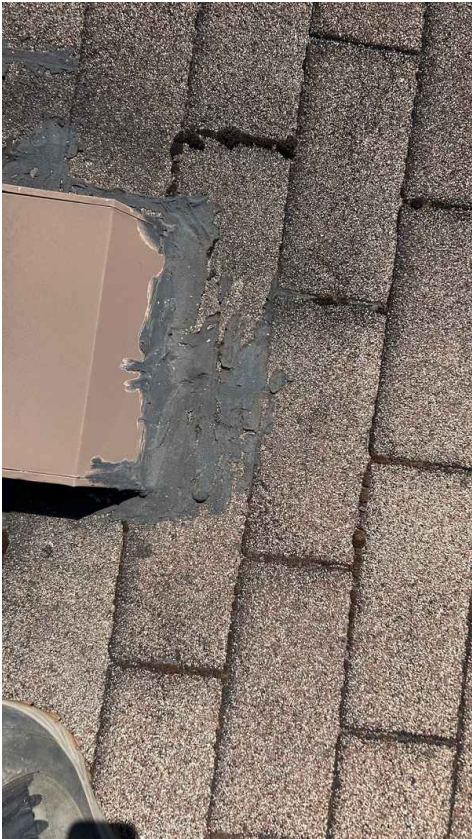
AGING ROOFING SYSTEMS WITH EVIDENCE OF DETERIORATION AND PREVIOUS REPAIRS

The main roof covering appeared to consist of 3-tab asphalt shingles, with some components dated to 1993. This material is well beyond its typical life expectancy. Several deficiencies were noted, including missing and flipped shingles, exposed fasteners, discolouration, visible fiberglass matting, missing drip edge flashing and soft spots in the roof surface. Multiple repair attempts were observed, including mismatched replacement shingles and unprofessionally applied mastic applied around the skylight and protrusions—suggesting a history of leakage. The skylight has also lost its seal. Replacement of the main roof is likely required in the near term.

Unprofessional Mastic Patch

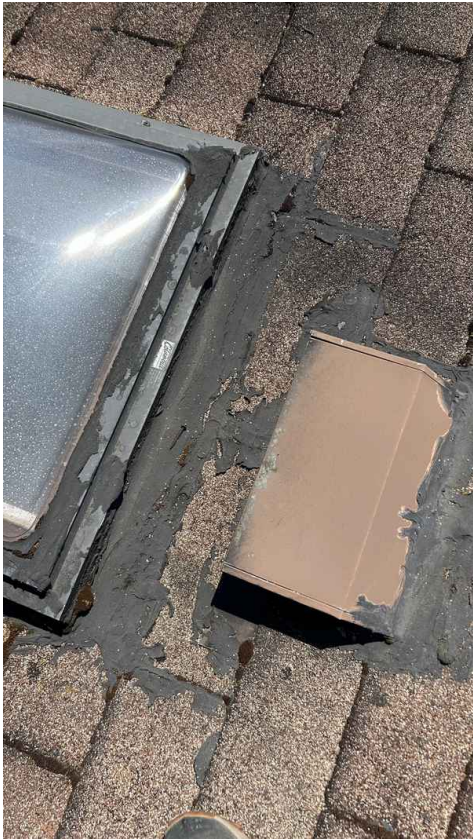
Previous Leak Likely]

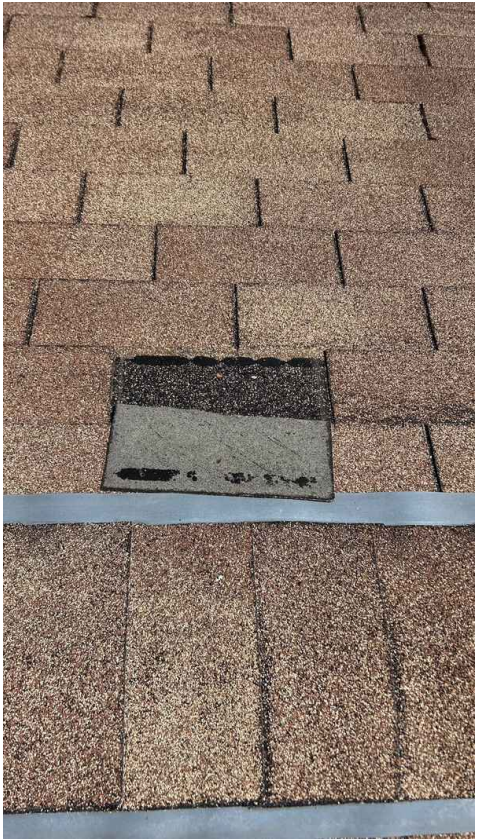
Flipped Shingle

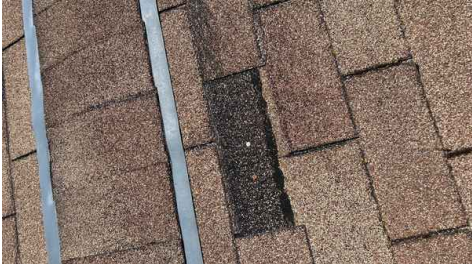
Missing Shingle

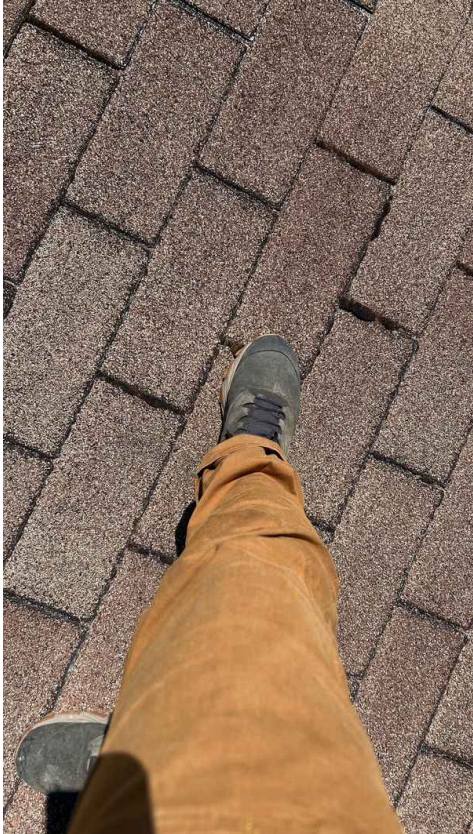
Soft Spots throughout

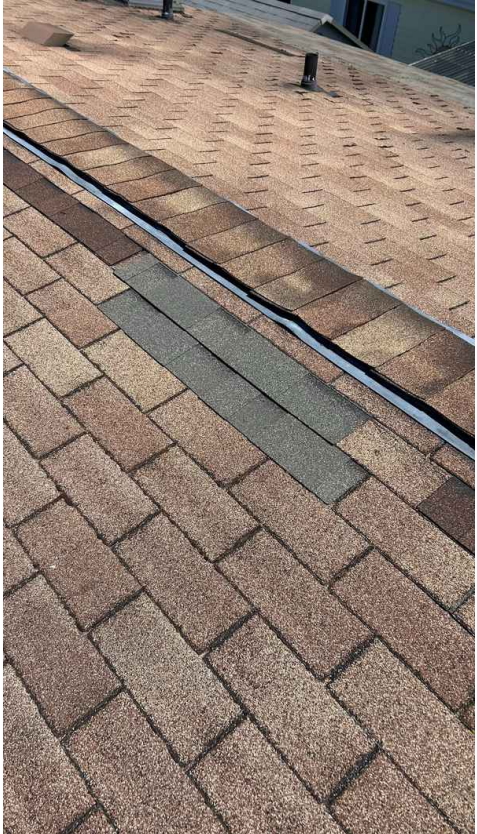
Additionally, the roof over the front addition was finished with roll roofing, a product with a typical lifespan of approximately five years, and the adjacent addition was surfaced with a fiberglass-based material. These coverings appeared weathered and should be monitored for deterioration and maintained regularly. A full roofing evaluation by a qualified contractor is recommended prior to subject removal to determine the remaining life and necessary repairs or replacement.

Different Product Indicating Possible Previous Leaks

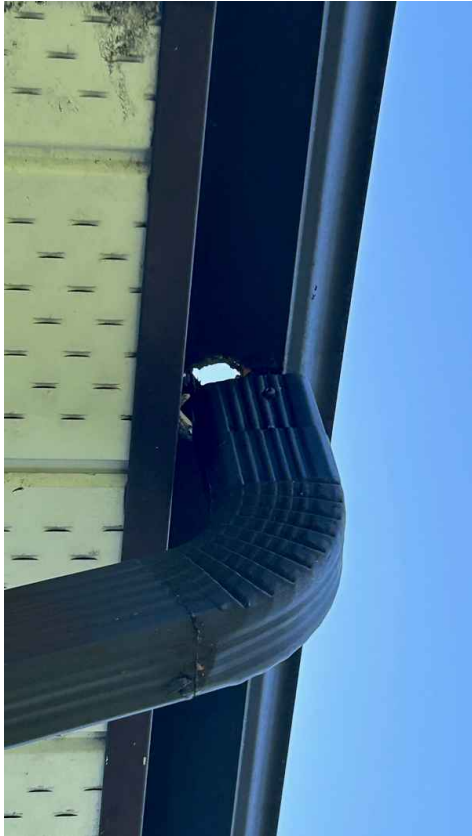
IMPROPER DOWNSPOUT DRAINAGE AND WATER ENTRY INTO CRAWLSPACE

Several downspouts around the property were observed to discharge water too close to the home's foundation. Of particular concern, one rear downspout was misaligned with the gutter above and extended directly into the crawlspace. Inside, the downspout was not connected to a drainage system, allowing roof runoff to discharge freely beneath the home. This has contributed to visible moisture damage, including deterioration of the skirting in the affected area. Although a drainage pipe was previously installed to manage this water, it has since disconnected. Reconnection or redirection of this system is recommended prior to subject removal to prevent ongoing moisture intrusion and further deterioration.

Misaligned Downspout

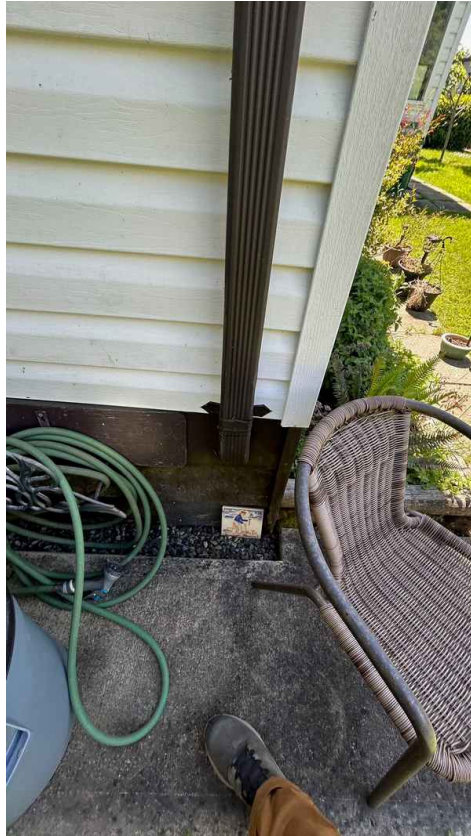
Downspout Entering Crawlspace

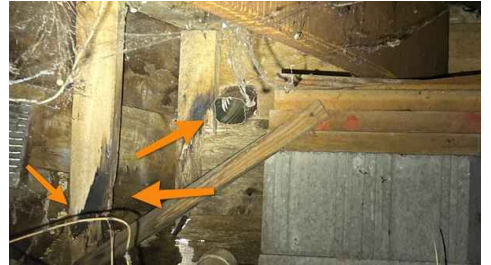
Downspout Draining into Crawl.
Rotting Skirting

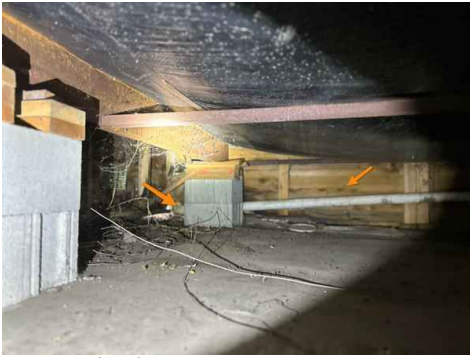
Unattached PVC

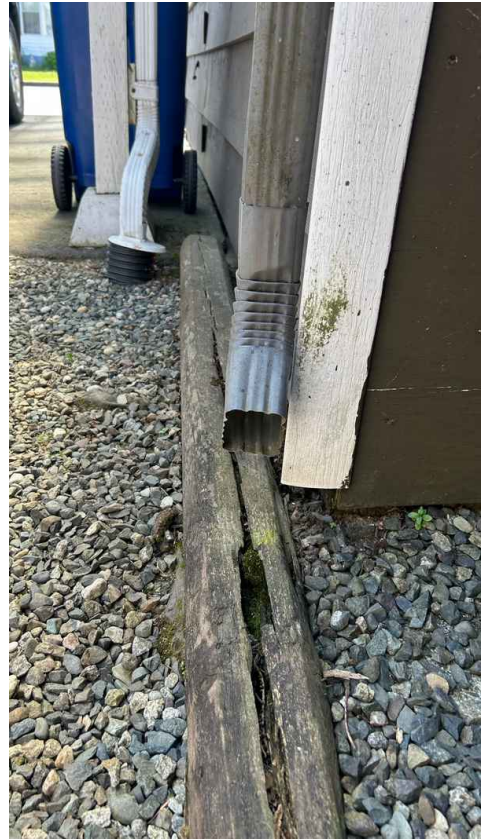
Downspout Draining too close to home

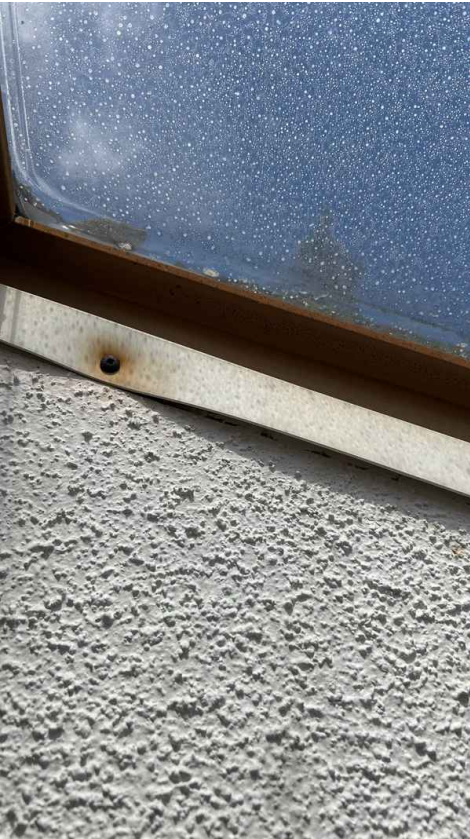
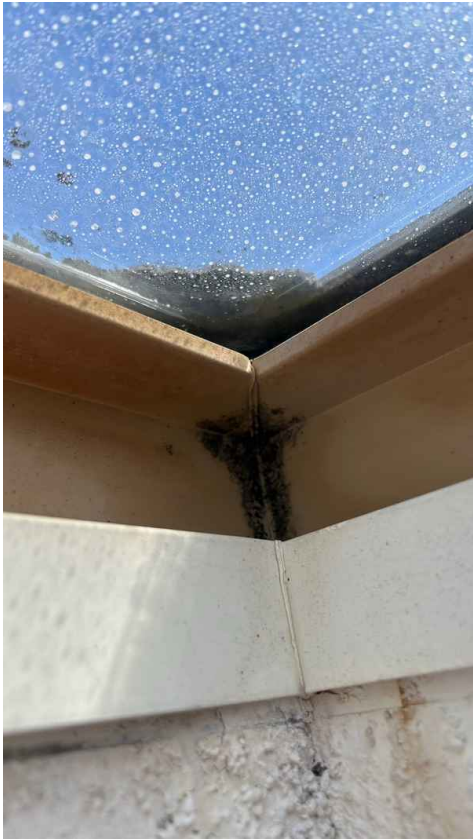
SIGNS OF PREVIOUS LEAK AT HALLWAY BATHROOM SKYLIGHT

Staining was observed around the skylight in the hallway bathroom, indicating a previous leak. This appears to correlate with an amateur roof patch visible at the skylight's exterior. The area tested dry at the time of inspection, suggesting no active leakage; however, the extent of any hidden damage within the ceiling cavity could not be confirmed. Further review is recommended upon possession to monitor for recurrence and assess whether repairs are needed.

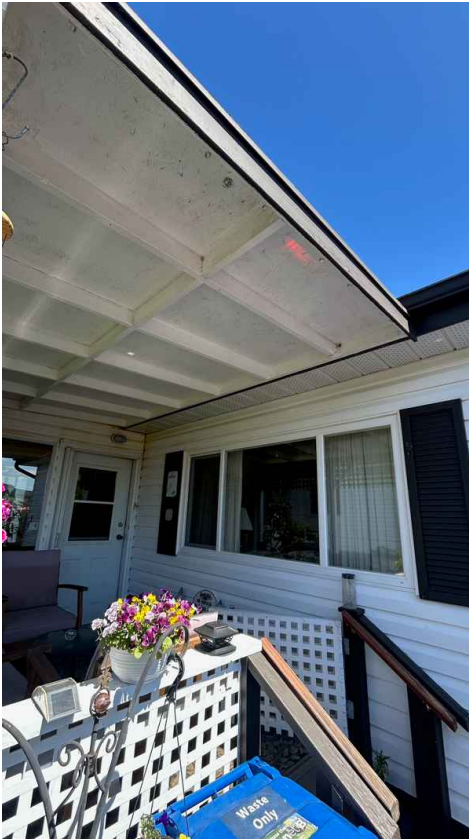
**ADDITIONS AND AWNINGS IMPROPERLY ATTACHED TO
MANUFACTURED HOME**

Several additions and exterior structures—including the front porch, shade awnings, and a rear deck—appeared to be physically attached to the manufactured home. Manufactured homes are not designed to support any load-bearing attachments, and such connections can place undue stress on the frame, potentially compromising its structural integrity. These structures should be independently supported and free-standing. Evaluation by a qualified structural professional is strongly recommended prior to subject removal to assess the appropriateness and safety of these attachments. Observed at the front and rear exterior of the home.

Awning not free standing

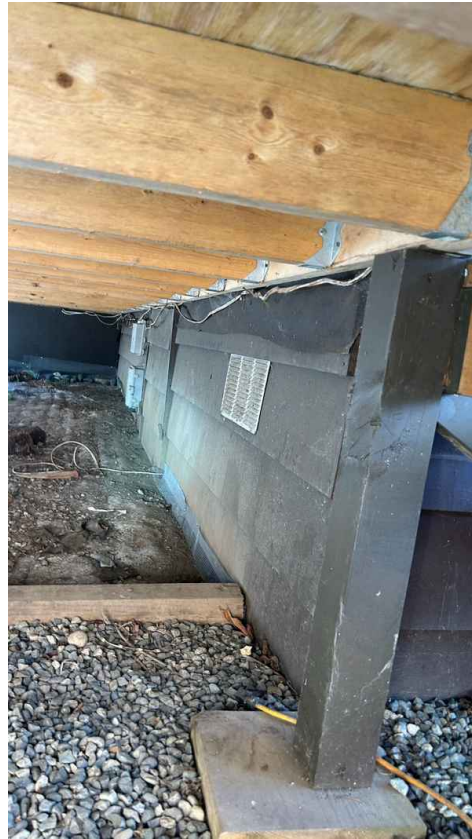
Deck using home for support

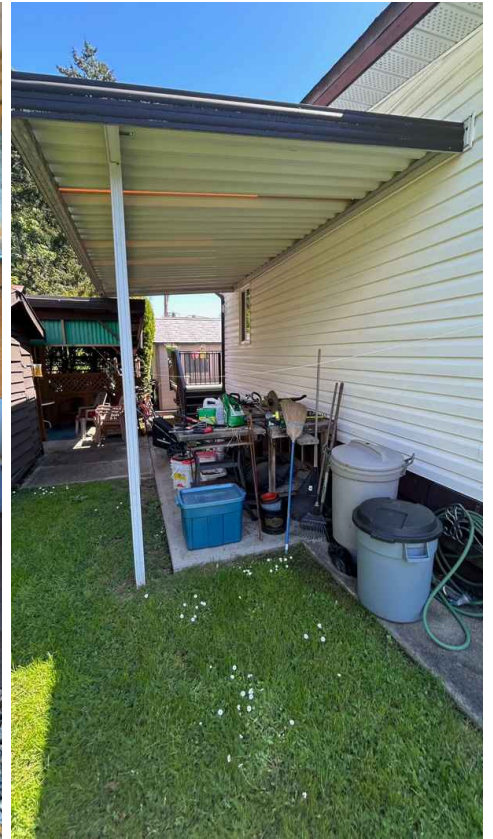
Awning not free standing

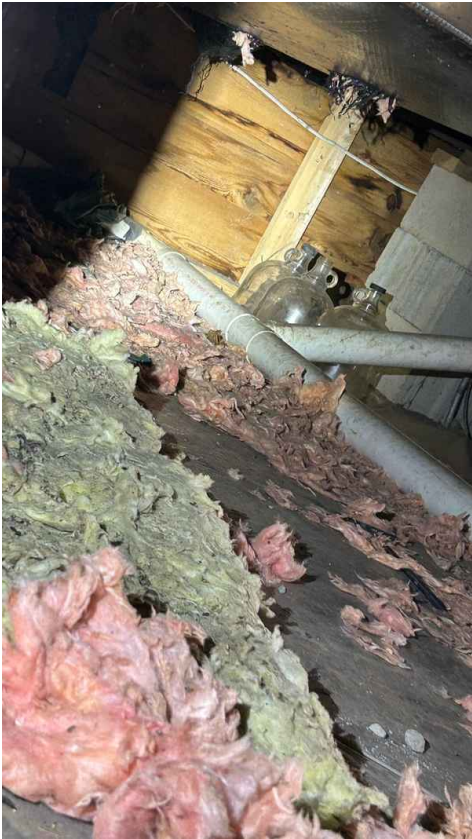
DAMAGED BELLY WRAP, EXPOSED INSULATION, AND VAPOUR BARRIER DEFICIENCIES IN CRAWLSPACE

Multiple rips and tears were noted in the belly wrap beneath the home, with areas of exposed, displaced, and shredded insulation—likely due to rodent activity. Additionally, the vapour barrier on the dirt crawlspace floor was incomplete or missing in sections. These conditions reduce the effectiveness of thermal insulation, allow moisture to migrate into the building envelope, and create opportunities for further pest intrusion or deterioration of materials. The belly wrap should be fully sealed and insulation properly restored to maintain energy efficiency and moisture control.

Insulation Shredded

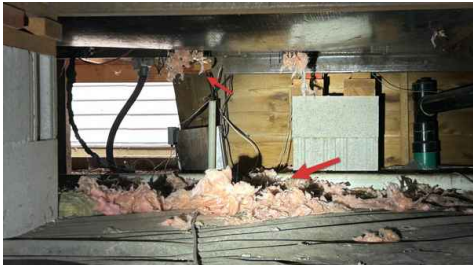
Exposed Belly/ Torn insulation

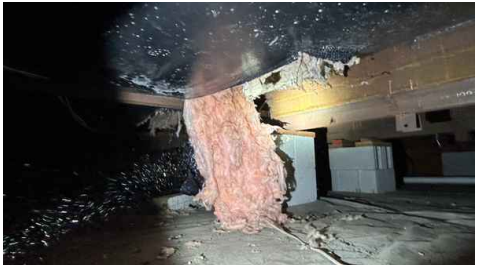
Torn Belly

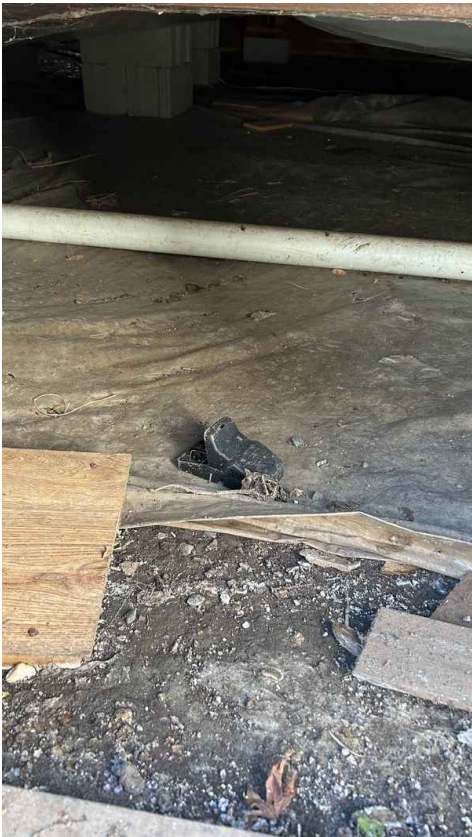
Incomplete vapor barrier

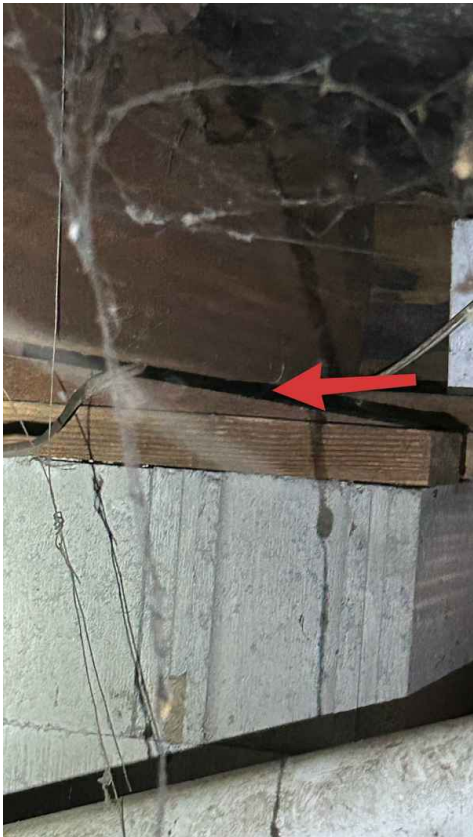
Structural supports beneath the home—including concrete blocks and wood cribs—were generally in fair condition; however, one crib appeared to be slightly leaning, and another showed a concrete block not in full contact with its shim, suggesting minor settling or misalignment. While not of immediate concern, these should be monitored. The exterior additions appear to contribute more significantly to structural stress, as noted elsewhere in the report. Obtain quote prior to subject removal to assess and address the damaged belly wrap, insulation, and vapour barrier.

Beam not touching shim

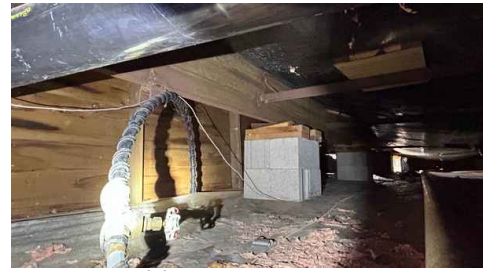
PRESSURE REDUCING VALVE NOT VISIBLE

No pressure reducing valve (PRV) visible - We advise to hire a plumbing contractor to add a PRV to protect fixtures, faucets and appliances from excess water pressure, which may shorten the life of fixtures, appliances, and increase the risk of leaks. Time frame: upon possession.

No PRV visible

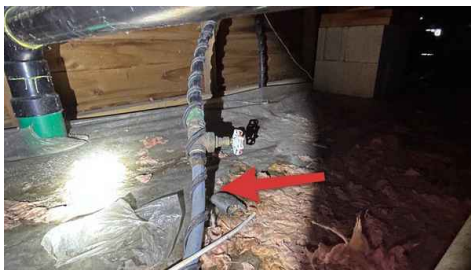
POLYBUTYLENE SUPPLY PIPING OBSERVED THROUGHOUT

Polybutylene (Poly-B) supply piping was observed at the main water line where it transitions from polyethylene, as well as at the main water shut-off, hot water tank, and various fixtures throughout the home. Poly-B is a flexible grey plastic piping with a known history of premature failure, and its presence can impact home insurability. Although no active leaks were noted at the time of inspection, many insurers may require replacement due to the material's reputation for reliability concerns. Obtain quote prior to subject removal to understand the potential cost of replacement and discuss implications with your insurance provider.

Poly B

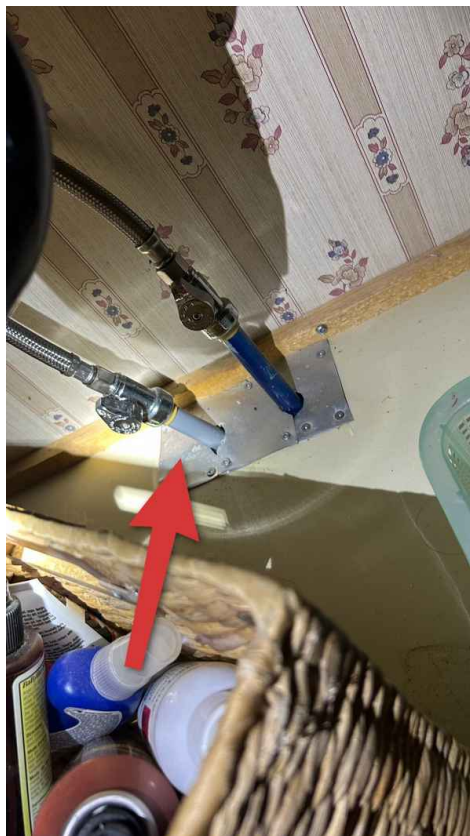
Poly B

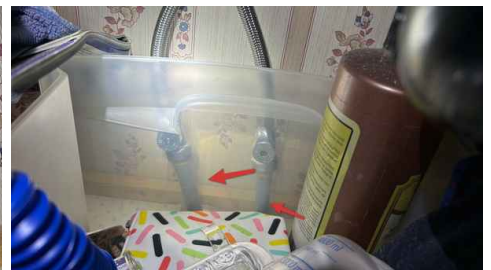
Poly B

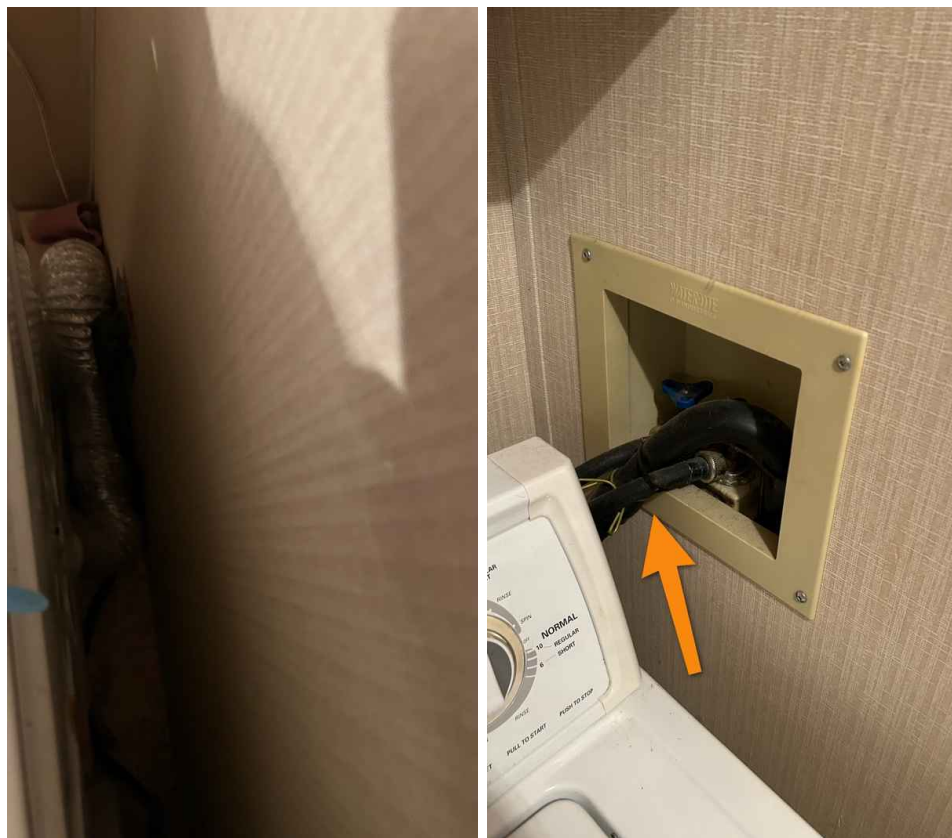
LAUNDRY HOOKUPS: HOSE UPGRADE AND DRYER VENT MAINTENANCE

The washing machine was connected using standard plastic supply hoses. For improved durability and leak prevention, upgrading to steel braided hoses is recommended. Additionally, the dryer vent material should be checked to ensure it is not crushed or obstructed and is free of lint buildup to reduce the risk of reduced airflow or fire hazard. These are simple maintenance items that can be addressed upon possession.

Slightly crushed dryer vent, clean yearly Replace hoses with steel braided

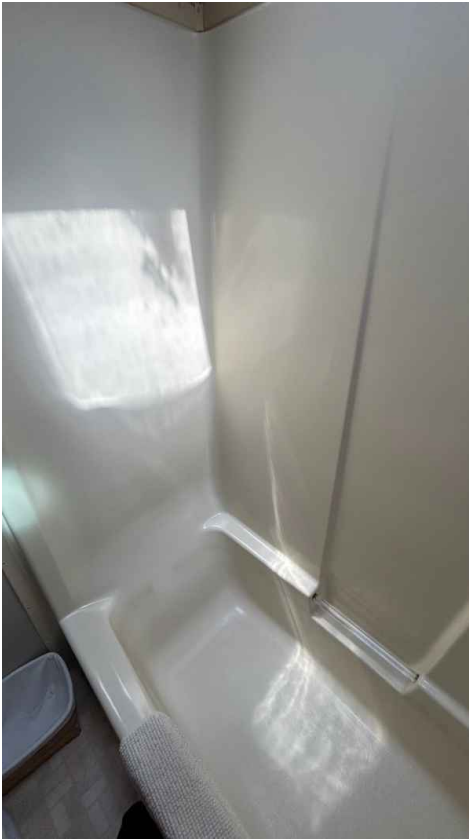
FLEXIBLE SHOWER INSERTS AND INCOMPLETE SEALING

Both shower/bath inserts were noted to have flexible wall panels with no apparent solid backing, suggesting a potentially substandard or lightweight installation. While functional at the time of inspection, the lack of rigidity may reduce long-term durability and resistance to water intrusion. In addition, several seams and fastener points around the inserts would benefit from caulking or resealing to prevent moisture entry behind the panels. Sealing and reinforcement, if necessary, are recommended upon possession to protect against potential water damage.

Material was flexible/ flimsy

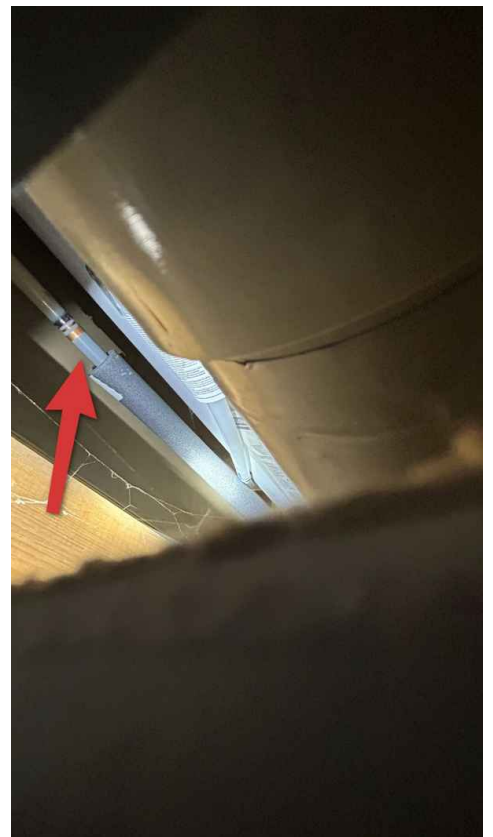
AGED HOT WATER TANK WITH LIMITED ACCESS AND POLYBUTYLENE SUPPLY

The hot water tank was located behind a panel that was not readily accessible, with only a partial view available behind the electrical panel. Based on visible components and general appearance, the tank appears to be older and likely beyond its expected service life. It was also missing seismic strapping, which is recommended for safety in regions with seismic activity. Additionally, polybutylene piping was observed supplying the unit. Due to the limited visibility and presence of aging components and Poly-B, obtain quote prior to subject removal for replacement and further evaluation by a licensed plumbing professional.

Poly B to HWT

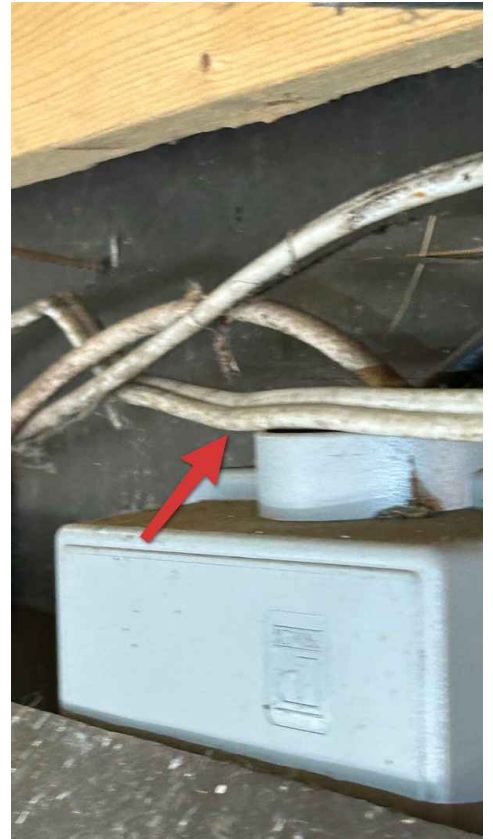
IMPROPER ELECTRICAL CONDUCTORS USED ON EXTERIOR

Electrical conductors intended for interior use were observed running beneath the rear deck and along the exterior of the home. These cables do not appear to be rated for outdoor conditions and were not adequately protected from physical damage or moisture exposure. When interior-rated wiring is used outside, it is more susceptible to deterioration, which can increase the risk of electrical shock or failure. A licensed electrician should be consulted to assess and correct the installation. Obtain quote prior to subject removal.

Conductors used outside must be rated for exterior

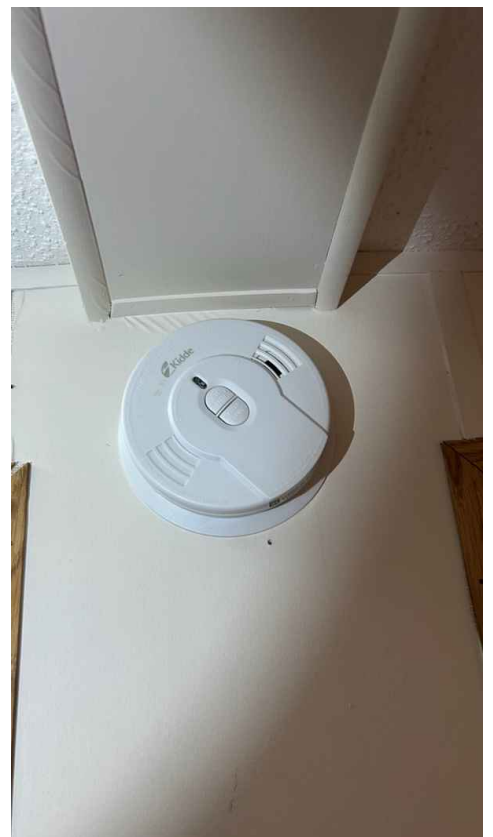
SMOKE AND CARBON MONOXIDE DETECTORS

It is important to note that smoke detectors should be installed in each room and living space, as well as carbon monoxide detectors on every floor and near appliances that emit CO. These detectors can help ensure the safety of occupants by providing early warning in case of fire or the presence of dangerous levels of carbon monoxide. It is recommended to test these detectors regularly and replace batteries as needed to ensure they are functioning properly. This is a life safety issue.

Place in all sleeping rooms and test monthly

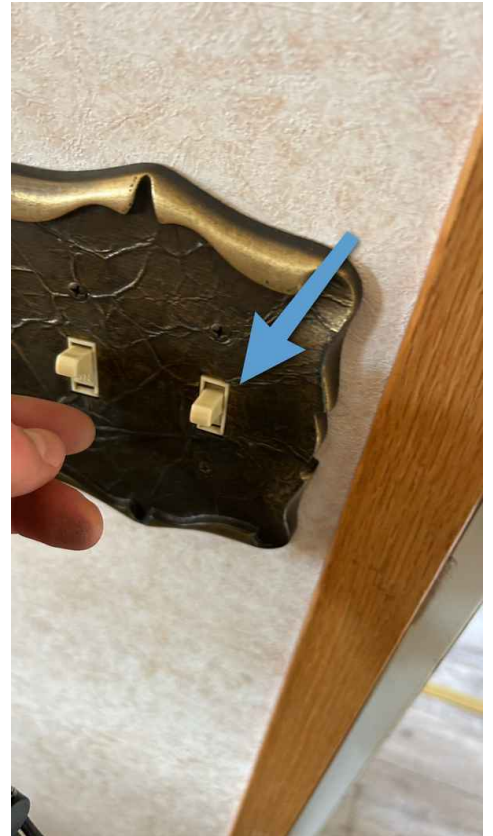
LOOSE LIGHT SWITCHES IN ENTRYWAY

Light switches located in the entryway to the main living area were observed to be loose within their electrical boxes. Loose switches can lead to wear on wiring connections over time, increasing the risk of malfunction or shock. It is recommended to have the switches properly secured upon possession to ensure safe and reliable operation.

Loose switch

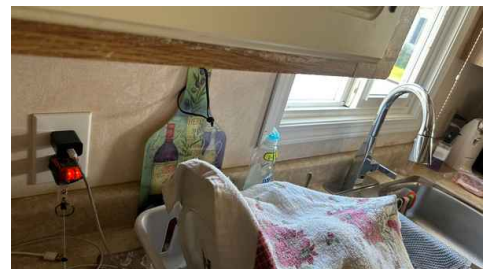
KITCHEN OUTLETS NOT GFCI PROTECTED

The electrical outlets in the kitchen did not appear to be GFCI (Ground Fault Circuit Interrupter) protected at the time of inspection. GFCI protection helps reduce the risk of electrical shock in areas where water is present, such as kitchens and bathrooms. Upgrading these outlets for improved safety is recommended upon possession.

Kitchen outlet not GFCI protected

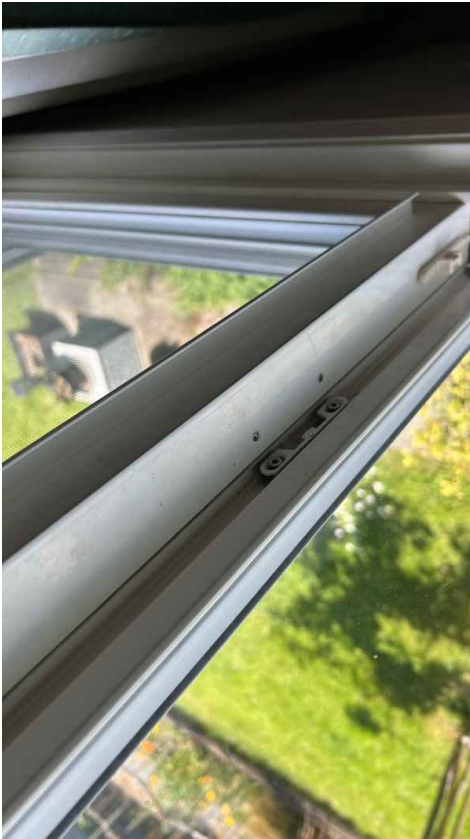
AGING WINDOWS THROUGHOUT THE HOME

The vinyl windows were dated 2001, making them approximately 24 years old. All windows were functional at the time of inspection; however, windows of this age may gradually lose thermal efficiency, develop air leakage, or experience hardware wear over time. While replacement is not immediately necessary, it may be considered in the future for comfort or energy efficiency. That said, window replacement is a significant investment and may not offer a quick return in energy savings alone. This note is provided at the buyer's discretion as a general heads-up regarding window age.

Missing Lock

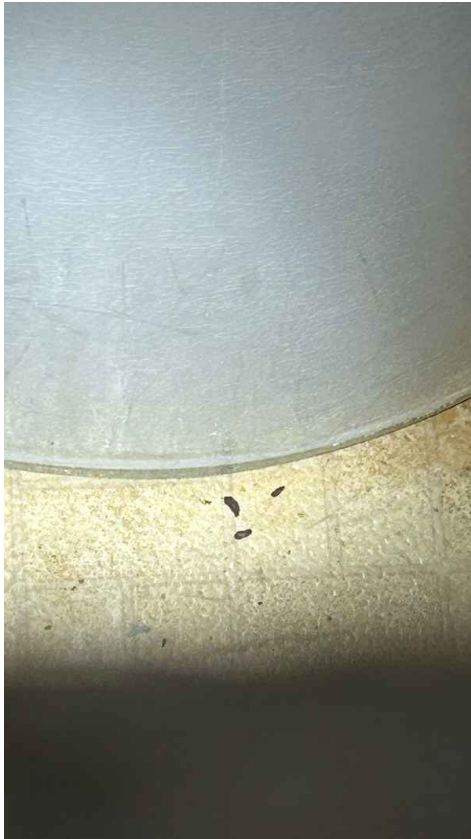
SIGNS OF PEST AND RODENT ACTIVITY

Small inactive wasp nests were observed in a few areas around the exterior of the home. Additionally, rodent droppings were noted inside the hot water tank enclosure, and widespread signs of rodent activity—including droppings and disturbed insulation—were present throughout the crawlspace. These conditions suggest a history of pest presence, and further evaluation and treatment by a licensed pest control professional is recommended upon possession to ensure the home is secure and sanitary.

Droppings in interior

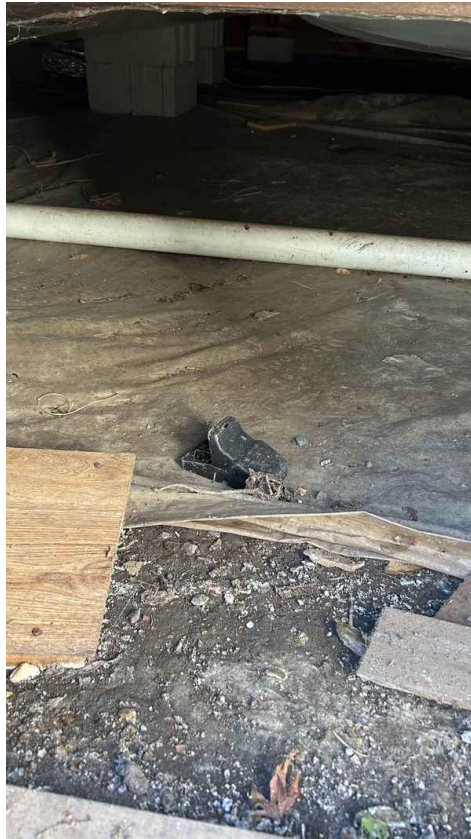
Traps and droppings in crawspace

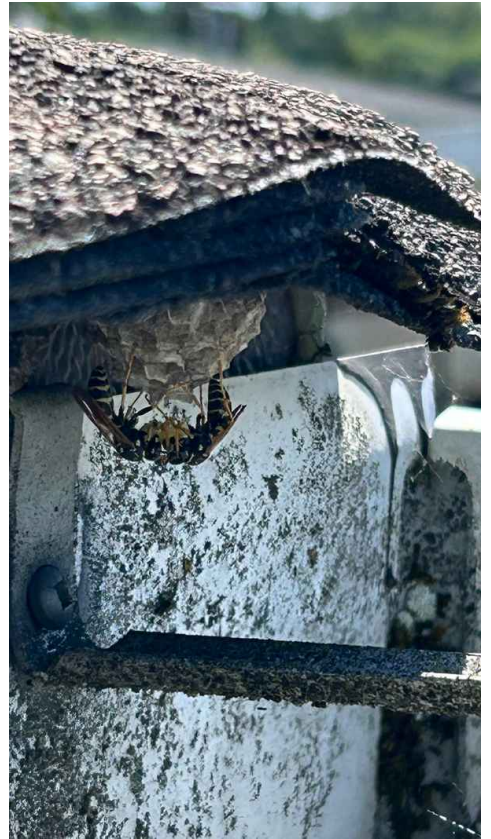
Wasp Nest

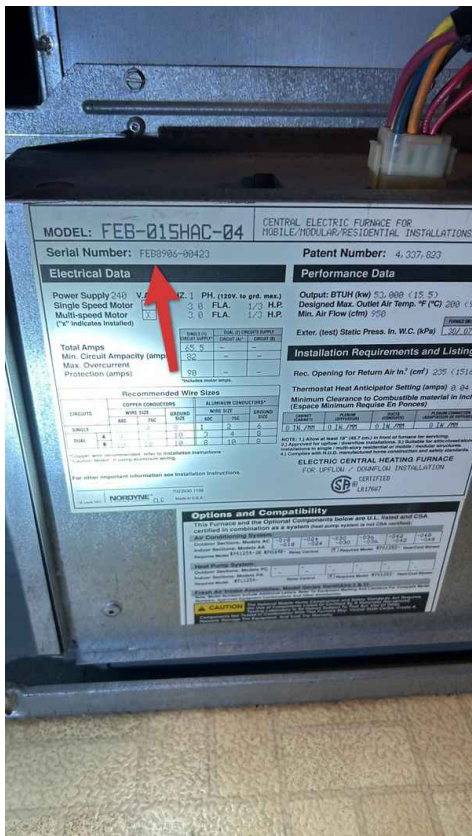
AGED ELECTRIC FURNACE WITH IMPROPER VENTING AND POOR MAINTENANCE

The electric furnace appeared to be original to the home, dating back to 1989, and has exceeded its typical service life. While the blower and heating function responded when the thermostat was triggered, the unit was in poor overall condition. The furnace and blower compartment were heavily soiled, the air filter was extremely dirty, and the exterior intake vent was constructed from an inappropriate material not intended for HVAC use. Additionally, the furnace access panels were secured with duct tape, indicating past difficulties in accessing or securing the unit properly. These conditions raise concerns about air quality, efficiency, and long-term reliability. Obtain quote prior to subject removal for servicing or replacement, and consult an HVAC professional to assess safe operation and proper ventilation.

Data plate (Feb 89')

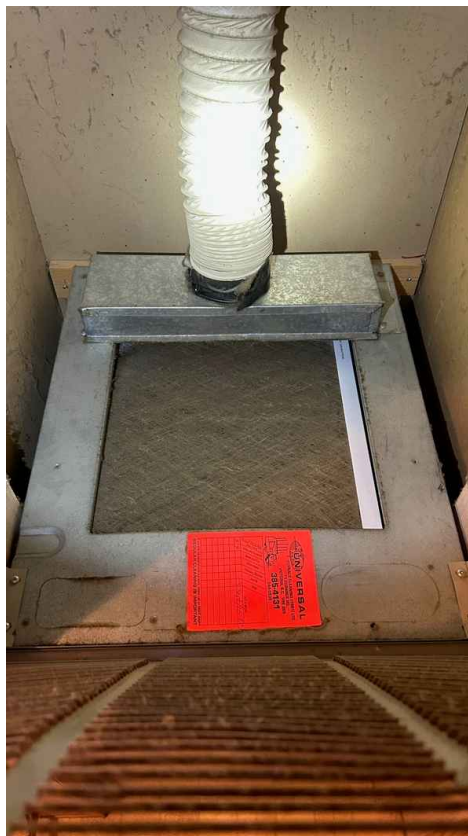
Improper venting material, Very dusty components and filter
