WATCHTOWER HOME INSPECTIONS

RESIDENTIAL REPORT

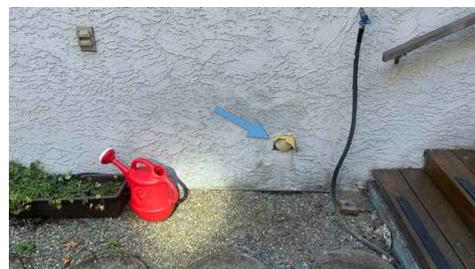
EXTERIOR – DAMAGED DRYER VENT

The dryer vent cover on the siding was broken, leaving the vent exposed. This can allow pests or moisture to enter and reduces the effectiveness of the venting system. Replacing the vent cover upon possession is recommended to maintain proper function and protection.

Damaged vent

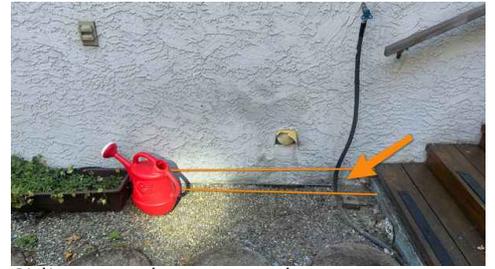
2.1.2 Siding, Flashing & Trim

At the suite deck entry, one section of siding was positioned too close to grade. This can allow moisture intrusion and shorten the life of the siding. Adjusting the landscaping in this area to provide approximately 6–8 inches of clearance is recommended to protect the wall assembly.

Siding too close to grade

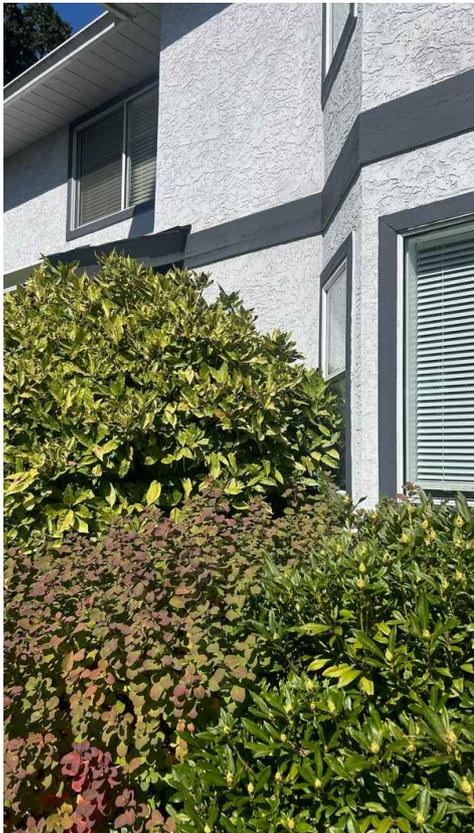
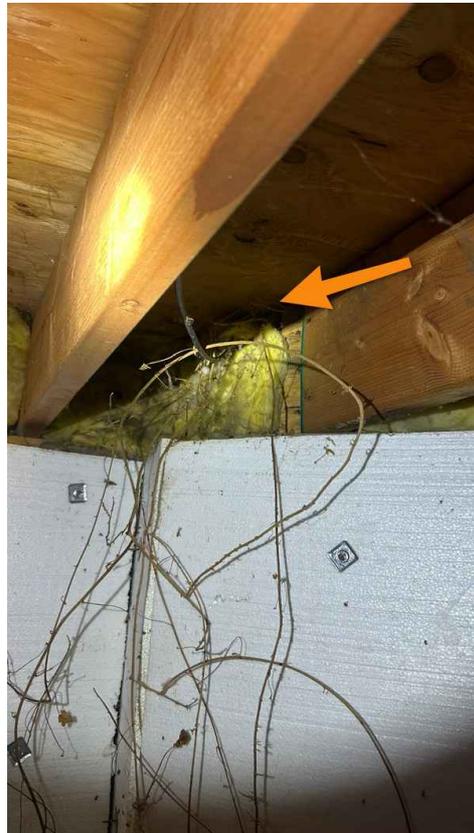
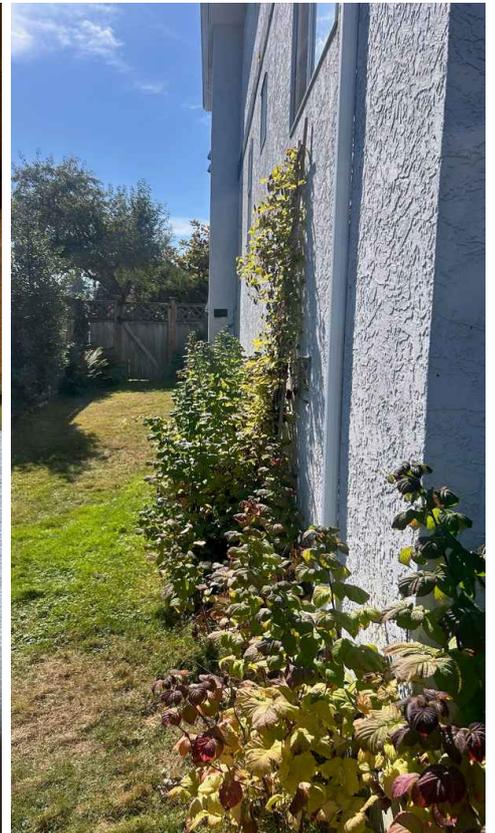
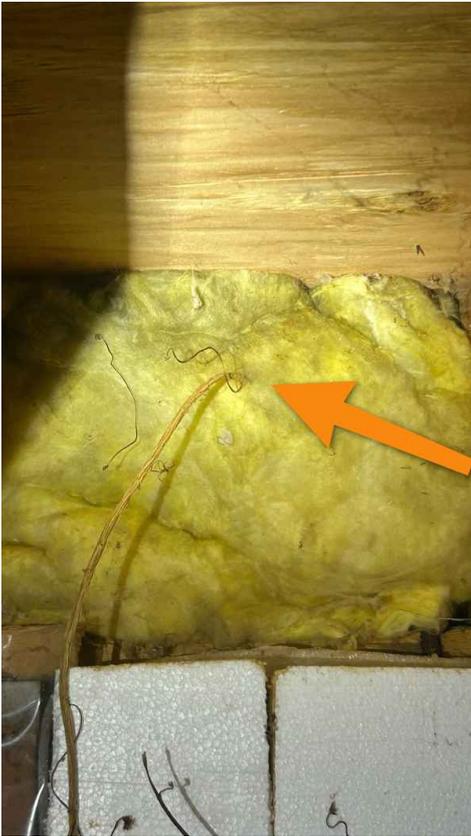
2.1.3 Siding, Flashing & Trim

EXTERIOR – VEGETATION TOO CLOSE TO SIDING

Thick vegetation was noted around the front portion of the house, including a raspberry bush on the right-hand side. Growth was in direct contact with the siding in several areas and had even penetrated into the crawlspace through a gap at the foundation/stucco joint, though the visible vegetation inside was dead. Vegetation in close contact with siding prevents proper drying and can lead to deterioration over time. Trimming all plants back at least three feet from the house upon possession is recommended to protect the siding and foundation.

Trim vegetation back 3 feet

Vines entering crawl

Trim vegetation back

Entering crawl

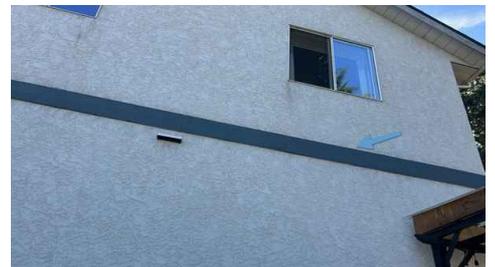
2.1.4 Siding, Flashing & Trim

All windows and protrusions appeared to be properly flashed; however, a belly board at the rear of the house resembled trim but did not appear to be flashed. This suggests that the wall may be a continuous stucco system without a modern rain screen, which is typical for homes of this build era. While this does not indicate an active issue, rain-screening improves drainage and drying, so ongoing monitoring and regular maintenance of caulking and sealants will be important to help manage moisture exposure.

No flashing on belly band

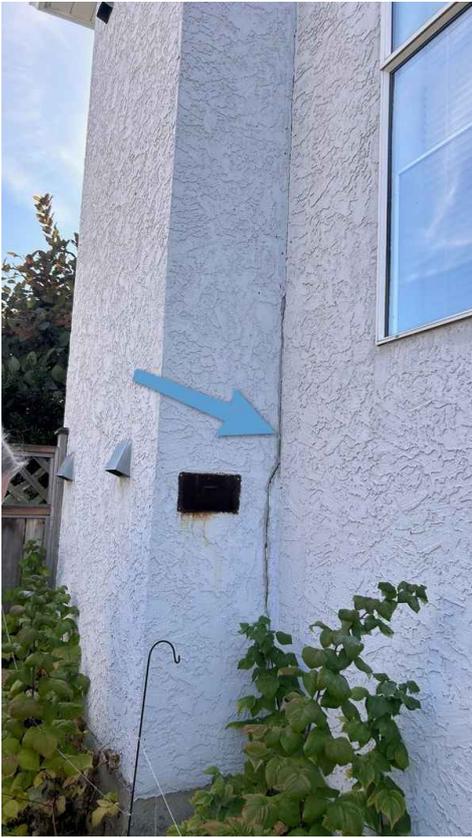
2.1.5 Siding, Flashing & Trim

CHIMNEY / SIDING – MINOR SEPARATION CRACK

A small crack was observed in the stucco siding along the right-hand side of the home where it meets the chimney. This is a common occurrence, as chimney slabs and house structures can shift slightly independently over time. The crack did not appear significant and is not a structural concern. At a minimum, sealing the crack to prevent moisture ingress is recommended.

Seal crack

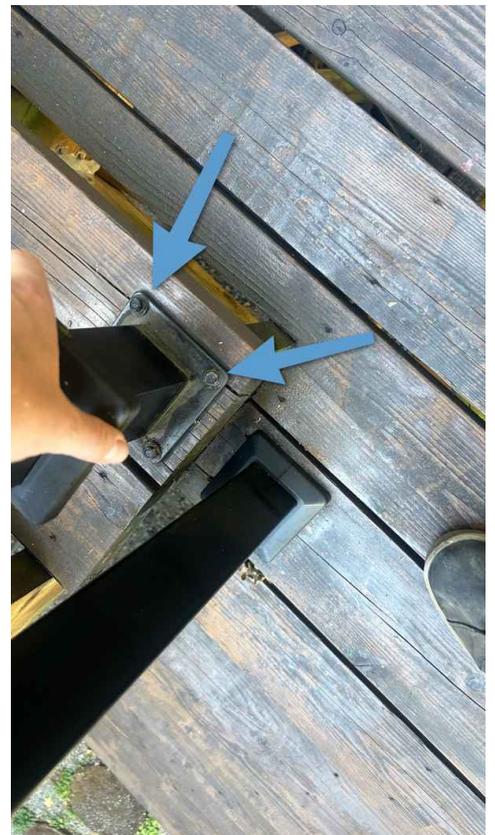
2.2.1 Decks, Balconies, Porches & Steps

DECK - HANDRAIL AND GUARDRAIL FASTENING

The handrail and guardrail for the deck and deck steps were horizontally fastened into the decking surface. This fastening style can allow water to penetrate around the screws, leading to deterioration of both the fasteners and the deck material over time. Installing a trim piece and sealing the fasteners upon possession is recommended to help protect the rail connections and prolong the life of the decking.

Seal hardware

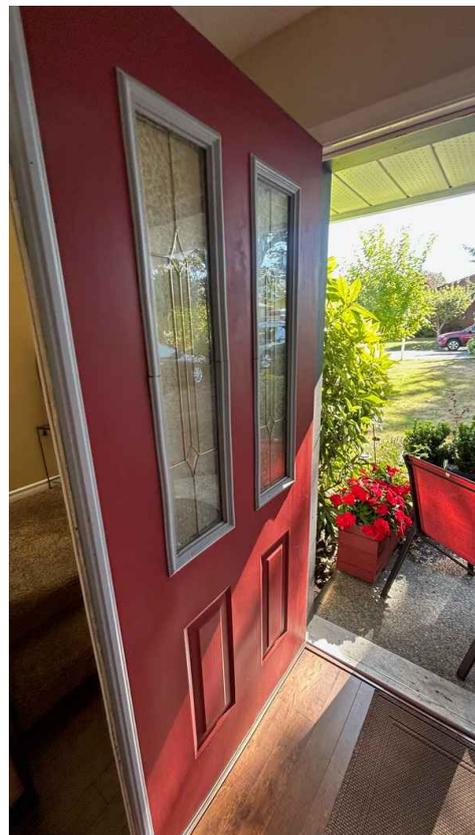
2.3.1 Exterior Doors

FRONT ENTRY DOORS – ADJUSTMENT NEEDED

The front entry door required a slight push to fully latch. The French door set at the entry was functional; however, the passive side that locks into the frame also needed extra force to release from its middle track. These issues appear to be minor alignment concerns and can be corrected with adjustment to improve smooth operation.

Adjustments needed

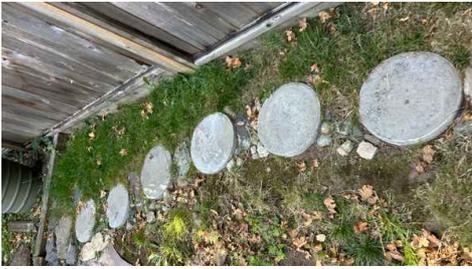
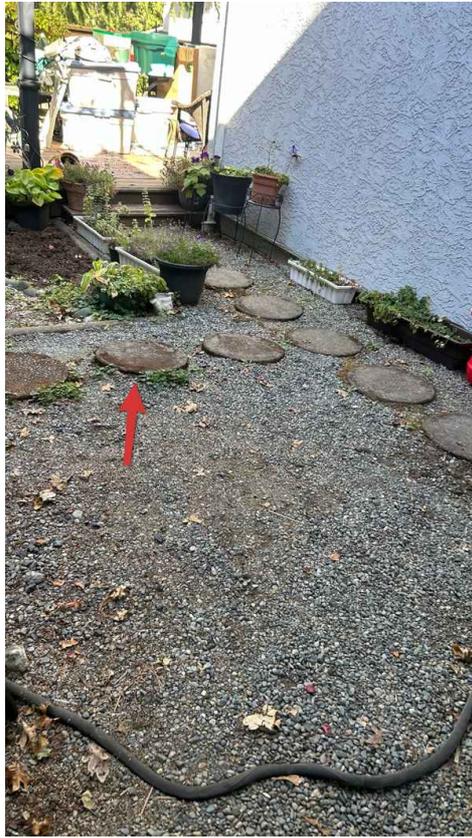
2.4.1 Walkways, Patios & Driveways

YARD – TRIP HAZARDS

In the backyard, several trip hazards were observed, including uneven pavers, awkward footing around the flat area where a trampoline well had been dug out, and a small wooden retaining wall that is leaning. While the retaining wall does show signs of structural concern, it is minor in size and more of a trip hazard than a stability risk. These conditions present awkward footing and could be a concern for children or elderly individuals, so caution is advised until repairs or adjustments are made.

Uneven pavers

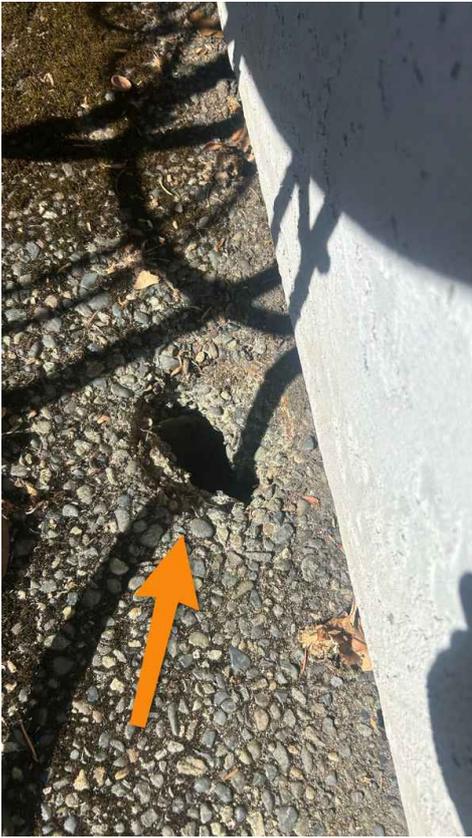
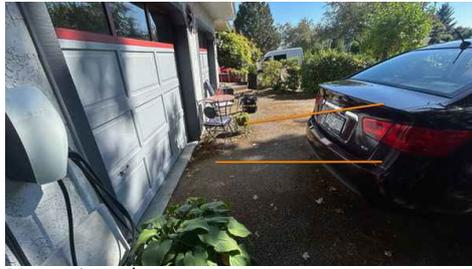
2.6.1 Grading and Lot Surfaces

DRIVEWAY DRAINAGE – NEGATIVE GRADE TOWARD GARAGE

The driveway slopes toward the garage, creating a negative grade. A central drain was present and appeared to be functioning adequately, as no notable/ water related deterioration was observed on the garage trim at the time of inspection. For long-term performance, a slot drain may be a worthwhile upgrade to ensure water is collected effectively during heavy rainfall. It is also advisable to inquire with the seller about the history of drainage performance during periods of intense rain to confirm the current system is sufficient.

Single drain

Negative slope

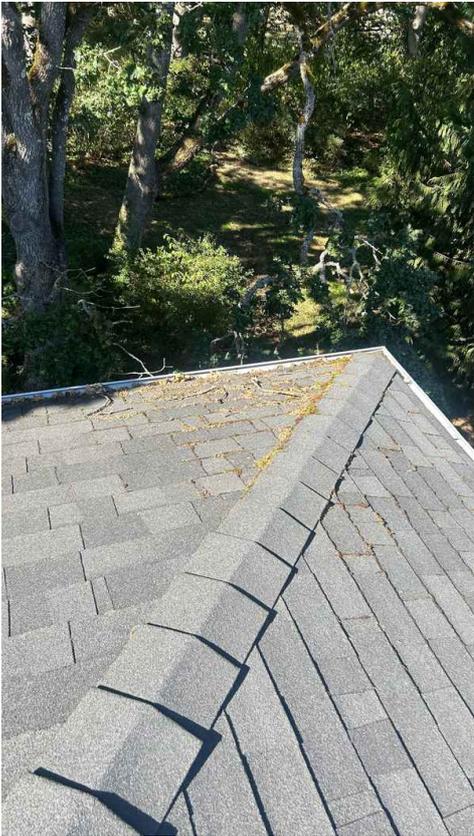
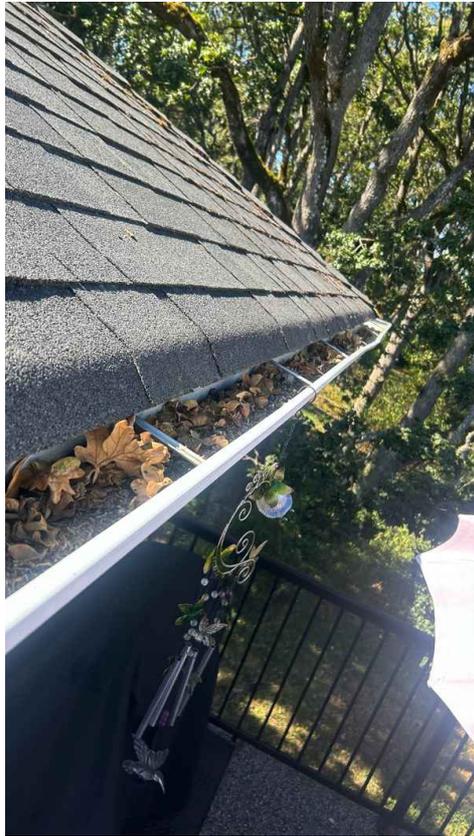
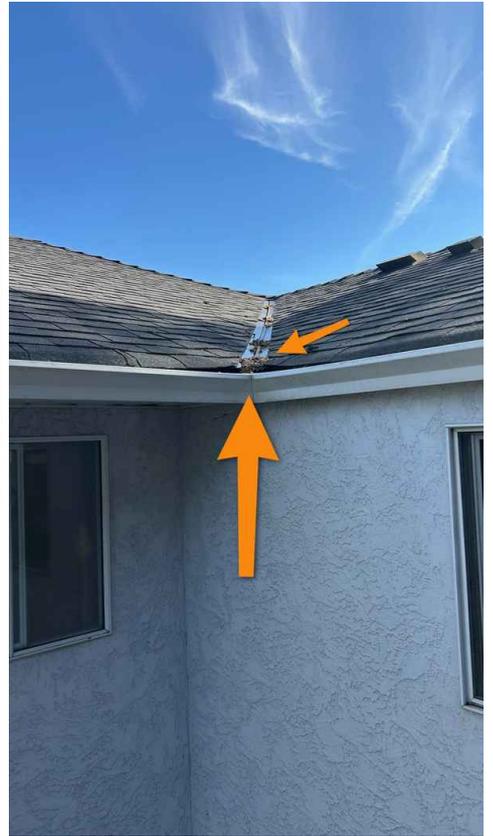
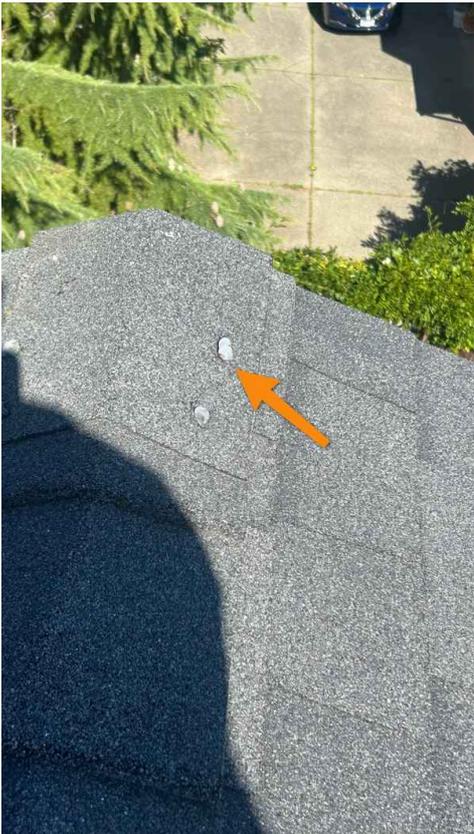
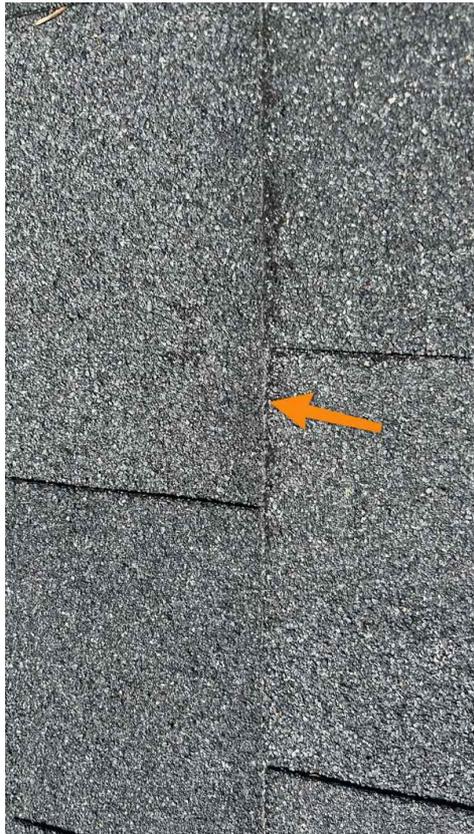
ROOF – ARCHITECTURAL LAMINATE SHINGLES

The roof surface was finished with architectural laminate shingles and appeared to be in the early to mid stages of its service life. Only minimal granular loss and slight fiberglass matting were observed on a few shingle edges. Some moss growth and gutter debris were present in areas beneath tree overhangs and should be cleared to improve drainage. Some downspouts were shedding water directly on to shingle surfaces and would benefit from an extended downspout to the gutter. One portion of flashing where it meets the corner gutter, adjacent to the deck, may allow water to overshoot during heavy rain depending on rainfall intensity or gutter placement; it would be worthwhile to ask the seller about past performance in this area. A few exposed fasteners were also noted. All work and touch ups should be done upon possession to maintain weather tightness and prolong the shingle life.

Moss growth

Gutters full of debris

Corner section may overshoot gutter

Slightly exposed fasteners

Tiny amount of exposed matting (good condition)

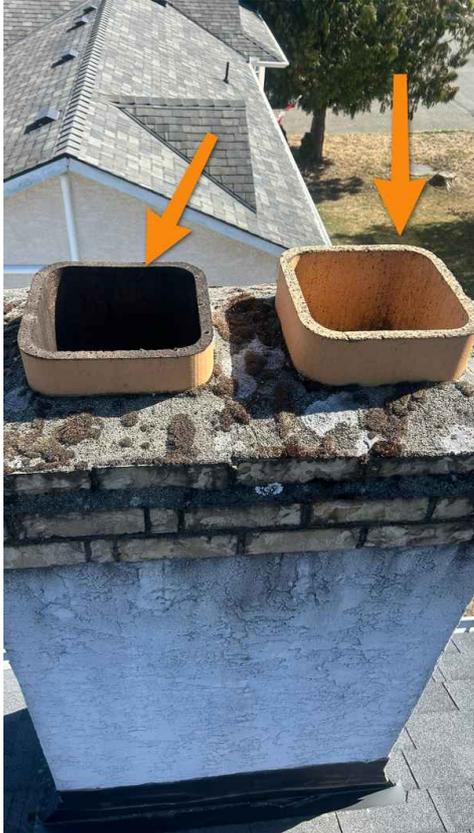
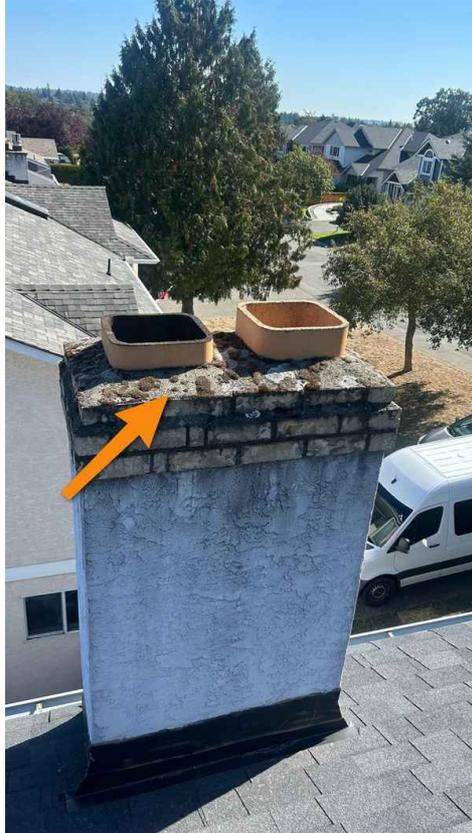
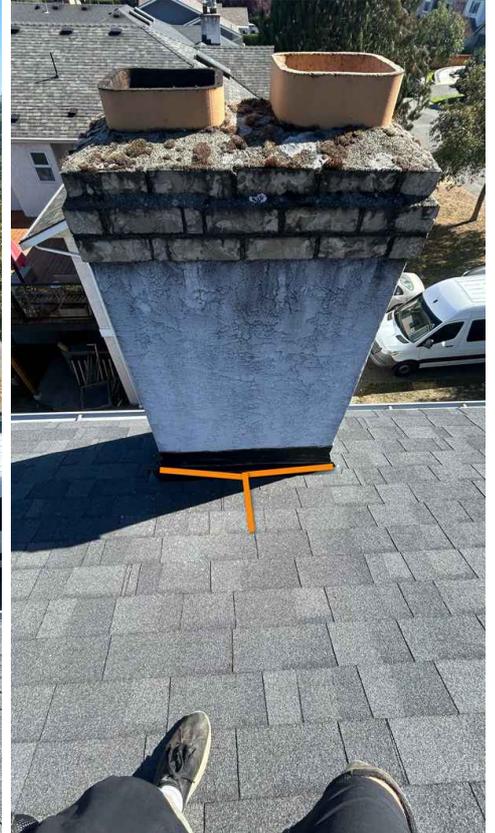
3.4.1 Skylights, Chimneys & Other Roof Penetrations

CHIMNEY – STUCCO MASONRY WITH DETERIORATED CROWN

The stucco-covered masonry chimney appeared generally in good condition, though the crown (concrete cap at the top) showed deterioration, lacking a water shedding overhang and surface moss growth. While it was still performing its function at the time of inspection, touch-up or repair may be needed within the first few years of ownership to ensure it continues to shed water effectively. In addition, the flues were missing rain caps, and these should be installed to prevent water ingress into the flues and fireplace assemblies. The chimney is wide and positioned on a sloped roof; while flashing appeared adequate, adding a cricket during a future re-roof would improve water shedding and long-term performance.

Missing rain cap

Crown deteriorating, lacking overhang

Consider adding cricket next re roof

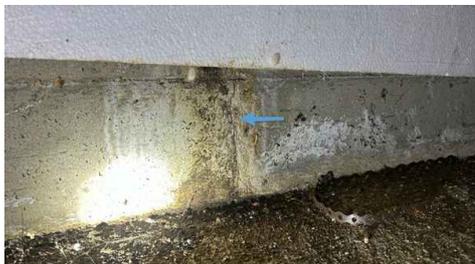
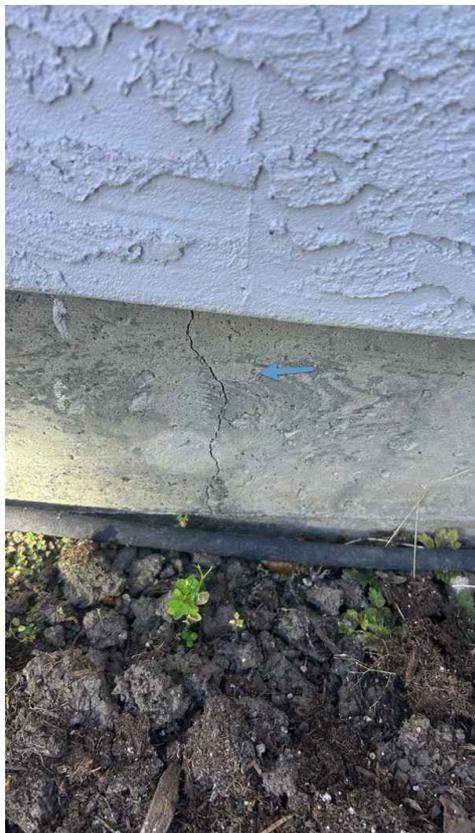
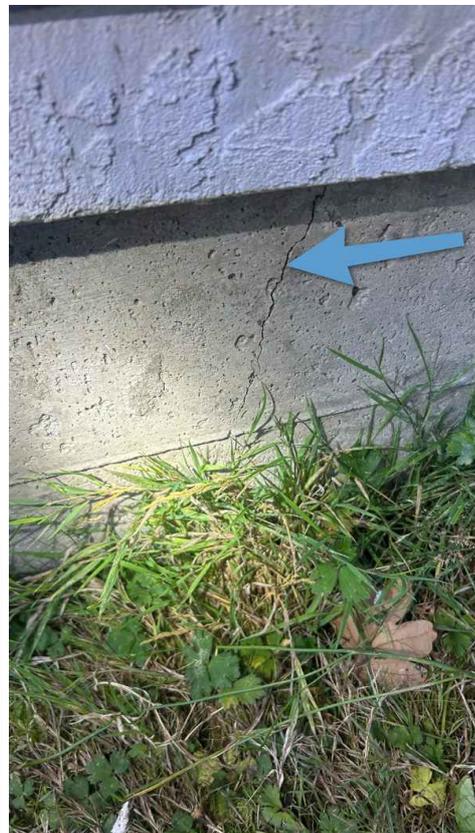
FOUNDATION – MINOR SHRINKAGE CRACKS

Three minor shrinkage cracks were observed in the foundation: one inside the crawlspace and two on the exterior walls. These appeared typical for the age of the home and did not show signs of significant movement. While no evidence of moisture intrusion was noted, sealing the interior crack in the crawlspace may help prevent potential moisture ingress. Otherwise, these cracks can simply be monitored over time.

Crawlspace shrinkage crack

Shrinkage crack

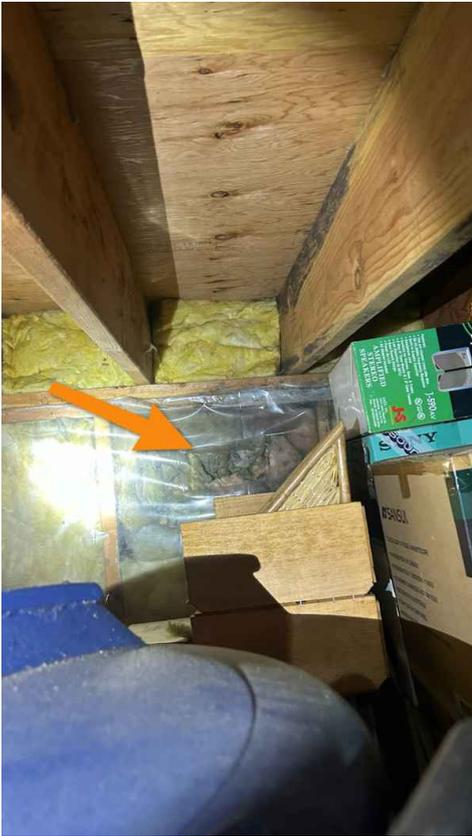
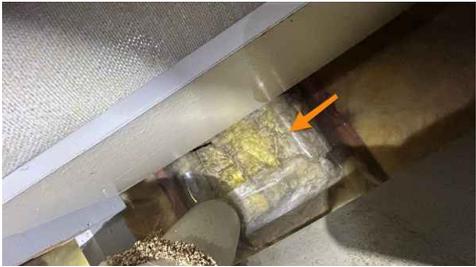
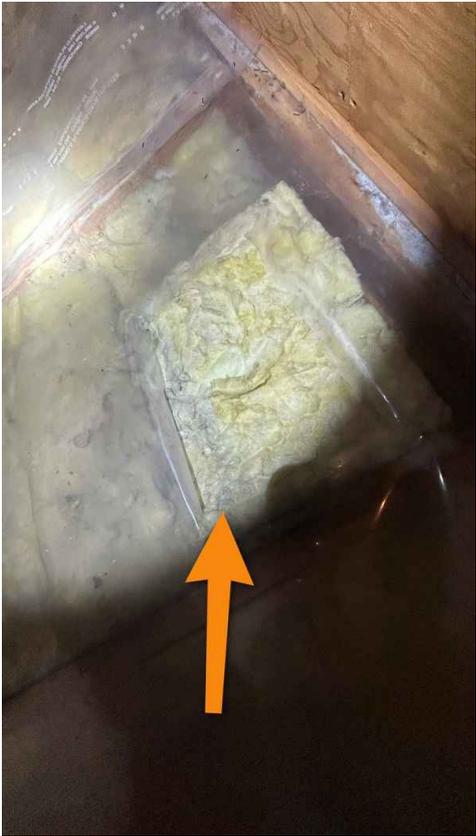
CRAWLSPACE – VAPOR BARRIER AND SERVICE PENETRATION

The crawlspace vapour barrier showed small intentional gaps along the perimeter where vents were located. Even with venting present, the barrier should ideally be continuous to reduce ground moisture migration, and minor repairs or sealing can easily be done to improve coverage. In addition, the main polybutylene water line entered the crawlspace through a wall penetration with a large gap around the pipe. Sealing this opening is recommended to help prevent moisture intrusion and pest entry.

Hole in vapour barrier

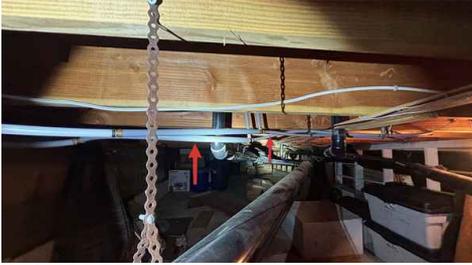
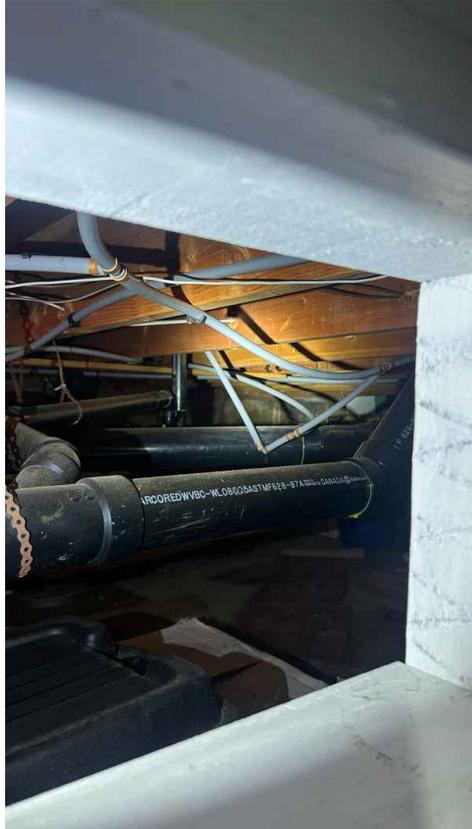
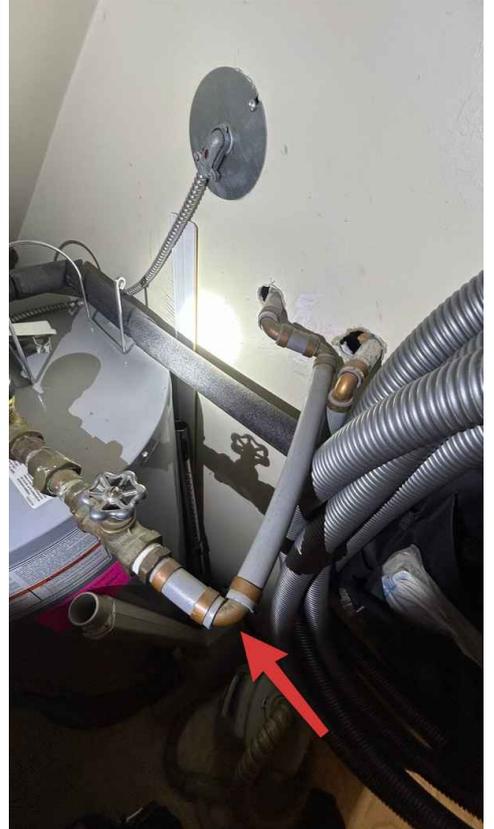
PLUMBING – POLYBUTYLENE (POLY-B) PIPING

The home contained extensive polybutylene (Poly-B) piping, including the main water line, both hot water tank connections, and numerous supply lines visible in the crawl space. While some upstairs fixtures appeared to be fed by copper at the stub-outs, Poly-B was still present in many areas. This material has a documented history of leakage and is a known concern with insurance providers. Replacement can be costly, so it is important to confirm with your insurance company whether coverage will be provided and whether higher deductibles or conditions will apply.

Poly B

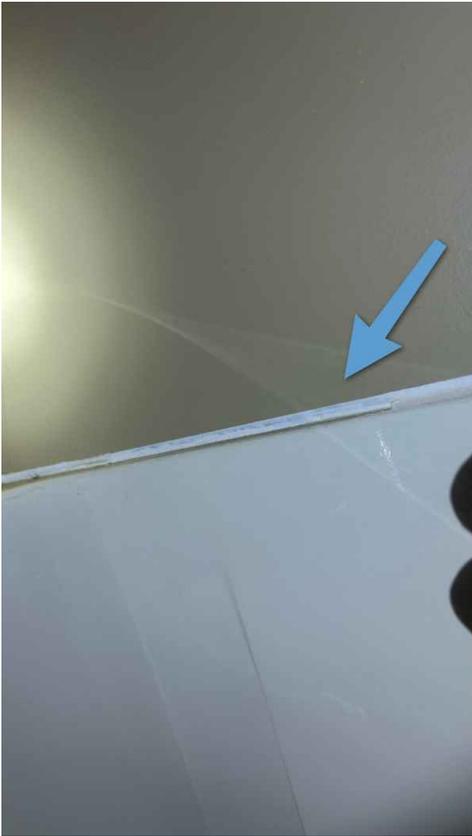
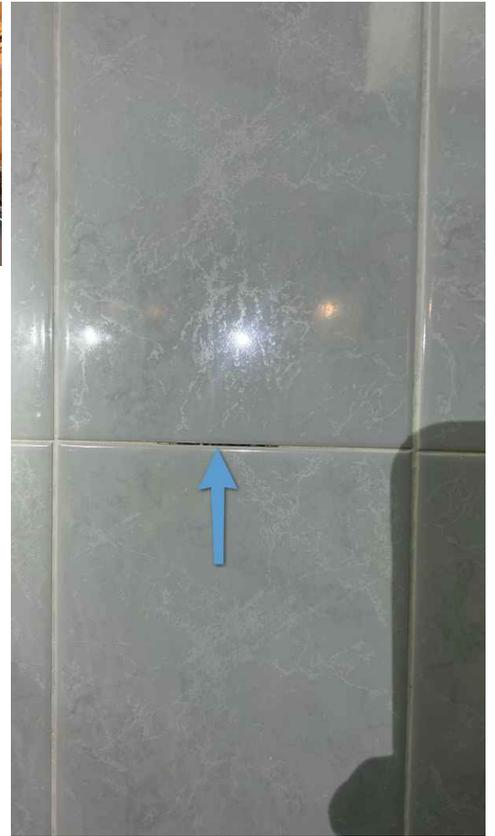
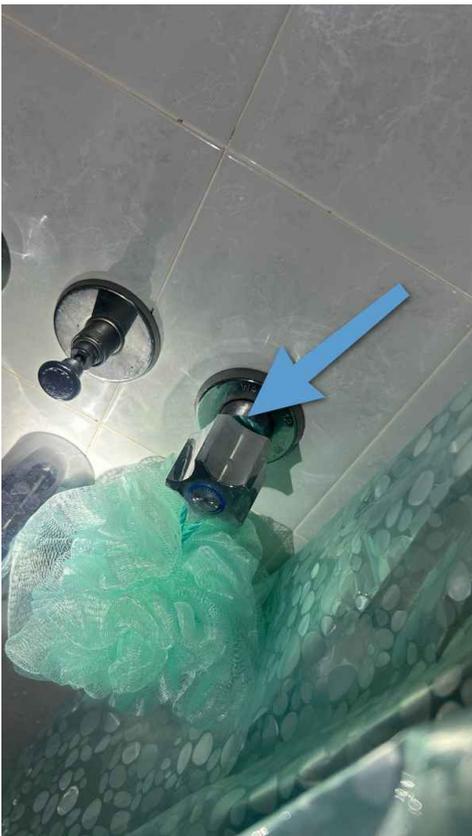
5.3.2 Distribution Systems & Fixtures

BATHROOMS – GENERAL MAINTENANCE ITEMS

Several minor maintenance issues were observed across the home's bathrooms. The basement suite shower stall had a few small chips that appeared to have been previously repaired. The primary ensuite shower showed missing grout lines and required caulk/sealant touch-ups. In the main upper-level bath/shower insert, some peeling sealant and drywall were noted where the unit meets the wall. Additionally, the upstairs bathroom taps were installed with reversed threading on the cold handle (right-loose, left-tight), which is more of a convenience issue than a defect. These items can be addressed through routine maintenance to maintain function and appearance.

Peeling sealant/drywall

Scuffs in shower pan

Missing grout

Reverse thread

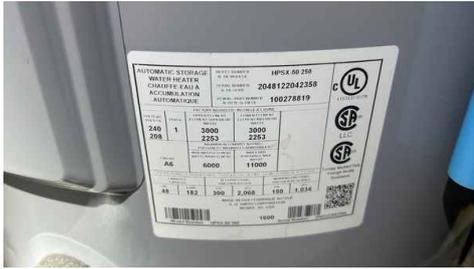
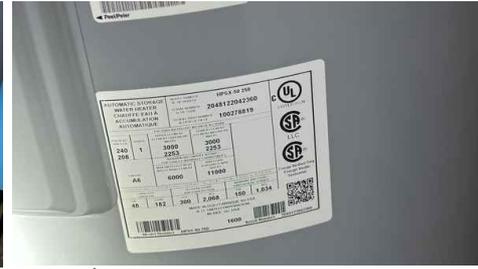
5.4.1 Hot Water Systems
HOT WATER TANKS – MANUFACTURED 2020

Both hot water tanks, located in the crawlspace and laundry area, were manufactured in 2020 and appeared operational at the time of inspection. Neither unit was equipped with seismic straps or expansion tanks, which are recommended safety features. Adding these components would improve overall safety and reduce strain on the plumbing system. Polybutylene piping was also connected to the tanks, as noted elsewhere in this report.

Data plate

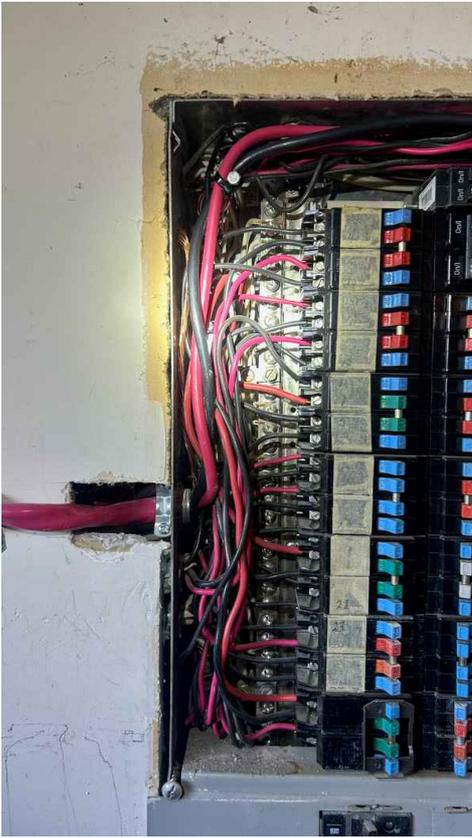
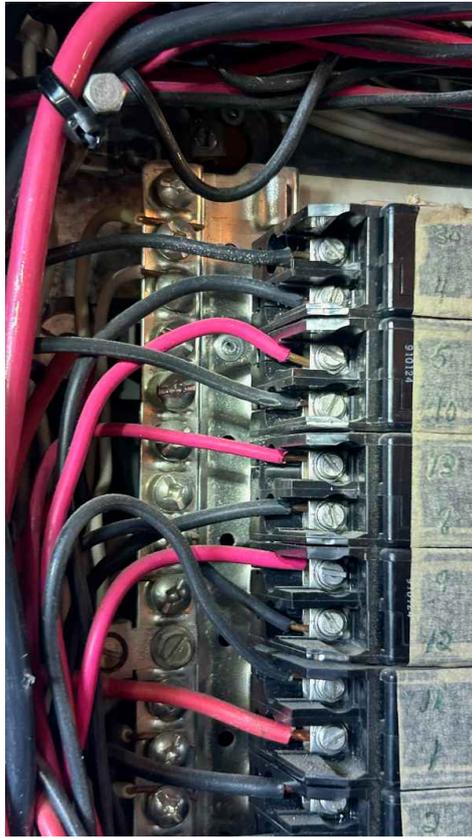
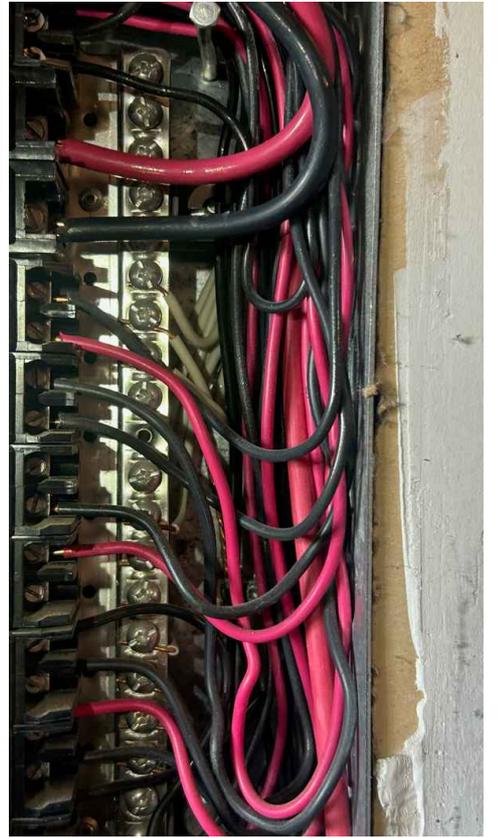
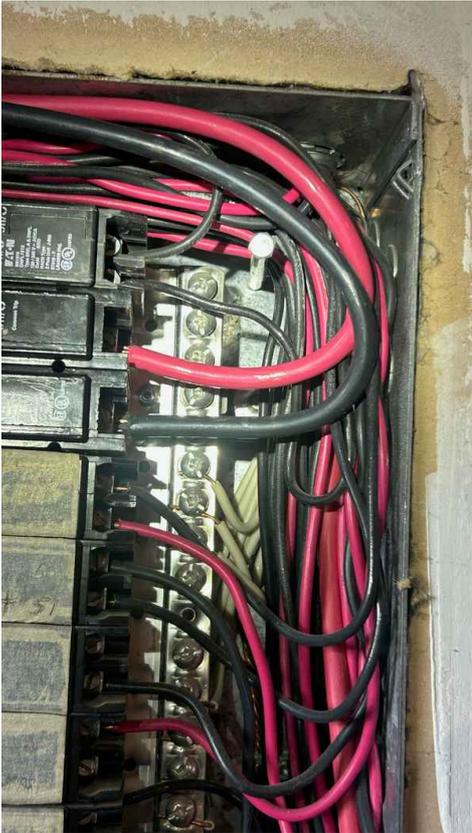
Panel Photos:

The home was equipped with a 200-amp main service panel with copper non-metallic sheathed wiring, all of which appeared in good condition. Only one breaker slot remained available, so any future electrical additions may require rearranging circuits or installing a sub-panel. In addition, the suite does not have a separate power supply and is connected to the main panel. An electrician can advise on options if additional capacity or separation is desired.

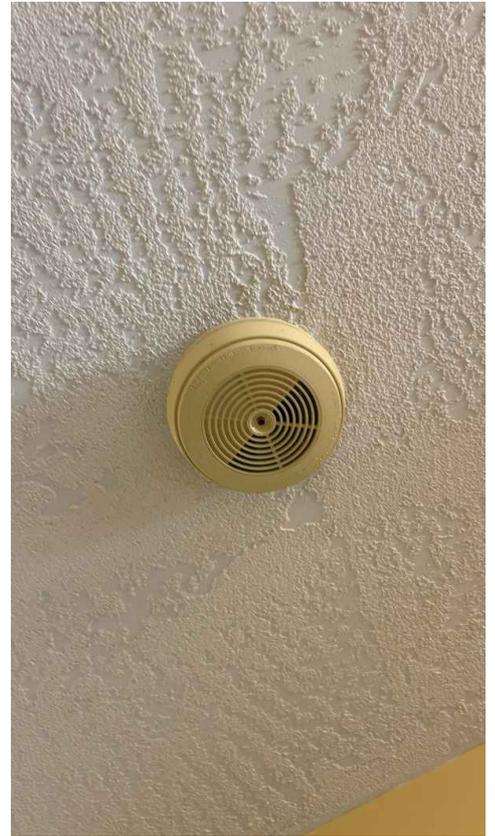
6.3.1 Smoke and Carbon Monoxide Detectors

**SMOKE DETECTORS –
INADEQUATE COVERAGE**

The home's smoke detector coverage was inadequate. The detector in the upstairs main hallway was expired, and detectors were not present in all sleeping rooms. To meet modern safety standards, new smoke detectors should be installed in all bedrooms and common areas, along with at least one carbon monoxide detector. This should be done immediately upon possession, as it is a life safety issue.

Update detector coverage

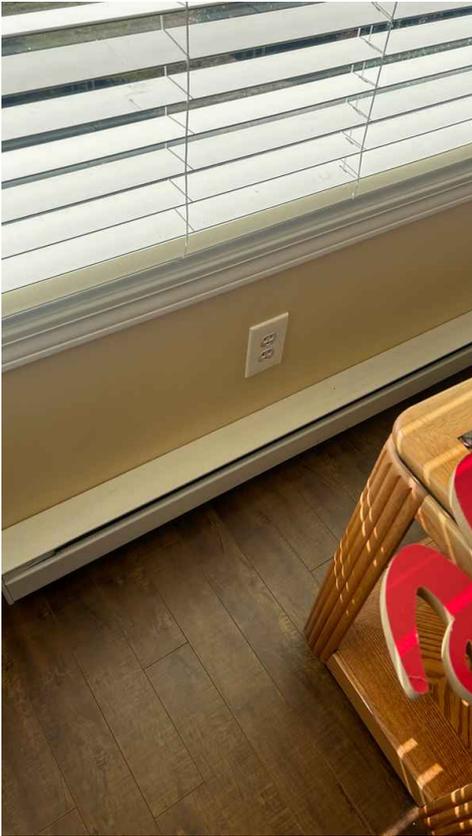
6.4.1 Fixtures, Switches & Receptacles

ELECTRICAL – MISSING GFCI PROTECTION AND OUTLET LOCATION

Neither of the kitchen outlets were GFCI-protected, which is a safety concern in areas near water. Upgrading these to GFCI outlets is recommended for added protection. In addition, one receptacle was located directly above a baseboard heater. This placement increases the risk of heat damage to cords, so caution should be used to ensure cords do not contact the heater. Relocating this outlet in the future would be a safer long-term solution.

Receptacle over heater

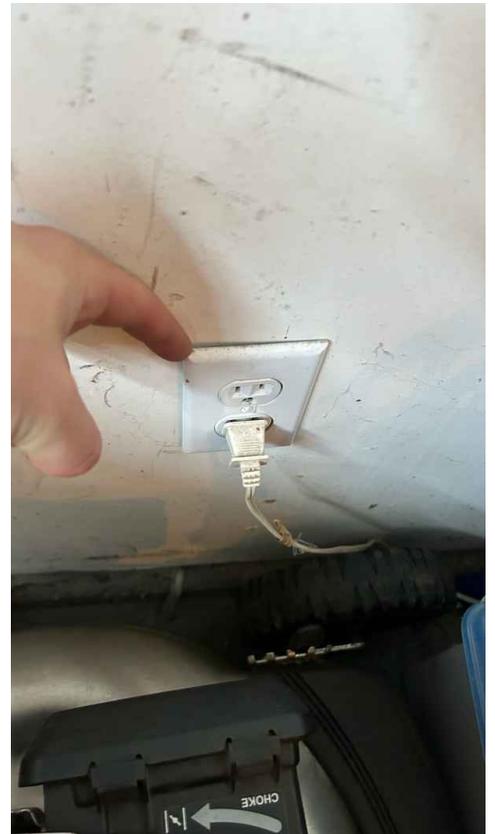
GARAGE – LOOSE RECEPTACLE

One electrical receptacle in the garage was slightly loose in its box. This can cause wear on the connections over time. Securing the receptacle upon possession is recommended to ensure safe and reliable use.

Loose receptacle

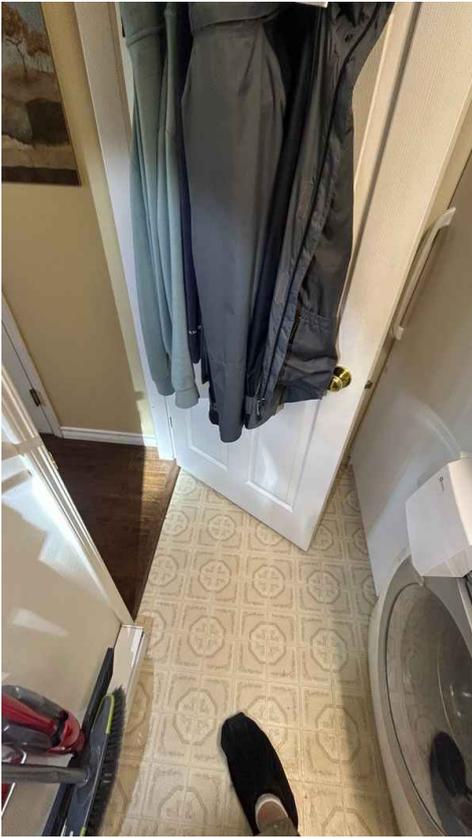
The door between the main home and the suite laundry room did not close properly due to interference with the flooring transition. Adjustment or trimming of the door will be needed to allow it to close fully.

Door wont close

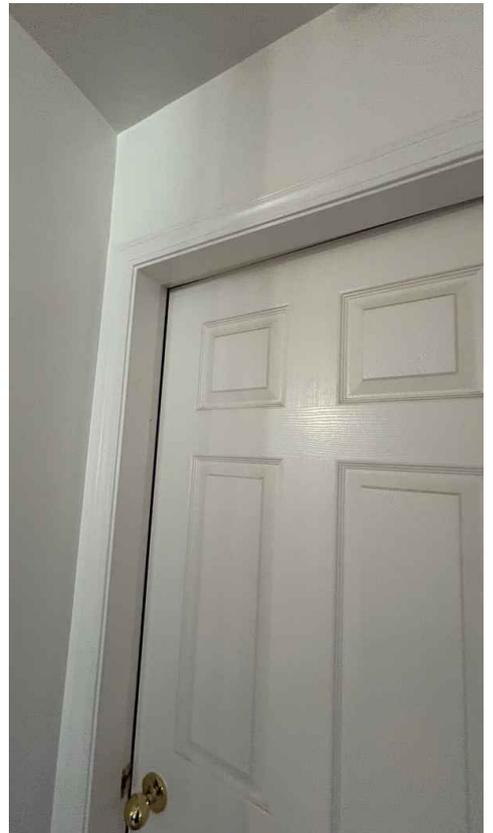
7.1.2 Doors

The spare bedroom door in the suite was out of alignment and could not be fully closed. Adjustment or rehanging of the door will be required to restore proper function.

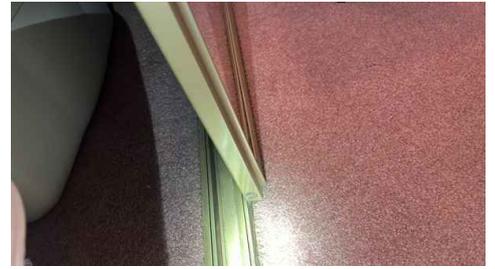
7.1.3 Doors

SUITE – PRIMARY BEDROOM CLOSET DOOR

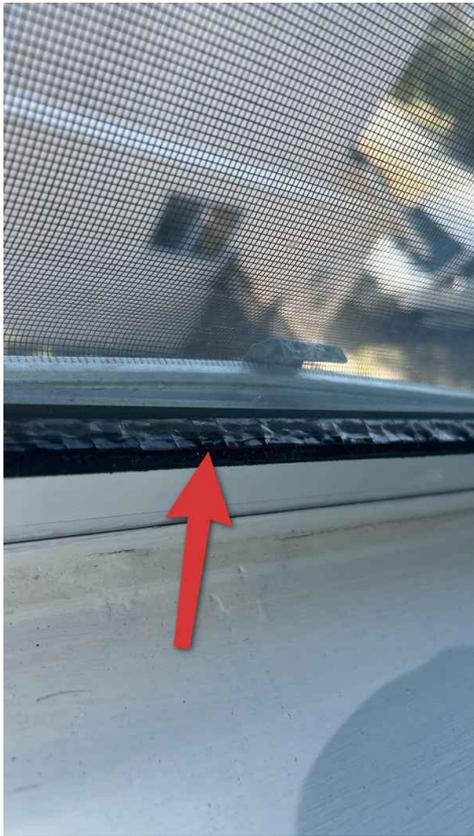
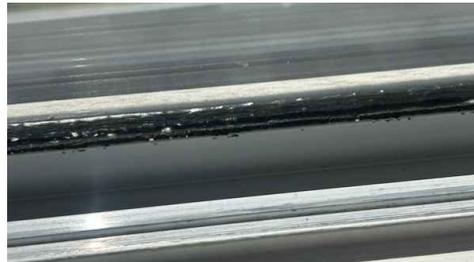
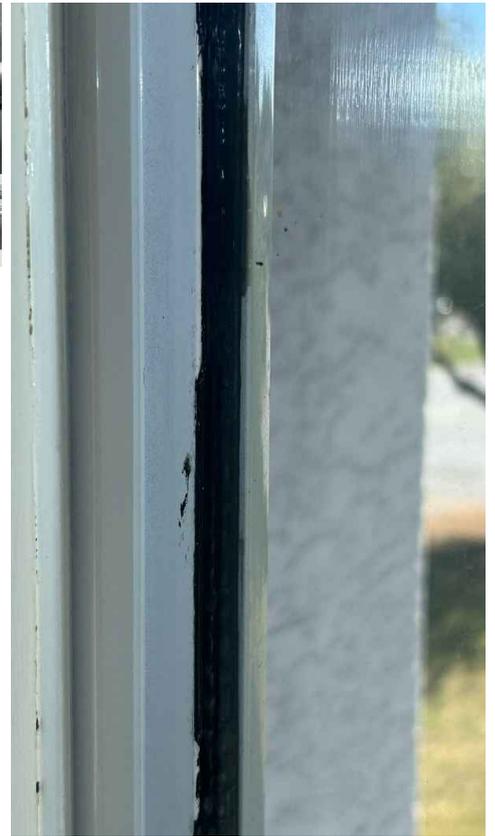
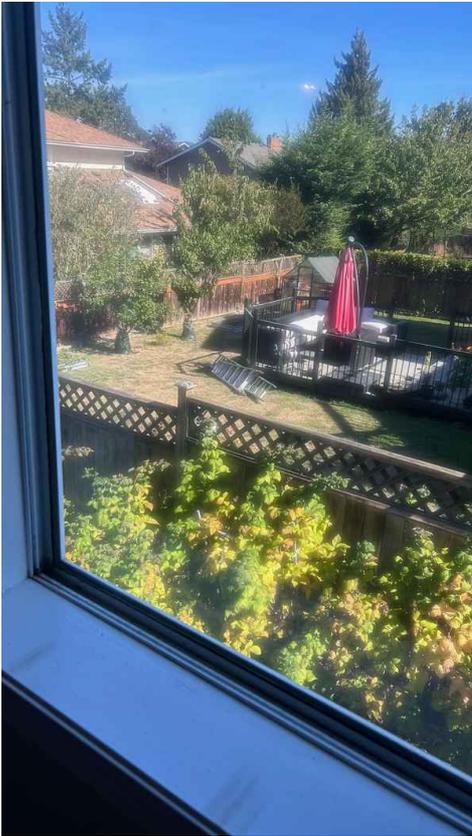
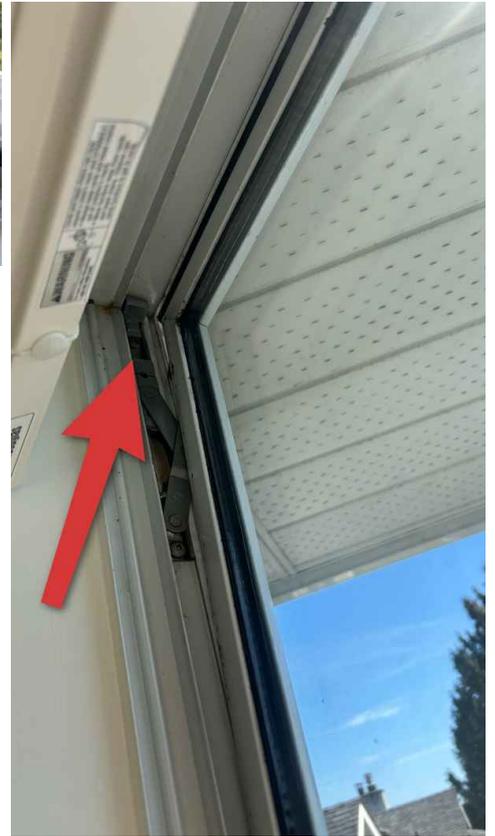
7.2.1 Windows

WINDOWS – ORIGINAL METAL-FRAMED UNITS

All of the home’s windows appeared to be original, approximately 35 years old, consisting of fixed, slider, and awning styles. While most were still functional, windows of this age are past their typical service life and will continue to lose functionality over time. Observations included spacer bar cracking, adhesive bleed at some panes, a few lost seals, and awning windows in the family room that were beginning to detach at their upper connections. Due to this, not all awning windows were tested to avoid damage. Although bedroom sliders still provide functional egress, full replacement of the windows should be anticipated within the first few years of ownership, both for reliability and energy efficiency. Replacement will be a significant expense.

Cracked, displaced spacer bar

Adhesive bleed

Lost seal

Adhesive seal

Frame coming off

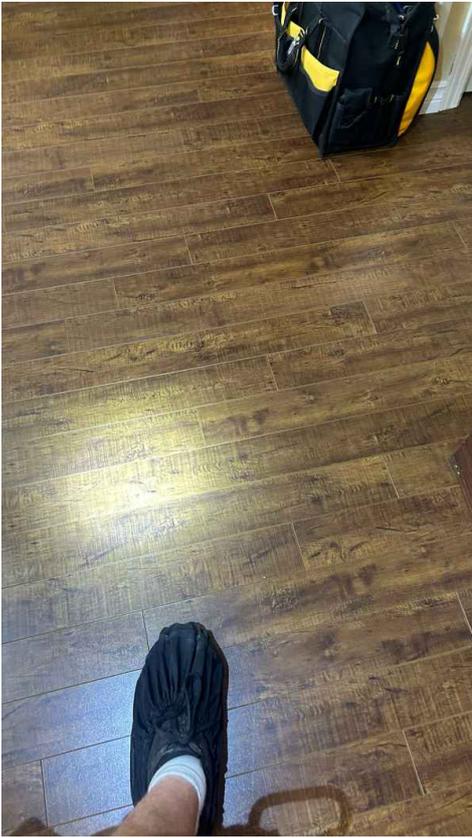
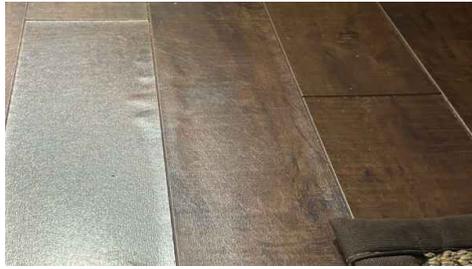
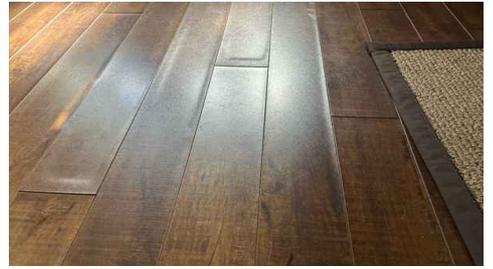
7.3.1 Floors

The laminate flooring showed areas of buckling and edge warping at some of the joints. In certain spots, the floor also had noticeable give or bounce, likely related to underlayment or installation rather than a structural concern. Minor displacement/deflection was felt underfoot, which is common with lower-quality laminate products or suboptimal installation. While the flooring remains serviceable, replacement or repair may be considered if the condition worsens or becomes bothersome.

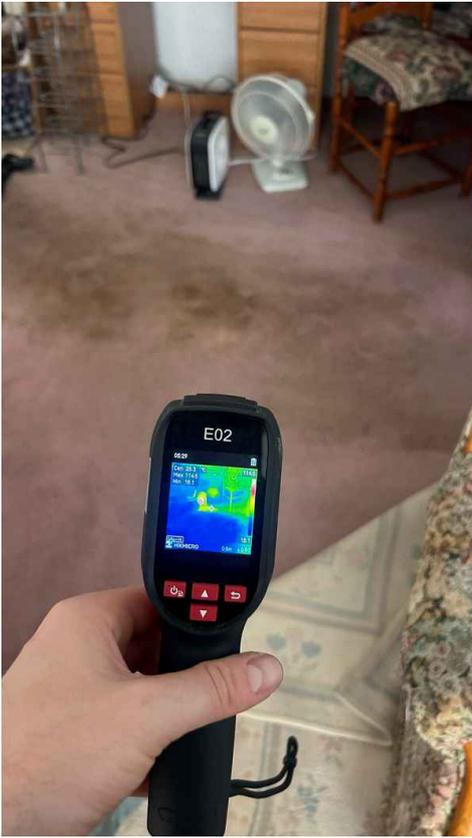
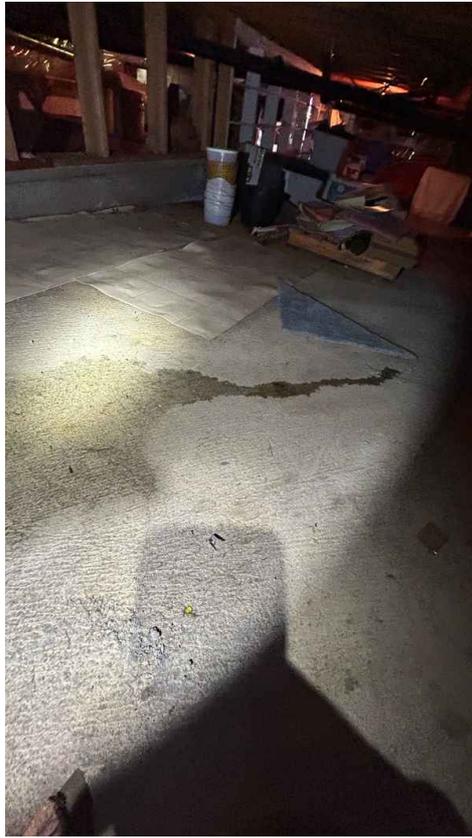
7.3.2 Floors

SUITE – RECENT FLOODING DISCLOSURE

It was disclosed that a flood occurred in the suite a few days prior to the inspection, reportedly from the laundry sink, though details were unclear. At the time of inspection, the main living area flooring was still wet, and signs of moisture were noted on the subfloor and in the crawlspace, likely from water migrating through the carpet. Clean-up efforts appeared to be underway, but further information should be obtained from the seller regarding the cause, extent, and remediation of the flood. Documentation of any repairs or drying measures should also be requested prior to subject removal.

Flooded carpet

Dripping into crawl
