WATCHTOWER HOME INSPECTIONS

RESIDENTIAL REPORT

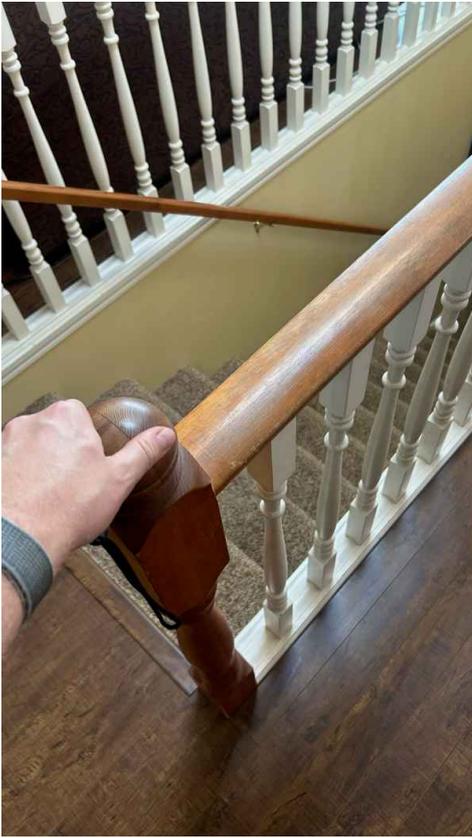
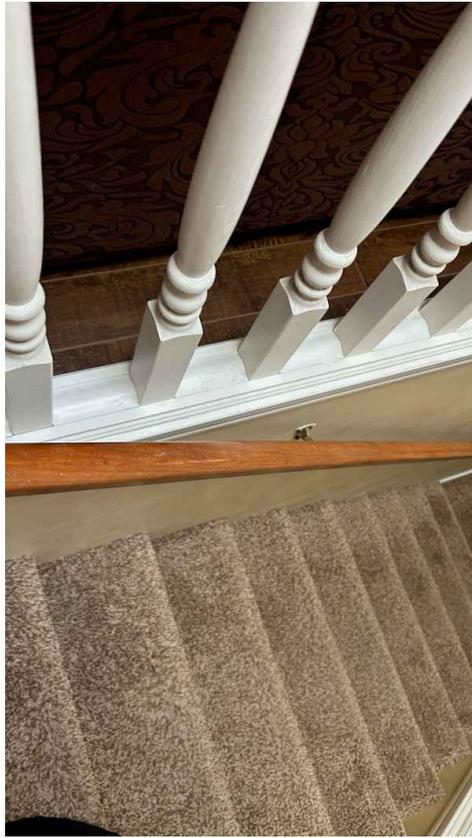
7.6.1 Steps, Stairways & Railings

STAIR RAILINGS – LOOSE BANISTER AND HANDRAIL

The guardrail along the dining room side of the stairs was very loose and unlikely to support significant weight if leaned on. In addition, the handrail on the same stairway was slightly loose in the middle section. The guardrail should be reinforced upon possession as a safety measure, and the handrail should be secured to ensure safe and reliable use.

Reinforce bannister

Slightly loose handrail

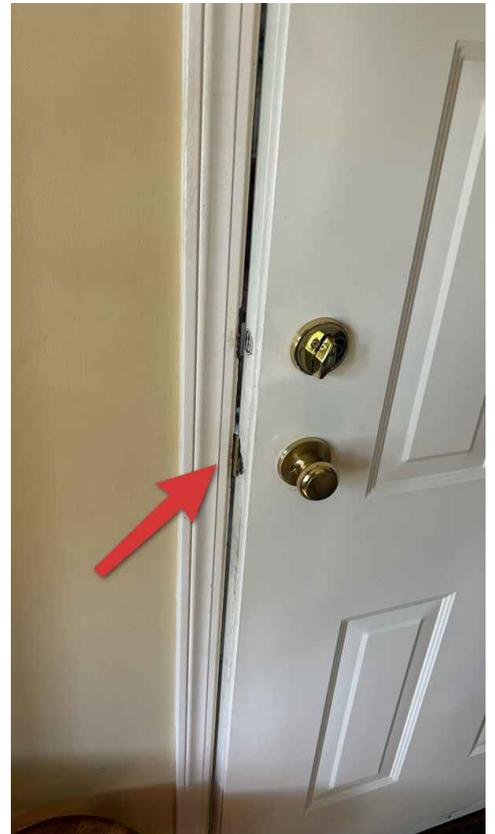
7.11.1 Garage

The man door between the garage and the home was equipped with self-closing hinges but was not closing fully due to the latch catch interfering. Adjustment of the latch or hinges is needed so the door closes as intended. Ensuring this door is self-closing is important to reduce the risk of products of combustion entering the living space.

Adjust latch

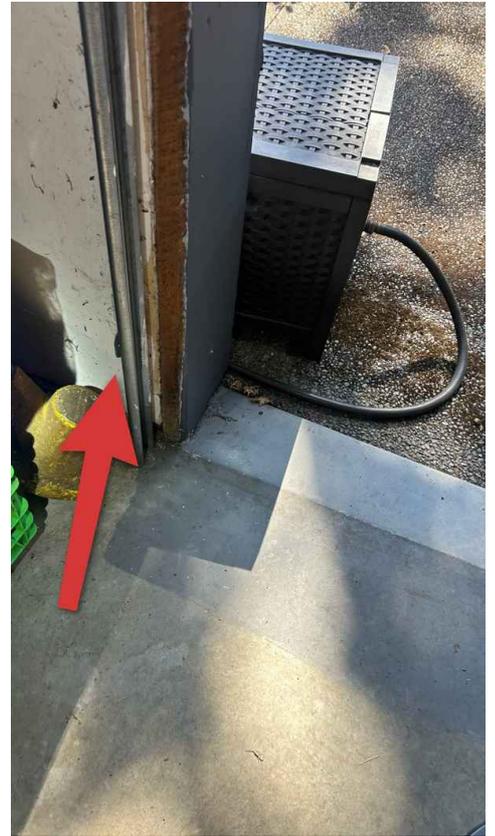
7.11.2 Garage

GARAGE DOORS – MISSING SAFETY SENSORS

Both garage doors were operational and constructed of wood. However, the right-hand door (when viewed from the front of the home) was missing photoelectric eye sensors. These sensors are an important safety feature that prevent the door from closing on a person, child, or object. Installing sensors immediately upon possession is recommended to bring the door up to modern safety standards.

Missing sensors

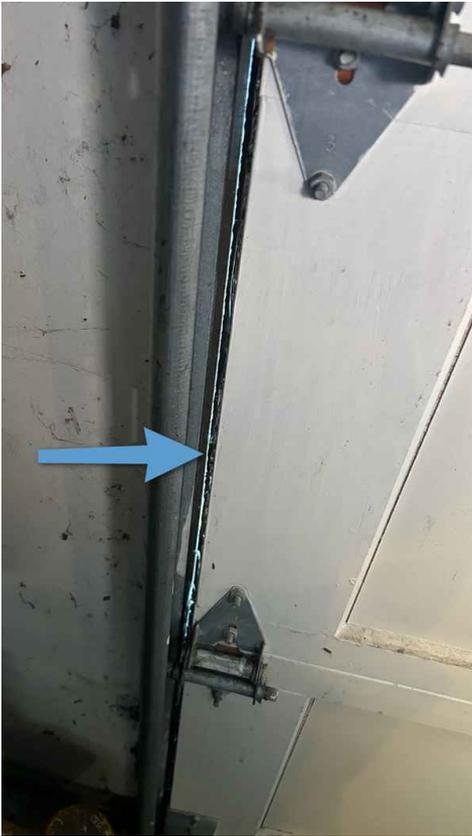
GARAGE DOORS – WEATHERSTRIPPING GAPS

Daylight was visible around the side weatherstripping of the garage doors. Adjusting or replacing the weatherstripping would improve energy efficiency and help keep out drafts, pests, and moisture.

Daylight

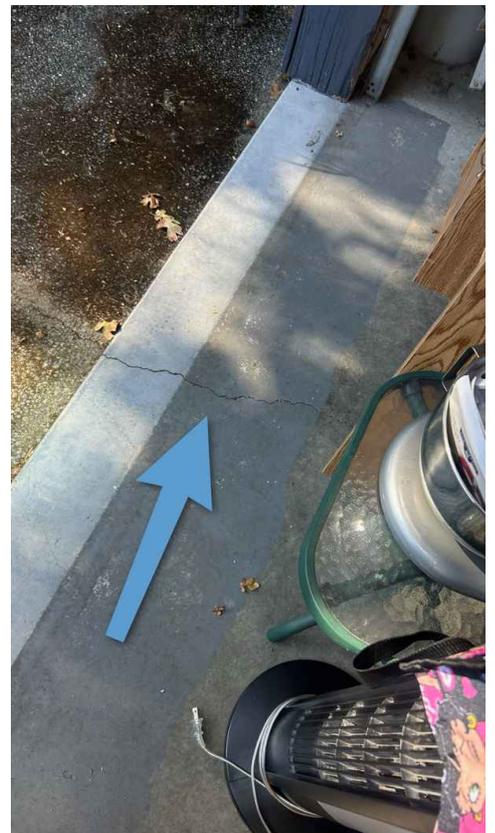
7.11.5 Garage

GARAGE - MINOR SLAB CRACKS

Small cracks was observed in the garage slab. This appears typical for concrete shrinkage and does not indicate structural concern. Sealing the crack can be considered to reduce the risk of moisture migration, but no immediate action is required.

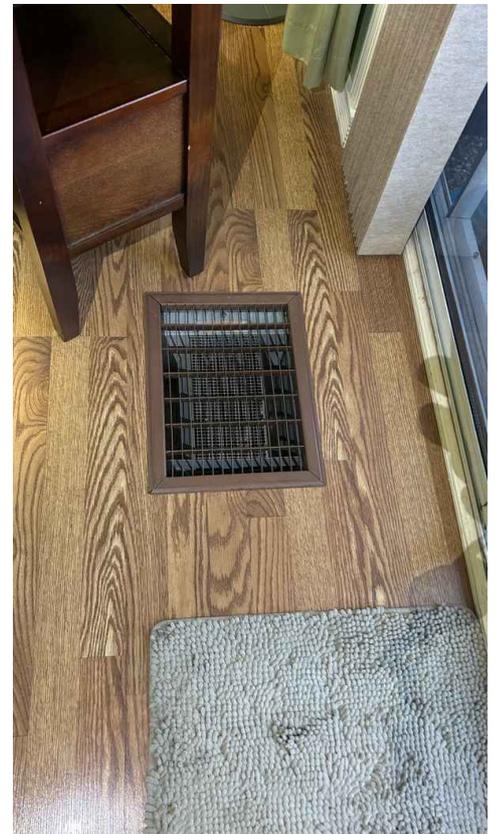
In the kitchen/TV room area, both a baseboard heater and a floor heater with a fan were present. The floor heater's fan produced a constant noise while operating, which may be bothersome. Since the baseboard heater in the same room is tied to the same heating zone, both units will run together, meaning the fan noise will be present whenever this area is heated. This is more of an annoyance than a defect, but it is something to be aware of during use.

Noisy

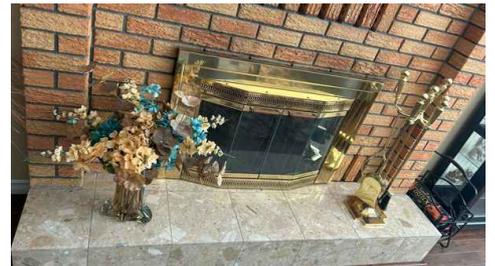
FIREPLACES – WETT INSPECTIONS REQUIRED (WOOD ENERGY TECHNOLOGY TRANSFER)

Both wood-burning fireplaces, one in the suite and one in the main home, will require WETT inspections prior to use, as this is typically an insurance requirement. These inspections confirm the safety and condition of the fireplaces and should be completed before operation.

Wett Inspection

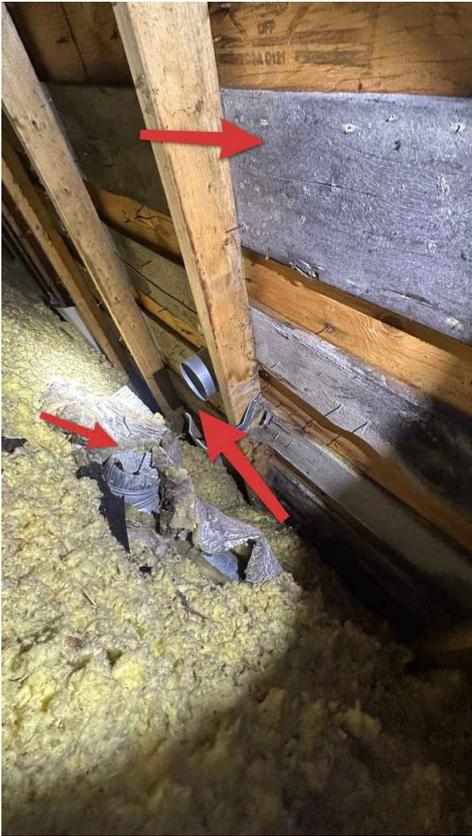
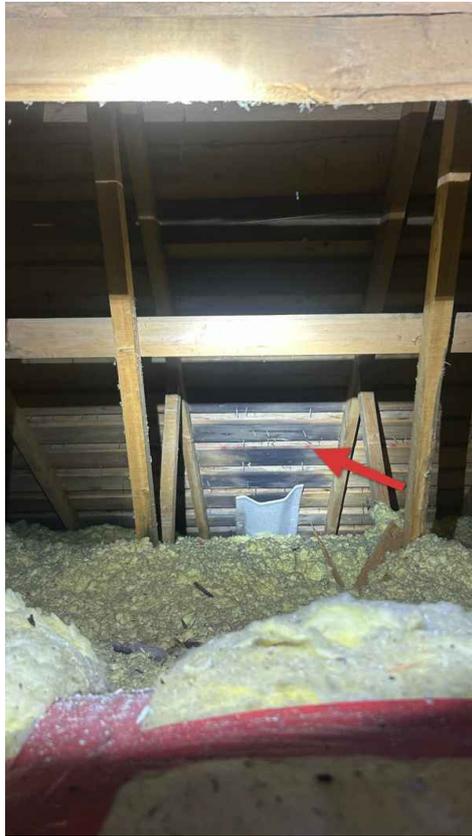
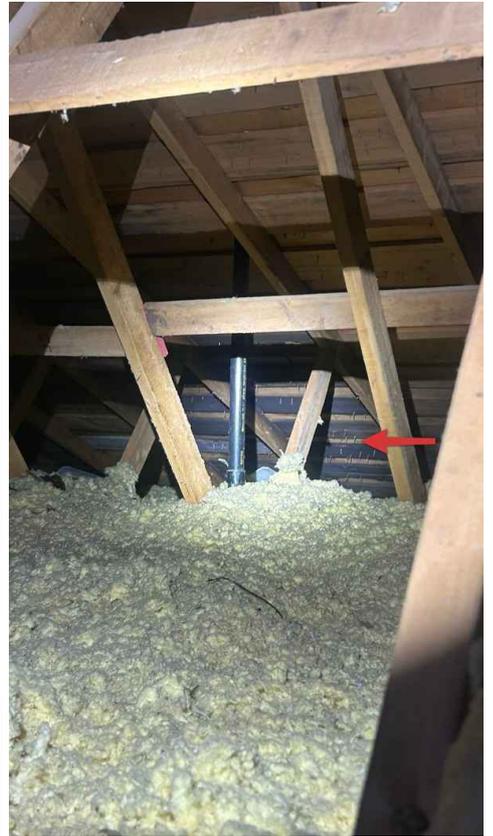
ATTIC – DETACHED VENT AND STAINING

The attic was insulated with loose-fill fiberglass. A bathroom fan vent had become detached, discharging humid air directly into the attic, which can contribute to moisture-related issues. Moderate staining was observed on the roof sheathing in multiple areas, particularly near the detached vent, suggesting past or ongoing ventilation concerns. The detached vent should be reconnected and insulated, and a ventilation specialist should evaluate the attic to confirm whether additional improvements are needed. Cleaning or treating the stained sheathing can also be considered after repairs are made.

Detached vent, Staining

Attic staining

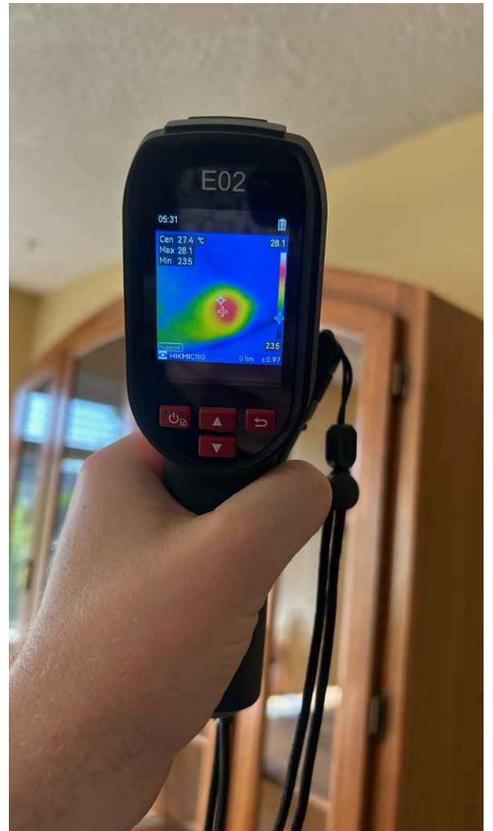
10.2.1 Vapor Retarders and Insulation

Thermal imaging revealed a few minor anomalies throughout the home, which are likely the result of small voids or inconsistencies in the attic insulation. These appeared limited and did not indicate widespread issues. The areas can be investigated further during any future attic work, but no immediate action is required.

Thermal anomaly \

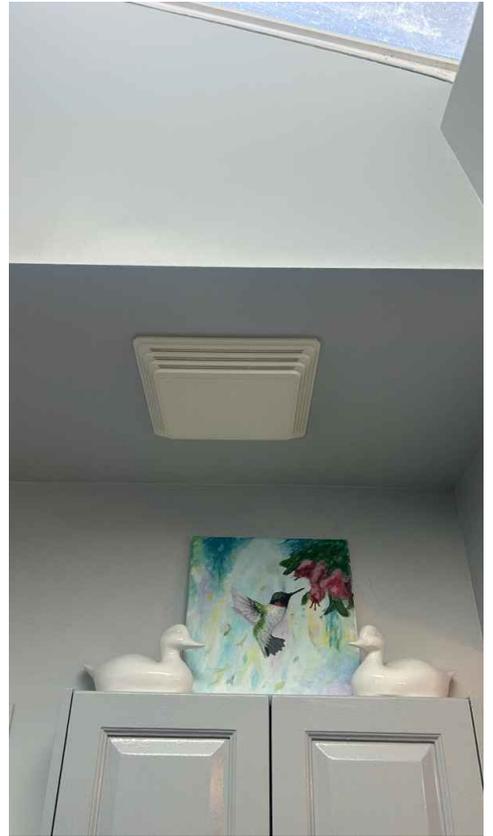
10.4.1 Mechanical Exhaust Systems

BATHROOM FAN – PRIMARY ENSUITE

The primary ensuite bathroom fan was operational but produced an unusually loud noise during use. This may indicate wear in the motor or loose components. Replacement or servicing may be required in the near future to restore quiet and efficient operation.

Noisey fan
