WATCHTOWER HOME INSPECTIONS

RESIDENTIAL REPORT

1: INSPECTION DETAILS

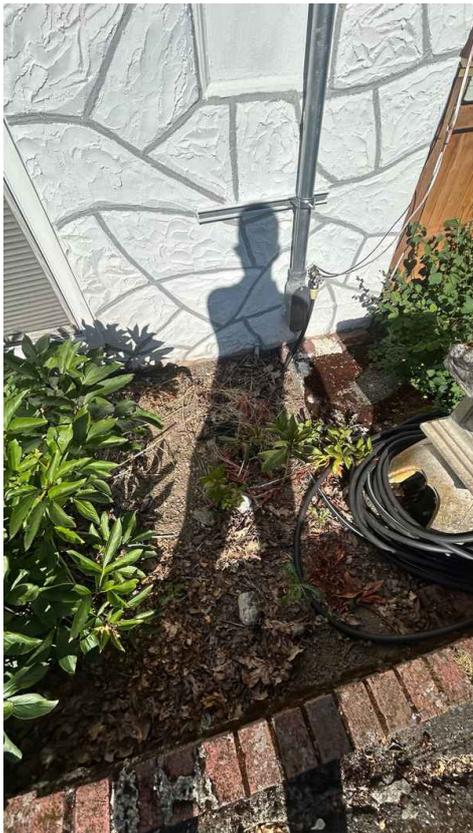
SIDING TOO CLOSE TO GRADE AT FRONT OF HOME

At the front of the home, the siding was noted to be too close to grade due to garden beds and planter boxes placed against the house, with some contact observed against the stucco. This condition can degrade the stucco and promote moisture-related issues. It is recommended to remove the garden beds and maintain a clearance of 6 to 8 inches around the foundation to help protect the exterior finishes upon possession.

Siding too close to grade

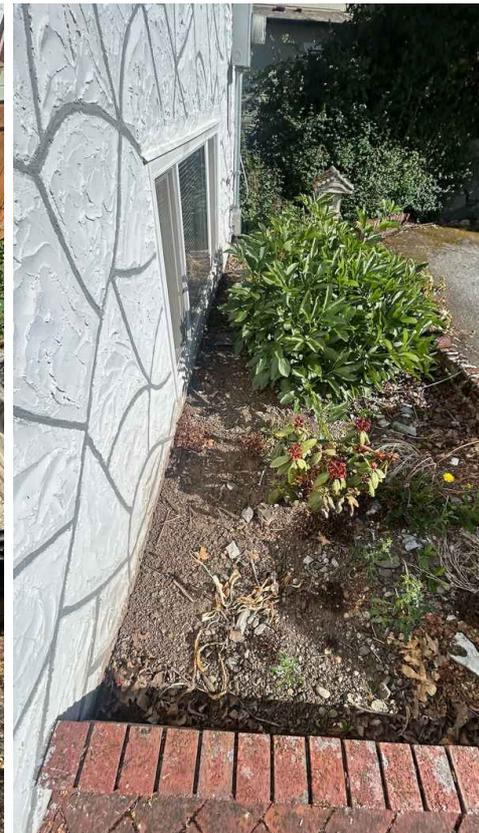
Remove garden beds

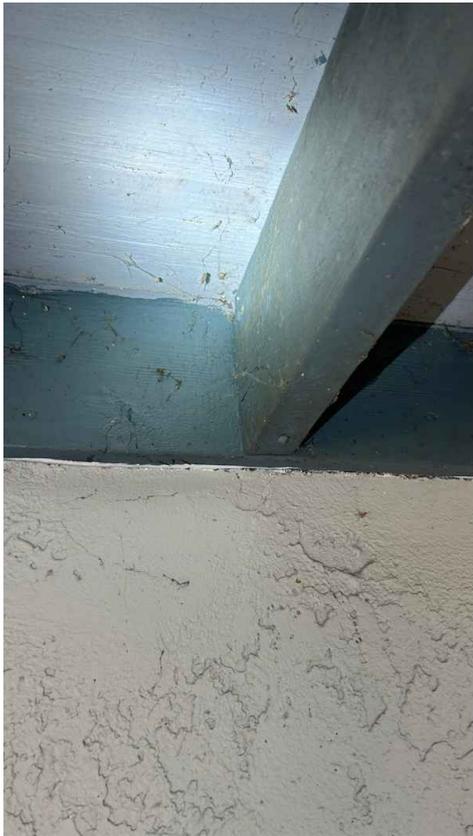
DECK STRUCTURAL DEFICIENCIES

The deck appeared generally solid but showed multiple construction deficiencies. Many of the joists were not properly supported with joist hangers at the ledger board, relying instead on nails, and only some joists were hung correctly. The ledger board was fastened to the house using nails rather than lag bolts, reducing its secure attachment. The deck displayed a notable lean, and the supporting beam was visibly twisted. At one point, two beam segments were joined with a visible gap allowing daylight through, lacking proper metal connectors or splice plates, and additional fasteners were used in an inadequate attempt to tie them together. The posts beneath the deck were misaligned, further compromising structural stability. Additionally, the stairs lack a handrail on the left side, and had non uniform steps, presenting a fall hazard. The roof over the deck is constructed with greenhouse-type material, which may not support a full snow load. These conditions present significant safety and structural concerns. It is recommended to have a specialized contractor evaluate the entire deck structure, provide necessary bracing or repairs, and consider full rebuilding if needed, prior to subject removal.

Missing joist hanger and lag bolts

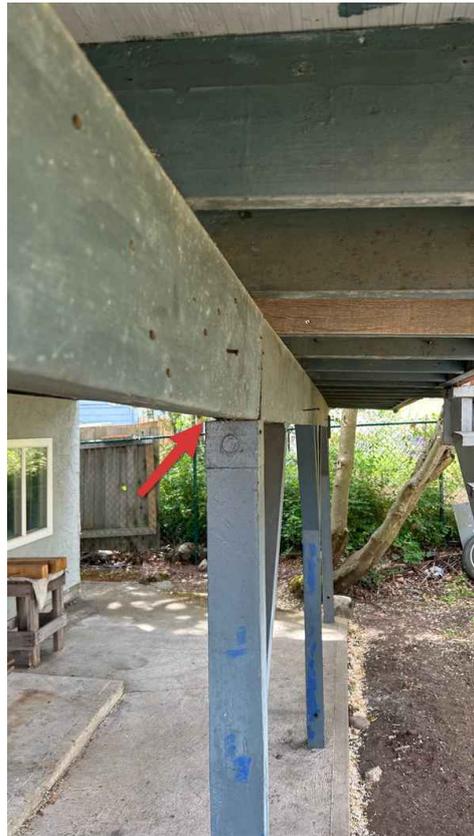
Twisting beam, not sitting on post fully

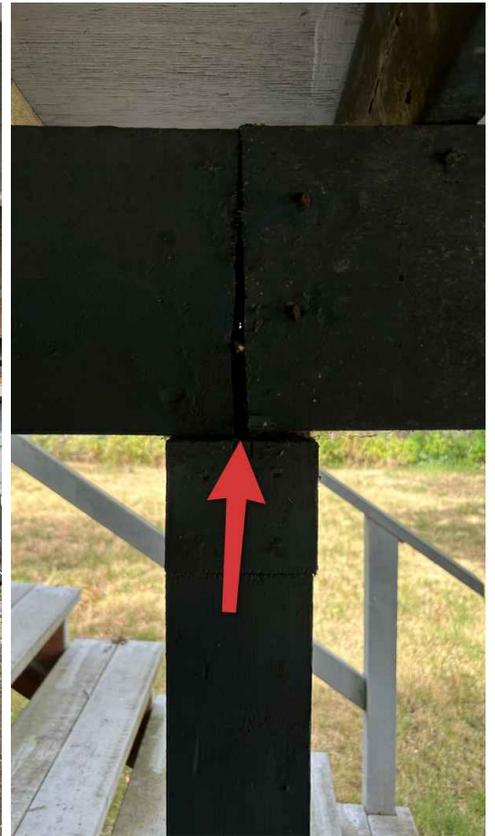
Visible daylight through beam members. Not joined correctly

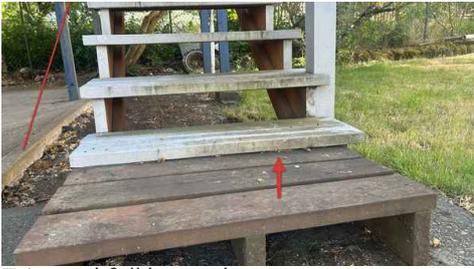
Trip and fall hazards

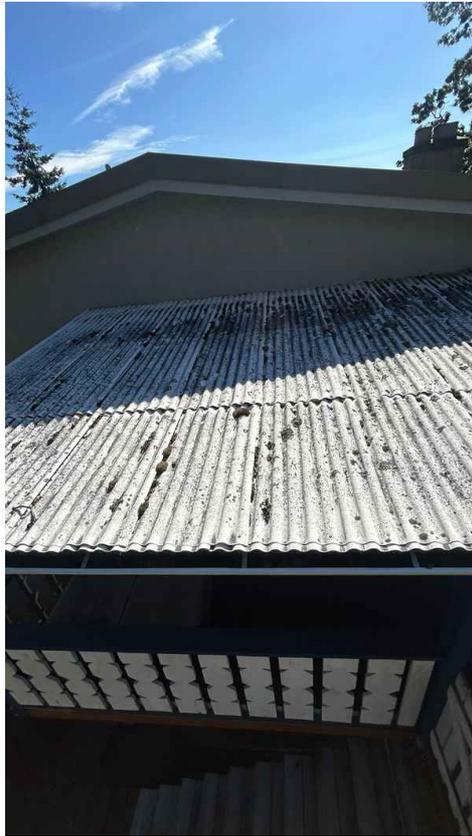
Roof may not handle heavy snow load

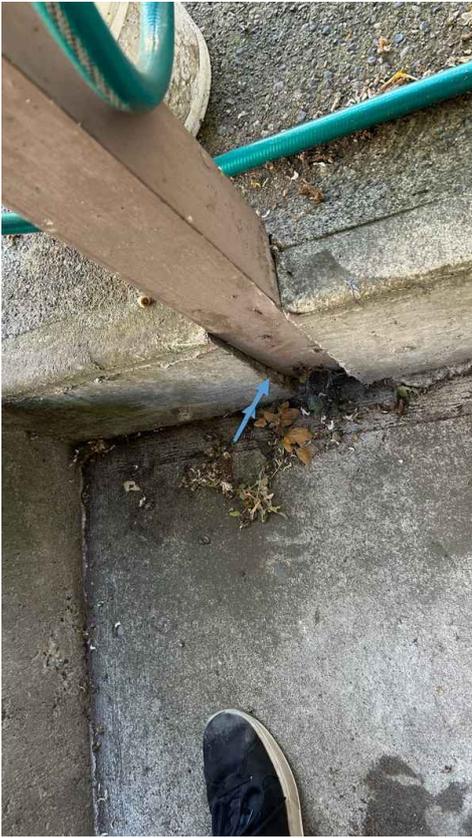
ROTTING NON-STRUCTURAL DECK MEMBER

A deck member supporting the coiled hose was found to be moveable by hand and showed significant rot at its end. This member does not appear to provide structural support to the deck. It is recommended to replace or remove this rotted piece upon possession to prevent further deterioration and maintain general site safety.

Post moveable by hand

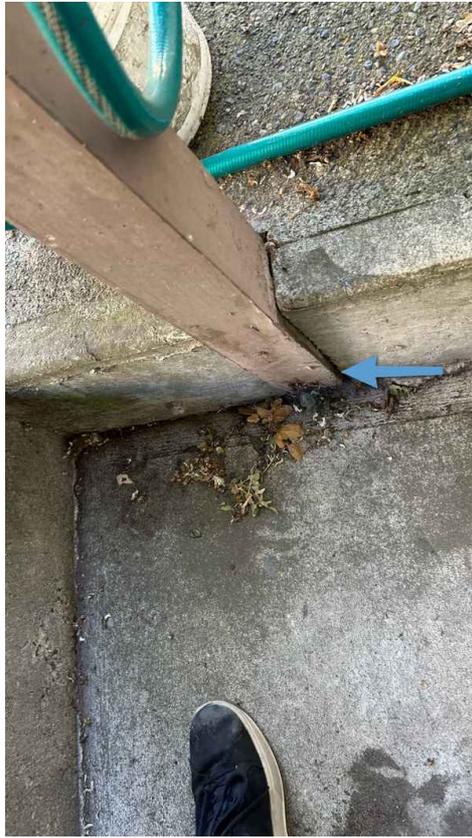
Rotting end

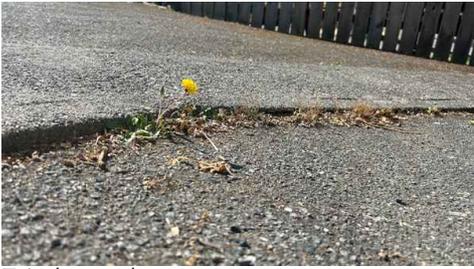
TRIP AND FALL HAZARDS AROUND PROPERTY

Various trip and fall hazards were observed throughout the property, including uneven footing, rocks at the front of the driveway that could pose a fall risk to children, and deck steps lacking a hand or guard rail on the left side. Additionally, a concrete platform beneath the deck protrudes awkwardly, creating another potential trip hazard, and other areas of uneven concrete pours further contribute to unlevel footing. These conditions present safety concerns for occupants and visitors. It is recommended to consult a qualified contractor to address these hazards and improve overall site safety upon possession.

Trip hazard

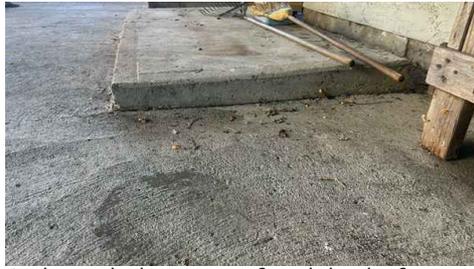
Awkward placement for slab platform

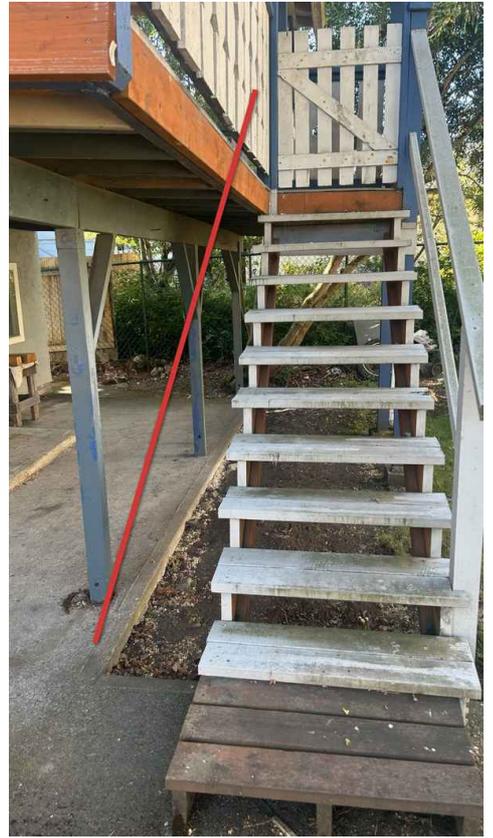
Deck stairs fall hazard

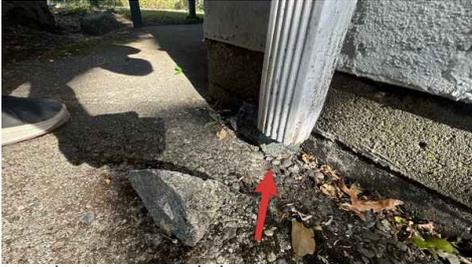
PERIMETER DRAINAGE AND SITE GRADING CONCERNS

The concrete perimeter drainage material used at this property is prone to collapsing or degrading over time. Additionally, areas of the grading on the right side of the house slope toward the foundation, which may contribute to drainage issues. The downspout at the rear left side of the property currently discharges too close to the home and should be extended further away, as it does not connect to a drain. The downspout at the back right side is discharging above the drain rather than directly into it, and the existing screen may obstruct flow. These conditions can increase the risk of moisture intrusion at the foundation. It is recommended to engage a specialized drainage contractor to scope and assess the perimeter drainage system, adjust downspout terminations, and improve grading as needed prior to subject removal.

No drain, extend downspout

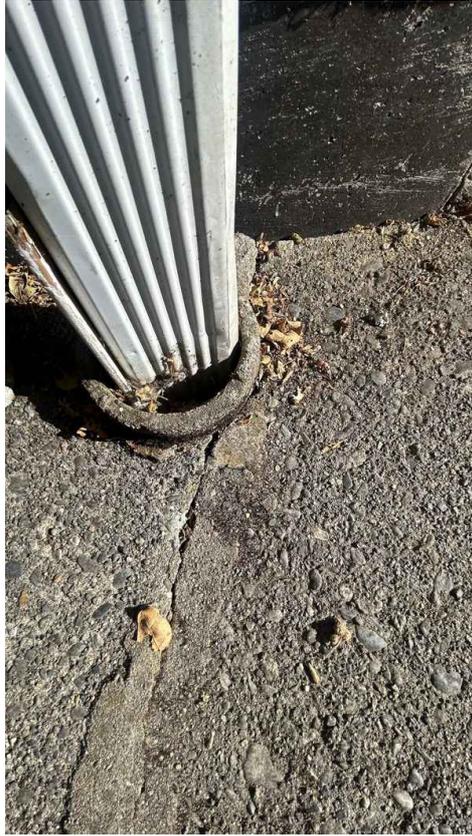
Concrete permitter drain material

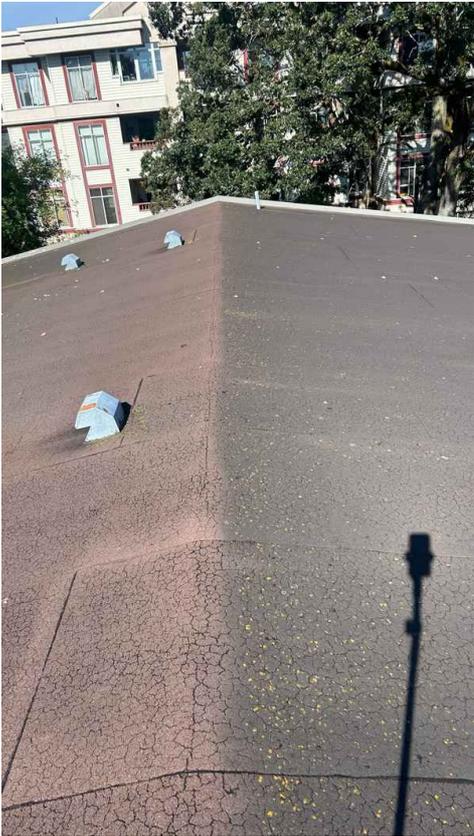
MODIFIED BITUMEN ROOF- MID TO LATE STAGES OF SERVICE LIFE

The modified bitumen roof appears to be in the mid to late stages of its service life, with typical alligator cracking and some blistering noted. Despite these signs of aging, the roof currently appears to be in serviceable condition. There is notable moss build-up due to the presence of trees above and around the roof, which can accelerate deterioration. Regular maintenance is essential at this stage, including keeping the roof clear of debris and moss. It would also be beneficial to trim or clear surrounding trees to reduce debris accumulation. A well-maintained modified bitumen roof can last 25 years or longer. These maintenance steps are recommended upon possession to help preserve the roof's remaining lifespan.

Moderate alligator cracking

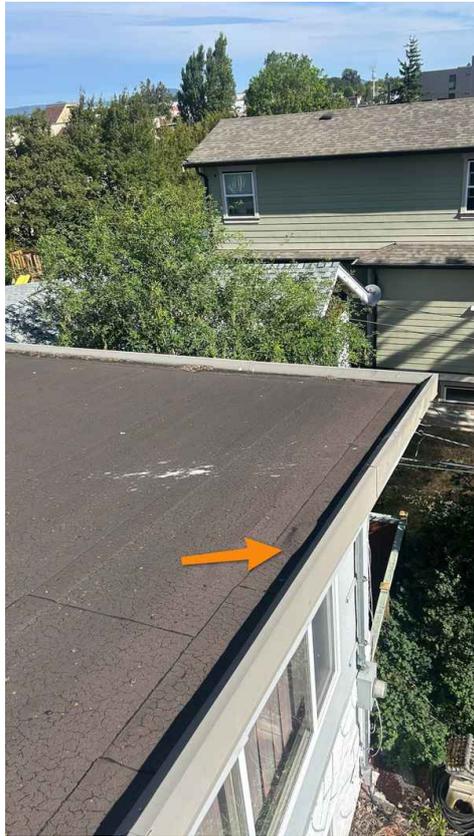
Small blister noted

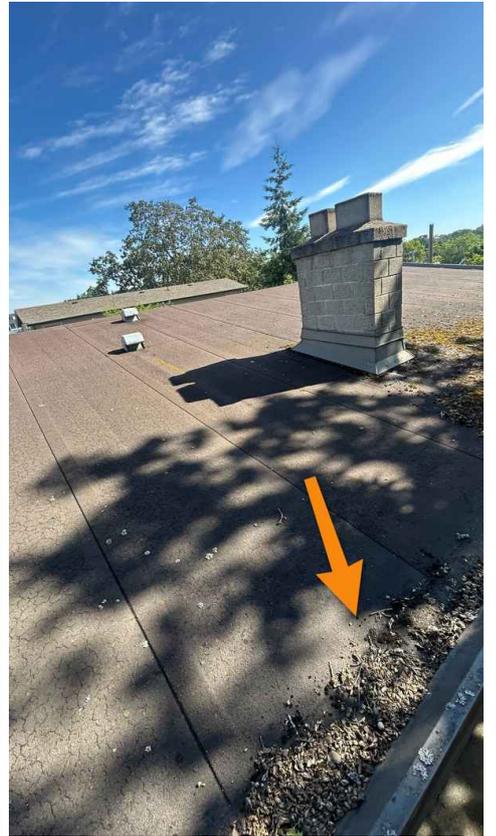
Debris

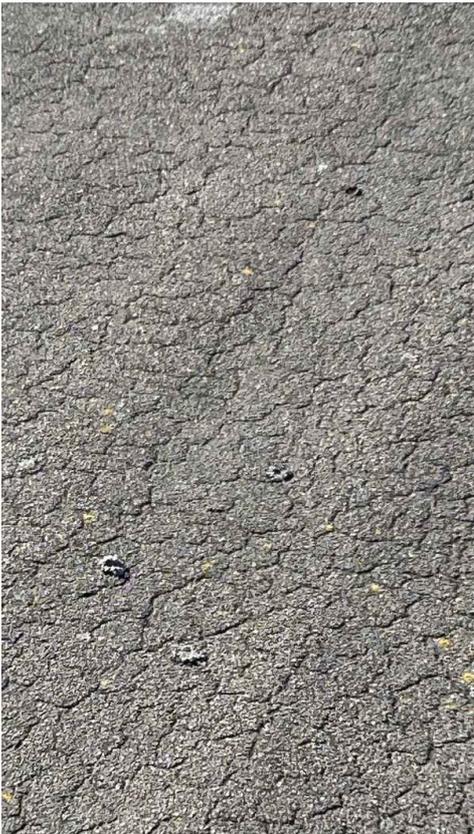
Cracking

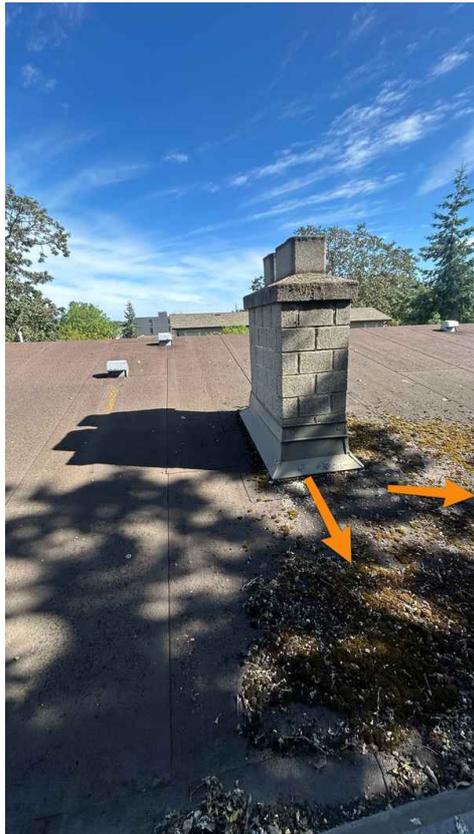
Moss build up

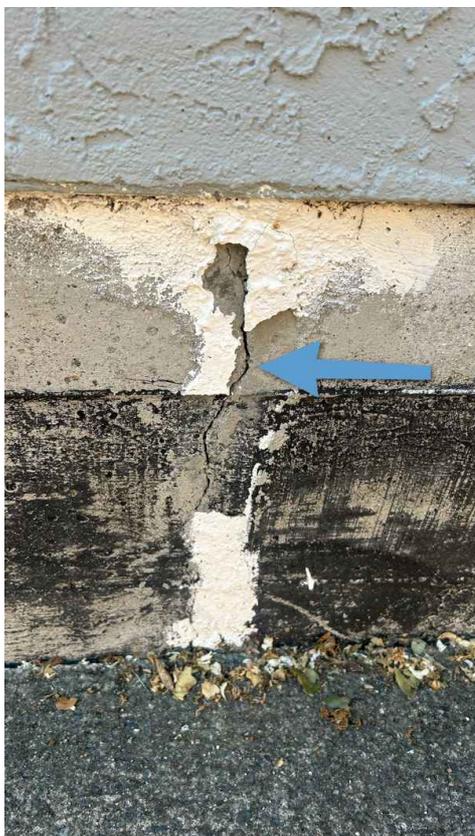
MINOR FOUNDATION DAMAGE AT RIGHT SIDE

A small chip in the concrete and a very minor foundation crack were observed on the right side of the foundation exterior. While these conditions appear limited at this time, they can allow moisture entry or progress further if not addressed. It is recommended to monitor the area and seal the crack upon possession.

Foundation Crack

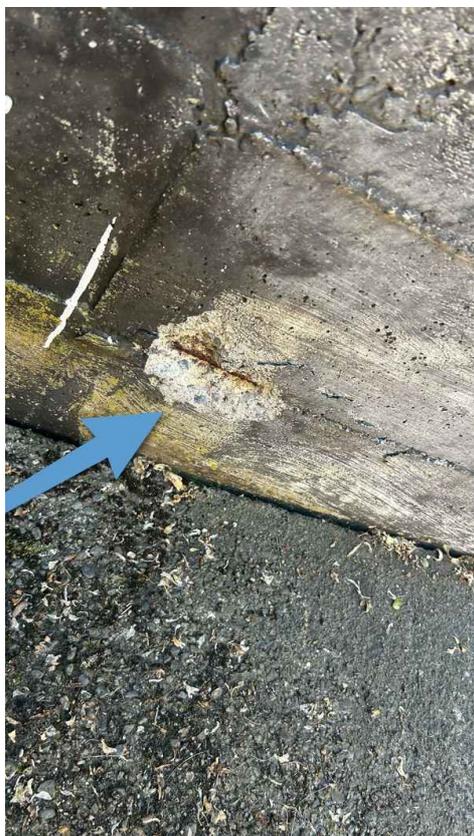
Chipped foundation

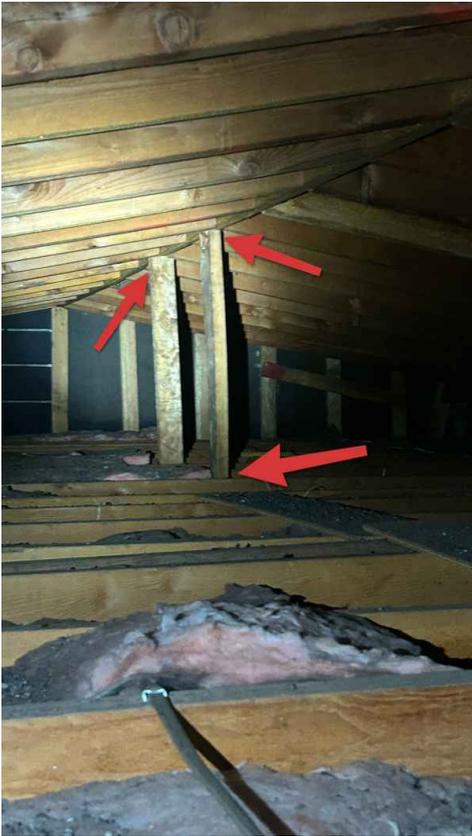
ATTIC STRUCTURAL MEMBER CONCERNS

In the attic, one of the beam members supporting the rafters was noted to be notched in the middle of a span, and a support member showed slight bowing. Additionally, a vertical support appeared to be simply resting on a ceiling joist without clear attachment, which may reduce overall stability. While these conditions have existed for some time and reflect construction practices common when the home was built, improvements could help strengthen the structure. It is recommended to have a qualified contractor or structural engineer further assess and shore up the attic framing as needed upon possession to improve long-term stability and safety.

Improvised support members

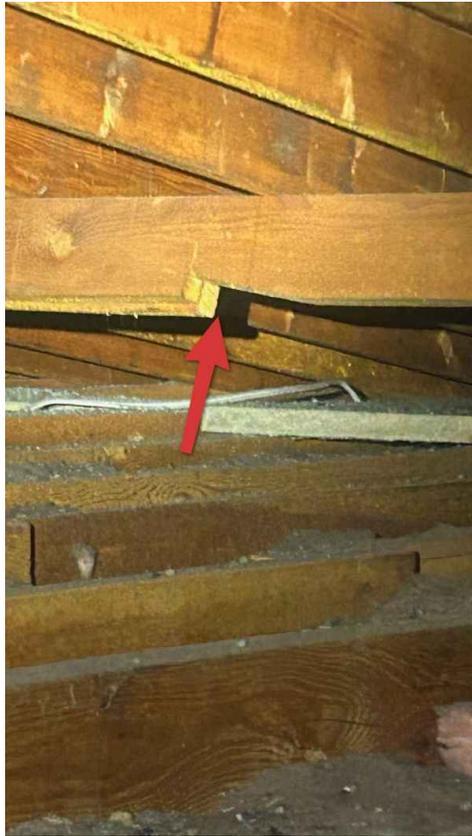
Notched support rafter member

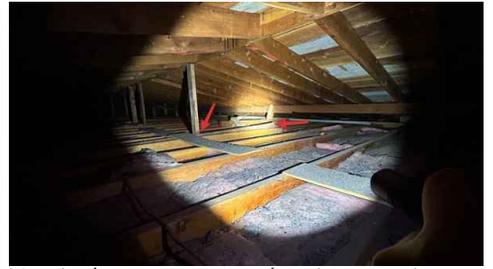
Vertical support member just resting on ceiling joist that is deflected

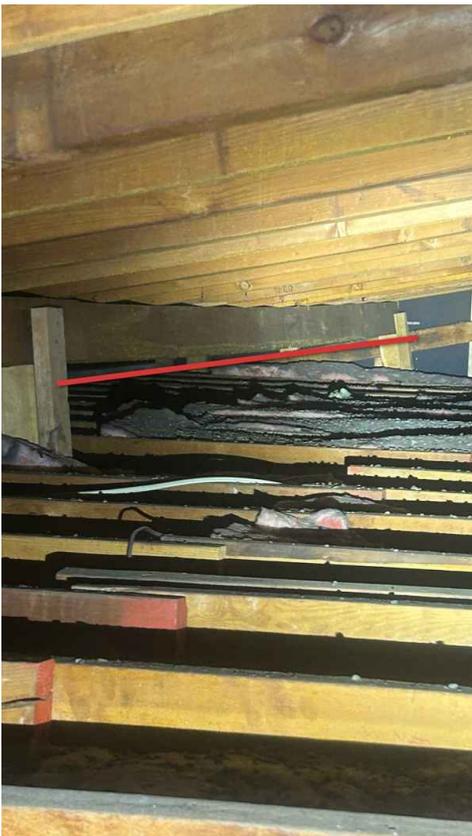
Slightly bowed rafter support member

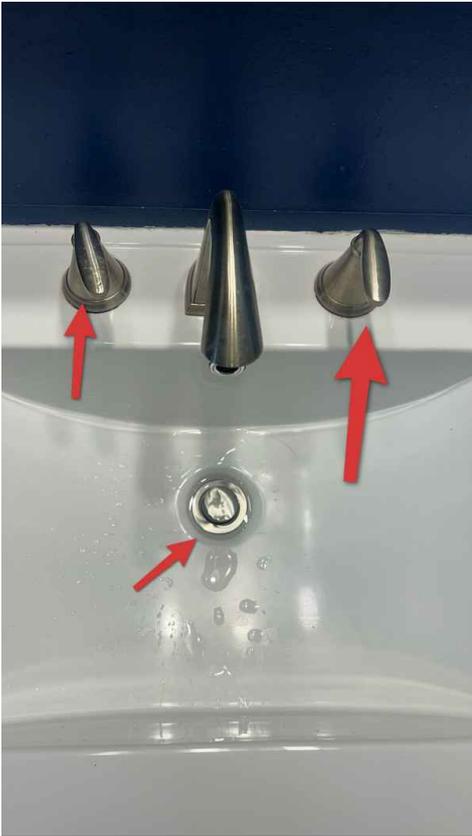
VARIOUS PLUMBING DEFICIENCIES

- -The faucet handles in the upstairs main bathroom were installed backwards.
- -An S-trap was found under the basin in the upstairs main bathroom, which can lead to siphoning and sewer gas entry.
- -The sink stoppers in the upstairs main bathroom were not usable.
- -The faucet handle controls in the kitchen were installed in an unusual manner.
- -In the upstairs powder room ensuite, the toilet leaked from the tank when flushed.
- -Plastic risers were used in the downstairs kitchen to connect copper piping to the fixture, which have a higher tendency to burst.
- -A plumbing vent stack in the basement terminated inside the living space next to the laundry sink, which can allow sewer gases to enter.

Faucet controls backwards

It is recommended to have a qualified plumber address these deficiencies, including correcting faucet installations, replacing the S-trap, repairing the toilet, replacing inappropriate risers, and properly extending the vent stack to the exterior, upon possession.

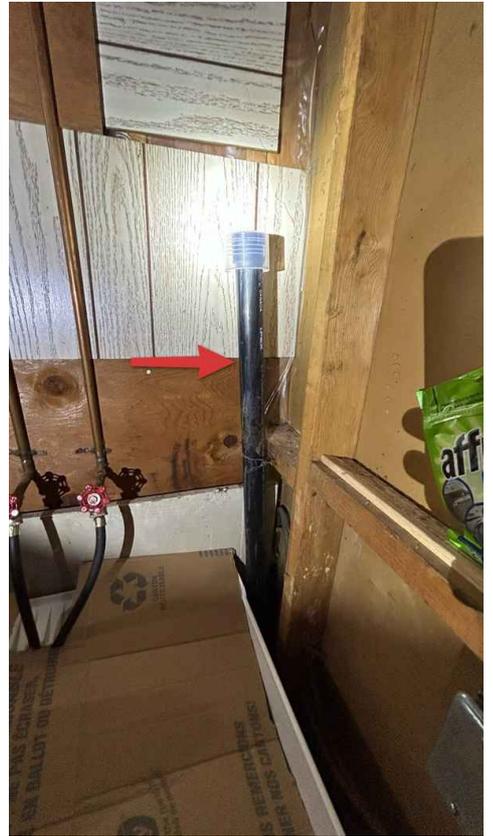
Interior vent stack

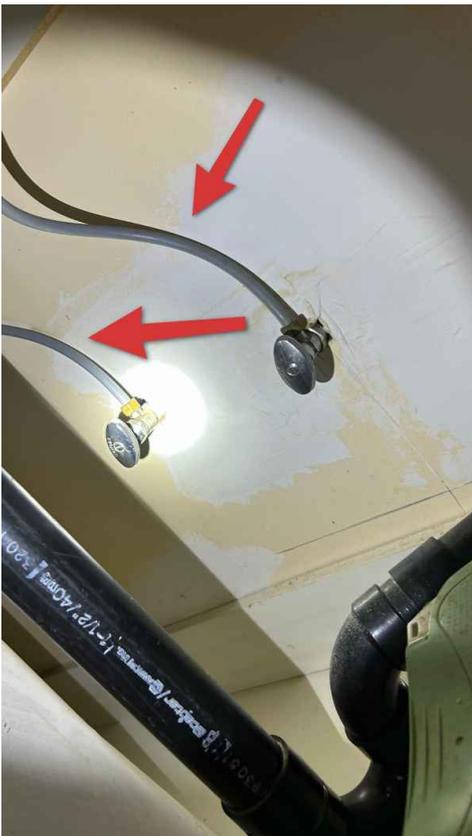
"plastic" hoses feeding sink

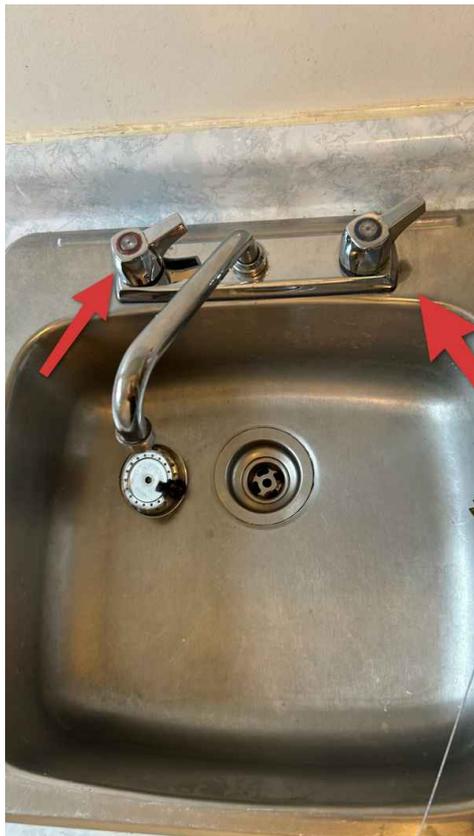
sink controls installed weird

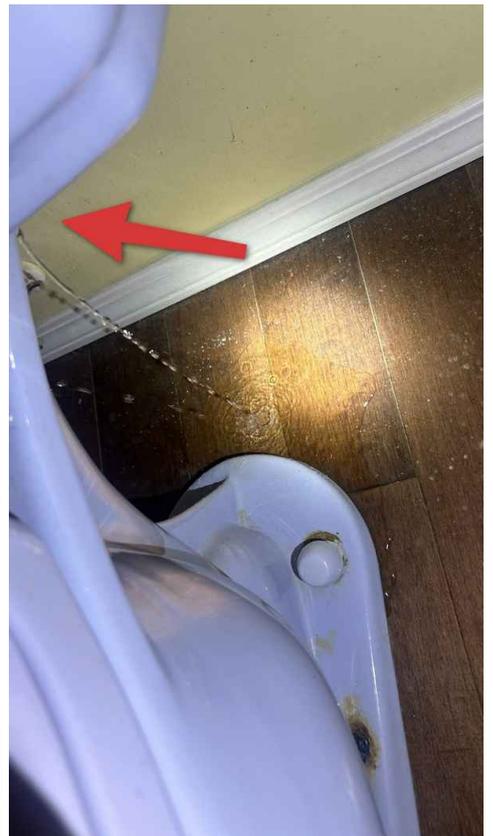
Leaking toilet tank

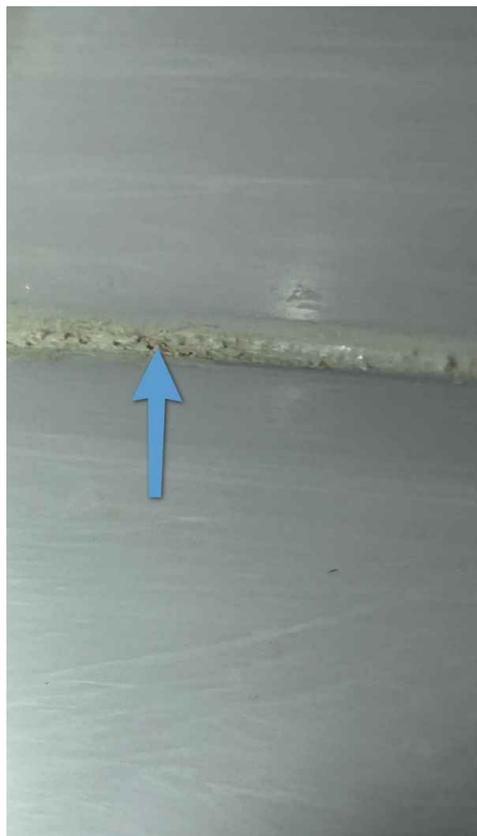
The caulking at both tubs, where the tub meets the tile and around any protrusions within the tub and shower enclosures, was noted to be in need of renewal. Deteriorated or missing caulking can allow water intrusion, leading to potential moisture damage behind finishes. It is recommended to re-caulk these areas upon possession to help maintain a watertight seal.

Recaulk

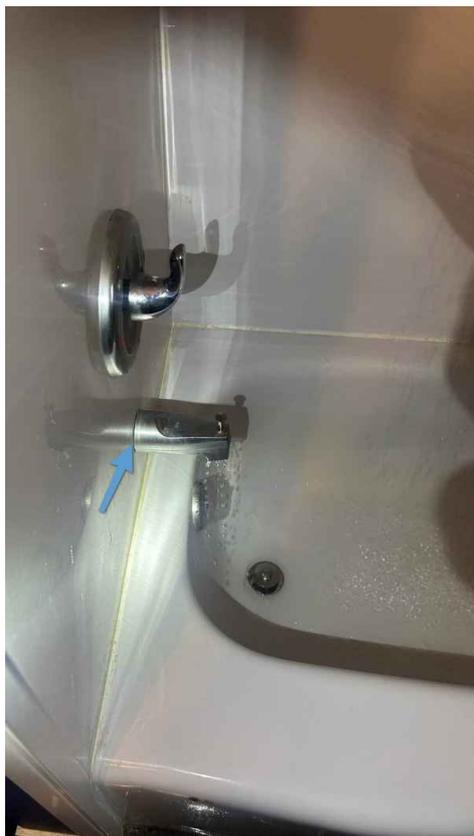
Seal protrusions

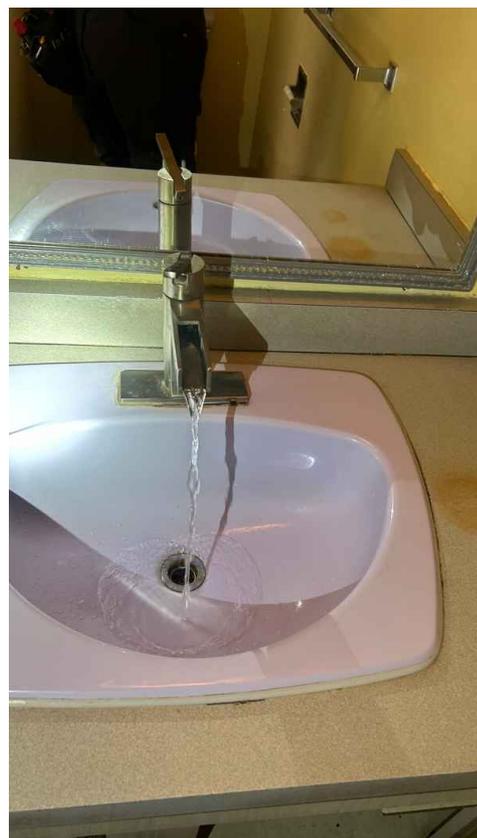
LOW WATER PRESSURE AT POWDER ROOM ENSUITE BASIN

Low water pressure was noted at the basin faucets in the powder room ensuite. This may be related to the fixture itself not supplying adequate aerated water. It is recommended to have a plumber or qualified contractor assess and service or replace the fixture as needed upon possession to restore proper flow.

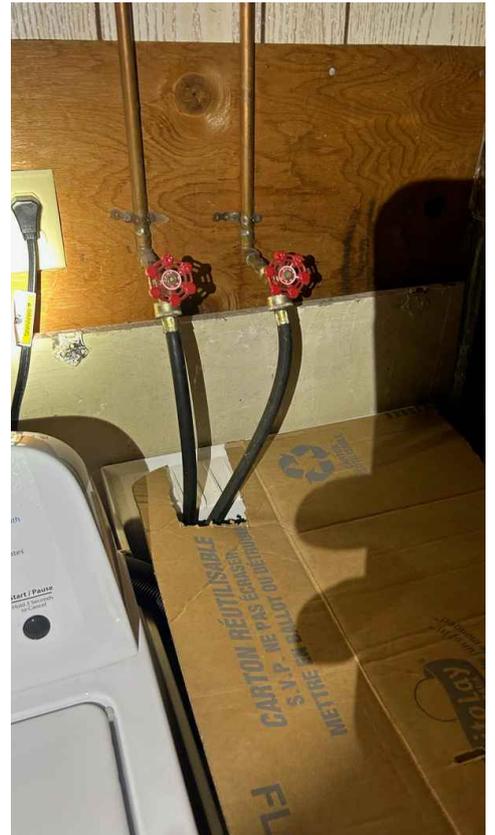
Marginal Defect**WASHER HOSE UPGRADE
RECOMMENDED**

The hoses supplying the washer and dryer are currently rubber or plastic. These types of hoses have a higher risk of bursting over time. It is recommended to upgrade to steel braided hoses upon possession to improve durability and reduce the risk of water damage.

Upgrade hoses to steel braided

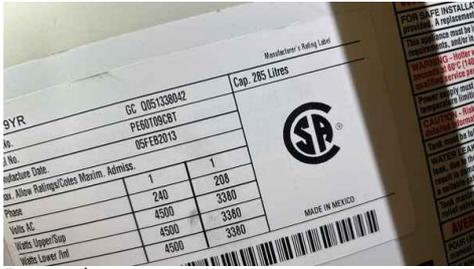
Significant Deficiency**HOT WATER TANK SAFETY AND REPLACEMENT CONCERNS**

The hot water tank was manufactured in 2013 and is now beyond its typical life expectancy, indicating it will need to be replaced soon. It is also missing seismic straps, an expansion tank, and a drip pan. Additionally, the T&P valve discharge tube does not extend to the floor, stopping partway and potentially posing a scalding risk. The cold water intake is connected at the bottom of the tank, which is an unusual configuration. It is recommended to plan for replacement of the hot water tank in the near term and ensure all safety features are properly installed at that time.

Data plate

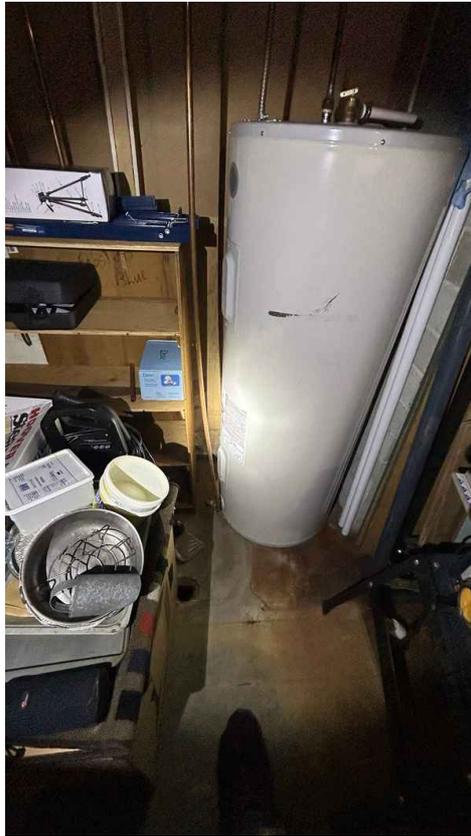
Missing safety features

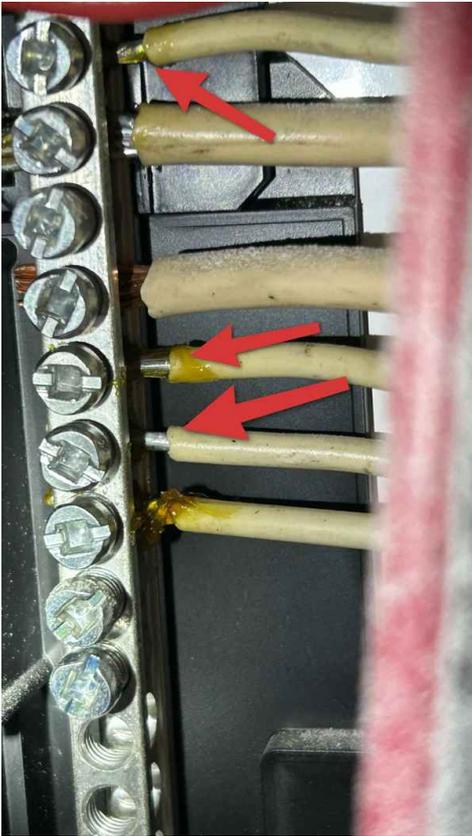
ALUMINUM WIRING AND PANEL CONCERNS

Several circuits in the electrical panel were noted to have single strand aluminum wiring. This can be a potential fire hazard and is an insurance concern. Many of the aluminum conductors were observed to have antioxidant paste applied at their connections, which is a positive measure. Some insurers may allow mitigation methods such as pigtail, where copper is connected to aluminum at terminations. It is strongly recommended to confirm insurability directly with your provider before subject removal. Additionally, a double tap was observed in the panel and some open splices, which should be corrected by a qualified electrician upon possession. The panel itself is a newer 200-amp panel, and it appears the service was upgraded, as older exterior conduit is still visible.

Aluminium wiring

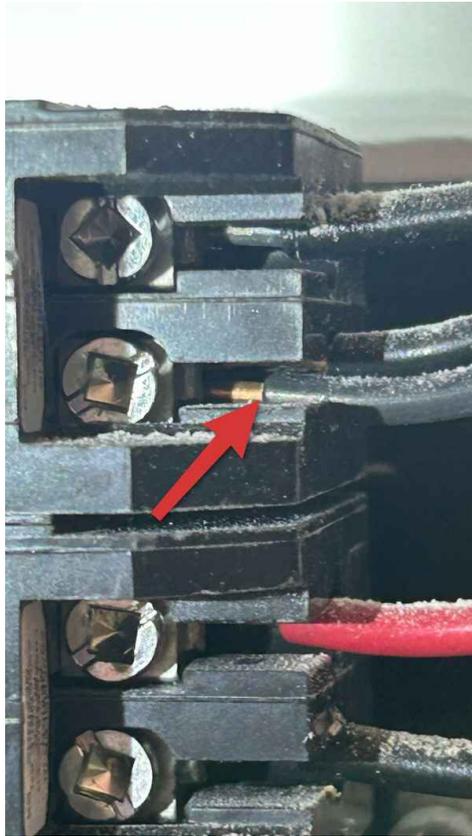
Double tap

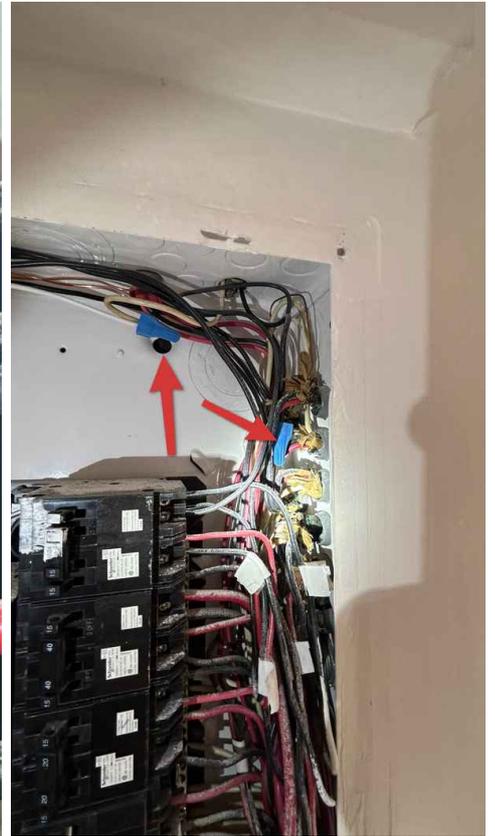
Open splices

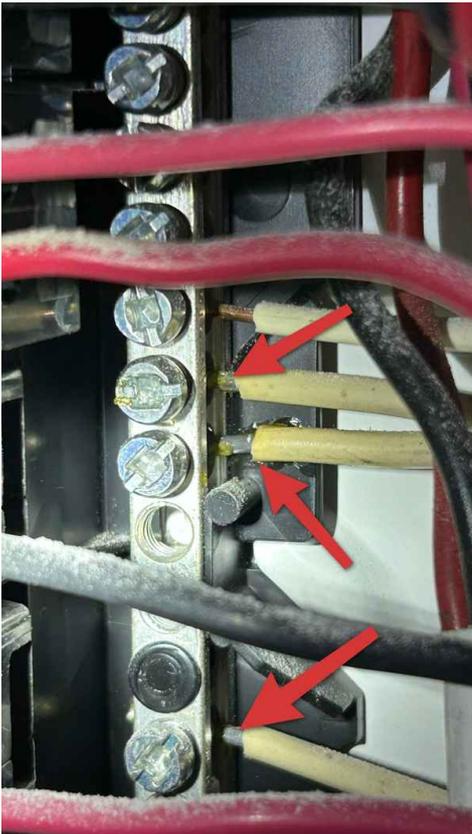
Aluminium wiring

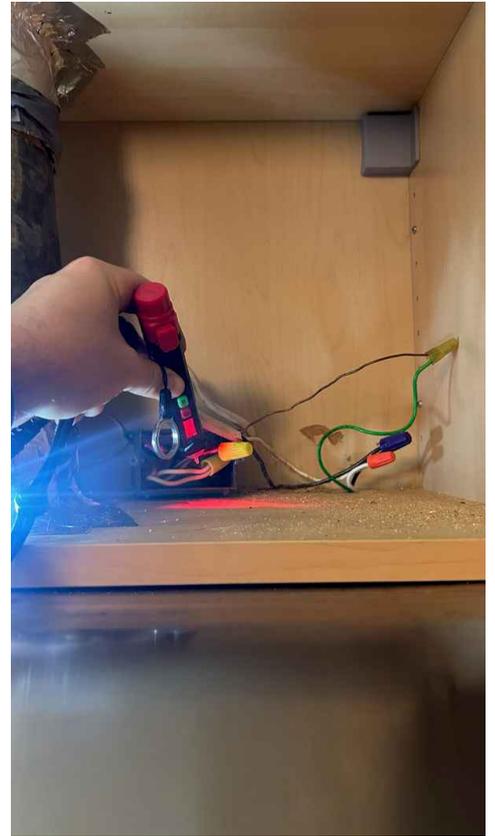
OPEN ELECTRICAL CONNECTIONS AND JUNCTION BOX CONCERNS

In the compartment above the stove at the fan housing, an open junction box with several exposed conductors was observed, and these conductors tested live. Additionally, multiple open connections and splices were noted in other areas, including the basement and above the panel ceiling. Exposed and improperly enclosed electrical connections present a significant shock and fire hazard. It is recommended to have a qualified electrician properly enclose and secure all open connections and junction boxes prior to subject removal.

Live conductors

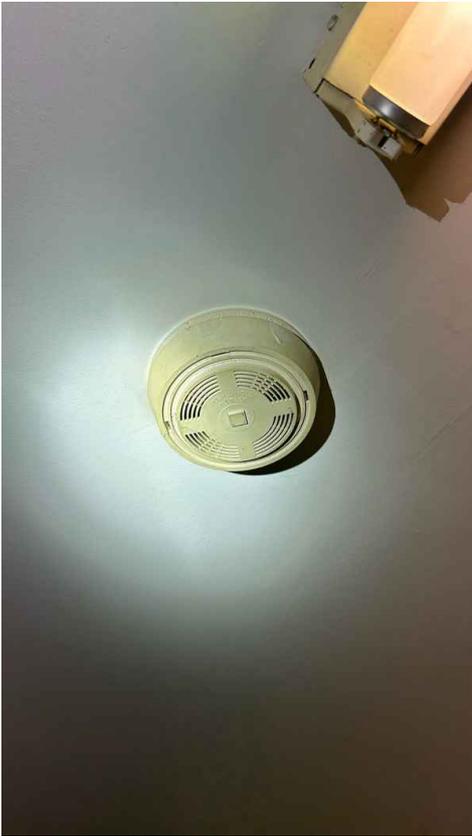
SMOKE AND CARBON MONOXIDE DETECTORS

It is important to note that smoke detectors should be installed in each room and living space, as well as carbon monoxide detectors on every floor and near appliances that emit CO. These detectors can help ensure the safety of occupants by providing early warning in case of fire or the presence of dangerous levels of carbon monoxide. It is recommended to test these detectors regularly and replace batteries as needed to ensure they are functioning properly. This is a life safety issue.

Update and test regularly

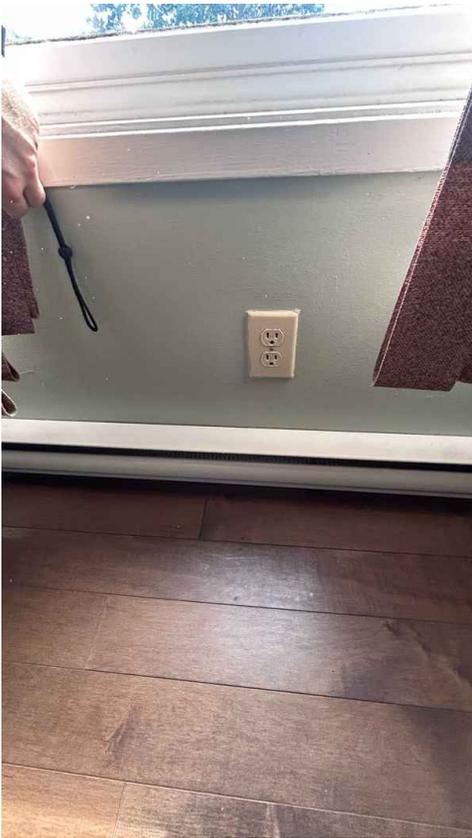
ELECTRICAL OUTLET SAFETY CONCERNS

The exterior outlets and several bathroom outlets (including those in the powder room, ensuite, and downstairs bathroom) were not GFCI protected, which increases the risk of shock in wet locations. Additionally, several receptacles were located directly above baseboard heaters, creating a potential shock and fire hazard if cords rest on or near the heaters. One armoured cable receptacle in the downstairs kitchen was also noted to be loose and slightly ajar. It is recommended to have a qualified electrician upgrade the necessary outlets to GFCI protection, secure the loose receptacle, and review the placement of outlets near baseboard heaters to improve safety upon possession.

Receptacle over baseboard heater

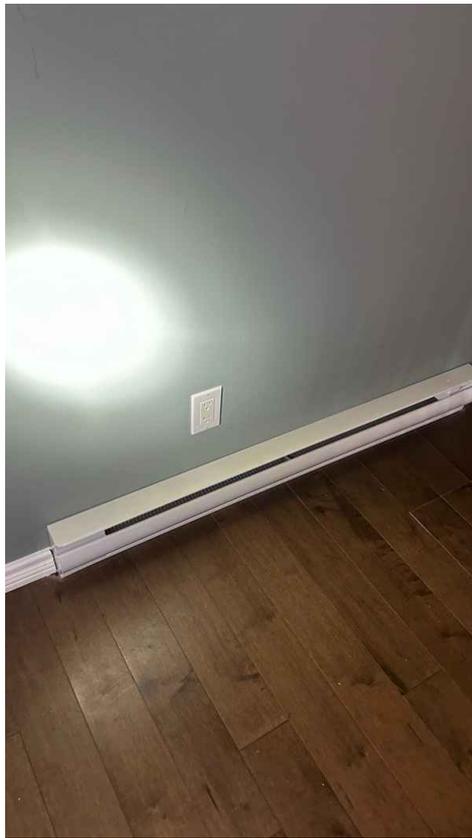
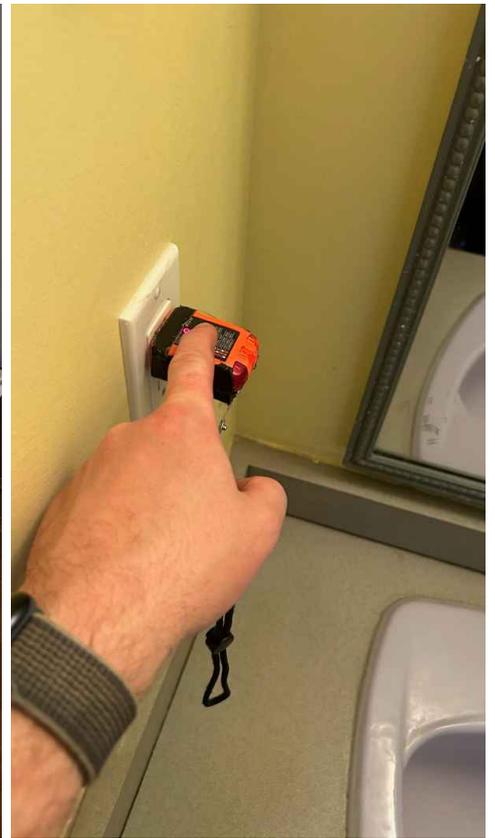
Areas not protected by GFCI

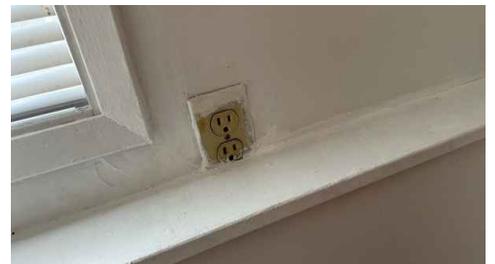
LIMITED USE OF RECEPTACLE ON FINISHED LEDGE

In one of the downstairs bedrooms, a finished ledge—likely concealing the foundation wall—was noted, with an outlet installed into it. Due to the ledge's position, the bottom receptacle may not be usable. It is recommended to be cautious when using this outlet and consider consulting an electrician if full access or modification is desired upon possession.

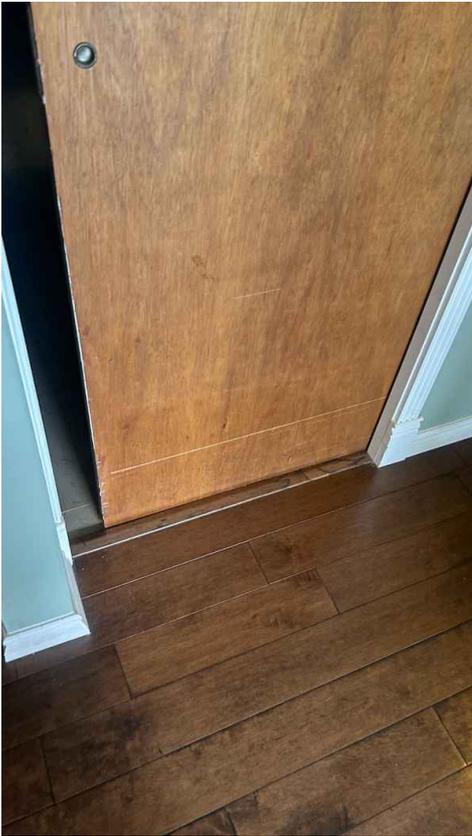
The upstairs powder room ensuite bathroom was missing a door, affecting privacy. The pocket door leading into the kitchen was difficult to operate. Additionally, two doors could not be operated during the inspection: one rear entry/exit door to the basement and one interior door to a suite area, both of which were locked and no keys were provided. It is recommended to install or repair doors as needed and obtain keys to ensure full access and proper function upon possession.

Adjust pocket door

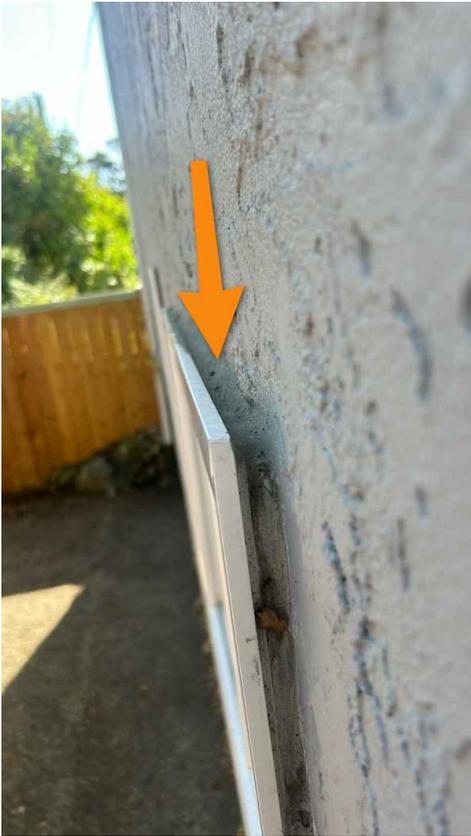
WINDOW FLASHING AND CONDITION OBSERVATIONS

On the right side of the house, particularly at the lower level, several windows were not properly flashed, which could allow water to enter the window assemblies. At a minimum, an exterior-grade sealant should be applied in the gaps between the siding and window assemblies to help prevent moisture intrusion. Overall, the windows appeared to be in acceptable condition; however, some showed visible deflection or fraying of the spacer bars between the panes, which is primarily a cosmetic concern. The windows are from 2001 and are beginning to show age, though most remain functional. Some windows could benefit from a thorough cleaning of the tracks. Additionally, in the primary bedroom ensuite, one window had visible caulk or sealant applied along the glass-to-frame connection, possibly indicating a prior repair attempt. It is recommended to seal the identified gaps prior to subject removal and monitor the windows, addressing maintenance or repairs as needed upon possession.

Flash exterior lower windows

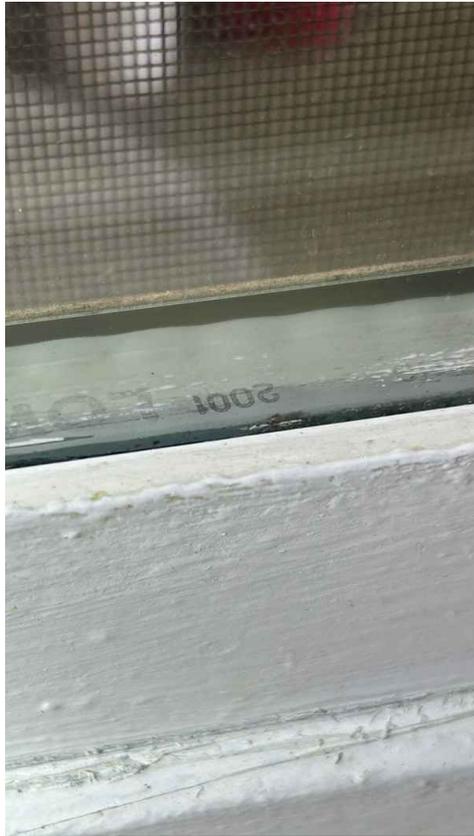
2001 windows (*majority)

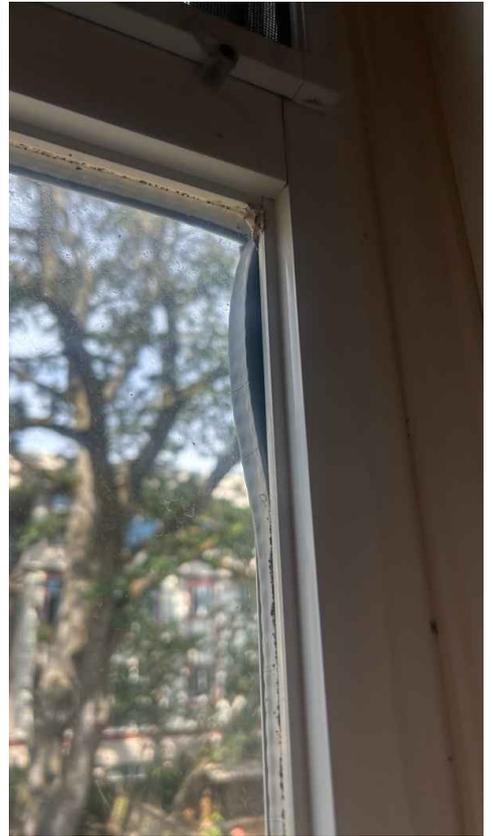
Spacer bar deflection

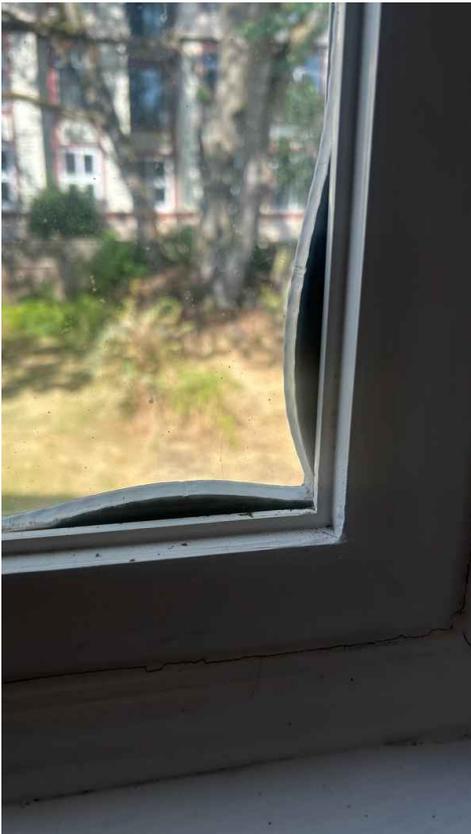
Spacer bar deflection

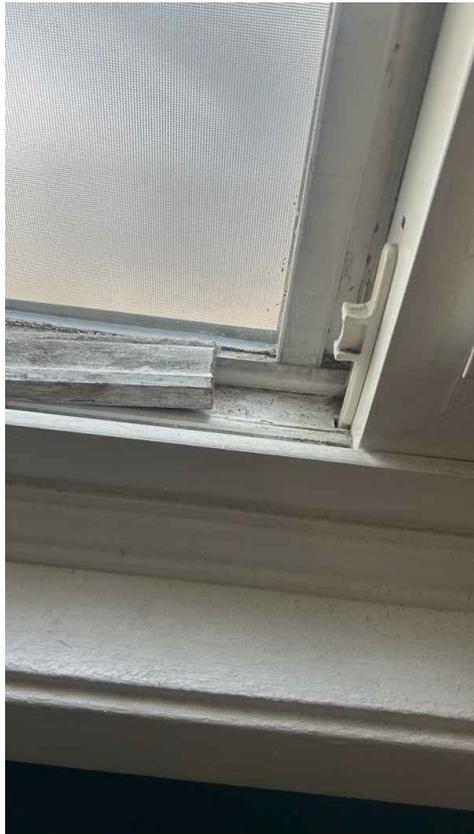
Clean tracks to improve function
