WATCHTOWER HOME INSPECTIONS

RESIDENTIAL REPORT

1: INSPECTION DETAILS

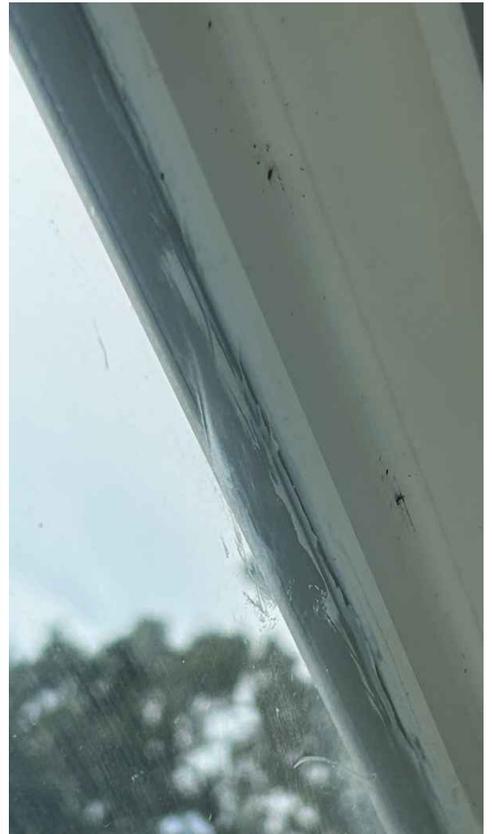
Sealant applied on window

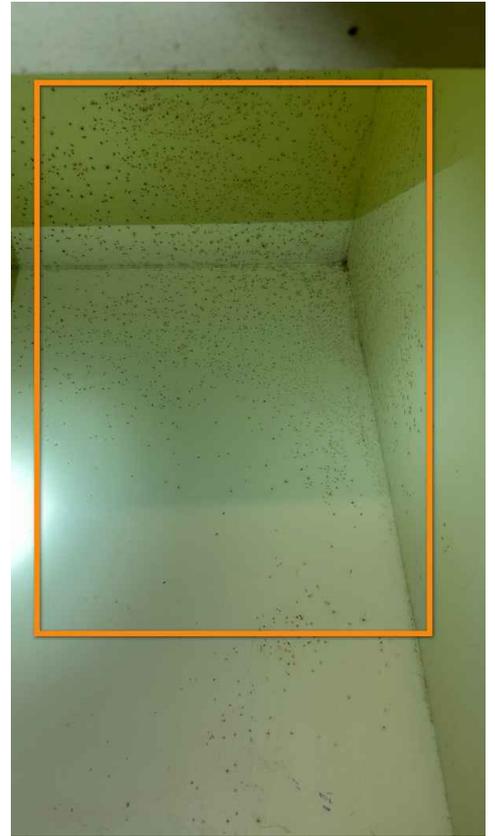
In the upstairs main bathroom closet, an unusual material was noted on the walls, which may indicate possible mould growth. Mould can affect indoor air quality and building materials. It is recommended to have a specialized contractor assess and remediate the area as needed upon possession.

Possible mould like appearance

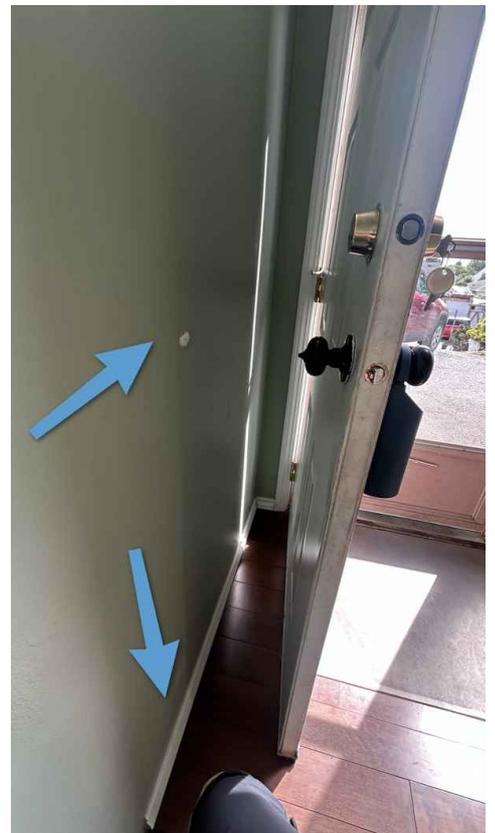
MISSING DOORSTOP AT FRONT ENTRY DOOR

The front entry door was missing a doorstop, resulting in a hole in the wall where the door handle has impacted. Missing doorstops can lead to wall damage and affect overall door function. It is recommended to repair the wall and install an appropriate doorstop upon possession to prevent further damage.

Missing door stop

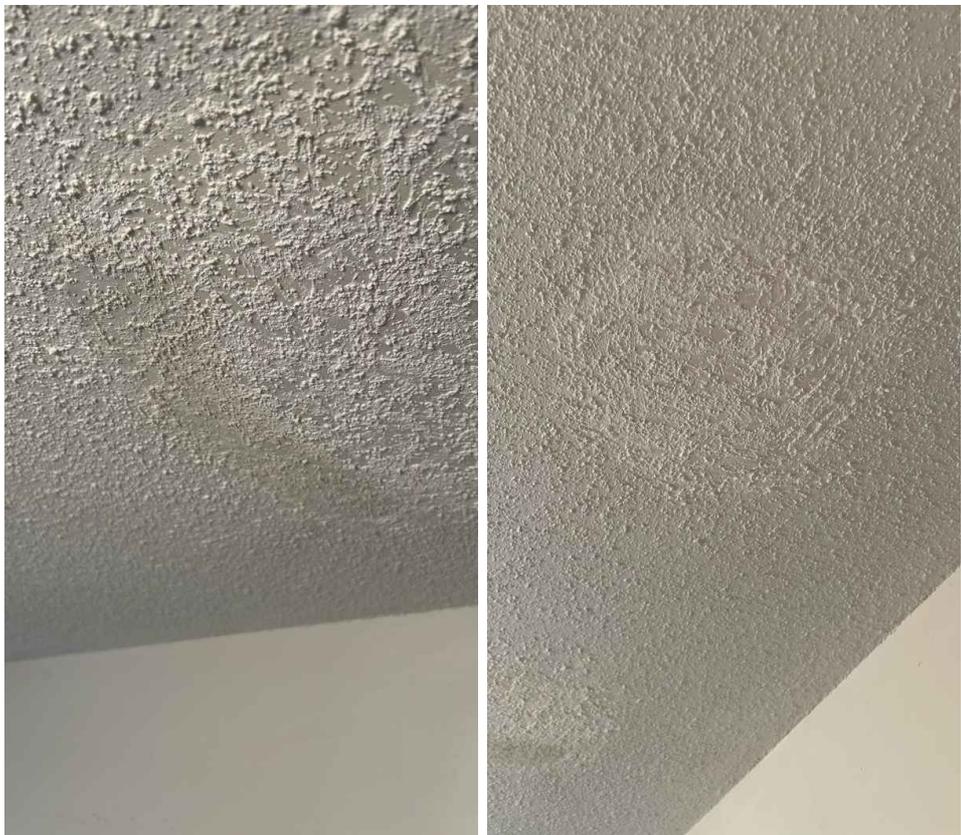
CEILING STAIN AND PATCH IN DOWNSTAIRS BATHROOM

An unusual stain and a ceiling patch were observed in the popcorn ceiling of the downstairs bathroom. Stains were also observed on the panels of the drop ceiling. Both areas appeared dry when checked with thermal imaging at the time of inspection. It is recommended to monitor these areas for any signs of future moisture and address as needed upon possession.

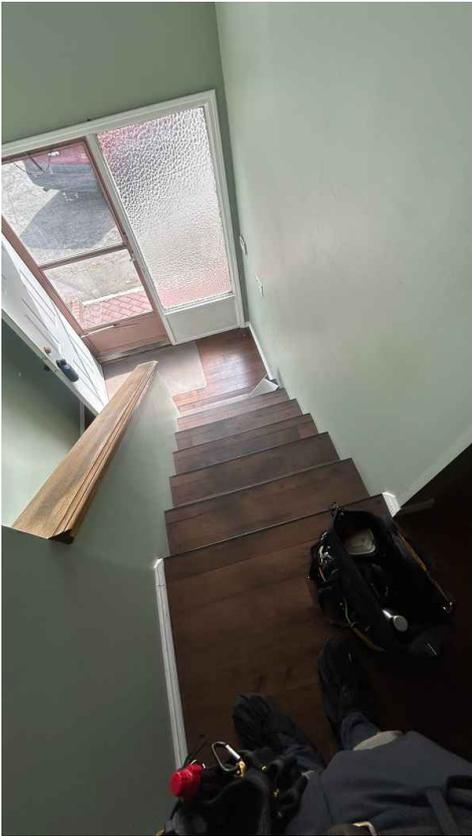
MISSING HANDRAILS AT ENTRYWAY STAIRS

The entryway stairs, both going up and down, lacked dedicated handrails on each set. The partition between the stairs is too wide to function as an effective handrail and does not extend the full length of the stairs. Proper handrails are important for occupant safety and to help prevent falls. It is recommended to install secure handrails on both sides of each staircase upon possession.

Add handrails

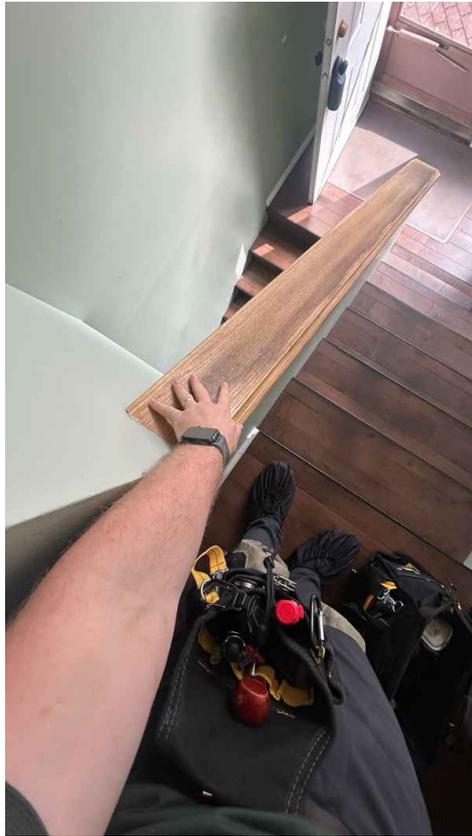
Partition too big to grab securely \

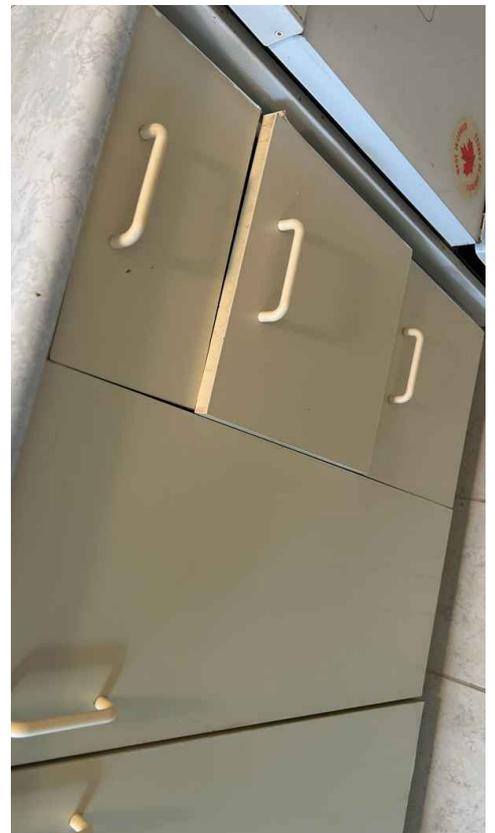
The drawers in the downstairs suite kitchen were noted to be out of alignment and did not close smoothly, often striking each other. Misaligned drawers can affect functionality and convenience. It is recommended to adjust or repair the drawers upon possession to ensure proper operation.

Misaligned drawers

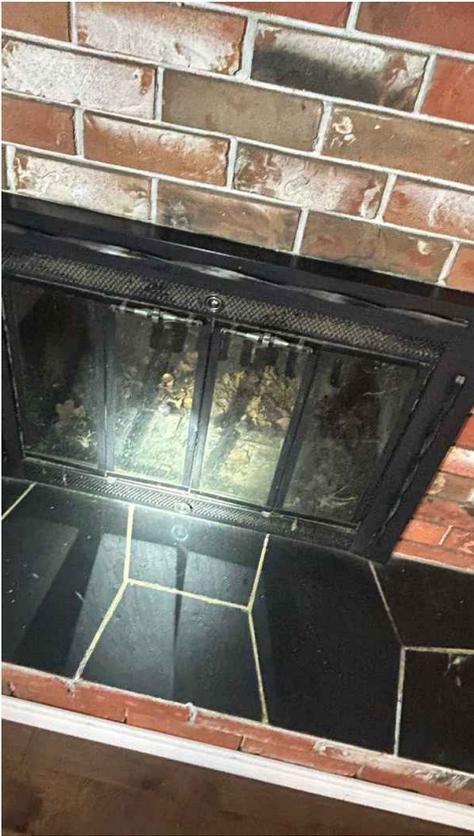
The double-sided fireplace in the dining and living room requires a WETT (Wood Energy Technology Transfer) inspection prior to use, as this is typically required for insurance purposes. The flue was noted to be open, which can reduce heating efficiency and allow weather ingress; it should be closed upon possession. Additionally, the chimney is missing two rain caps, increasing the risk of water and debris entering the chimney system. It is recommended to install proper rain caps and complete these actions upon possession to ensure safe and efficient operation.

WETT inspection required

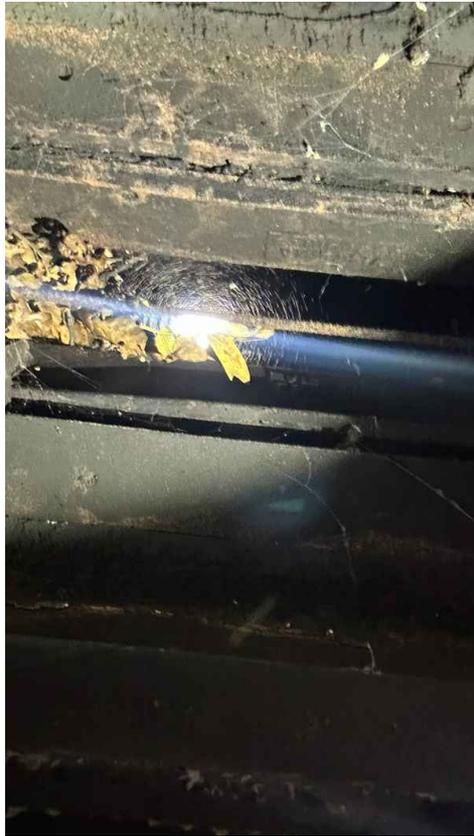
Missing rain cap (visible light)

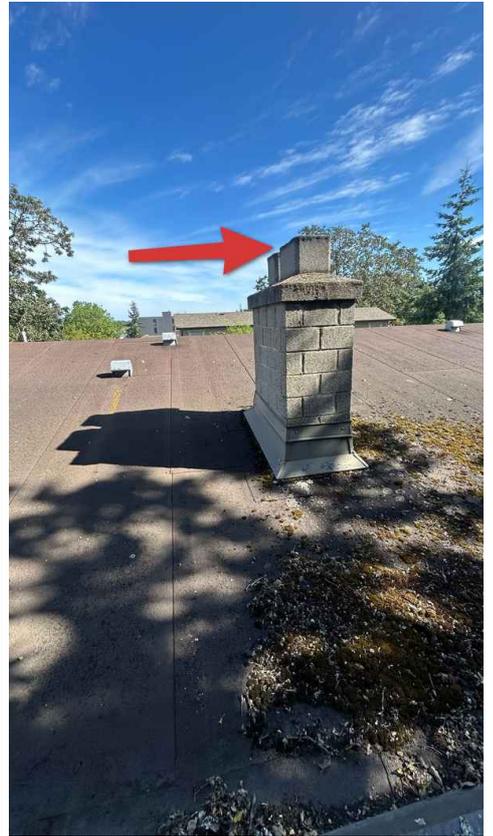
Missing raincaps

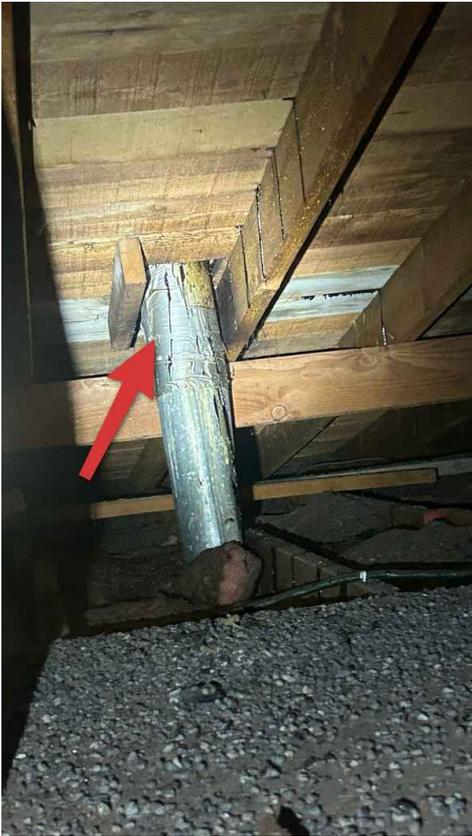
ATTIC INSULATION AND VENTING DEFICIENCIES

The attic was noted to have inadequate insulation, with large exposed ceiling joist members contributing to thermal bridging. As a result, the upper floor was excessively warm on the inspection day, indicating poor thermal performance. The bathroom vent observed in the attic was made of uninsulated plastic material and was not fully connected to the exterior vent, which can cause condensation in the attic space. The kitchen fan ducting, while metal, was joined using duct tape, which is not an appropriate fastening method. Additionally, there was loose pebble-like material scattered in the attic, likely remnants from previous roof construction, possibly used as aggregate for UV protection on a former flat or low-slope roof. While this material did not appear to be vermiculite or asbestos, testing can be considered if there are concerns. It is recommended to improve attic insulation, properly connect and insulate all venting, replace inappropriate duct materials, and insulate the attic hatch upon possession to enhance energy efficiency and reduce moisture risks.

Duct tape used on vent

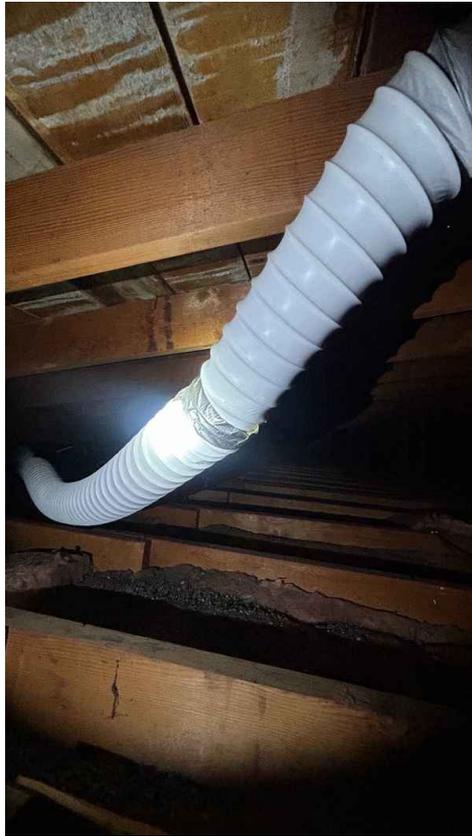
Non insulated plastic vent not connected to vent exit

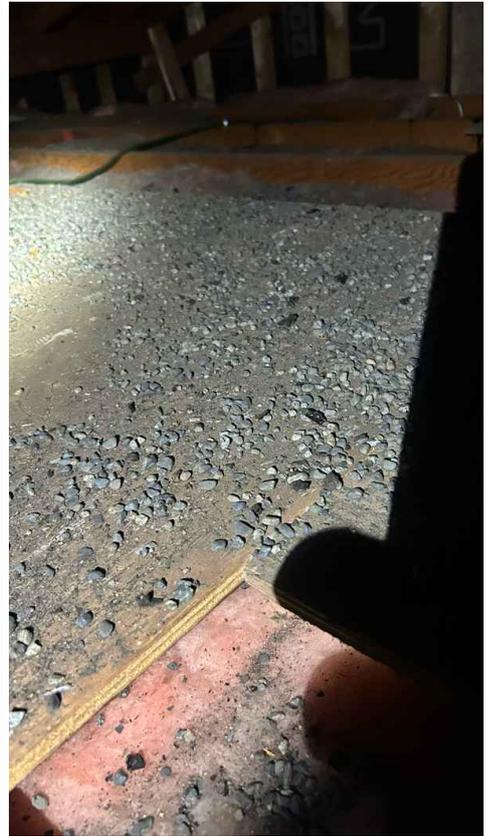
Pebbles in attic

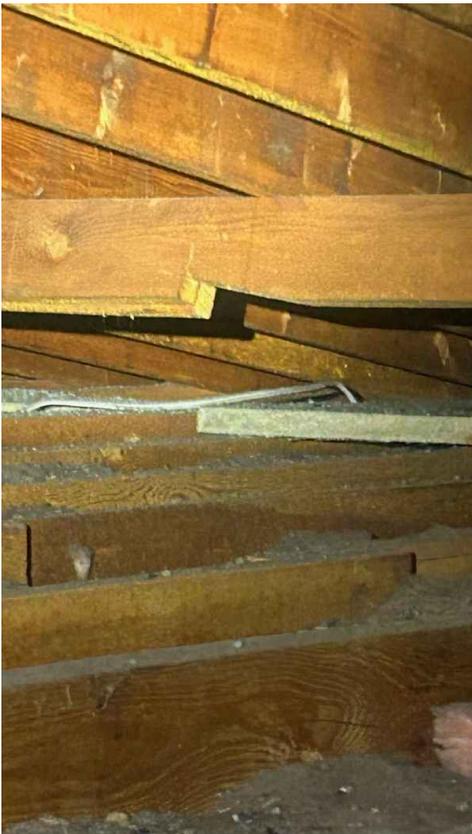
Insufficient insulation

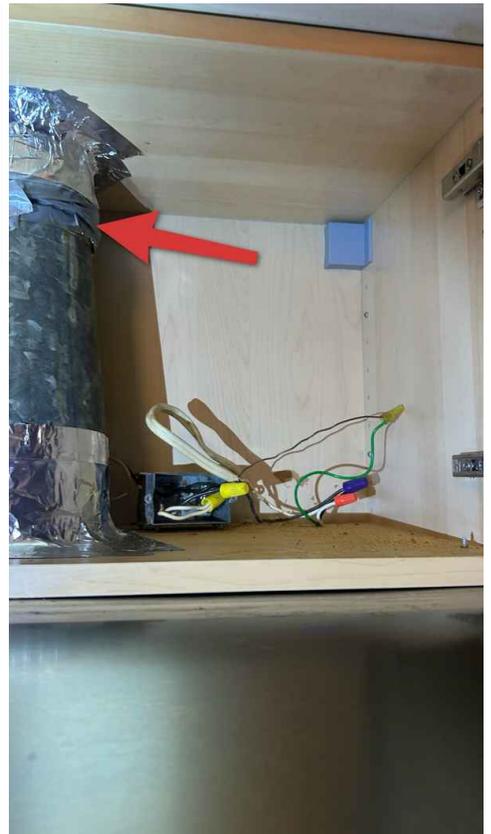
Duct tape

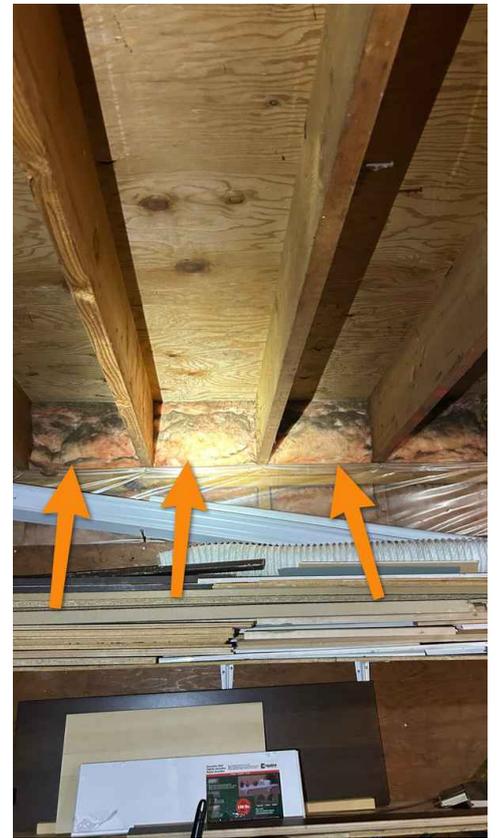
10.2.1 Vapor Retarders and Insulation
**INCOMPLETE VAPOUR BARRIER IN
BASEMENT STORAGE ROOM**

In the basement storage room housing the hot water tank, an incomplete vapour barrier was observed where the joists intersect, leaving insulation exposed. The insulation showed slight staining, likely from prolonged exposure. Exposed insulation can reduce thermal performance and increase the risk of moisture issues. It is recommended to complete the vapour barrier to cover all visible insulation upon possession.

incomplete Vapour barrier
