**WATCHTOWER**  
HOME INSPECTIONS

## RESIDENTIAL REPORT

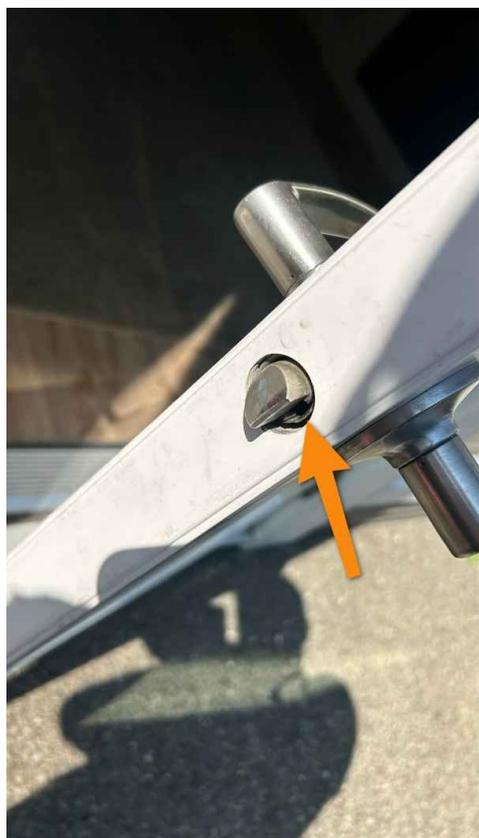
#### DOORS – LOOSE HARDWARE AND ALIGNMENT

Several doors in the home had loose hardware, most notably the rear entry door, which was also missing components in its hardware assembly. This rear door was slightly out of alignment, making operation difficult. Tightening or replacing hardware and adjusting the door alignment are recommended to restore smooth function and security.

Missing hardware, door out of alignment

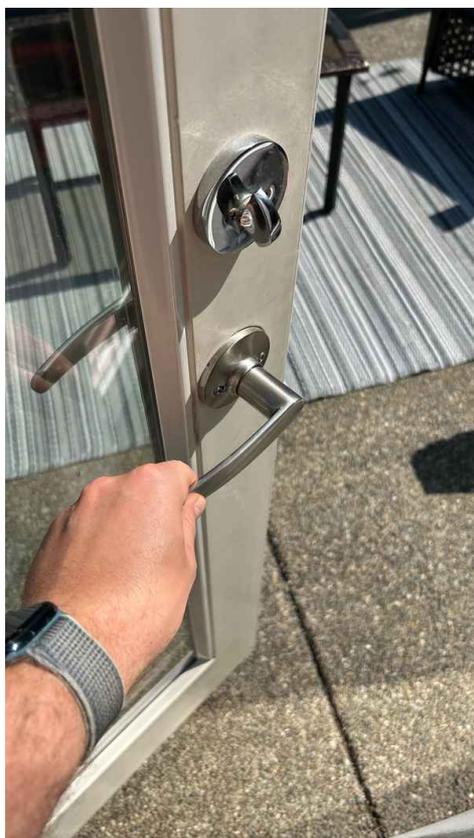
Loose hardware

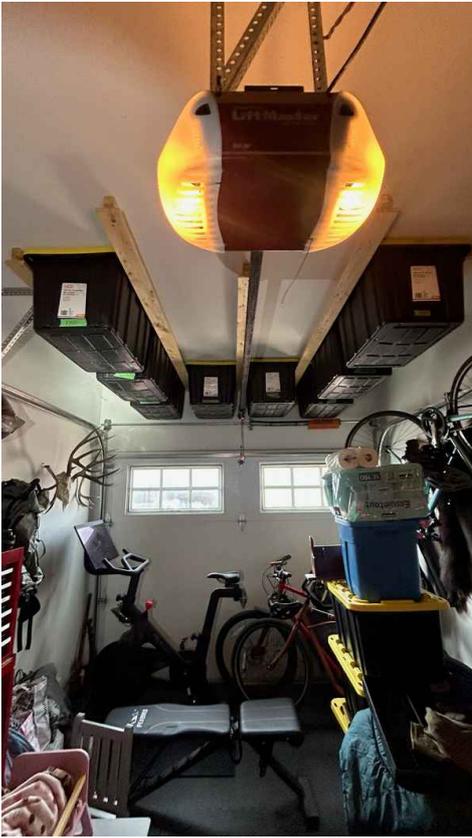
#### GARAGE DOOR – NOT TESTED

The garage door could not be operated or tested due to significant storage inside the garage, including items placed on the tracks. Operation and safety features should be confirmed once the storage is removed, ideally prior to possession.

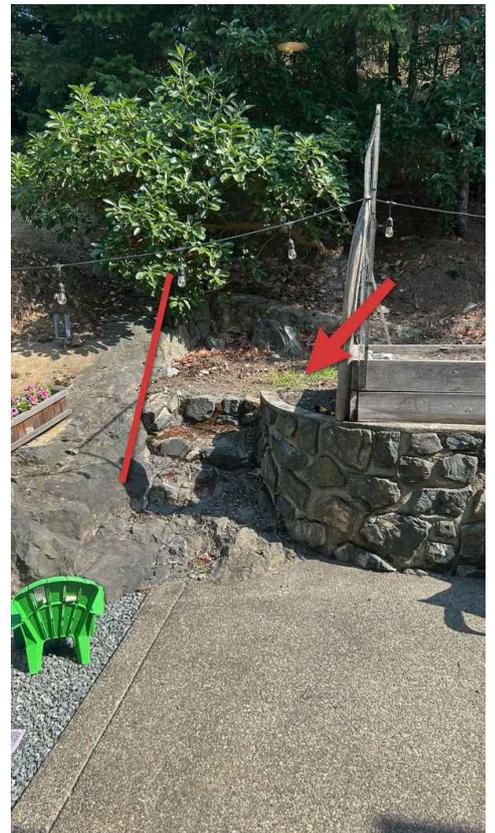
### BACKYARD – ROCK STEPS WITHOUT HANDRAIL

In the rear yard, a set of makeshift steps was built into the rock face. These steps lacked a handrail and presented uneven surfaces, creating a potential trip and fall hazard, particularly for children. Caution is advised when using this area, and installation of a proper handrail or modifications to improve stability may be considered.

Missing hand and guard rail

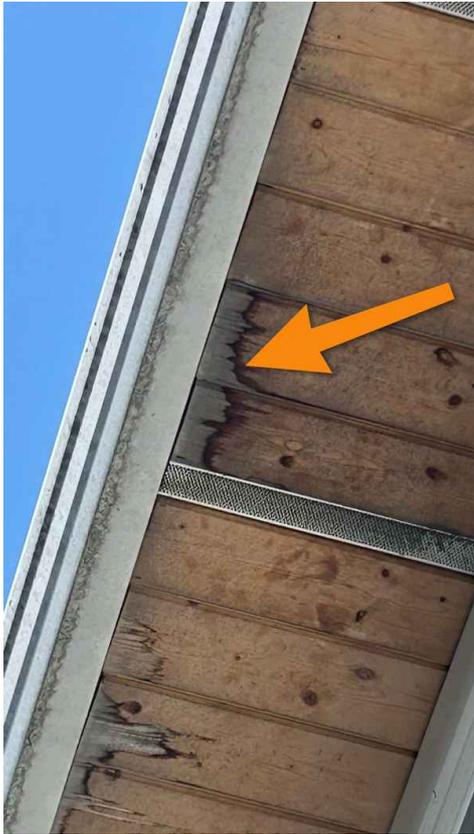
### FASCIA AND SOFFITS – LOCALIZED DETERIORATION AND DISCOLOURATION

One fascia end board at the front of the home showed signs of deterioration. In addition, select areas of the soffit displayed varied discolouration, possibly from minor leakage between the fascia and gutter system or simply surface staining. At the rear, one soffit section appeared unusually pressure-washed, creating inconsistent surface appearance. Ask seller conditions during heavy rainfalls, and if any leaking is occurring between fascia and gutter. Repair of the deteriorated fascia board and continued monitoring of soffit conditions are recommended, with touch-up or cleaning carried out as desired.

Soffit discoloured

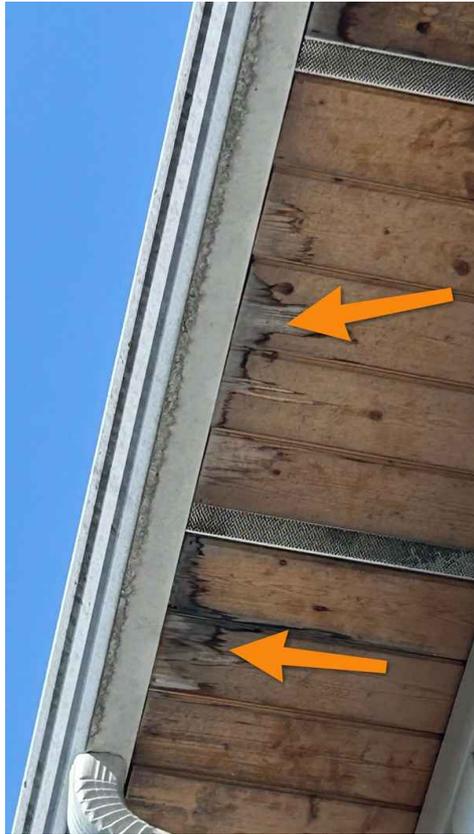
Soffit staining

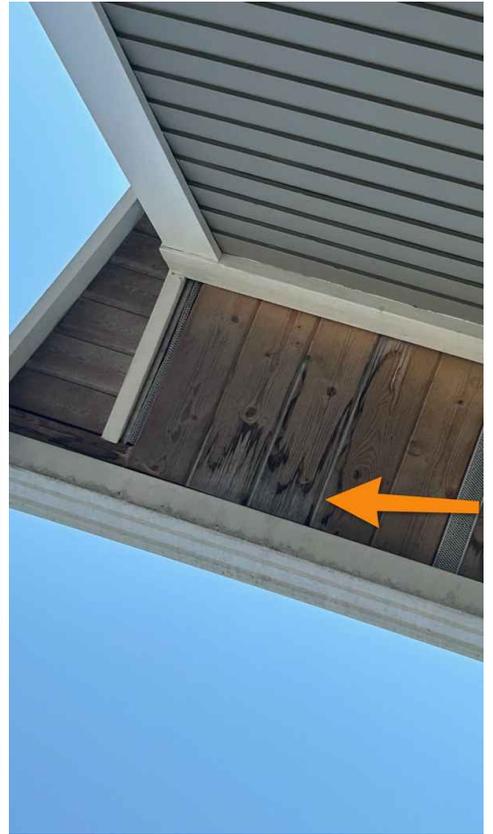
Soffit staining

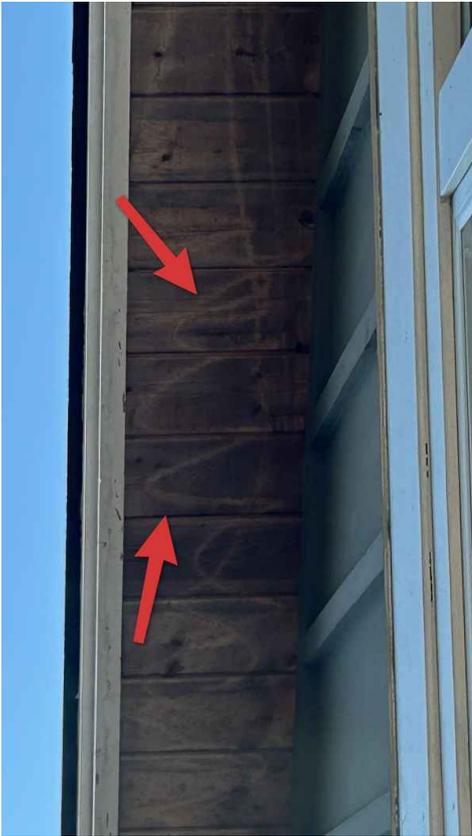
Pressure wash marks

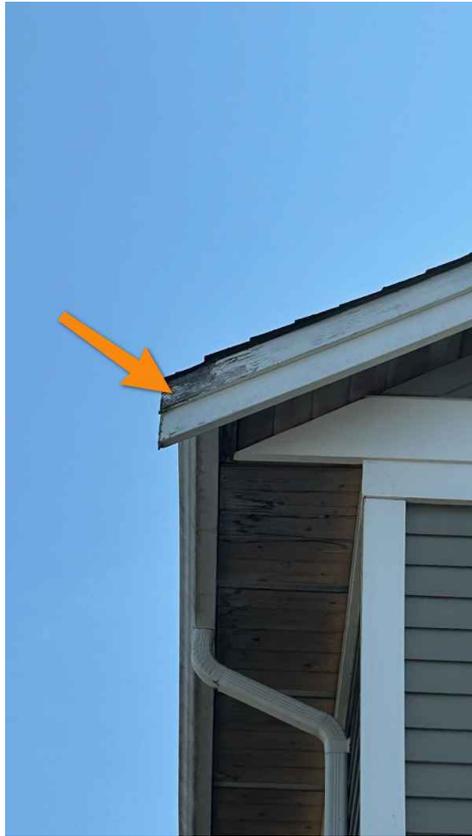
Fascia end board deterioration

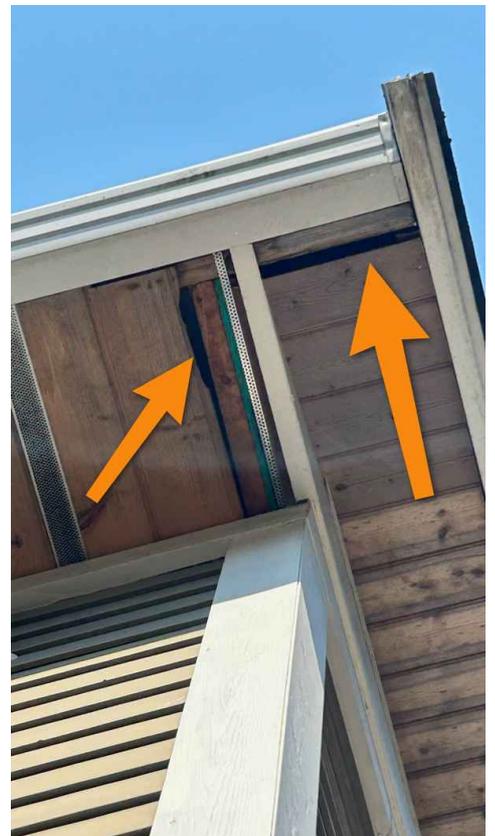
**SOFFITS – MINOR GAPS**

A few small gaps were observed in the soffits at the rear right-hand corner of the home. These openings can allow pest entry and reduce ventilation effectiveness. Sealing or repairing the soffits in this area is recommended upon possession.

Gaps

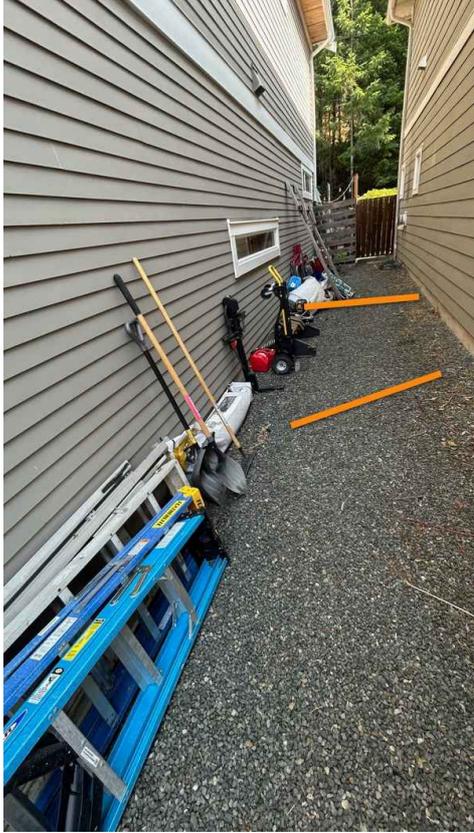
**RIGHT SIDE YARD – BURIED DOWNSPOUT AND GRADING**

A buried downspout was present on the right-hand side of the home, along with slightly negative grading in this area. As the home is on a slab foundation, the grading is less of a concern, though monitoring during heavy rainfall is recommended to ensure water does not collect against the foundation. Adjustments can be made if pooling is observed over time.

Negative Grade

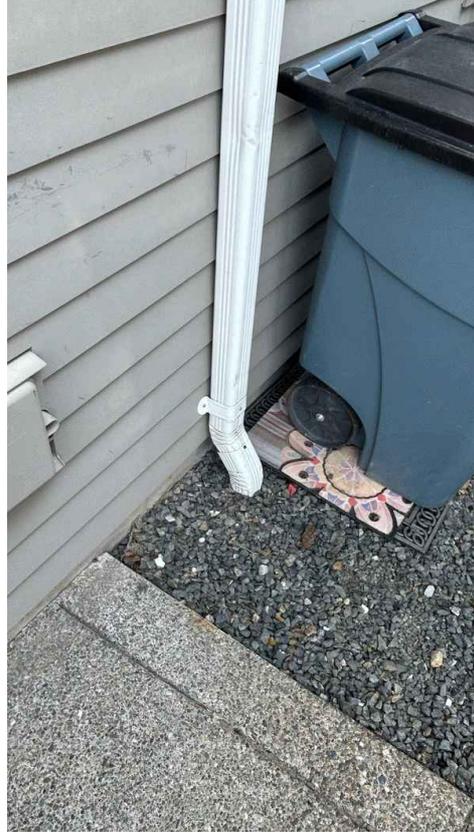
Buried downspout

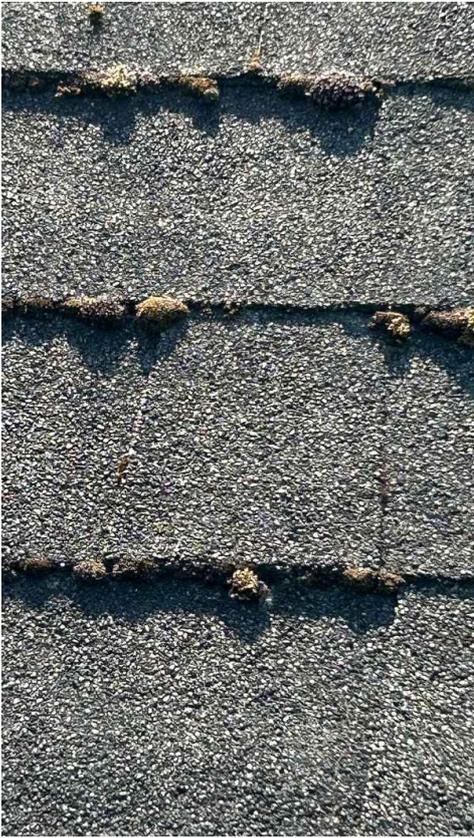
### ROOF CONDITION – MODERATE WEAR AND MOSS GROWTH

The roof covering appeared to be in the mid stages of its service life with moderate granular loss. Moss growth was noted across sections of the surface. Cleaning of the moss, as well as clearing gutters and removing any debris, is recommended to help extend the roof's serviceable life and maintain proper drainage.

Moss Growth

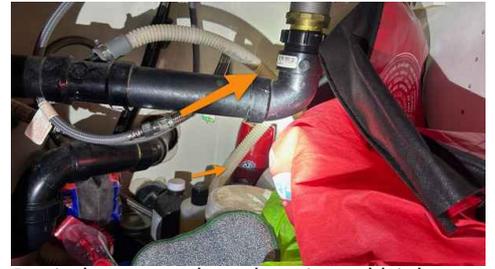
The dishwasher drain line was present but not secured in a proper high loop configuration within the sink cabinet. Raising and securing the drain line higher under the counter is recommended to reduce the risk of wastewater backflow into the dishwasher.

Drain loop needs to be pinned higher

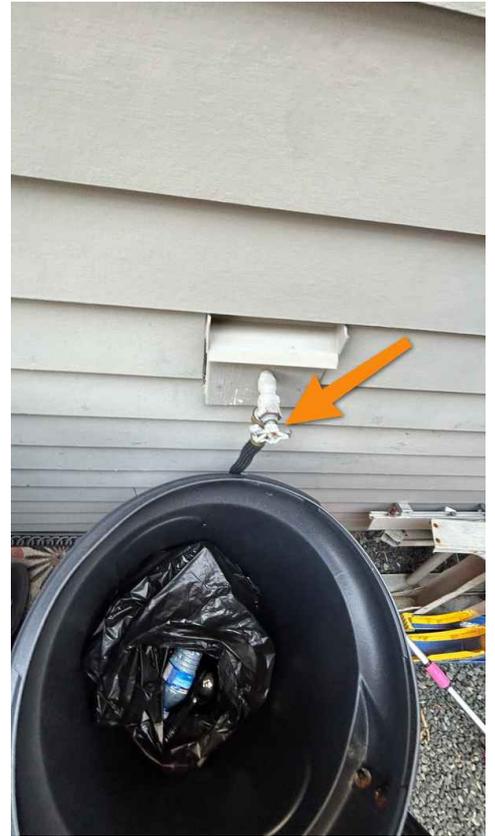
## EXTERIOR HOSE BIBS – UPGRADE AND REPAIR

The hose control on the right-hand side of the home was broken. In addition, the exterior hose bibs were standard style units. Upgrading to frost-free, winterized hose bibs is recommended to improve durability and reduce the risk of freezing. Repair or replacement of the damaged hose control should also be completed upon possession.

Broken control, Upgrade bibs

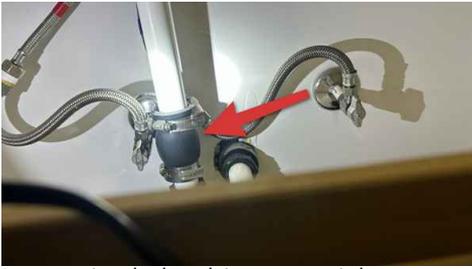
## BATHROOM VANITIES – INSTALLATION AND PLUMBING CONCERNS

All bathroom vanities appeared to be aftermarket installations with sub par workmanship. The primary ensuite vanity was leaking into the cupboard beneath, while other vanities were not set flush against the walls, leaving small gaps. Improvised P-traps and connection points were also noted behind some units. These conditions suggest unprofessional installation, and the plumbing associated with the vanities may not be reliable. Replacement of the vanities and correction of the plumbing connections is recommended to improve function, durability, and appearance.

Improvised plumbing materials

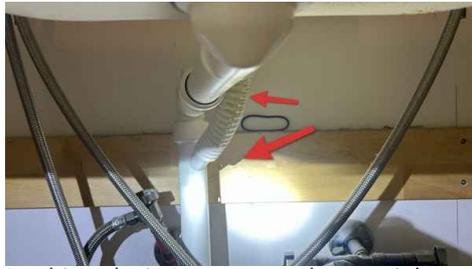
Leaking drain/ corrugated material

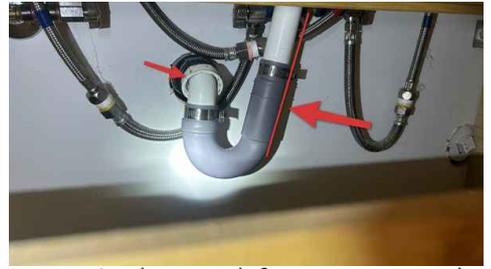
Improvised p trap, left over screw seal

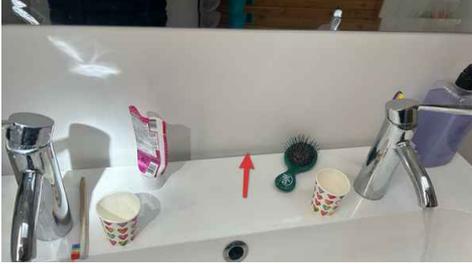
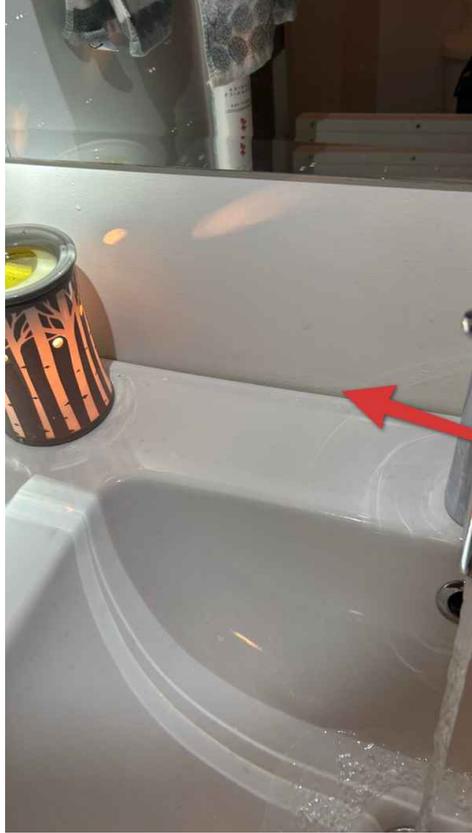
Gap in vanity

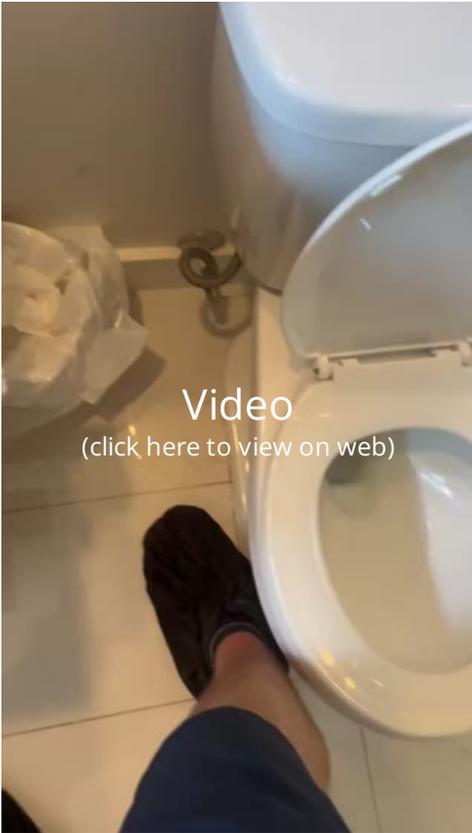
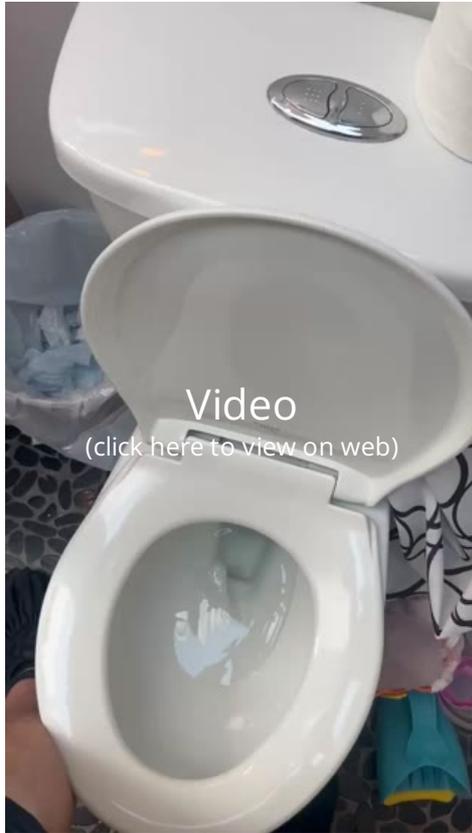
#### **TOILETS – LOOSE INSTALLATION**

Both upstairs toilets were loose at the time of inspection. The primary ensuite toilet rocked when tested, while the main upstairs bathroom toilet shifted side to side. Loose toilets can compromise the wax seal and lead to leaks if not corrected. Re-securing the toilets to the floor and replacing the wax seals as needed is recommended upon possession.

Loose toilet

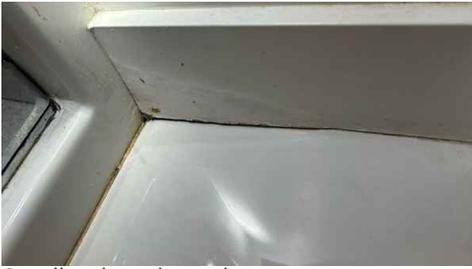
### **UPSTAIRS ENSUITE BATHROOM – SHOWER STALL SURROUNDINGS**

The shower stall showed evidence of past moisture exposure. Baseboards at the entryway were swollen, and a moisture meter confirmed elevated moisture levels in this area. Near the shower head, drywall showed signs of peeling and slight swelling, though it tested dry at the time of inspection. The shower head also had intermittent pressure; when turned on fully, the water pressure decreased. The glass partition had an amateur caulking application, with soiled caulking noted at the base inside the enclosure, which may not provide reliable long-term sealing and could be difficult to correct neatly. While this type of shower stall is generally resilient, the conditions indicate that surrounding finishes have been exposed to water in the past, resulting in visible damage. Repair of affected finishes, cleaning and replacing caulking, and addressing the shower head pressure issue are recommended.

Swollen baseboard

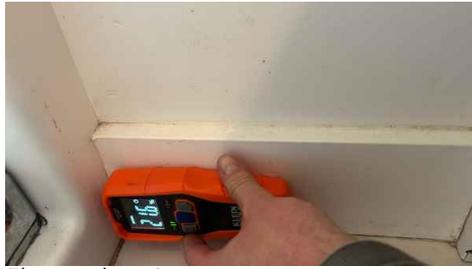
Elevated moisture

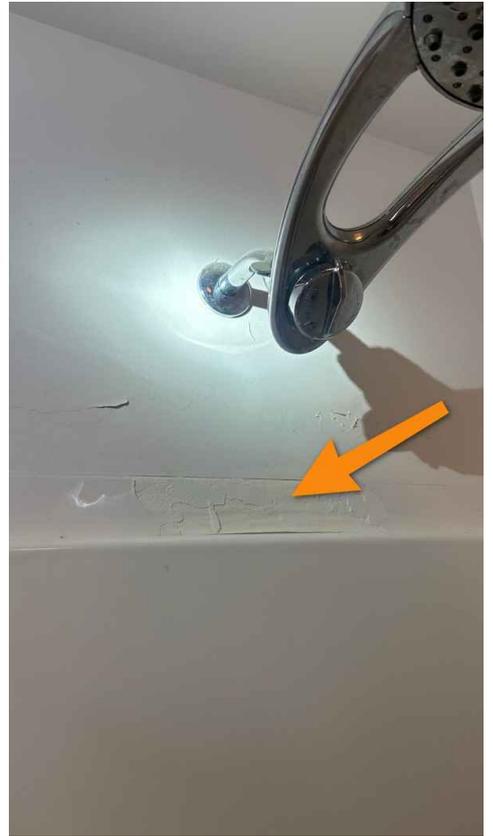
Drywall exposed to water

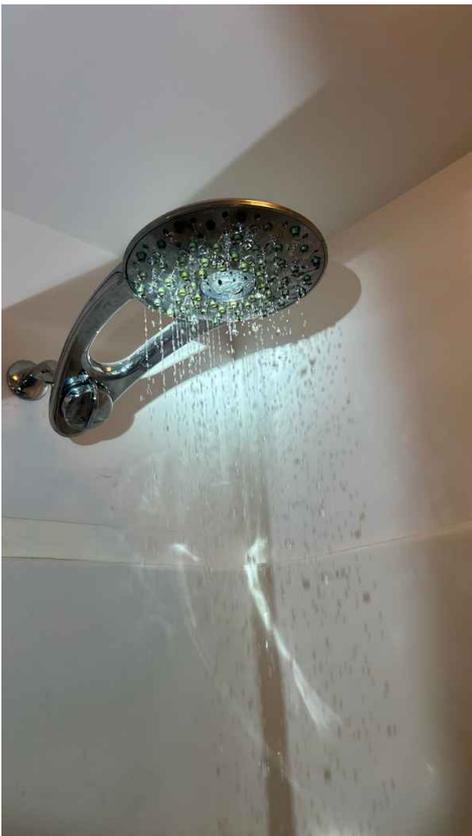
Waterpressure issues

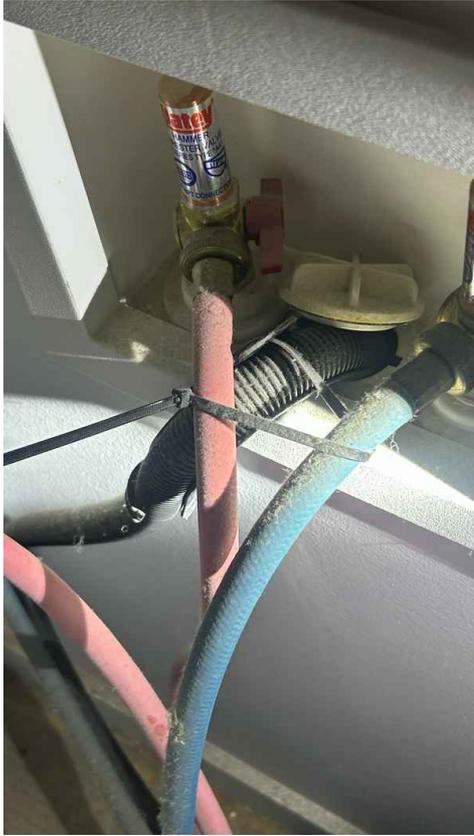
Upgrade hoses

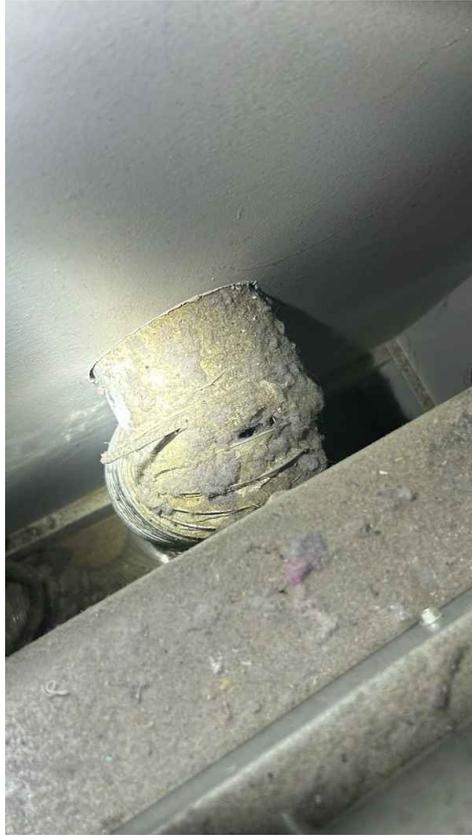
The dryer vent duct had a hole or gap in the material, which can reduce efficiency and allow lint to escape. Repair or replacement of the vent duct is recommended to ensure proper venting. The washing machine was connected with standard plastic/rubber supply hoses, which are prone to deterioration over time. Upgrading to braided stainless steel hoses is advised to improve durability and reduce the risk of leaks.

Hole in vent

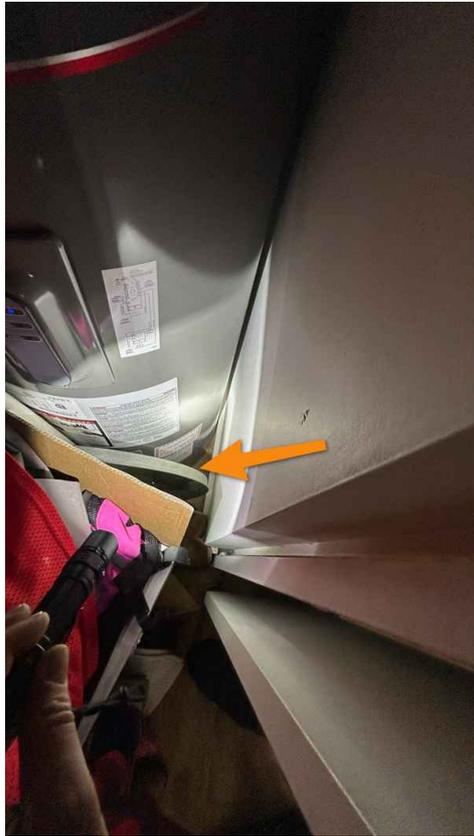
The electric water heater was manufactured in 2024 and appeared to be in serviceable condition. A drip pan was present but was not installed beneath the tank, as it was leaning against the unit. A vacuum breaker was installed on the hot water supply line; however, this is only effective when installed on the cold water inlet. Confirmation and correction by a plumber is recommended. The tank was not equipped with seismic straps, though given the tight closet location, installation may not be practical.

Drip pan not installed

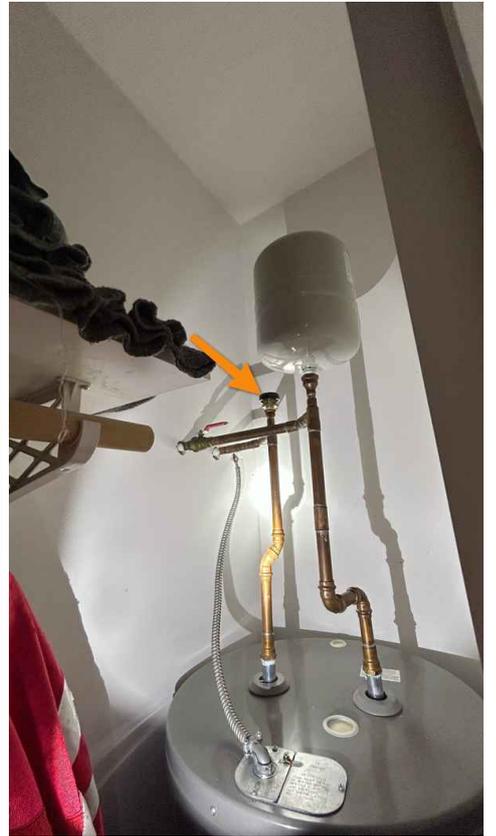
Vacuum breaker on hot water line

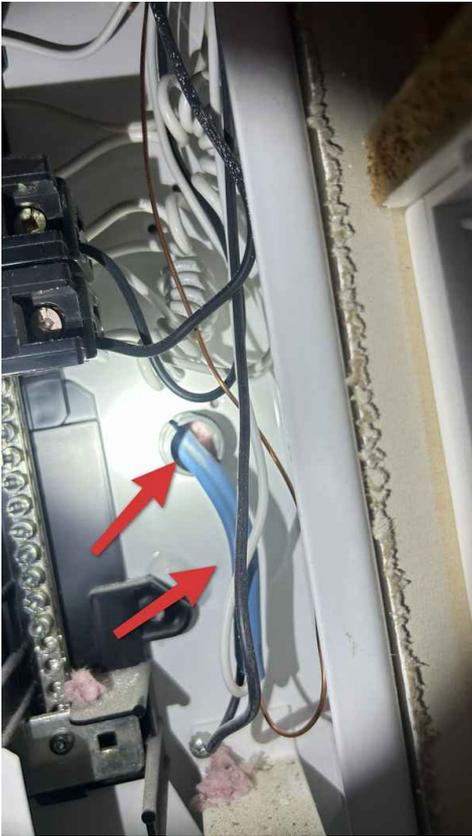
### MAIN ELECTRICAL PANEL – 200 AMP SERVICE

The home was equipped with a 200-amp main electrical panel. Several conditions inside the panel suggested unprofessional or handyman electrical work. A few open splices were present, including one splice where four to five conductors were joined at a single point, which is not a proper termination method. In addition, one conductor entering through a knockout had excessive sheathing remaining and the knockout was not fitted with a proper grommet or bushing. These conditions should be reviewed and corrected by a licensed electrician to ensure safe and proper configuration of the panel.

Excessive Sheathing, No Bushing

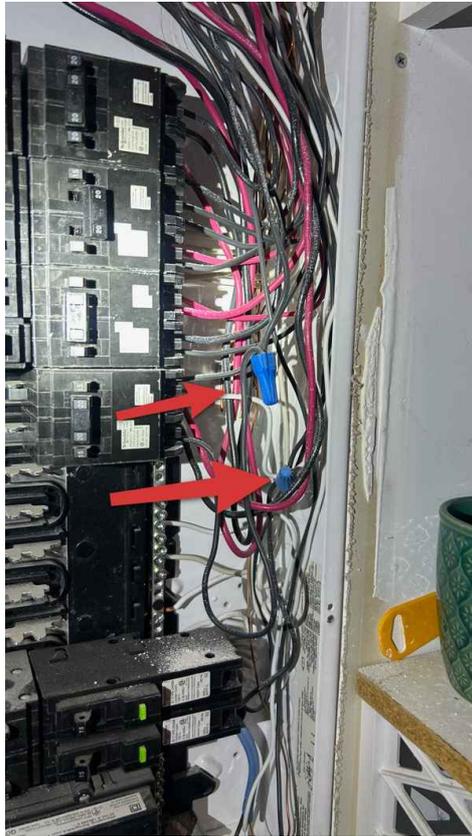
Open splices

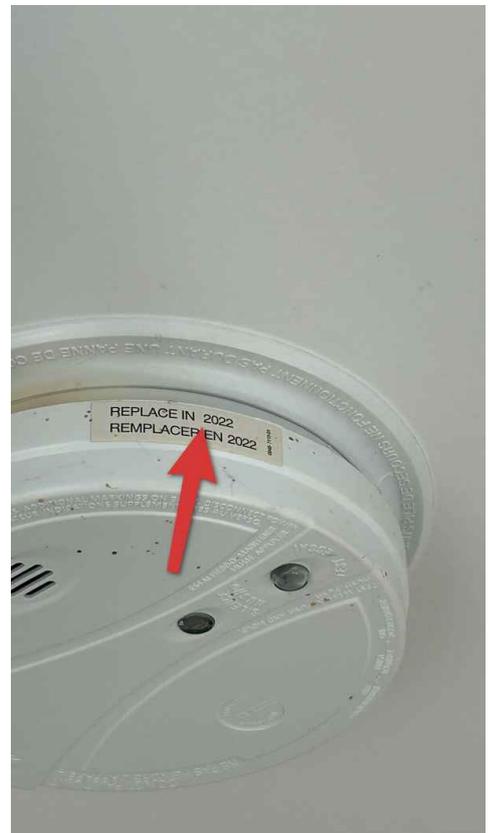
#### **SMOKE AND CARBON MONOXIDE DETECTORS – EXPIRED AND MISSING UNITS**

The smoke detector in the upstairs hallway was expired, with a listed date of 2022. Updated detectors were present in both spare bedrooms, though the primary bedroom lacked a smoke detector. Replacement of expired units and installation of a detector in the primary bedroom are advised. All sleeping rooms should have properly functioning smoke detectors. In addition, carbon monoxide detectors should be installed near fuel-burning appliances to provide adequate coverage.

Expired

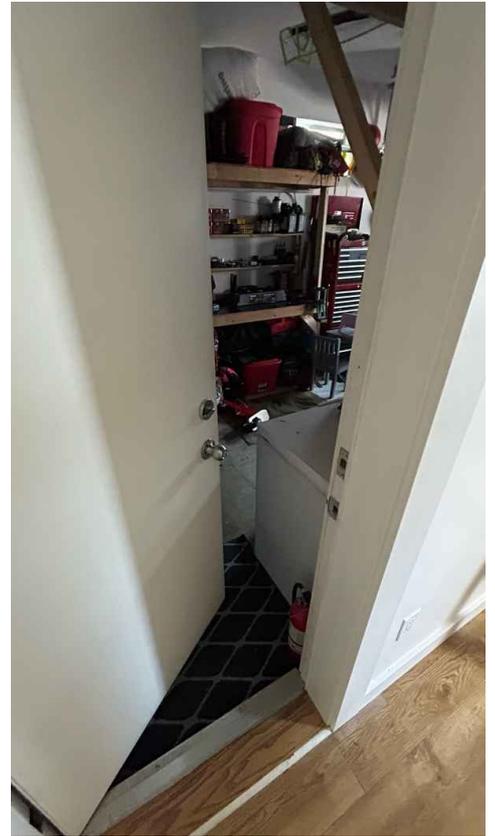
### **GARAGE MAN DOOR – MISSING SELF-CLOSING FUNCTION**

The man door between the garage and the living space was not self-closing at the time of inspection, though self-closing hinges were present. If the garage is used for vehicle parking, restoring the self-closing function is recommended to help prevent products of combustion from entering the home.

Man door not self closing

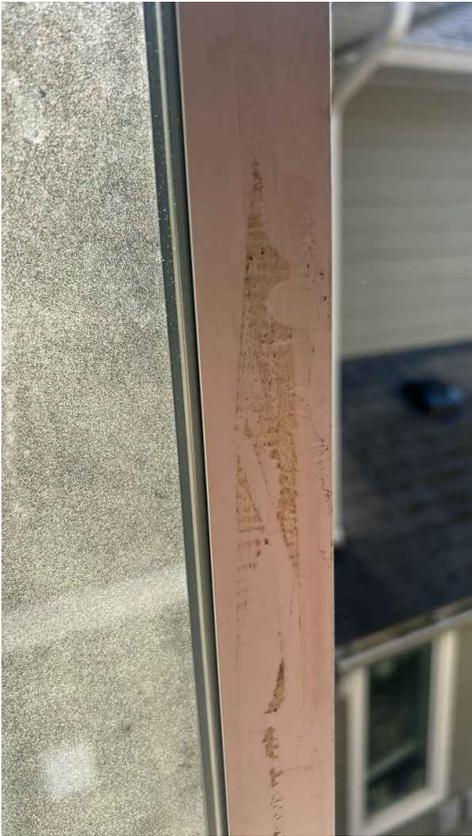
### **WINDOWS – EXTERIOR SEALANT, LOCKS, AND SCREENS**

At least one window showed deterioration of the exterior sealant along the glazing, with sections lifting away from the frame. This condition can allow moisture to collect at the window assembly over time. Some windows were also missing locking or backup lock components, and sticky residue was noted on portions of the frames. In addition, several windows were missing insect screens. Resealing the affected glazing, repairing or replacing lock hardware, removing residue, and adding screens where needed are recommended upon possession to restore full function and durability.

Sticky residue

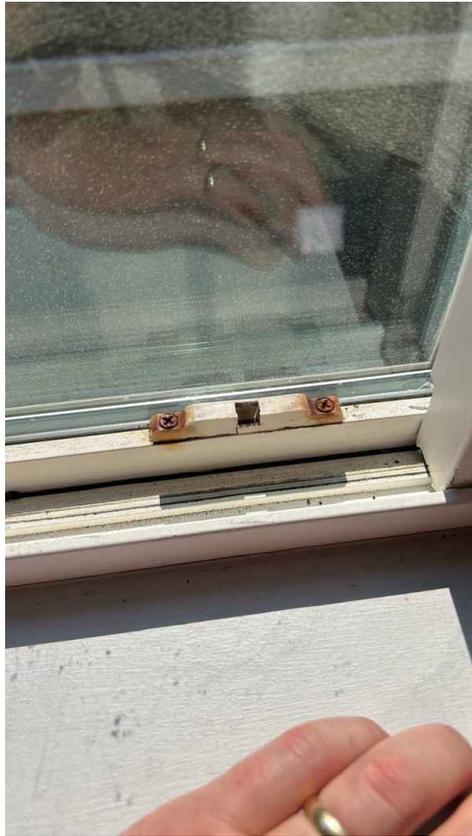
Missing components

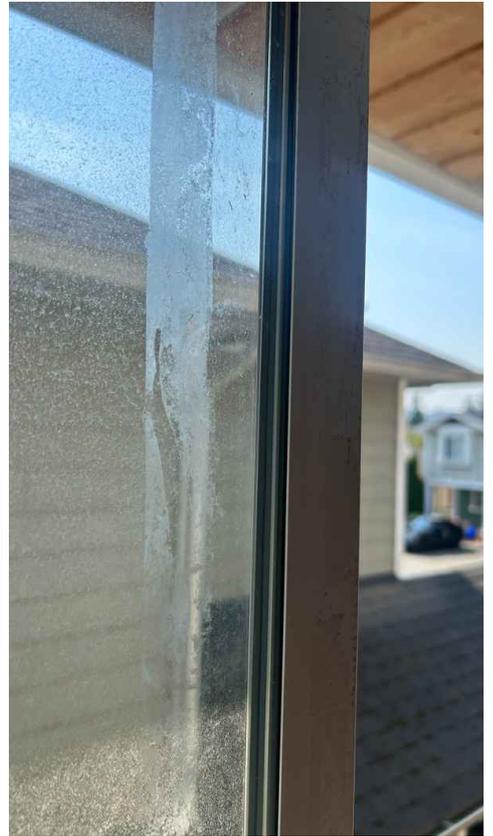
Sticky residue

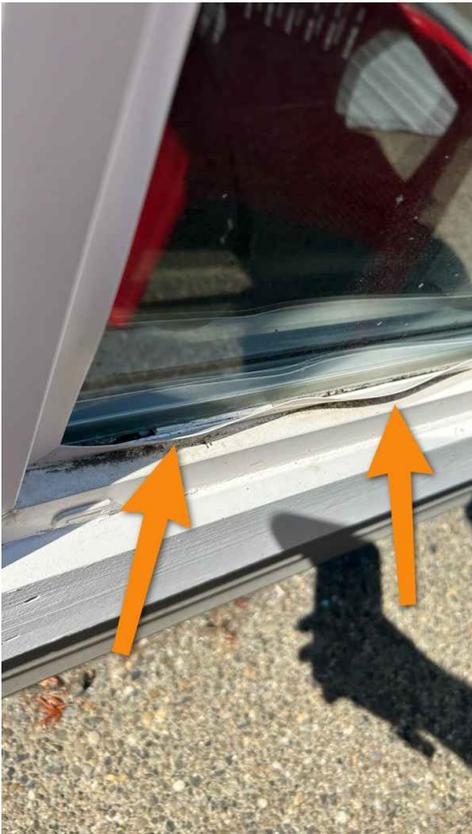
Warped trim seal

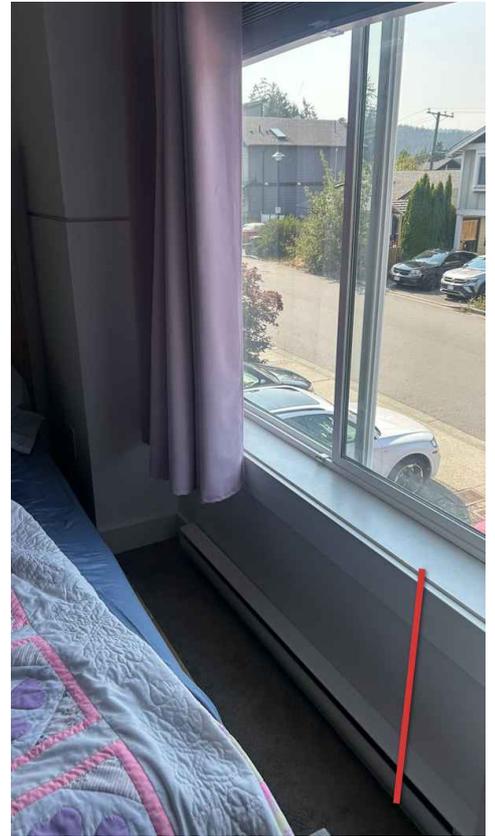
The front-facing window in the spare bedroom was set unusually low to the floor, presenting a potential fall hazard, particularly for children. While the window was functional, consideration should be given to installing a window guard or other safety measure if the room will be used by children.

Low Window sill

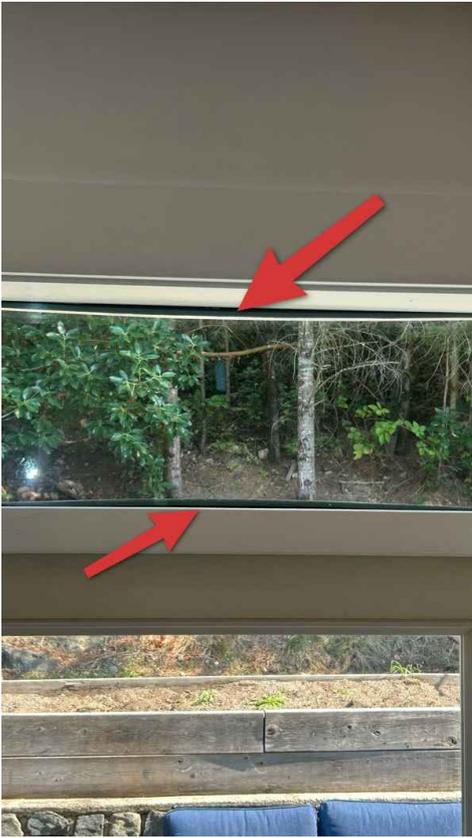
#### **REAR EXIT BAY WINDOW – SPACER BAR DEFLECTION**

The bay window above the rear exit hinged door showed deflection in the spacer bars at both the top and bottom. This condition is likely related to a manufacturing defect and may result in premature failure of the window seal. No repair is possible for the spacer bars themselves; replacement of the glazing unit may eventually be required if the seal fails. Monitoring over time is recommended.

Spacer bar deflection

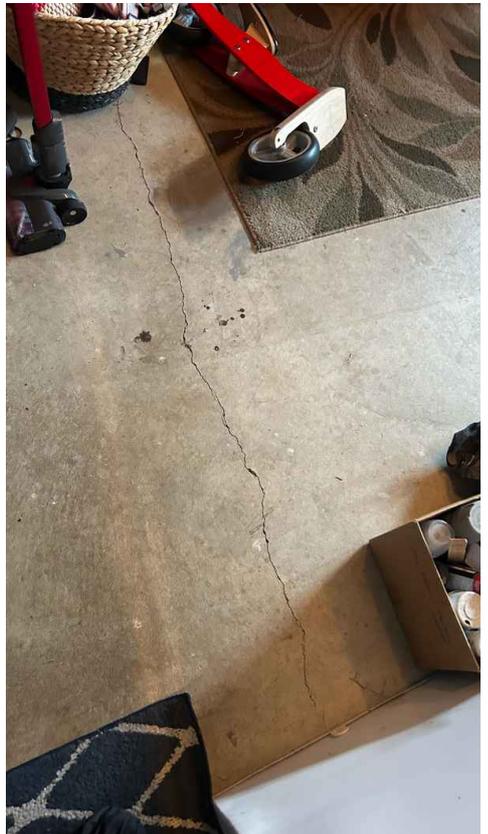
**GARAGE FLOOR – SLAB CRACK**

A crack was observed in the garage slab. This is a common condition in concrete and appeared minor, with no evidence of structural concern at the time of inspection. Monitoring over time is recommended, with repairs carried out if movement or widening occurs.

Slab crack

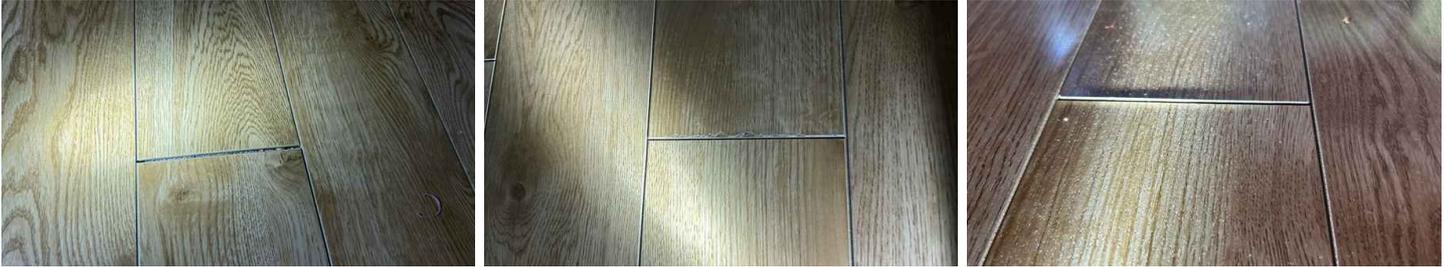
**FLOORING – GAPS AND MINOR BUCKLING**

The laminate/vinyl flooring showed minor gaps and slight buckling or raised edges in some areas. These conditions appear consistent with normal wear and tear and are primarily cosmetic. Repair or replacement can be carried out as desired for appearance.

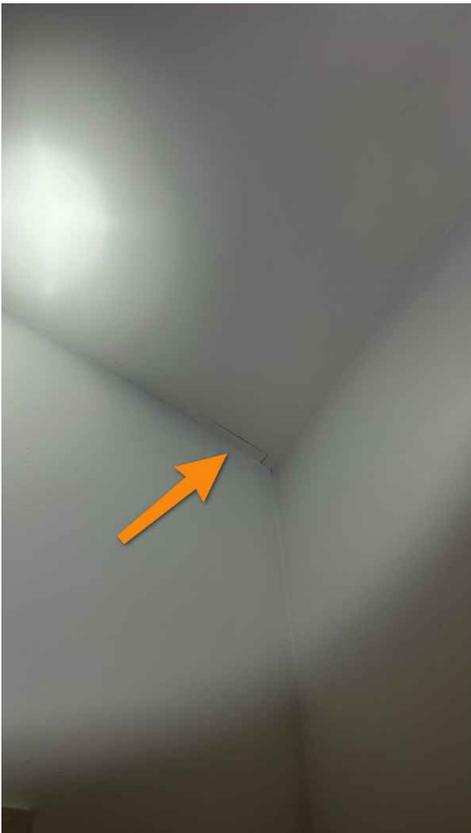
Peeling drywall tape was observed in the primary bedroom ceiling. In the spare bedroom, drywall and paint finishes showed evidence of amateur repair or modification, including added accent walls with bubbling drywall tape, uneven mudding, and messy paint application. These conditions are cosmetic in nature but affect appearance. Refinishing the affected areas is recommended as desired for aesthetics.

Drywall tape

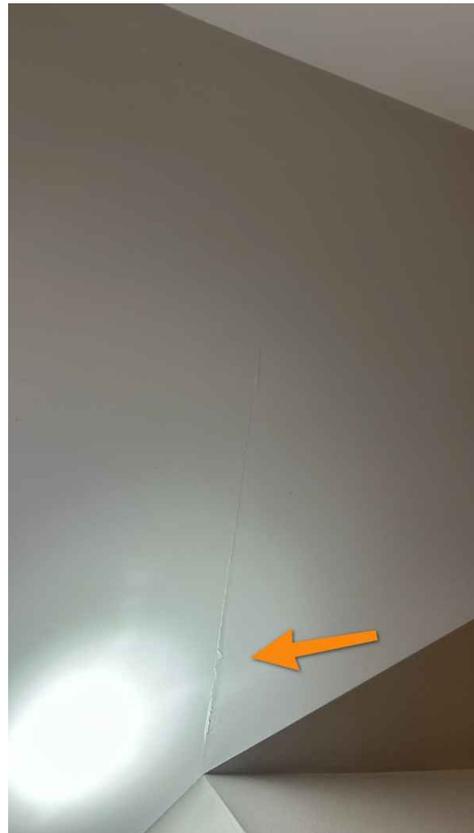
Ceiling crack

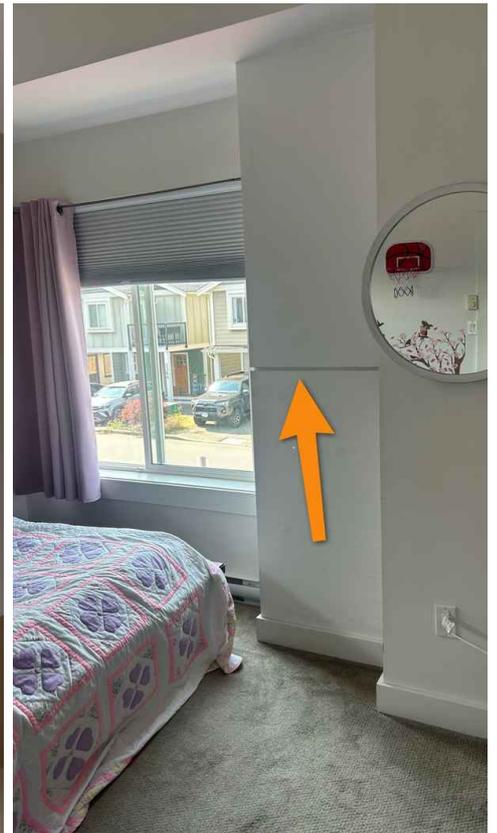
Accent wall

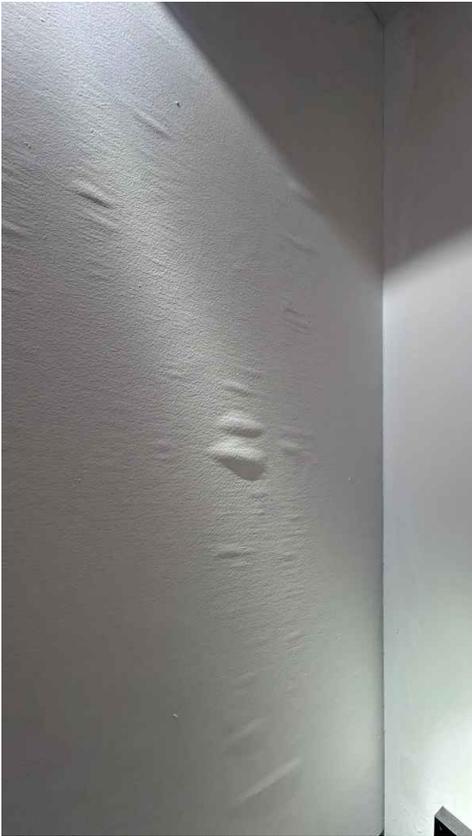
Bubbling paint/ drywall compound

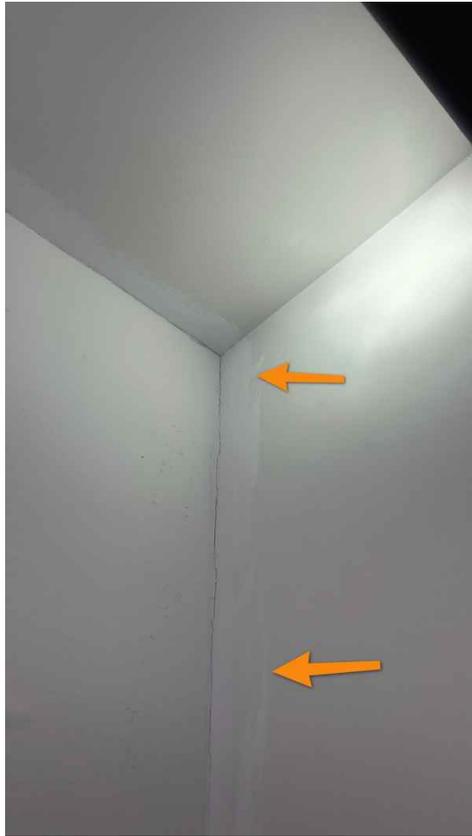
Bad paint job

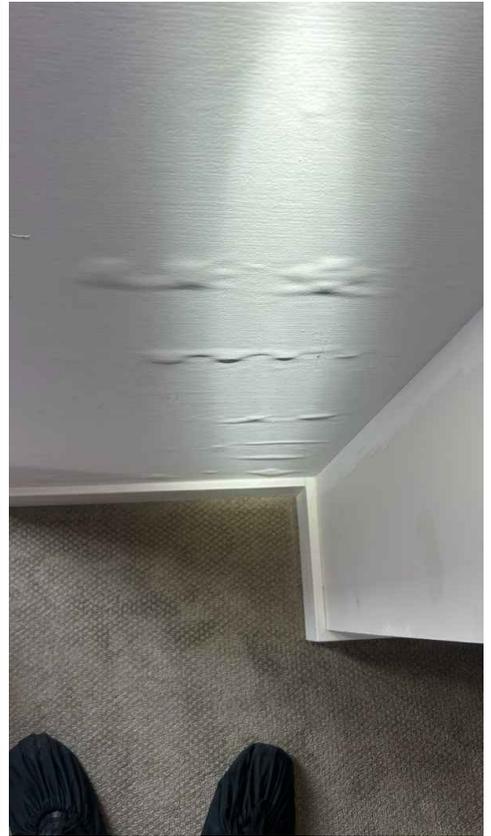
Bubbling paint/ drywall compound

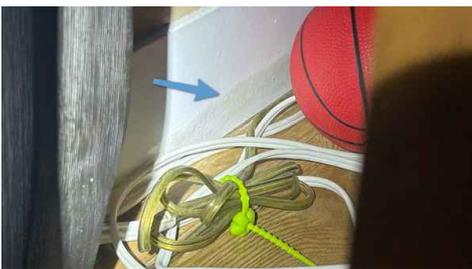
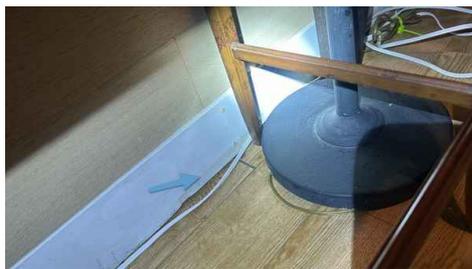
Swollen baseboards were observed in the dining room area, suggesting past moisture exposure. No active leaks were detected at the time of inspection. Repair or replacement of the affected trim can be carried out as desired for appearance, with monitoring recommended to ensure no ongoing moisture issues are present.

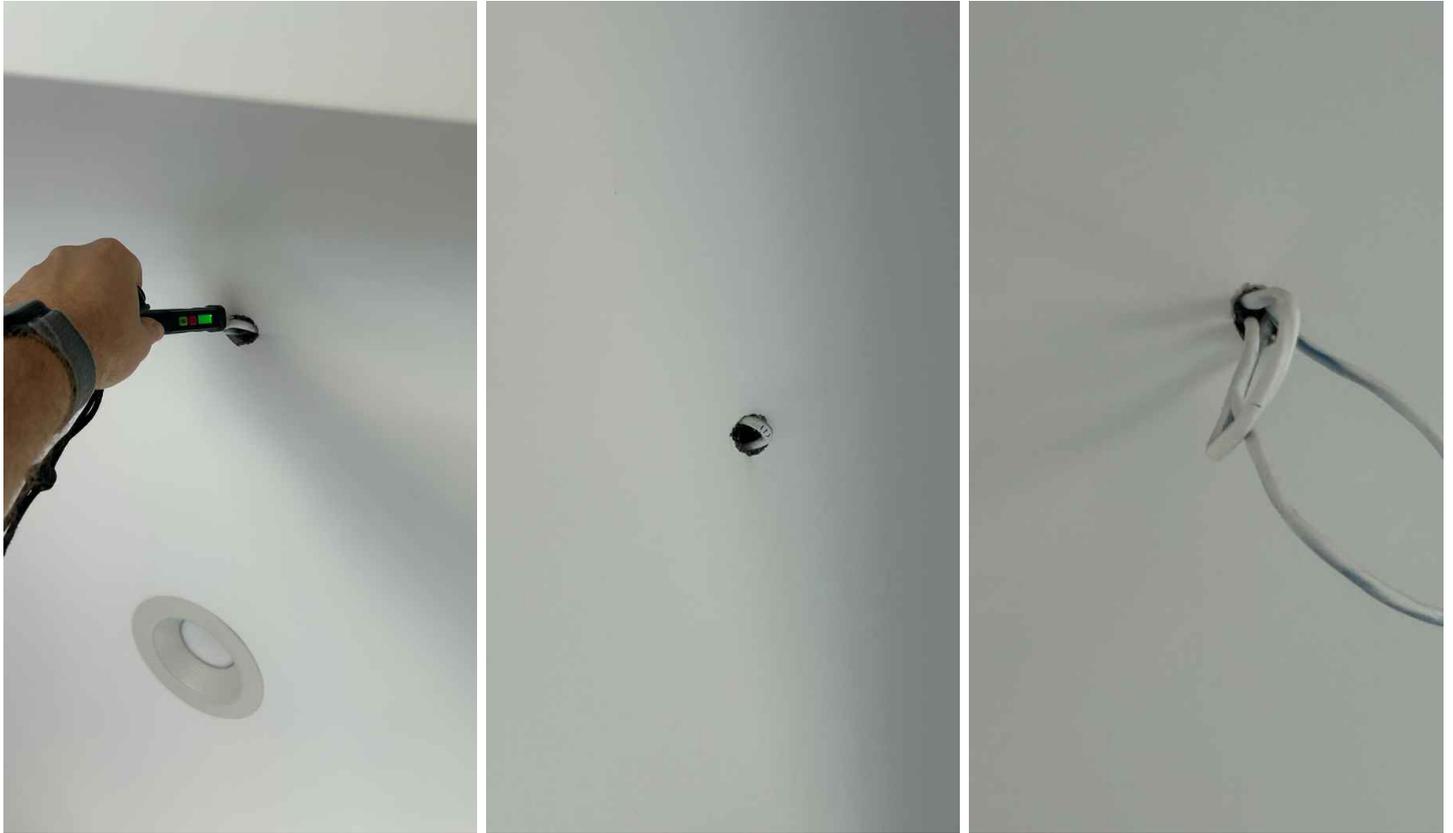
**SPARE BEDROOM – RANDOM CONDUCTORS IN VAULTED CEILING (ASK SELLER PURPOSE)**

Two holes were present in the vaulted ceiling of the spare bedroom, each with electrical conductors extending from them. One hole contained two looped conductors with no terminated ends, while the other contained a single conductor. All tested dead at the time of inspection. The purpose of these conductors was unclear, and they appeared to be the result of unfinished or amateur electrical work. This condition may relate to the boards observed in the attic, suggesting someone may have attempted to fish wiring through the ceiling. Clarification from the seller is strongly recommended, including whether permits were obtained and the intended purpose of the wiring. Further review and correction by a licensed electrician is advised if the wiring is to remain in use.

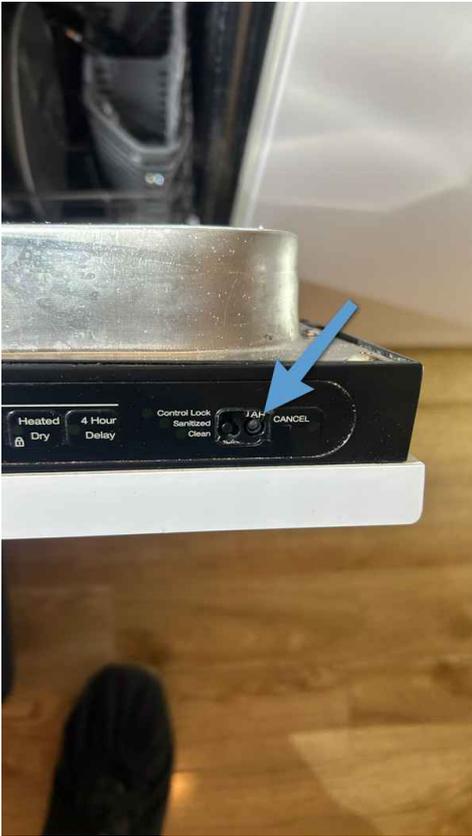
### **DISHWASHER – BROKEN START BUTTON COVER**

The dishwasher's start button was functional; however, the plastic cover over the button was missing. While the unit could still be operated, this condition may reduce durability and ease of use. Repair or replacement of the control panel or button cover is recommended as desired.

Broken button cover
