**WATCHTOWER**  
HOME INSPECTIONS

## RESIDENTIAL REPORT

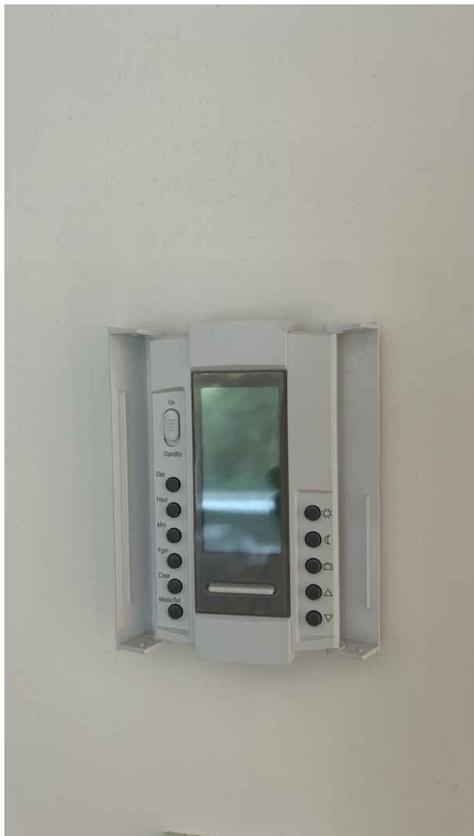
### HEATING – BASEBOARD HEATERS OFF AT PANEL

All baseboard heaters in the home were non-functional at the time of inspection as their circuits had been shut off at the electrical panel. As breakers are not re-energized during inspection, the heaters could not be tested. It is recommended to confirm with the seller that all baseboard heaters are operational and to verify their function once the breakers are restored.

No power to baseboard heaters

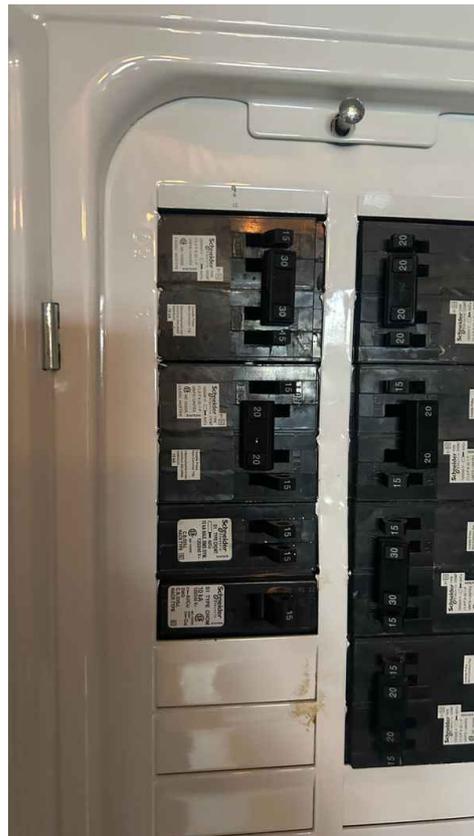
Heat off at panel

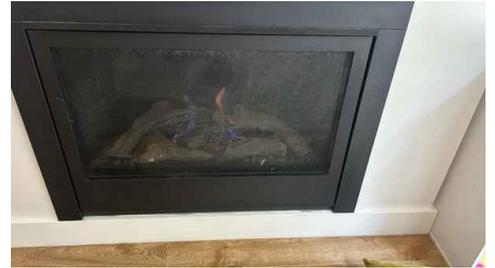
### **GAS FIREPLACE – FUNCTIONAL, SERVICE RECOMMENDED**

The gas fireplace was functional at the time of inspection and was equipped with a shut-off. Servicing by a qualified technician upon possession is recommended to establish a maintenance baseline, followed by routine servicing to ensure safe and efficient operation.

Service fireplace

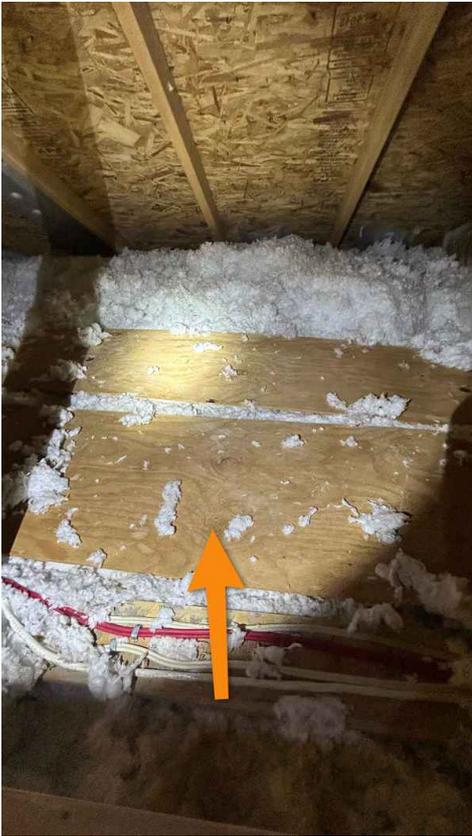
Several plywood boards were observed laid across the attic insulation, likely from previous handyman or trades work. These boards had compressed portions of the loose-fill fibreglass insulation, reducing its effectiveness since this insulation type relies on air pockets between the fibres for proper performance. At a minimum, the boards should be removed and the insulation fluffed back up to restore coverage. It is possible these boards are related to the presence of random conductors observed hanging from the ceiling in one of the bedrooms, though the purpose of these conductors could not be determined. Further clarification from the seller is recommended. Additional details on the conductors are provided in the electrical section of this report.

Plywood boards

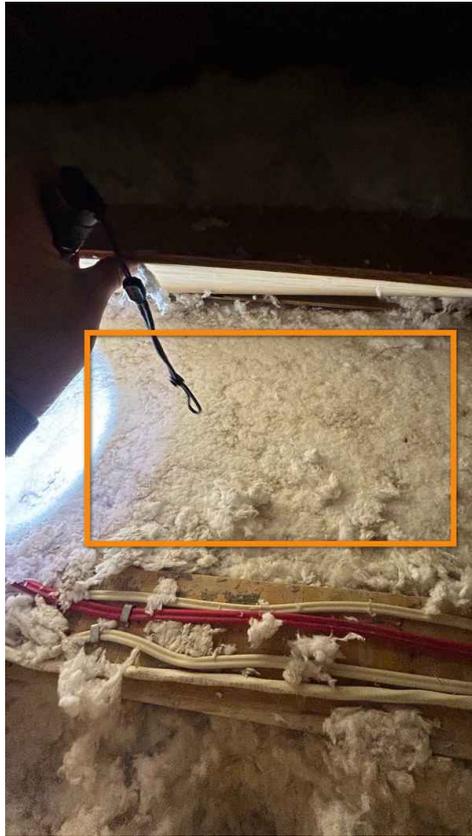
Compressed insulation

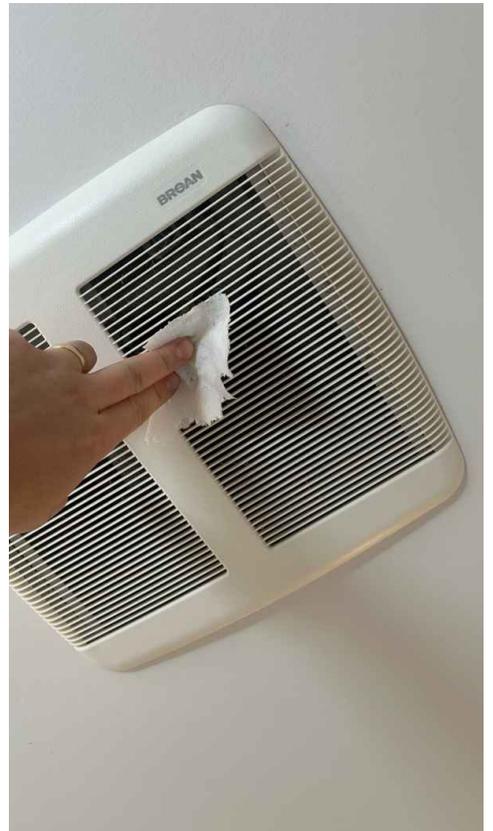
### PRIMARY ENSUITE BATHROOM – WEAK VENTILATION FAN

The ventilation fan in the primary ensuite bathroom had weak airflow at the time of inspection. Servicing or replacement is recommended to improve ventilation and help reduce excess humidity in the bathroom.

Fan cant pull toilet paper

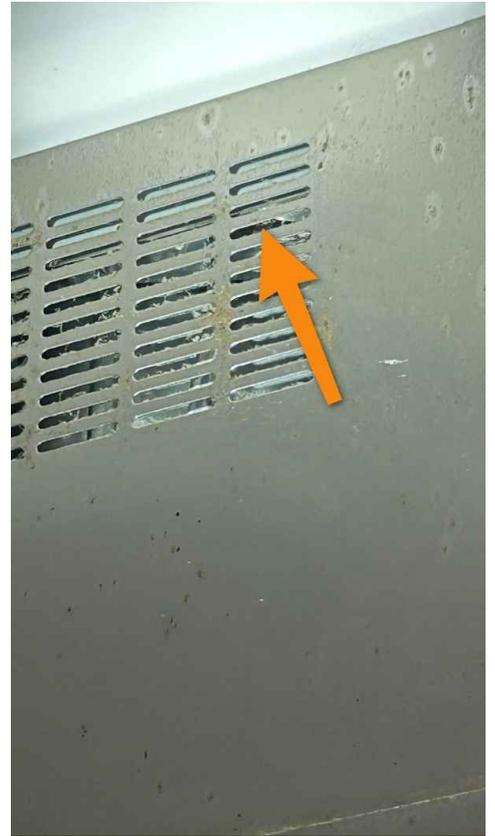
### **KITCHEN ISLAND HOOD VENT – POSSIBLE GAP AT CONNECTION**

The kitchen island hood vent appeared to be connected to exterior venting; however, a visible gap was noted at the duct connection when viewed through the upper grille. When the fan was operated on high, dust movement was observed, suggesting the seal may not be fully tight. While the vent is likely exhausting the majority of air as intended, the connection may not be completely sealed. This is noted for information, and resealing the duct connection can be considered to improve efficiency.

Gap at connection
