WATCHTOWER
HOME INSPECTIONS

RESIDENTIAL REPORT

1: INSPECTION DETAILS

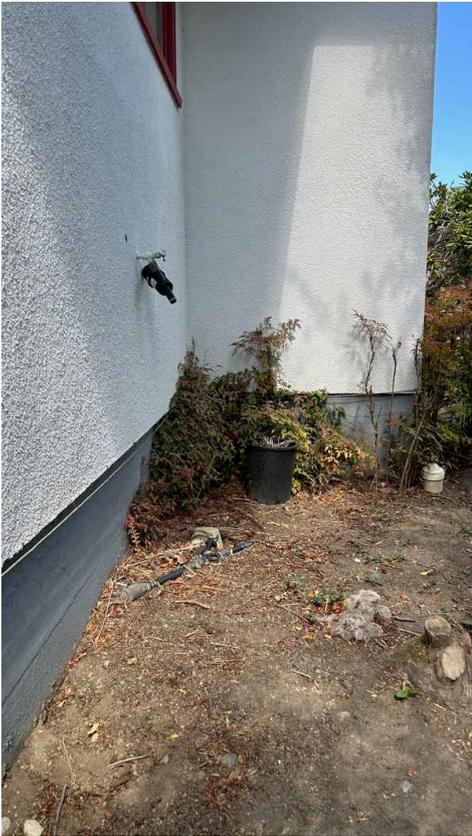
EXTERIOR STUCCO, WOOD SIDING, AND VEGETATION – CRACKING, PEELING PAINT, AND CONTACT ISSUES

The exterior stucco showed multiple areas of cracking and general degradation. The front-facing wood siding also displayed peeling paint, likely due to exposure from the limited roof overhang at the front of the home. In addition, vegetation was noted in contact with the siding in several locations. Stucco cracking and peeling paint can allow moisture intrusion and accelerate deterioration if not addressed, while vegetation contact restricts airflow and promotes wear. Maintenance is recommended, including sealing stucco cracks, repainting the exposed siding, and trimming vegetation back from the home's exterior.

Vegetation touching siding

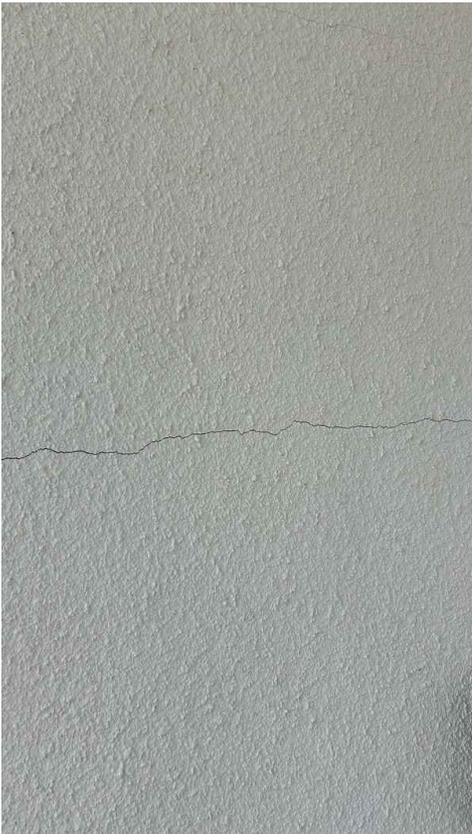
Stucco crack

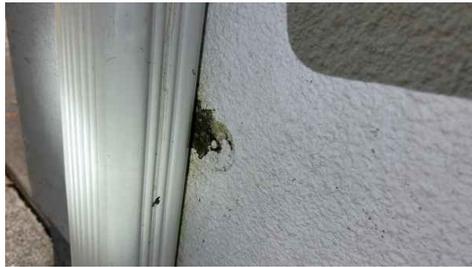
Stucco damage

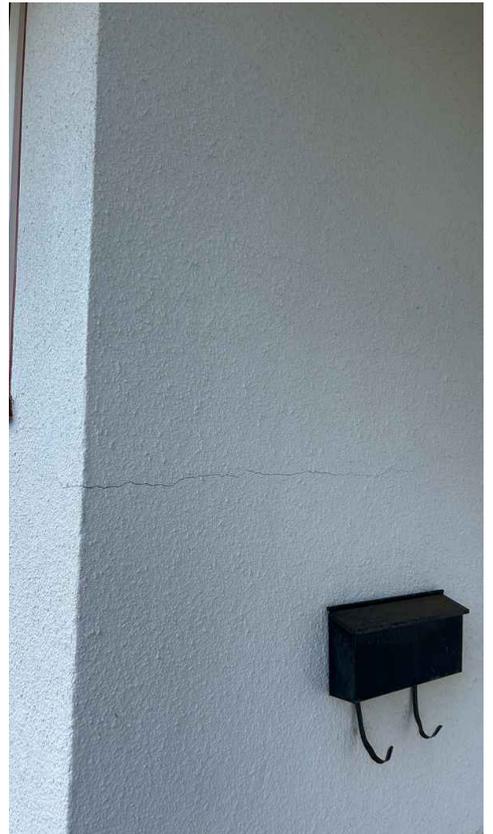
Stucco crack

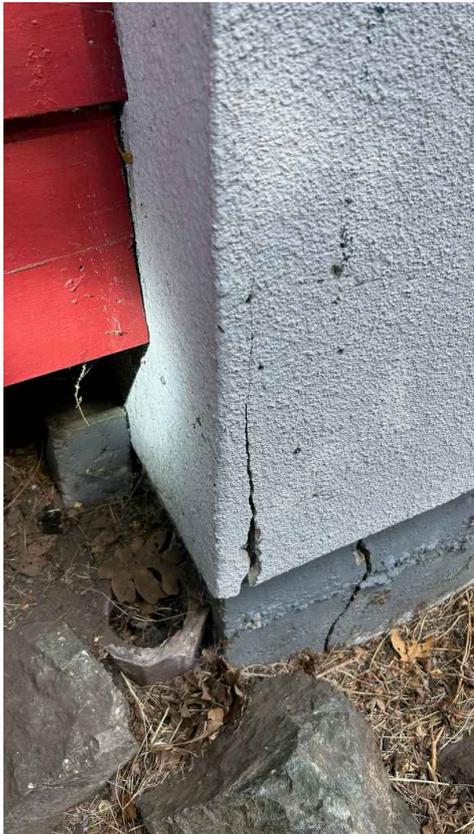
A small addition or jut-out of the kitchen, finished with wood siding, was observed. The structure appeared to be properly supported on posts and footings; however, the underside of the addition was not insulated. While structurally sound, adding insulation to the created cavity is recommended to improve energy efficiency and comfort in the kitchen area.

Additio wood/ Stucco cracks

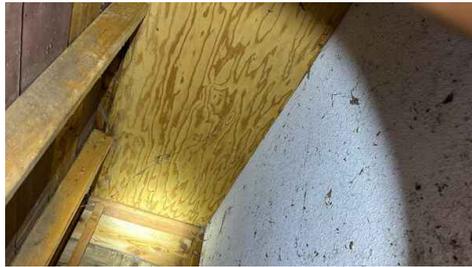
No insulation

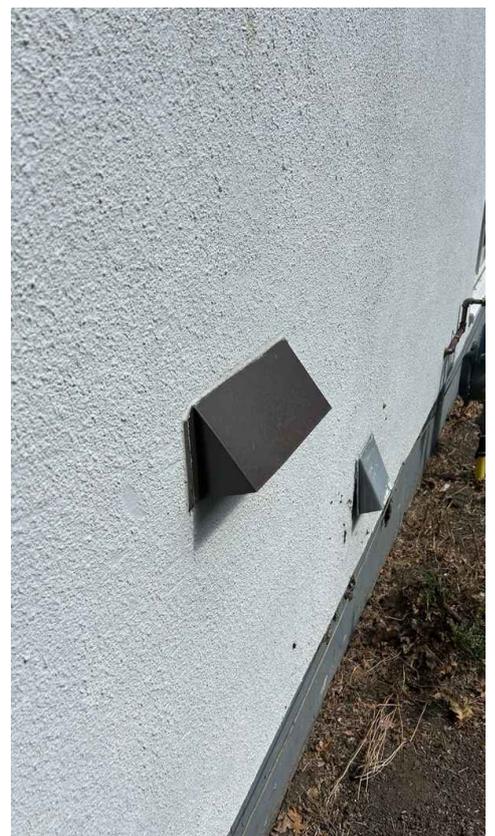
2.1.2 Siding, Flashing & Trim

EXTERIOR SIDING – MISSING FLASHINGS AT PROTRUSIONS

Several siding penetrations, such as vents, were missing proper flashings. Relying solely on sealant in these areas can increase the risk of water intrusion over time. Installing appropriate flashing around siding penetrations is recommended to improve durability and weather resistance.

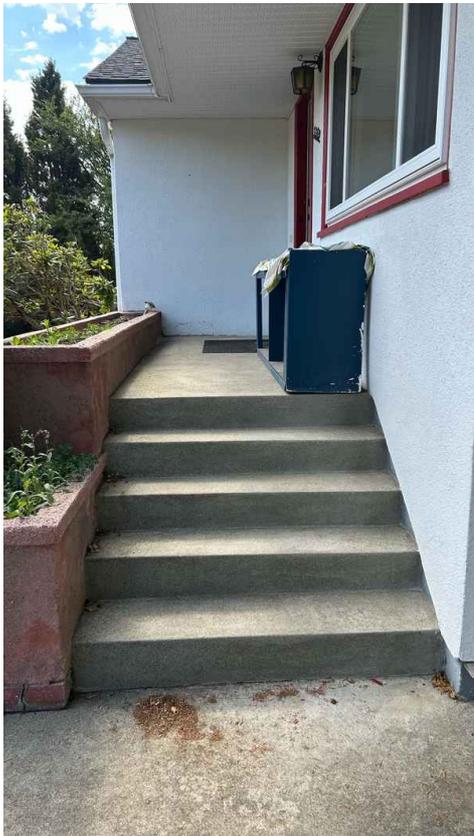
ENTRYWAYS, STAIRS, AND DECK – MISSING HANDRAILS, TRIP HAZARDS, AND DETERIORATION

All primary entry points into the home presented safety concerns. The front concrete steps leading to the main entry were missing a handrail, and the driveway surface was cracked, creating potential trip hazards. At the rear, the concrete steps descending into the basement were also without a handrail. A small wooden deck with stairs was noted to have an incomplete handrail that did not extend the full length of the stairs. The supporting post for this deck was rotted, and the stair treads showed sagging. The overall stability of the deck could not be confirmed, as the connection to the house was not visible. While currently functional, the deck was not constructed to proper standards, and replacement or significant upgrades, along with the installation of handrails at all stairways, is strongly recommended to improve safety.

Missing handrail

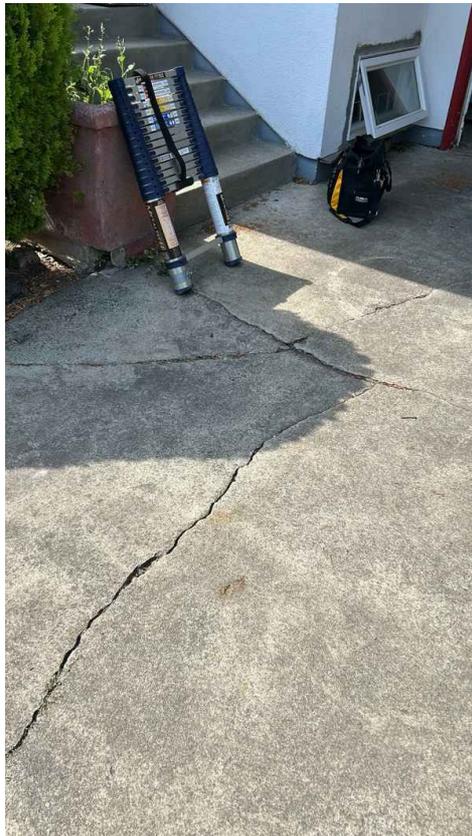
Trip hazards

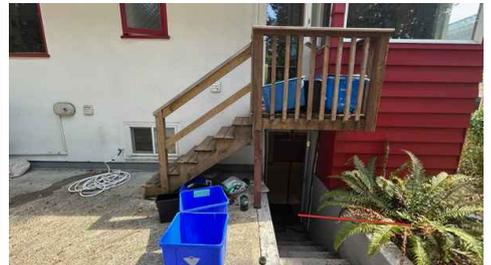
Missing handrail, unsafe deck

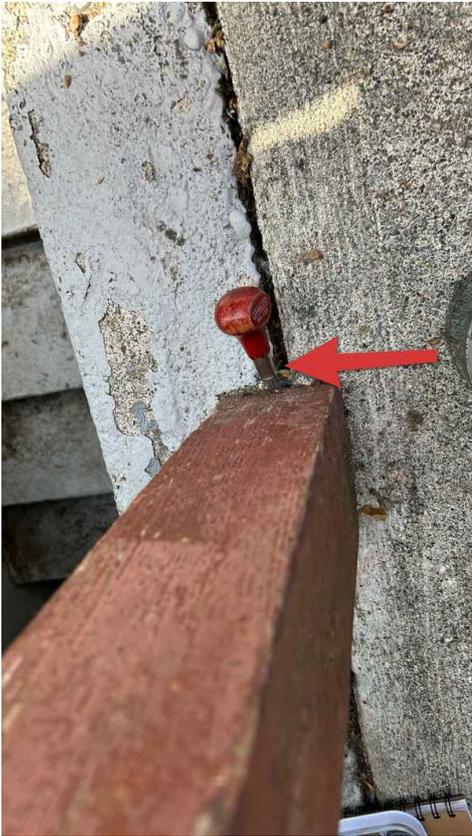
Rotten post

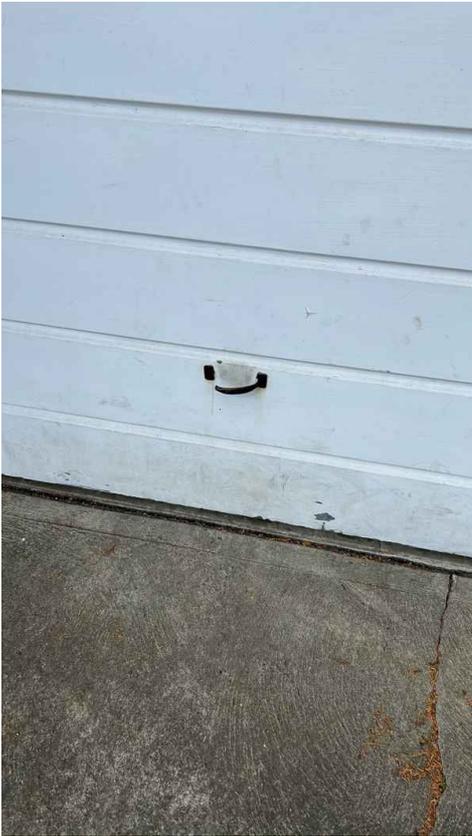
The garage door was an older aluminum style without interlocking panels and was difficult to operate. The handle was broken, and the springs remained under tension when the door was closed. The door did not fully shut, leaving gaps that allow weather and rodents to enter the garage. Evidence of rodent activity was also noted in the garage space. While the door provided limited function, it did not offer adequate security or weather protection and will likely require replacement.

Broken handle

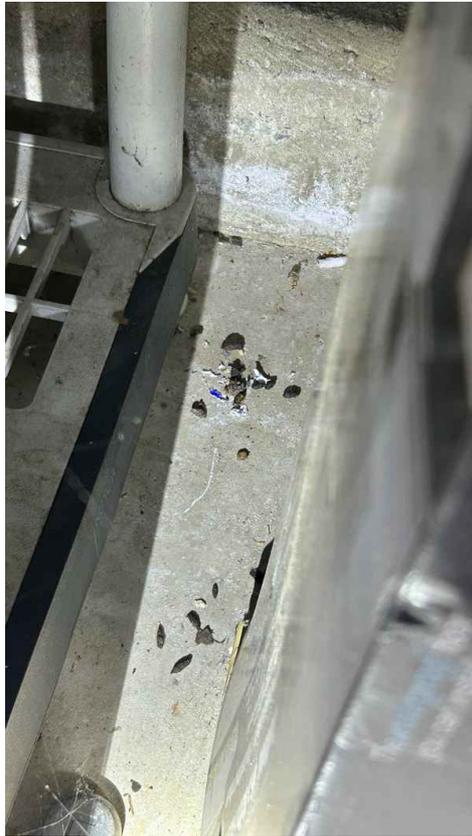
Rat Droppings

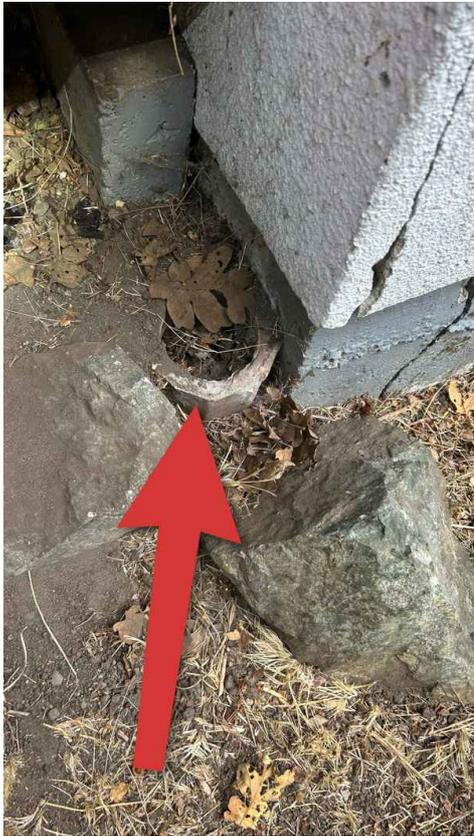
The property's perimeter drainage system appeared to consist of mixed materials, including concrete tile, clay tile, and possibly metal sections. These older materials are prone to deterioration, blockages, and reduced effectiveness over time. A perimeter drainage scope by a qualified contractor is strongly recommended before subject removal to confirm condition and functionality. In addition, many of the downspouts had been updated to larger, modern sizes that did not fit securely into the smaller perimeter drainage risers. As a result, water may bypass the system and discharge adjacent to the foundation, increasing the risk of localized water intrusion. Adjusting downspouts to properly connect with the perimeter drainage system, or otherwise directing water away from the foundation, is recommended.

Clay tile

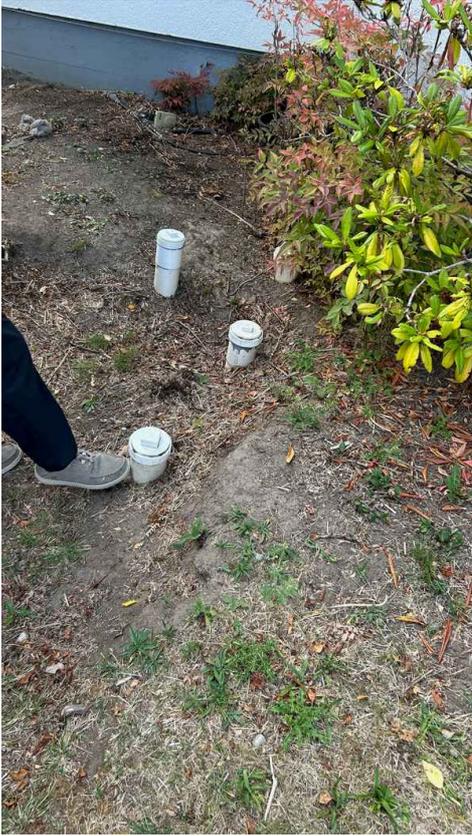
At the front of the property, four PVC risers with drain-style covers were observed protruding from the ground. These did not appear to be functional perimeter drainage risers. Their purpose is unclear, though they may be related to a previously buried oil tank or other historical site work. Further investigation is recommended to determine their function and confirm whether any environmental or structural concerns are associated with them.

Identify what these are for

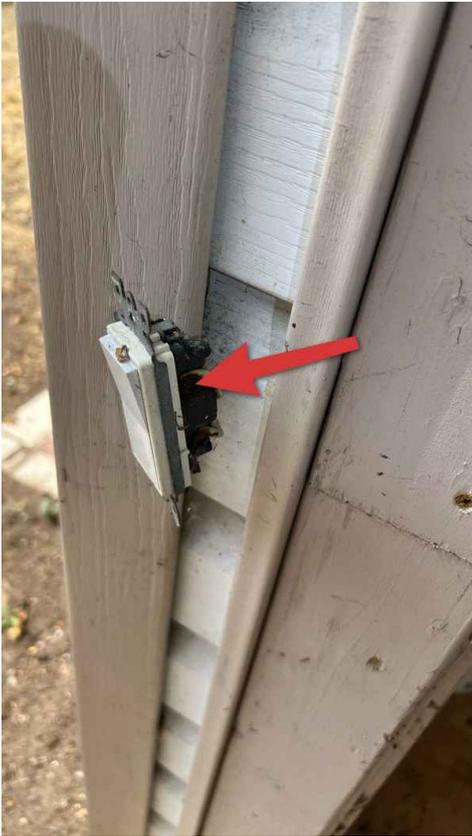
The backyard shed-like structure was in poor condition and appeared to be a makeshift or amateur build. The overhang at the entryway was sagging, and a tree was growing through part of the roof and gutter area. Significant moss buildup, siding covered by grade, unstable flooring, evidence of rodents and pests, open soffits, and exposed electrical connections were also observed. The structure is not suitable as a living space and offers limited practical use in its current state. It should be considered as-is, with no specific recommendations other than noting its deteriorated condition.

Elec hazard

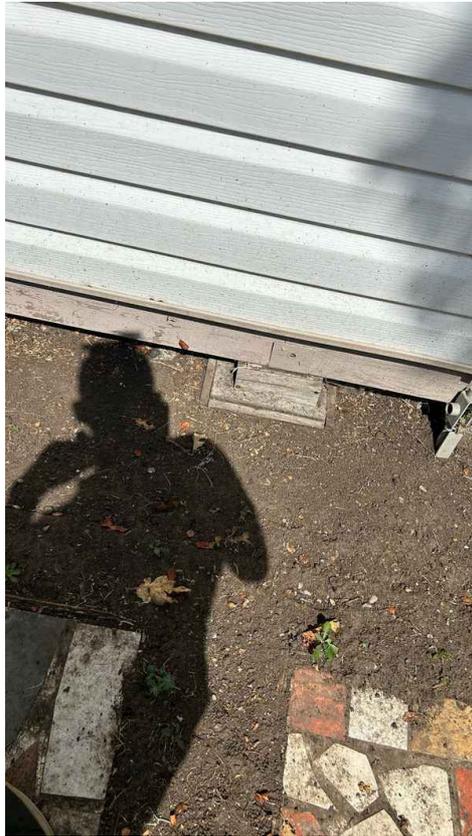
Unstable structure

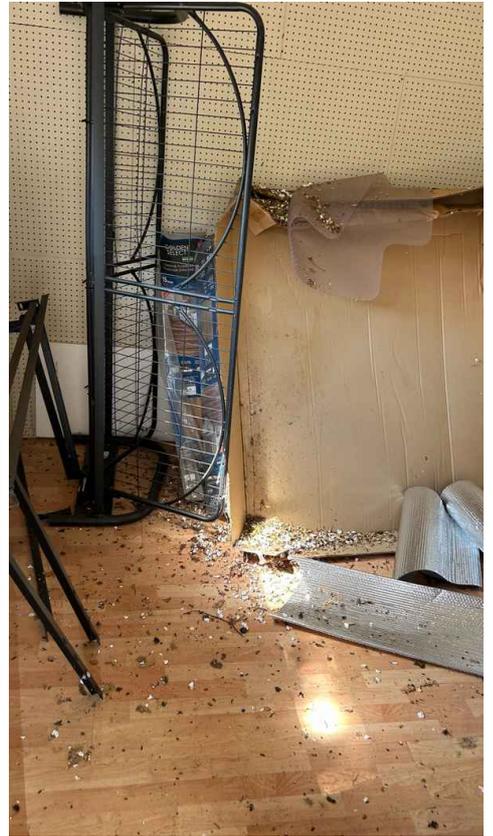
Pests

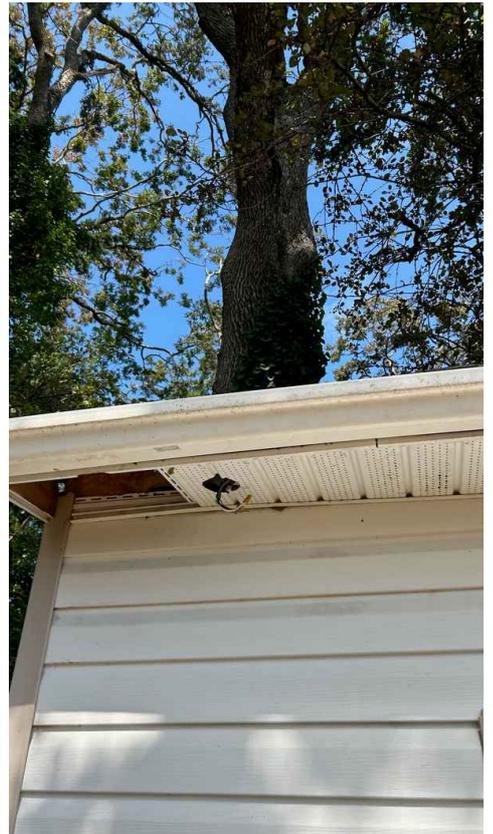
Hole in soffit, open junction box

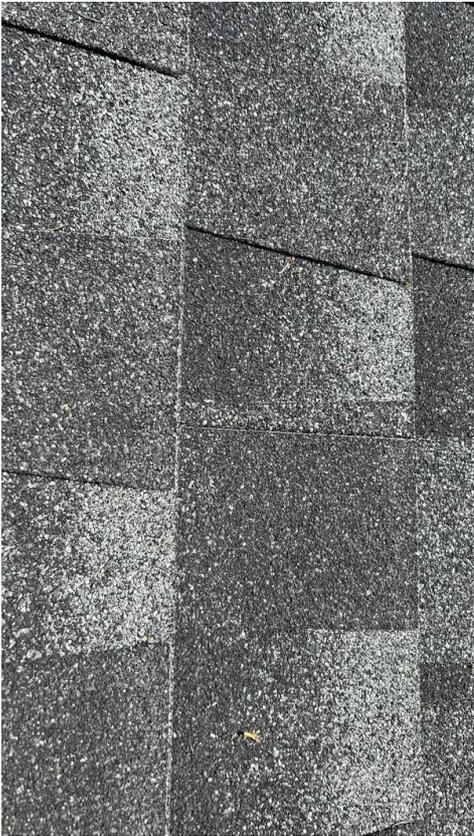
The roof appeared to be in the middle stages of its service life, with minimal fiberglass matting exposed and moderate to low granular loss. Debris and some moss growth were observed on the surface. Cleaning the roof and trimming back nearby trees will help extend the longevity of the roofing material. The chimney itself was in excellent condition; however, rain caps should be installed on the flues to prevent water entry and improve durability. Regular maintenance and upkeep will support the continued service life of the roof.

Shingle condition

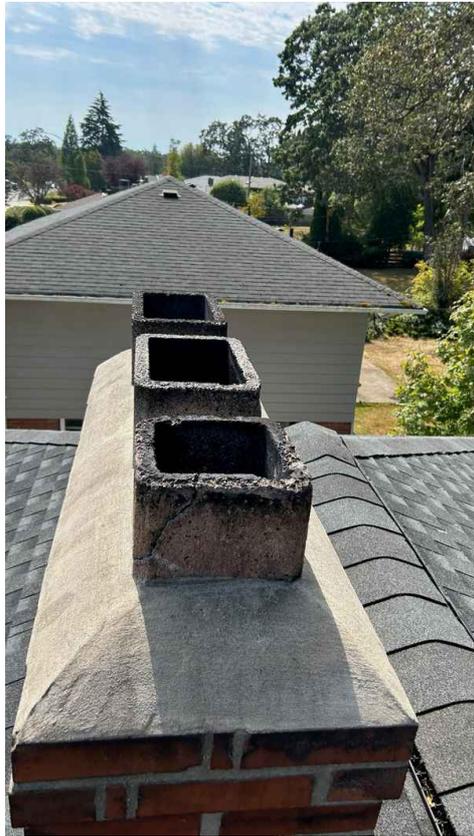
Missing rain cap

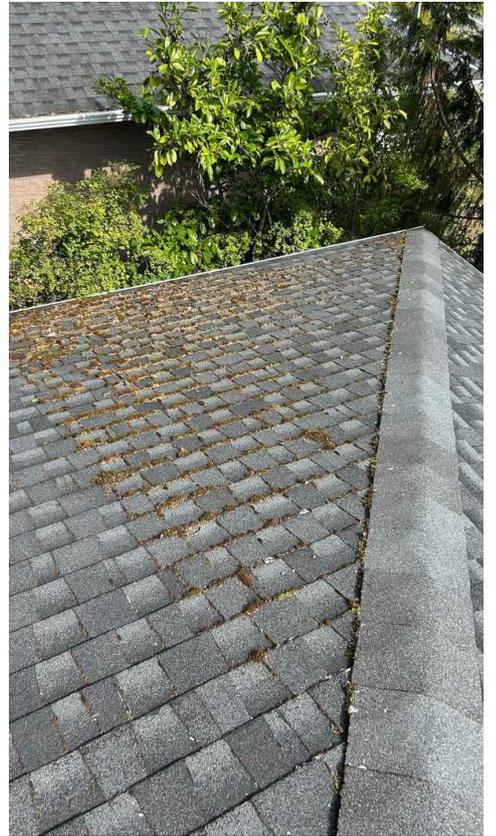
Moss growth

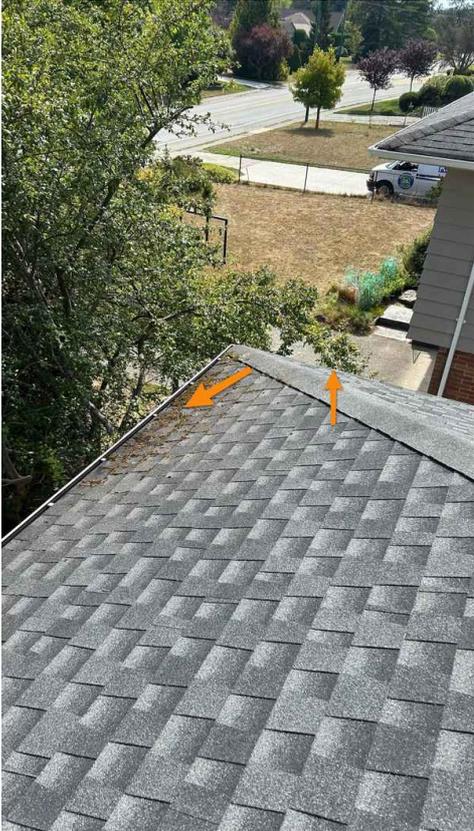
Moss growth, tree proximity

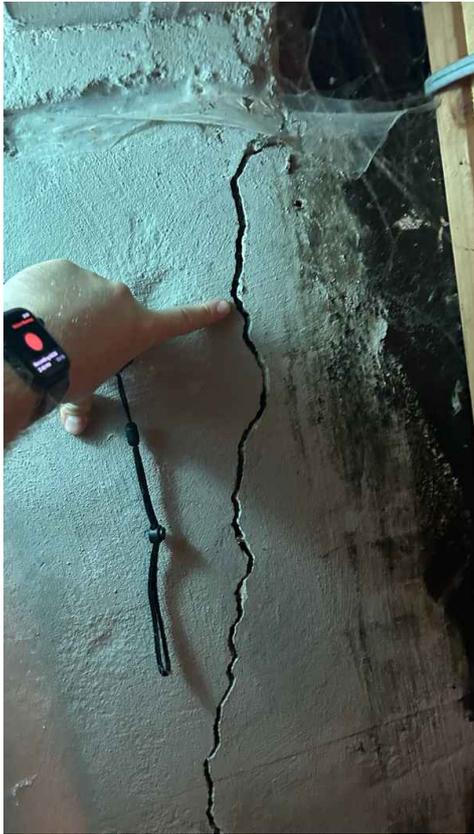
FRONT CONCRETE PORCH AND FOUNDATION - UNDERMINING AND STRUCTURAL CONCERNS

The front concrete porch showed signs of undermining, likely related to negative grading in the area directing water toward the foundation. Significant cracking was observed in the basement foundation wall adjacent to the porch. While this may indicate the porch is moving independently of the main foundation, the extent of cracking warrants review by a structural engineer to determine stability and required repairs. Additional minor cracks were noted in other areas of the exterior foundation; however, the primary concern remains the significant basement crack near the porch. Correction of grading around the porch is also recommended to help limit further water intrusion and movement.

Crack under porch

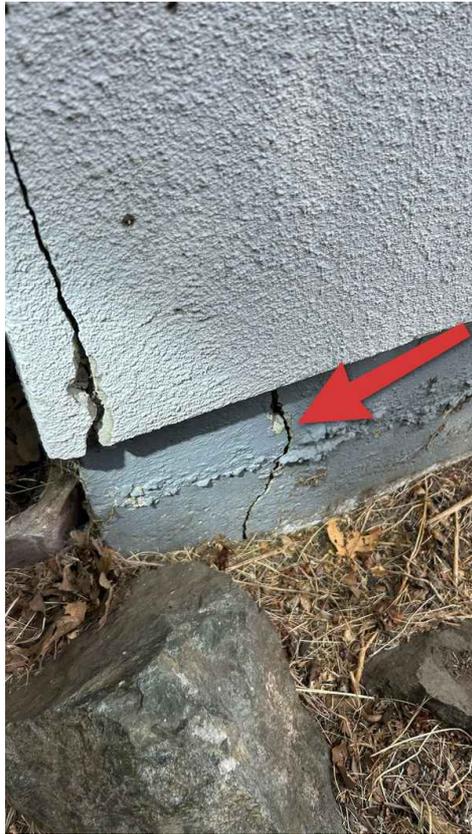
Foundation crack

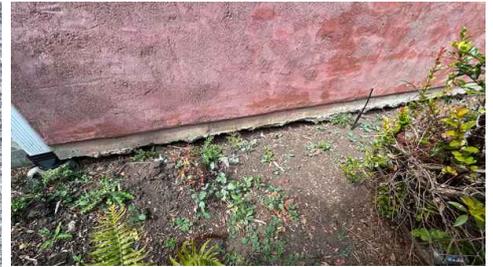
Undermining of porch

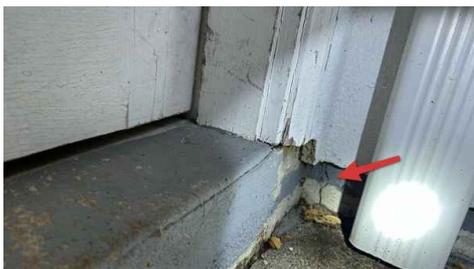
Minor crack

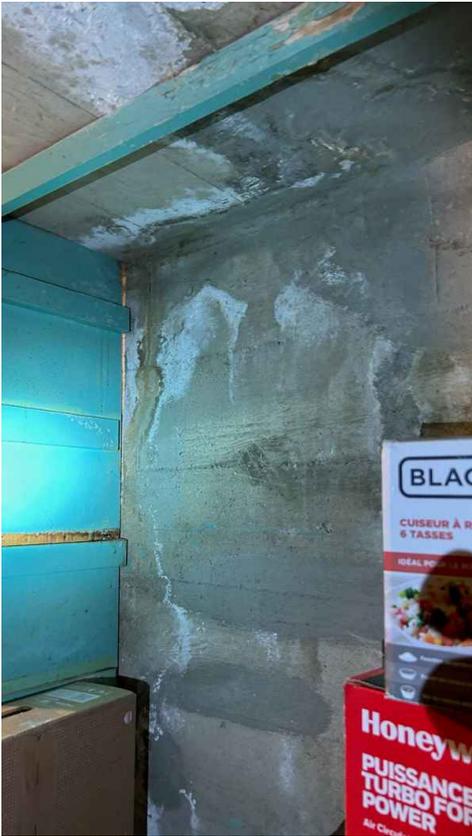
FOUNDATION EFFLORESCENCE - GARAGE AND PORCH BASEMENT

Efflorescence was observed on sections of the garage foundation and in the porch basement area. This is likely due to moisture migrating through the concrete, possibly from irrigation or surface water contact. While not uncommon or immediately concerning, continued monitoring is recommended, and managing surface water away from the foundation will help reduce recurrence.

Efflorescence

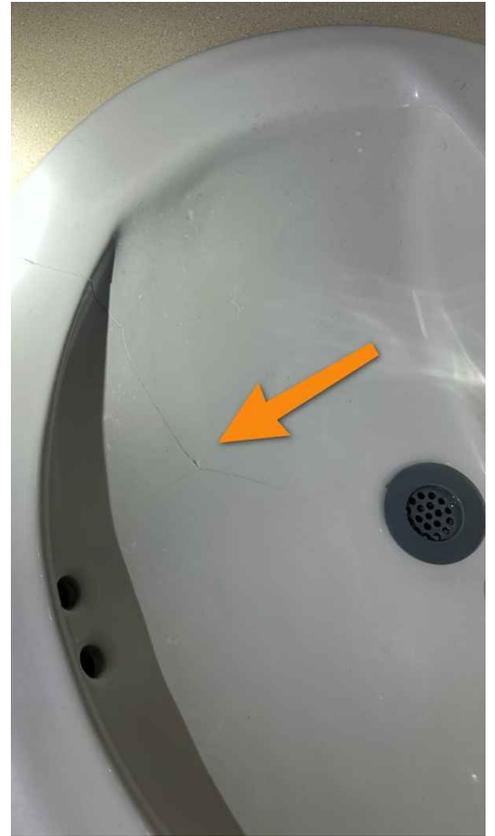
DOWNSTAIRS BATHROOM – CRACKED SINK BASIN

The sink basin in the downstairs bathroom was cracked. Replacement of the basin is recommended to restore full function and prevent further deterioration.

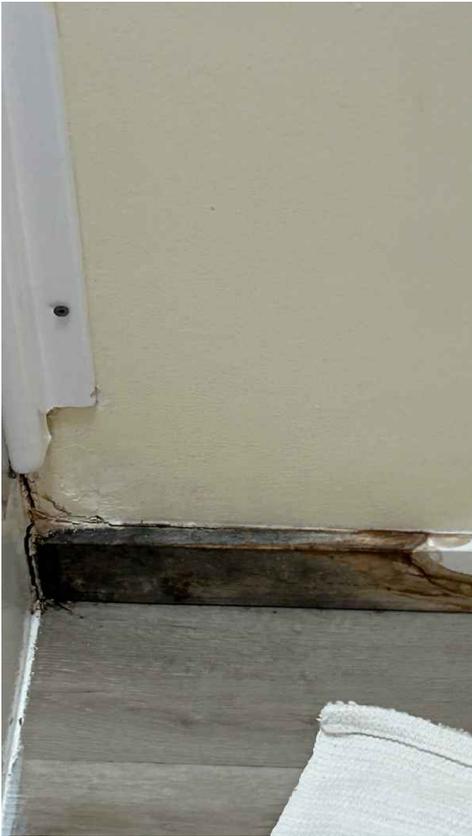
BATHROOMS – POOR CAULKING, MOISTURE CONCERNS, AND POSSIBLE HIDDEN DAMAGE

Caulking maintenance was needed throughout the home. The upstairs en-suite shower had deteriorated caulking, and the upstairs main bathroom's caulking was in very poor condition, with evidence of improper application. These conditions increase the likelihood of moisture intrusion and hidden damage behind tiled surfaces. In the basement bathroom, the stall shower showed the most concern: the adjacent baseboard was severely rotted and moisture meter readings were elevated in surrounding areas. This indicates an active leak with a high likelihood of concealed damage. Re-caulking and sealing are recommended in all bathrooms, and repairs to the basement shower should be prioritized, with further evaluation for hidden damage behind the affected areas.

Severe rot, possible mould, hidden damage likely

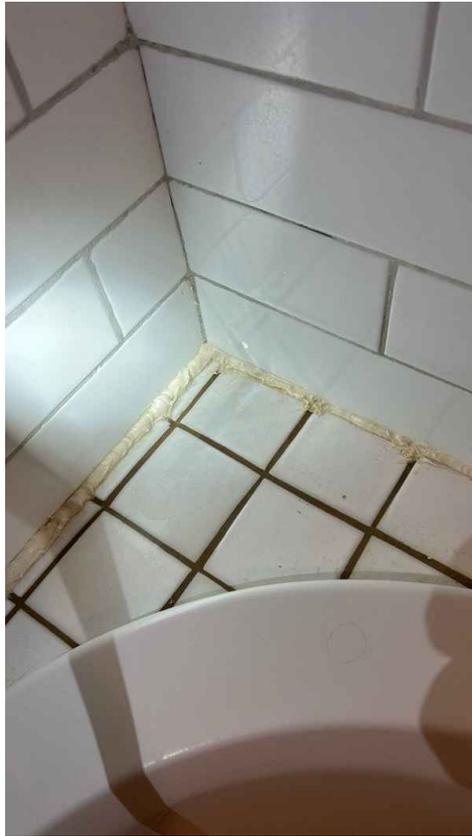
Amateur caulk job

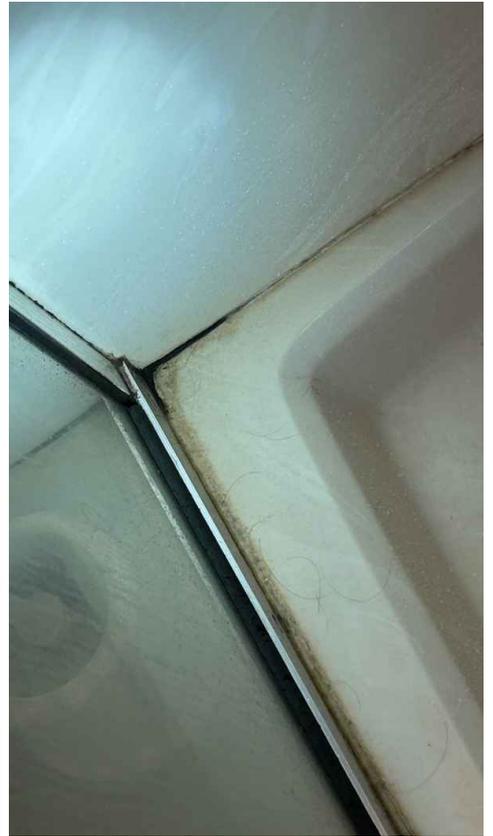
Resilicone

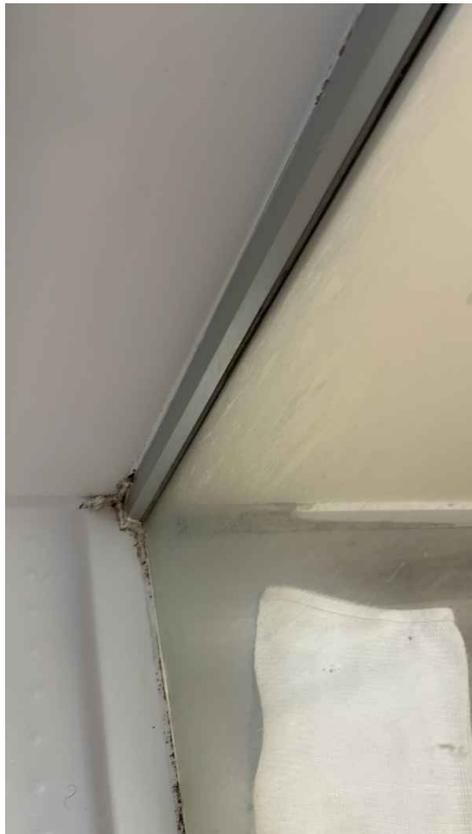
Update seal, possible replacement of stall

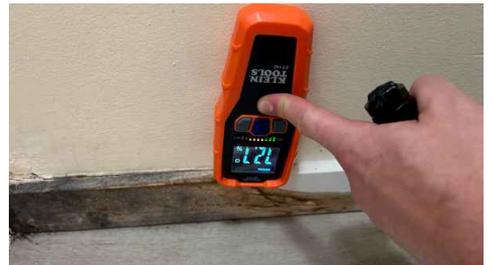
High moisture readings

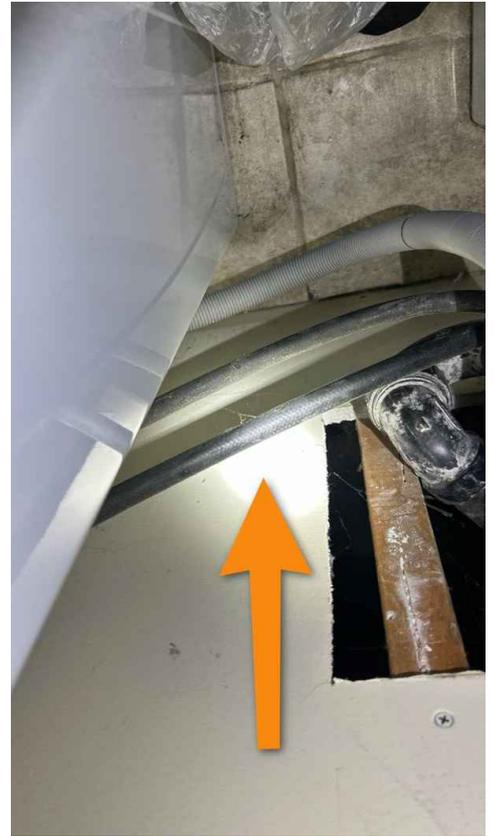
LAUNDRY AREA – WASHING MACHINE HOSES

The washing machine in the downstairs laundry area was equipped with standard rubber hoses. Upgrading to braided stainless steel hoses is recommended, as they are more durable and significantly reduce the risk of hose rupture and water damage.

Upgrade washer hoses

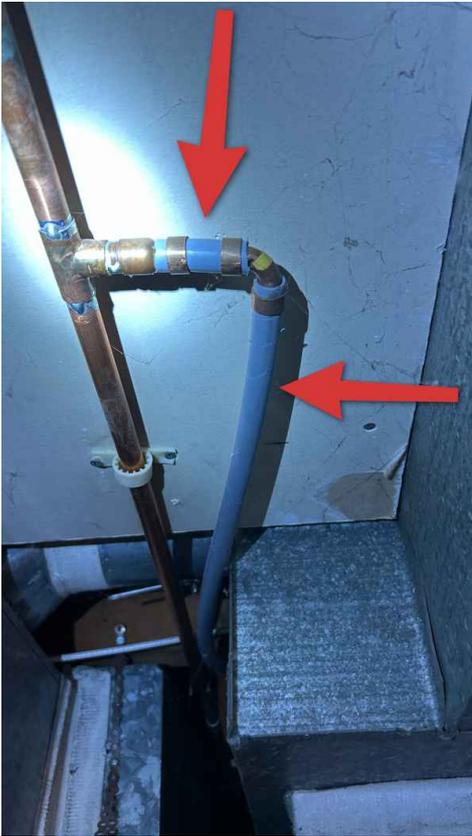
PLUMBING MATERIALS – CAST IRON, COPPER, AND POLY-B PRESENT

The home contained a mix of plumbing materials, including cast iron drain, waste, and vent piping, with portions of the sewer line also in cast iron. Cast iron piping is often past its service life and is prone to internal corrosion and eventual failure. Given the home's 1957 build era, older copper supply piping may also still be present within the walls. Copper has an expected service life of 40–60 years depending on water conditions, meaning remaining original sections could be approaching or past their useful life despite subsequent renovations. In addition, a section of polybutylene (Poly-B) piping was observed near the utility area at the furnace and hot water tank. Poly-B is considered an insurance concern due to its documented history of failures. The combination of these older and less reliable materials should be considered when planning future upgrades, and confirmation with your insurance provider is recommended before subject removal.

Poly B

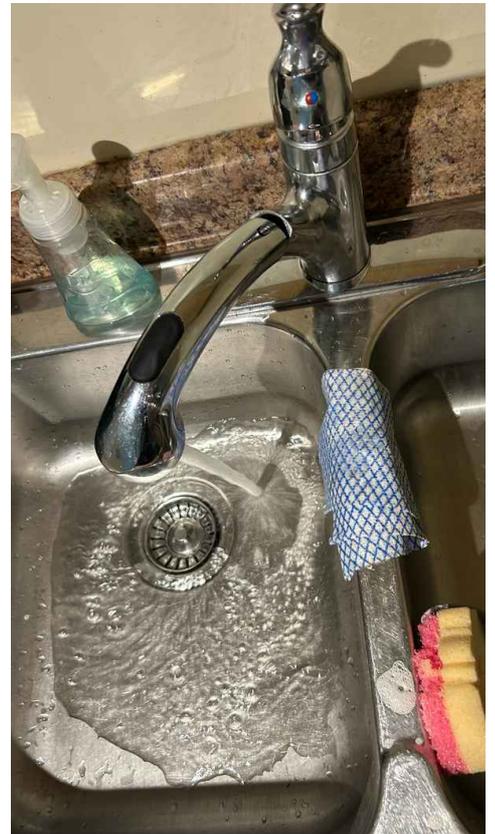
BASEMENT KITCHEN SINK – LOOSE FAUCET WAND

The faucet wand at the basement kitchen sink could not be secured into its holder and remained sagging when not in use. Adjustment or replacement of the faucet assembly is recommended to restore proper function.

Loose faucet

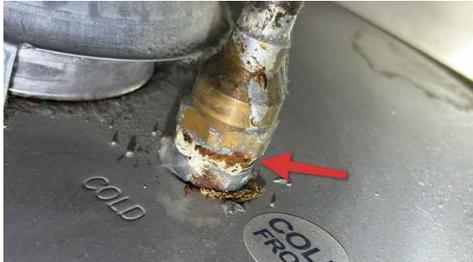
HOT WATER TANK – 2016 UNIT, APPROACHING END OF LIFE

The natural gas hot water tank was manufactured in 2016. It was missing an expansion tank, seismic straps, and a drip pan, all of which are recommended safety features. The cold-water inlet also showed minor signs of corrosion, rusting, or possible leakage. With a typical service life of 9–12 years, this unit is approaching the end of its expected lifespan. Replacement planning is advised in the next couple years, and installation of the missing safety components should be addressed.

Rusted cold inlet possible leak

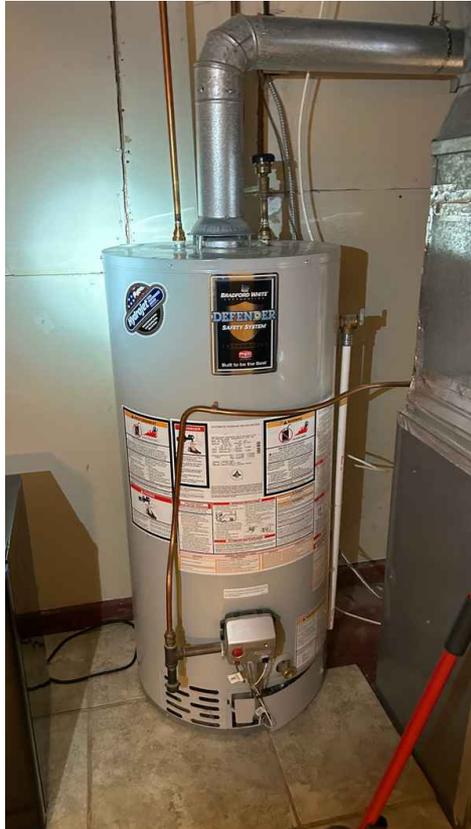
Missing safety features

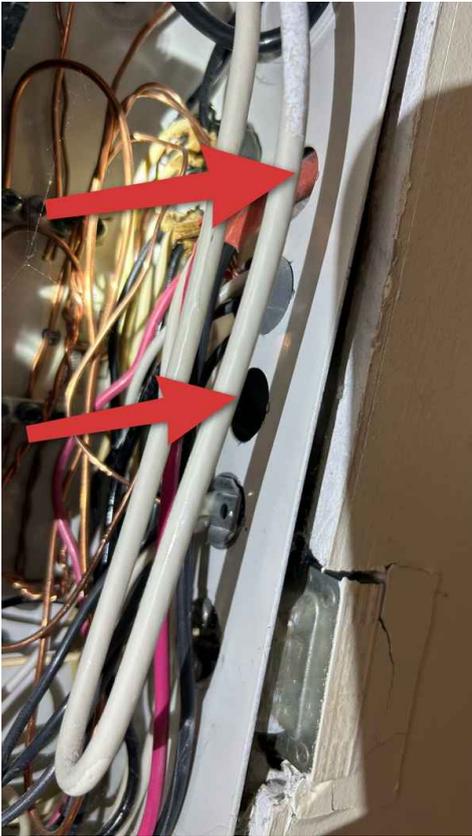
The home was equipped with a 100-amp main electrical service. Within the panel, two double taps, a terminated conductor, and two missing knockouts were observed. The panel was also completely full, with no available space for additional breakers. For a house of this size (six to seven bedrooms), a 100-amp service is undersized for the electrical demand and number of potential occupants. Upgrading the service size is strongly recommended, along with consideration of splitting circuits between a main panel and sub-panel(s) to better accommodate the home's layout and provide safer, more reliable electrical distribution.

Missing knockouts

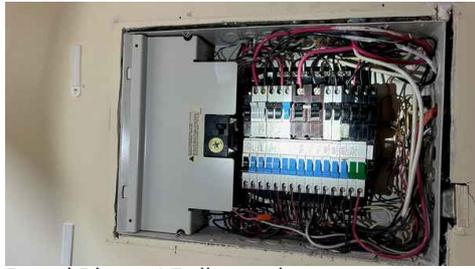
Panel Photo/ Full panel

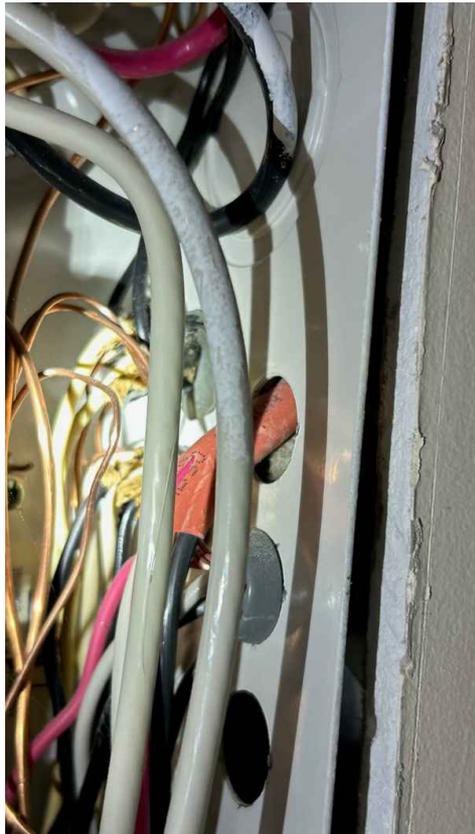
Missing knockout

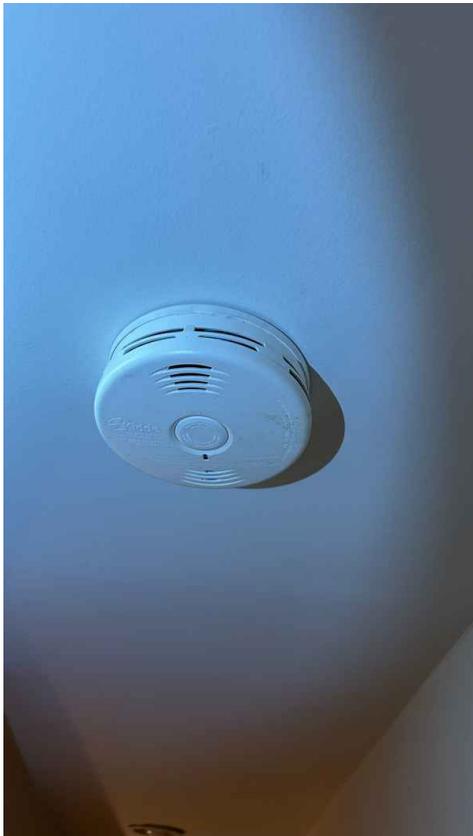
The upstairs level was equipped with a single smoke detector in the common area, expiring in 2029. The downstairs had smoke and carbon monoxide detectors present, though at least one unit appeared significantly aged and may be past its service life. Current safety standards recommend smoke detectors in all sleeping rooms, as well as smoke and carbon monoxide detectors in common areas and near fuel-burning appliances. For life safety, installation of new, up-to-date detectors in the recommended locations is strongly advised immediately upon possession.

Expired CO detector

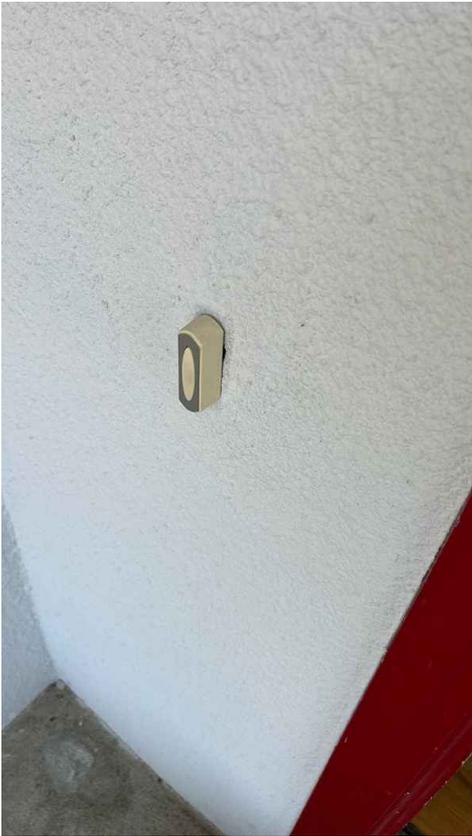
FRONT ENTRY DOORBELL – NOT FUNCTIONAL

The doorbell at the front entry was not operational at the time of inspection. Repair or replacement is recommended if desired for convenience and functionality.

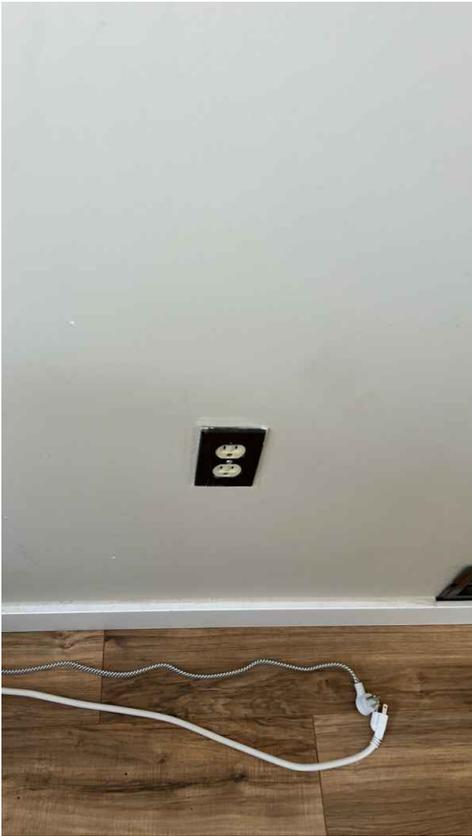
Several electrical concerns were noted throughout the home. Some outlets were of the older two-prong style without a ground connection and should be updated for safety and modern use. No GFCI protection was present in the kitchens, and a few outlets around the home were loose. Missing cover plates were also observed, and one outlet tested as having an open neutral. These conditions reduce electrical safety and functionality. General electrical cleanup and upgrades by a licensed electrician are recommended.

Loose outlet

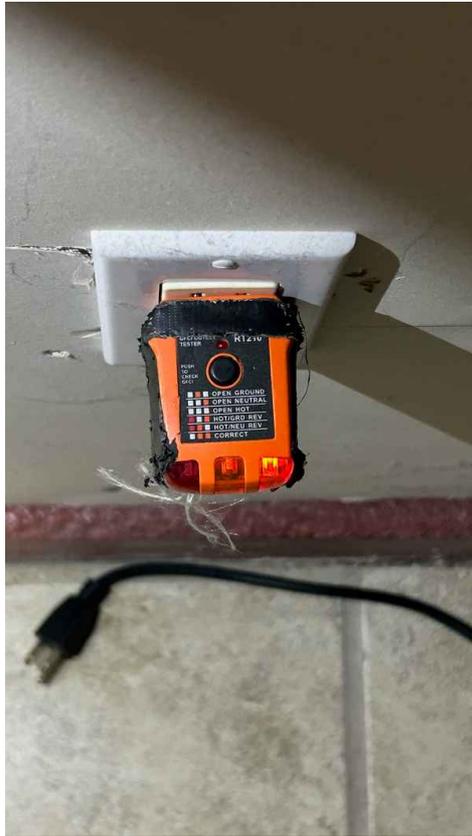
Open neutral

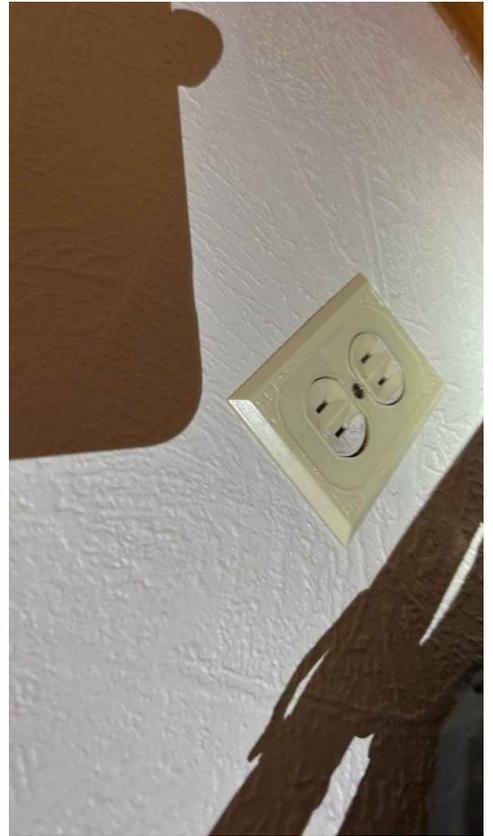
Outdated outlet

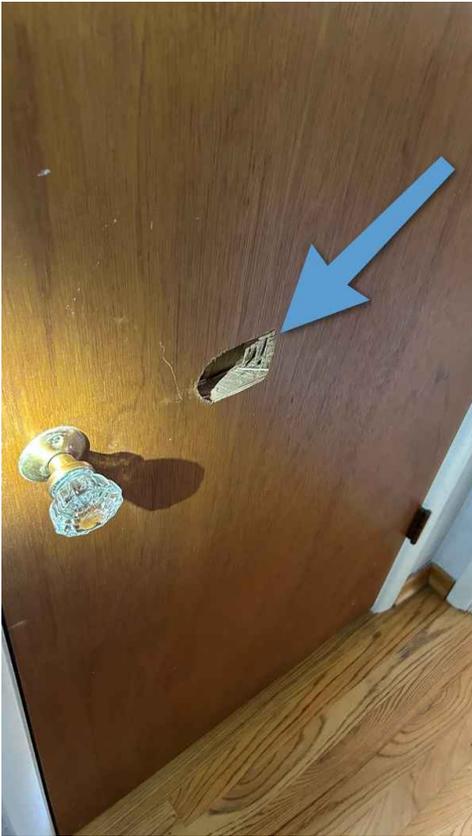
INTERIOR DOORS – GENERAL DAMAGE AND LOOSE HARDWARE

Several interior doors were noted to be in poor condition. Issues included loose hardware, a door with a hole in it, and others with damage such as flaking or deterioration at the bottom. Most doors were of a hollow-core style and showed wear consistent with age and use. Repair or replacement of damaged doors and adjustment of loose hardware is recommended for proper function and appearance.

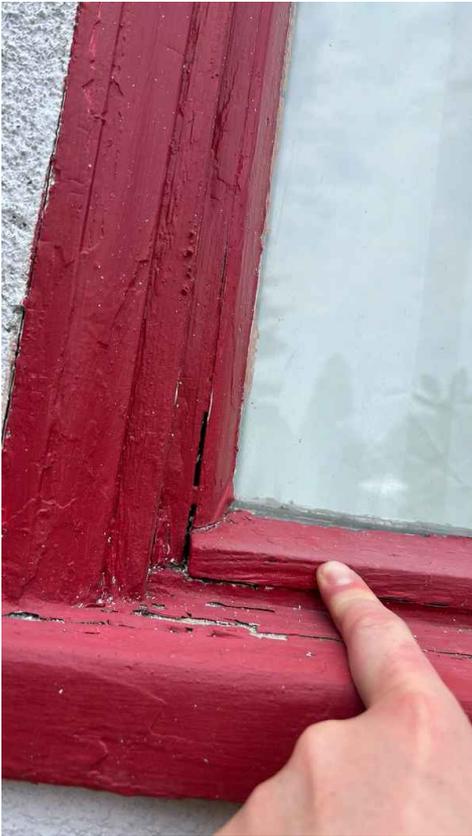
WINDOWS – MIXED AGES, MISSING FLASHINGS, AND REPLACEMENT RECOMMENDED

The home was equipped with a mixture of updated vinyl windows and older single-pane casement or fixed units. In one bedroom, a window was entirely missing and had been boarded over. None of the windows were equipped with exterior flashings, instead relying on exterior-grade sealant, which provides less durable protection against water intrusion. Many of the single-pane wood-framed windows were inefficient, showed signs of wear, and were difficult to operate due to loose hardware or early stages of exterior frame rot. These conditions reduce energy efficiency and durability. Replacement of older and deteriorated windows, along with proper flashing installation, is recommended in the near future.

Rotting frames

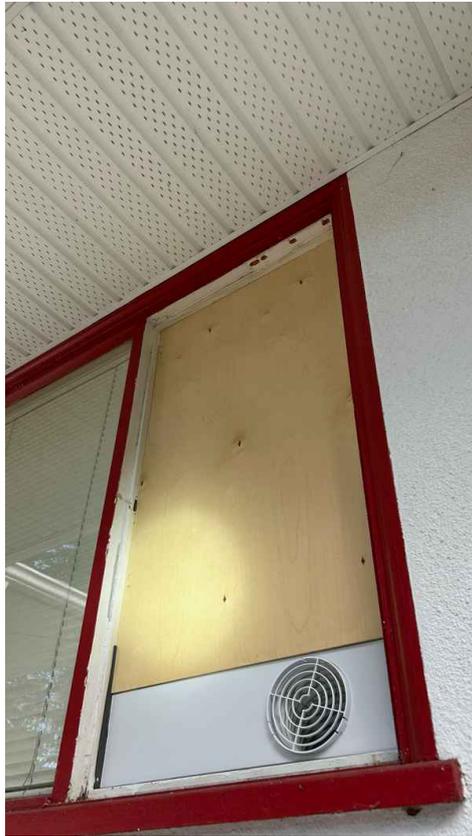
Missing pane

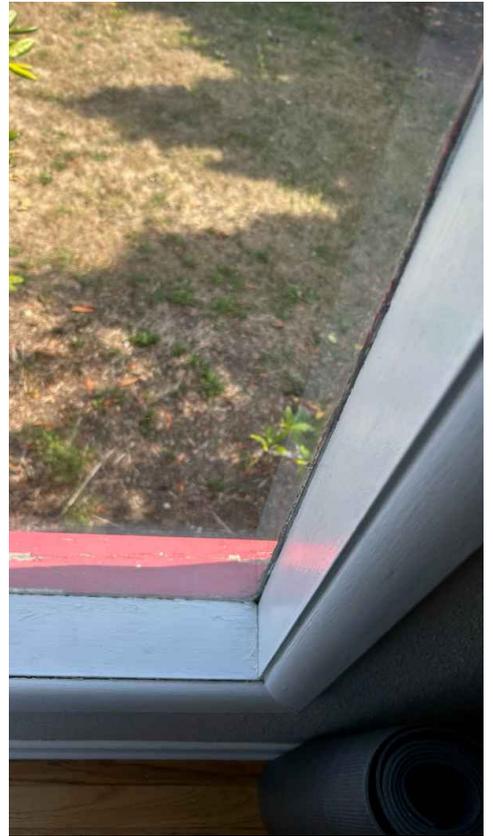
Single pane windows

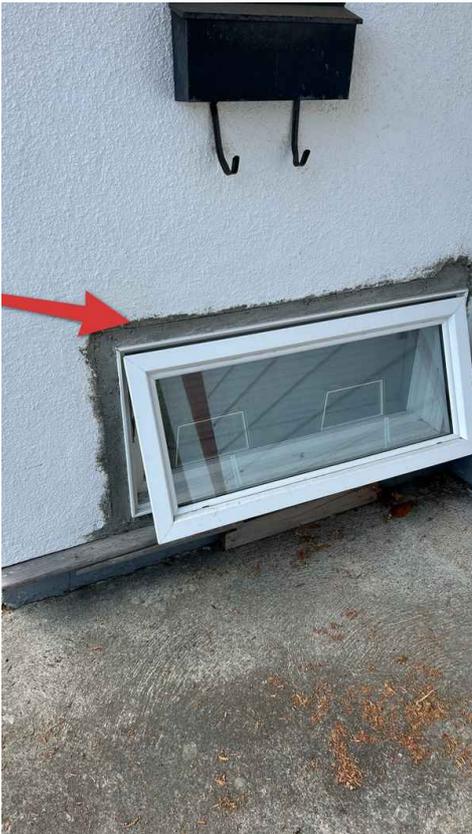
Missing flashing

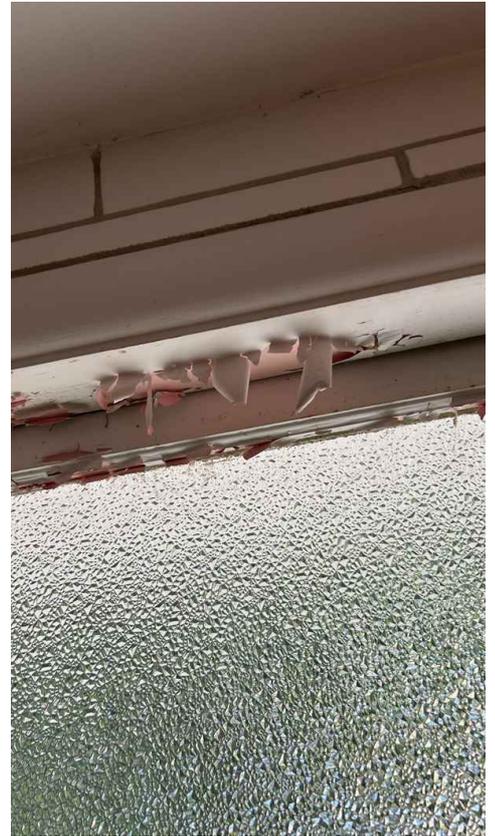
7.2.2 Windows

One of the upstairs bathroom window frames exhibited severely peeling paint. This condition leaves the wood vulnerable to moisture intrusion and deterioration. Scraping, priming, and repainting are recommended to protect the frame and restore its appearance.
