WATCHTOWER
HOME INSPECTIONS

RESIDENTIAL REPORT

1: INSPECTION DETAILS

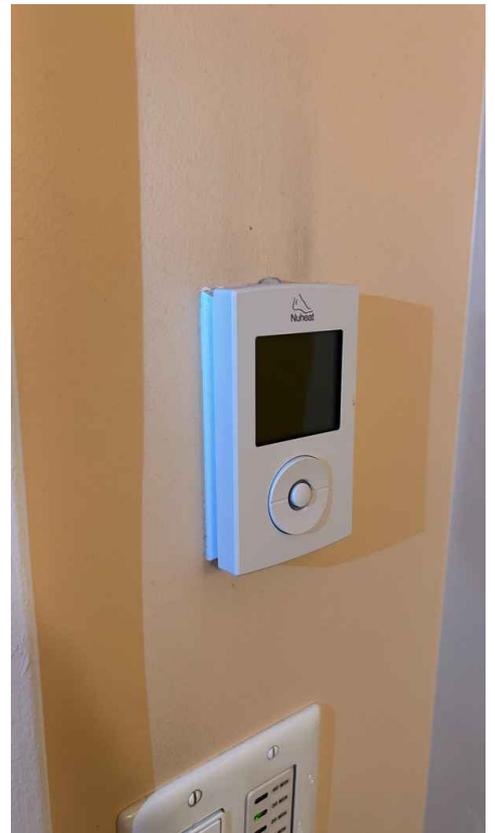
PRIMARY EN-SUITE – HEATED FLOOR NOT OPERATIONAL

The heated floor in the primary en-suite bathroom was not functional at the time of inspection, with no power detected at the system. As a result, its operation could not be confirmed. Further evaluation and repair by a qualified contractor is recommended if use of the heated floor is desired.

Infloor heat not functional

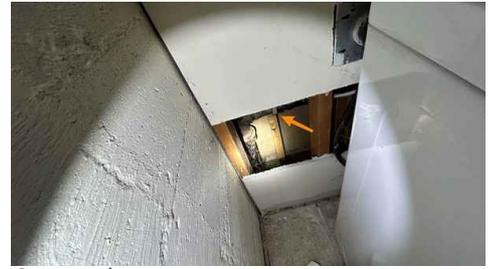
In the unfinished wall of the laundry room, one wall stud had been notched to accommodate plumbing. While this is not uncommon, notching can reduce the structural strength of the stud. Monitoring is recommended, and reinforcement or installation of a protective plate may be considered to maintain wall integrity.

Cut stud

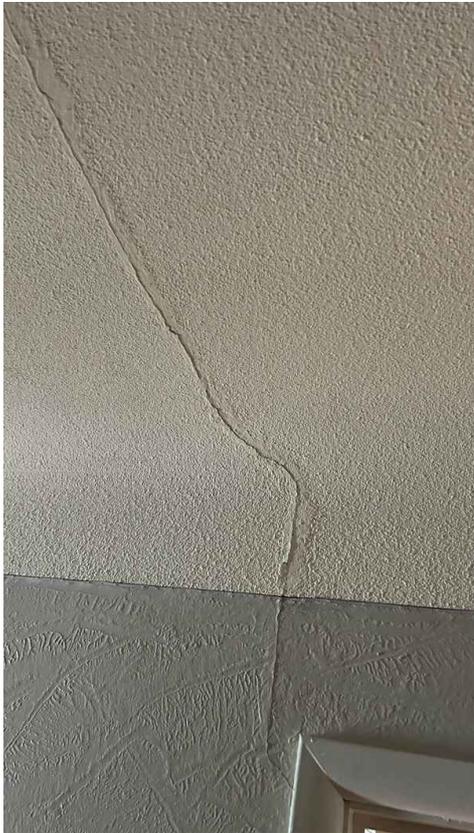
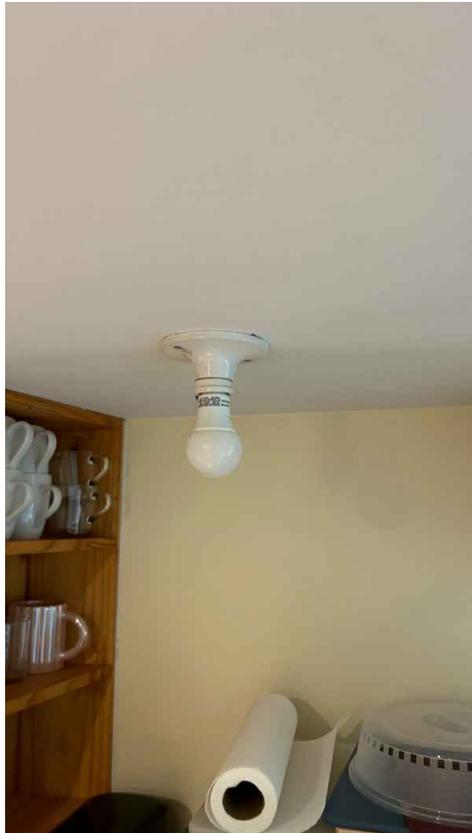
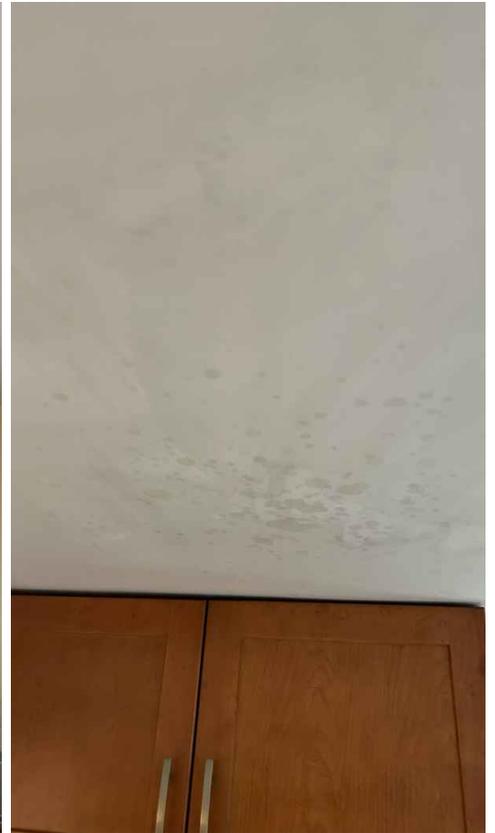
7.5.1 Ceilings

Various cosmetic issues were noted throughout the home. These included ceiling stains and cracks, patched areas in one of the bedrooms, an unprotected light fixture in the basement kitchen, and what appeared to be surface water stains in the basement bathroom. These concerns are largely cosmetic in nature but reflect general wear and maintenance needs.

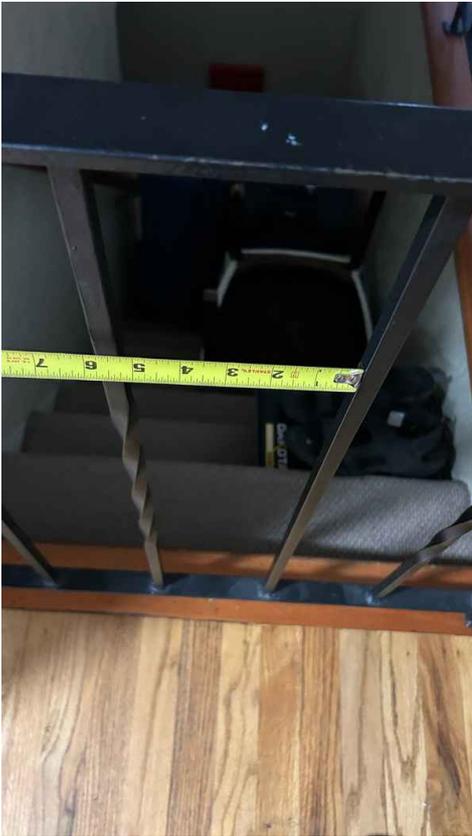
The top-floor staircase leading to the lower level was not in use, as the home was divided into separate suites. The stairway was obstructed by storage, limiting access and preventing full inspection. The door at the bottom of the hallway could not be tested and appeared either seized or deadbolted. Safety concerns included the absence of a light fixture over the stairwell, a loose handrail, and baluster spacing greater than 4 inches, which poses a risk for children. Due to the storage limitations and restricted access, a full evaluation of this stairway could not be completed.

Baluster spaces too wide

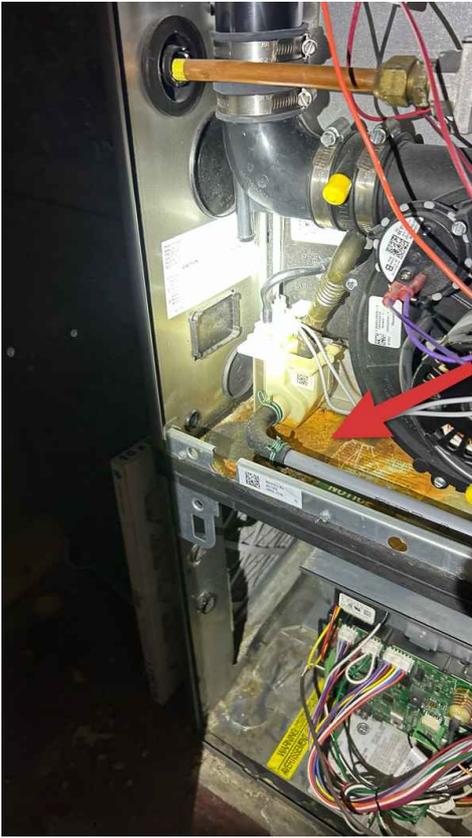
FURNACE SYSTEM – RUST, DIRTY COMPONENTS, AND LIMITED THERMOSTAT CONTROL

The furnace unit, manufactured in 2017, showed rusting within the housing, likely from a condensate drain leak. The blower housing was also dirty, and the air filter in place was the incorrect size, being too long for the compartment. Only one thermostat was present to control the system; without zone control, additional thermostats cannot be added, which may be inconvenient for regulating temperatures across different levels of the home. Servicing the furnace is recommended to address the rust, clean the blower housing, and install the correct filter size to ensure proper function and efficiency.

Rusted furnace housing

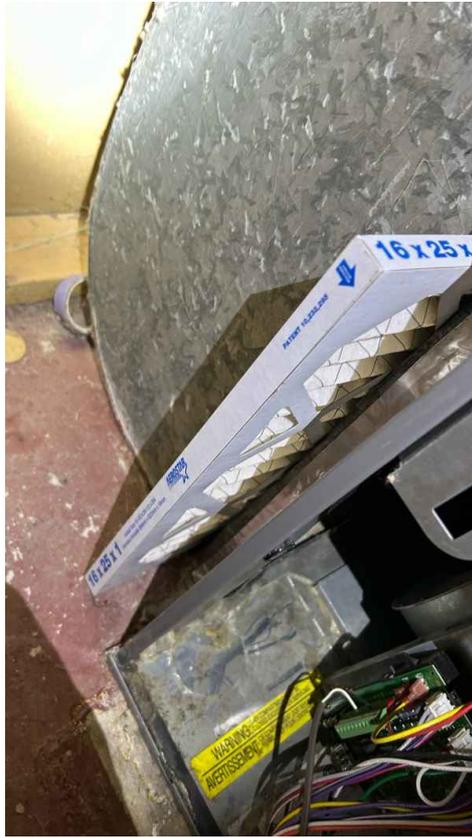
Incorrect filter

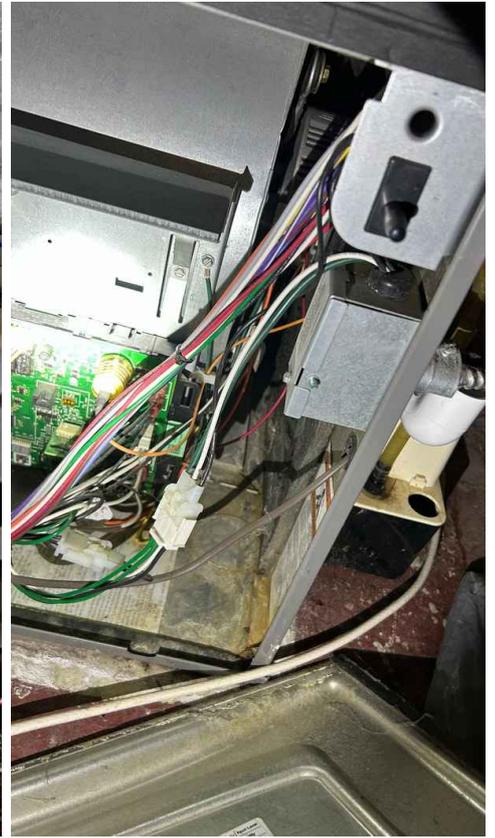
Dirty blower housing

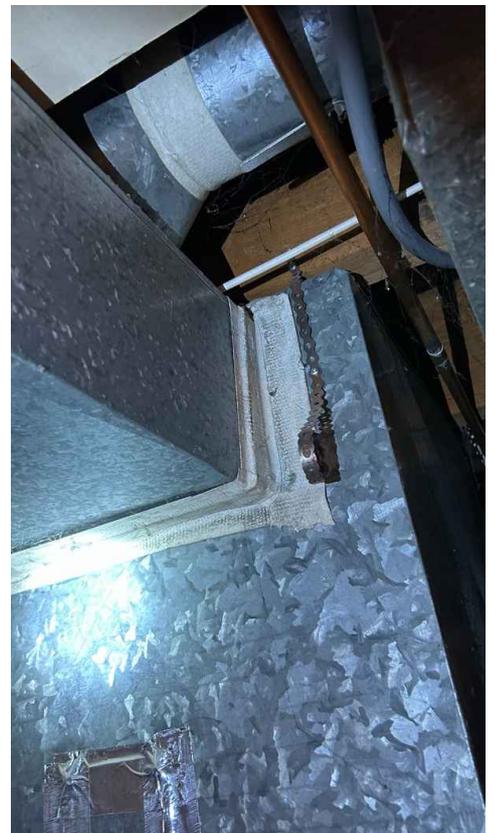
Sections of the furnace ducting were wrapped with asbestos-containing tape. This material is generally not a concern if left undisturbed; however, disturbing or damaging it can release asbestos fibres. Encapsulation products are available to seal the tape if desired. Professional remediation may also be considered if future renovations or duct work are planned.

Asbestos Tape

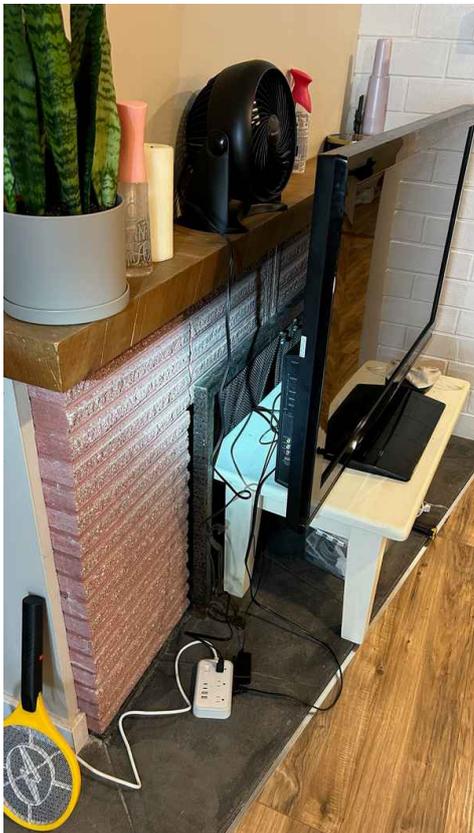
FIREPLACES – WET INSPECTION RECOMMENDED

The home contained two fireplaces, both of which appeared unused for an extended period. Due to storage and tenant belongings, both fireplaces were largely inaccessible and could not be fully inspected. Before use, a WETT (Wood Energy Technology Transfer) inspection is required for insurance purposes and to confirm safe operation.

Limitation

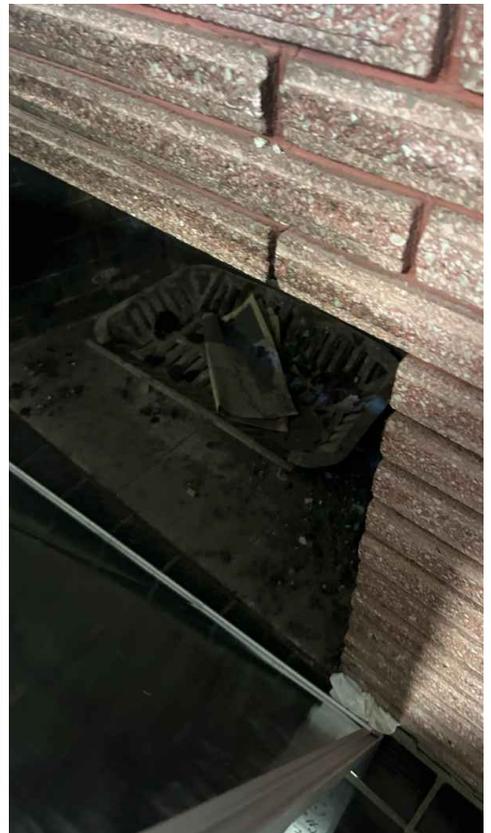
WETT inspection required

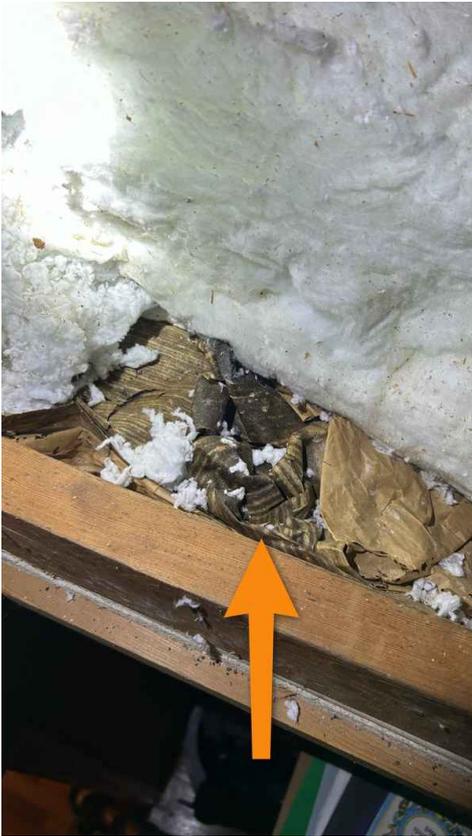
ATTIC SPACE – INSULATION AND MISSING VAPOUR BARRIER

The attic space appeared clean, with loose fiberglass insulation placed over older rockwool. No staining was observed. However, a continuous vapour barrier was not detected; while some old kraft paper may be present, it is not continuous due to the presence of ceiling joists. A few insulation voids were also noted, particularly near the attic hatch and confirmed later with thermal imaging. Improving insulation coverage and installing a proper vapour barrier would enhance energy efficiency and help control moisture migration.

Kraft paper

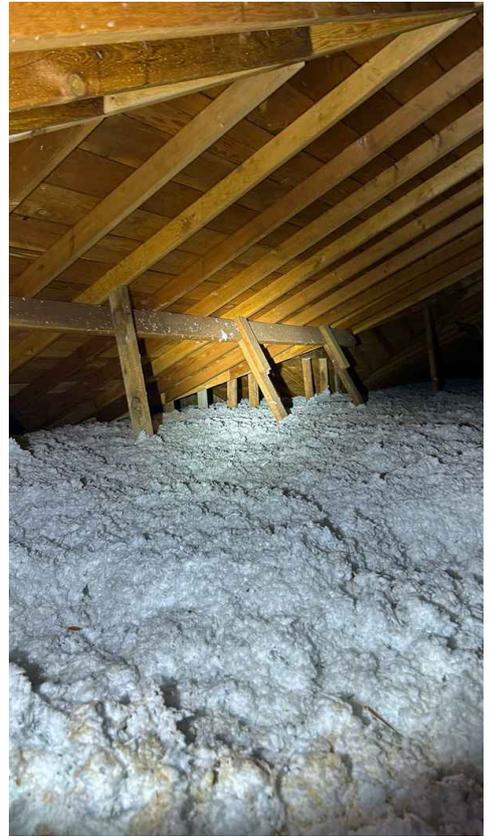
Attic photos

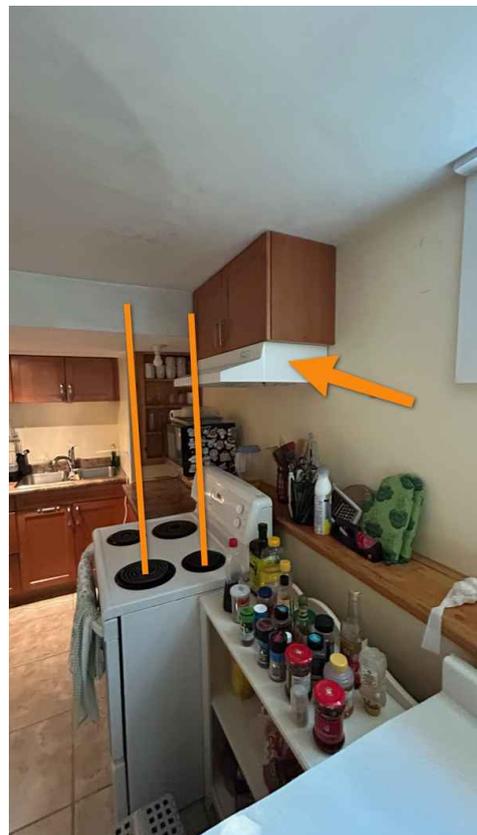
The basement kitchen hood vent appeared to be ducted to the exterior but was not functioning at the time of inspection. In addition, the stove was positioned too far from the hood vent for it to operate effectively, even if restored to working condition. As currently configured, the hood vent provides little benefit for ventilation or smoke removal. Relocation or reconfiguration would be required for effective use.

Range out of place, not working fan
