WATCHTOWER
HOME INSPECTIONS

RESIDENTIAL REPORT

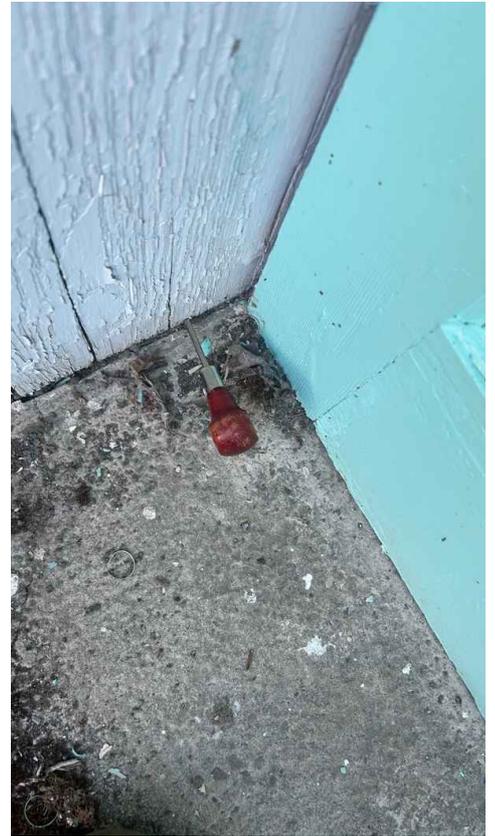
LOCALIZED DECAY AT GARAGE TRIM

A small area of decay was observed on the garage trim, likely due to prolonged moisture exposure. While the damage appeared minor at the time of inspection, repair or replacement of the affected section is recommended to prevent further deterioration.

Trim rot

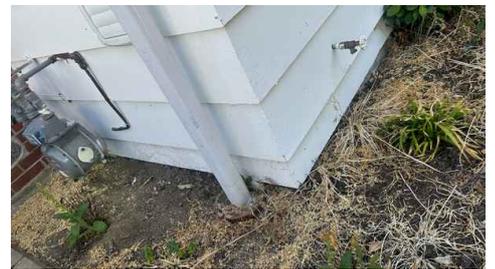
2.1.2 Siding, Flashing & Trim

SIDING CLEARANCE AND GARDEN BED AGAINST FOUNDATION

On the left-hand side of the home, a section of siding was installed too close to grade, which can promote moisture wicking and potential material deterioration. Additionally, a garden bed was positioned directly against the foundation wall in this area. While common in landscaping, this arrangement can allow water to accumulate and gradually seep into the foundation over time. Improving siding clearance and reconfiguring the garden bed to direct water away from the structure is recommended upon possession to help protect the building envelope.

Siding too close to grade, Garden bed against foundation

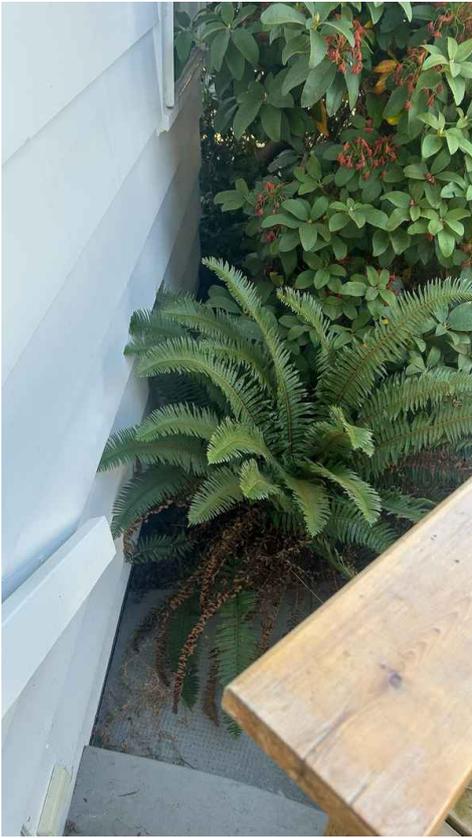
2.1.3 Siding, Flashing & Trim

Vegetation was observed in direct contact with the exterior siding in multiple areas around the home. Plant growth against the siding can trap moisture, promote deterioration of materials, and provide a pathway for pests. Trimming back vegetation to allow for adequate airflow and clearance is recommended upon possession as part of routine exterior maintenance.

Trim vegetation back 3 feet

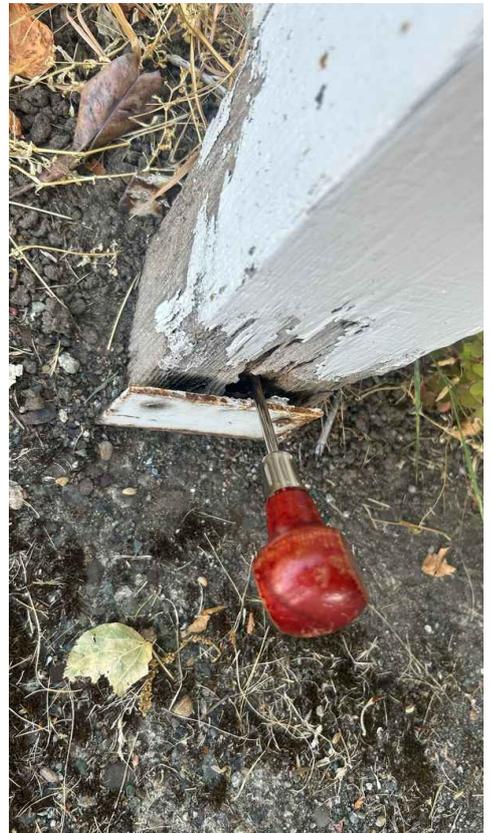
2.2.1 Decks, Balconies, Porches & Steps

DETERIORATED SUPPORT POST AT CARPORT

At least one support post at the front carport was visibly deteriorated and exhibited rot. The structure could be moved slightly by hand, indicating compromised stability. Replacement of the affected post is recommended to maintain structural support and prevent further deterioration.

Rotted post

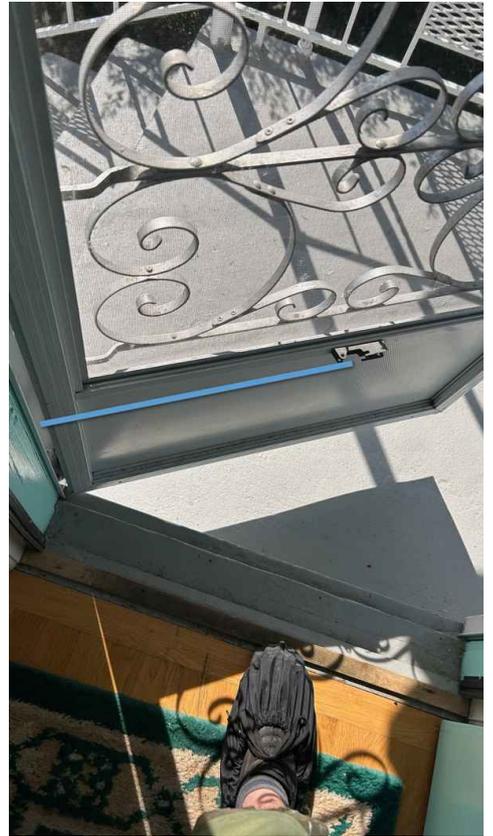
2.3.1 Exterior Doors

MISSING GAS CLOSER – SIDE ENTRY STORM DOOR

The side entry storm door was missing its gas closer, which assists in the controlled opening and closing of the door. Without this component, the door may swing freely, increasing the risk of damage or injury from sudden movement. Installing a new gas closer is recommended upon possession to restore safe and proper function.

Missing closer

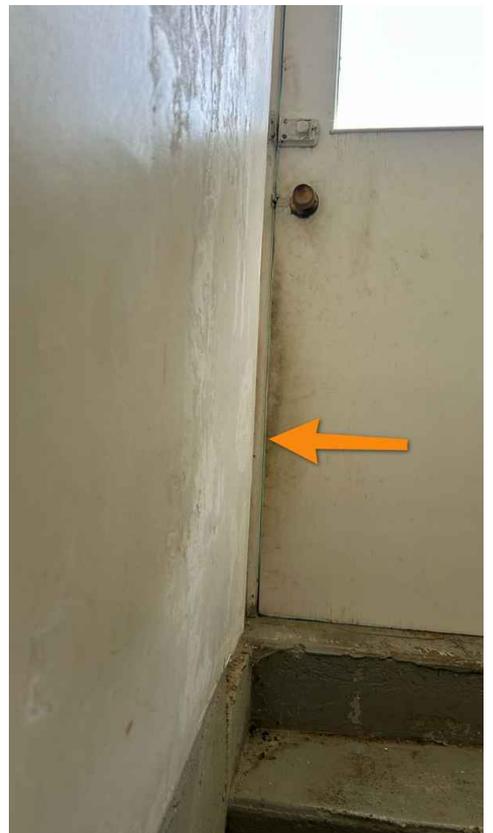
2.3.2 Exterior Doors

REAR BASEMENT ENTRY DOOR – SEALING AND FIT ISSUES

The exterior rear entry door from the basement, along with the adjacent stairway, exhibited sealing concerns. Visible light was observed around the door edges, indicating poor weathersealing, and the door slid against the concrete when operated, suggesting misalignment or improper fit. These conditions may allow drafts, moisture, or pests to enter the home. Adjustment of the door and installation of appropriate weatherstripping are recommended upon possession to improve energy efficiency and functionality.

Add weather stripping and adjust

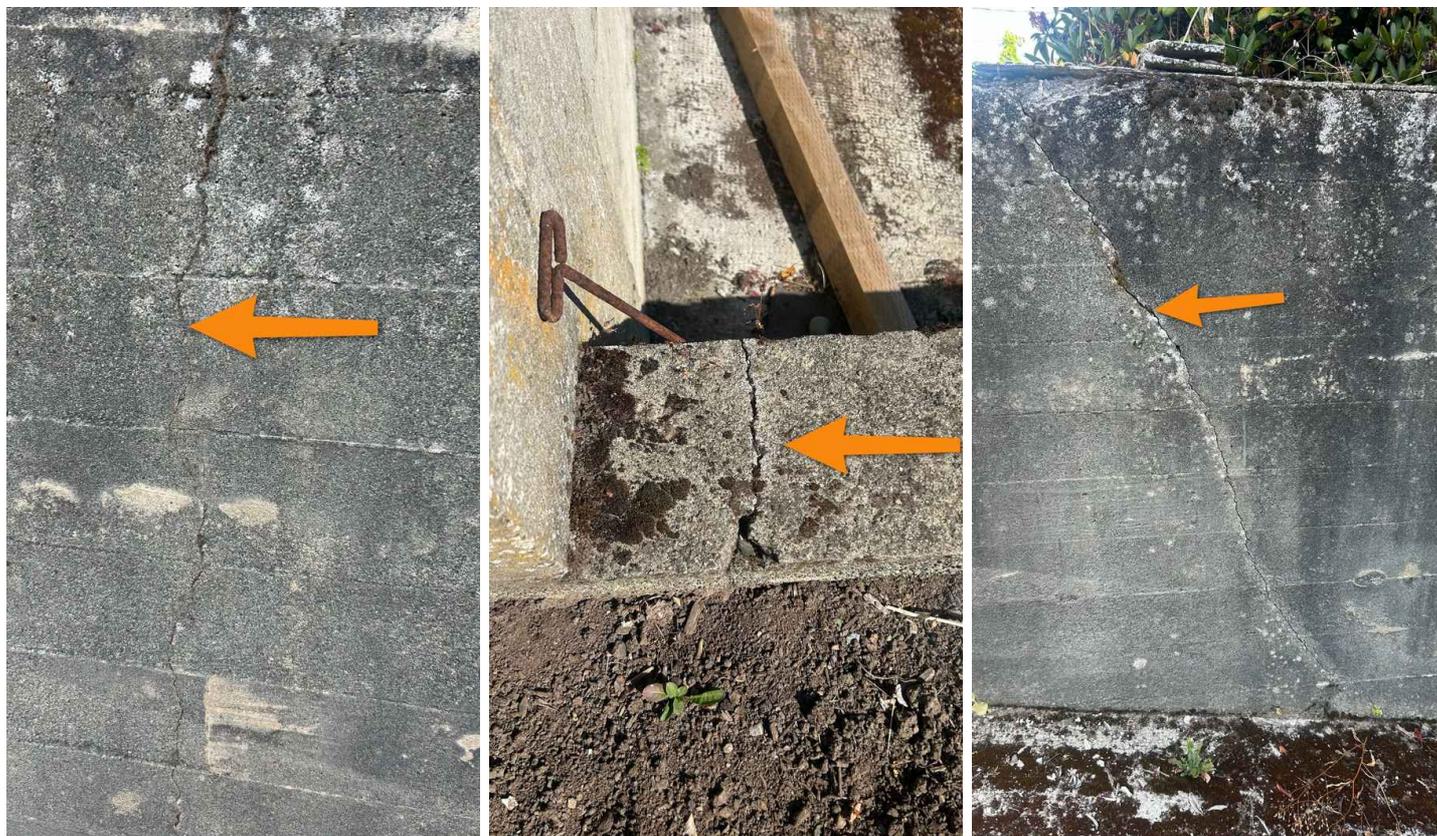
CRACKING OBSERVED AT RETAINING WALLS FLANKING DRIVEWAY

The driveway was bordered by two large retaining walls, with the slope directing towards the garage. Several notable cracks were observed in these retaining walls, which may indicate movement or ongoing stress. Further evaluation by a geotechnical engineer is recommended to assess the condition and provide guidance on any necessary repairs or maintenance.

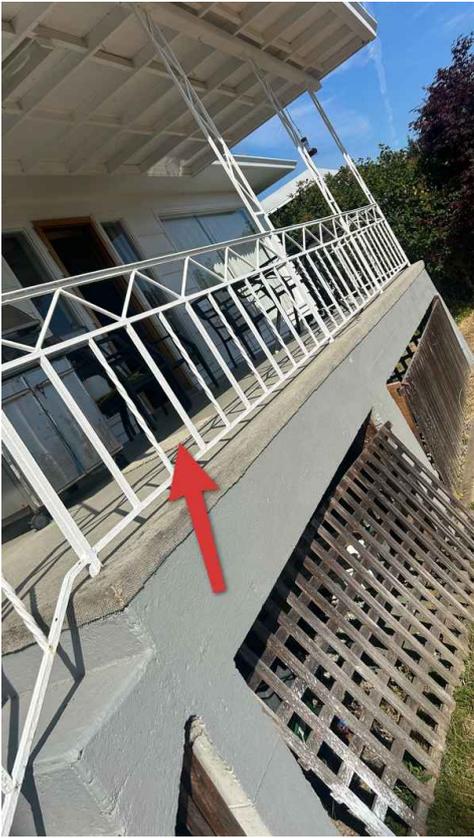
FALL AND TRIP HAZARDS AROUND PROPERTY

Several potential fall and trip hazards were noted around the property. These included a lack of guardrails at the retaining walls flanking the driveway, wide baluster spacing on the stair railings for the deck, and open gaps between interior steps. These conditions may pose a risk, particularly to children and individuals with mobility challenges. Installing appropriate guardrails, modifying railing spacing, and addressing interior stair gaps is recommended to reduce the likelihood of injury.

Baulaster spaces too wide

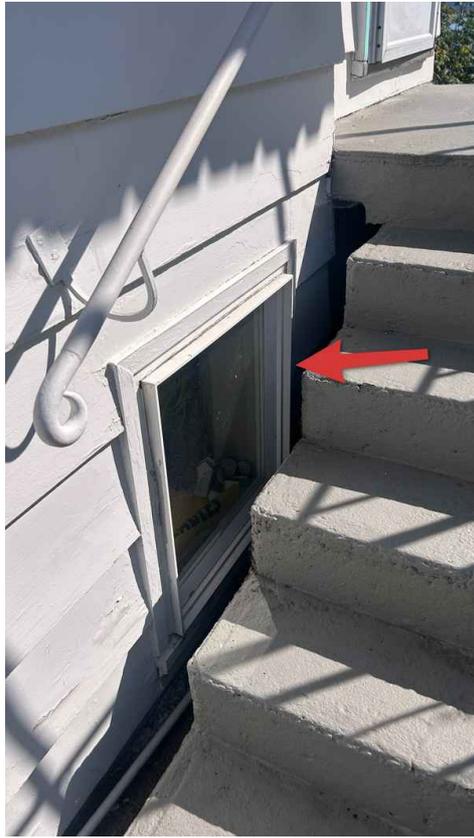
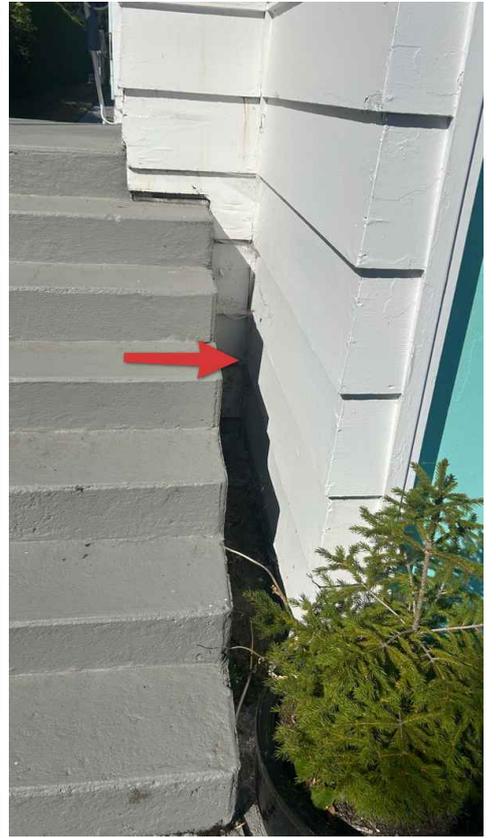
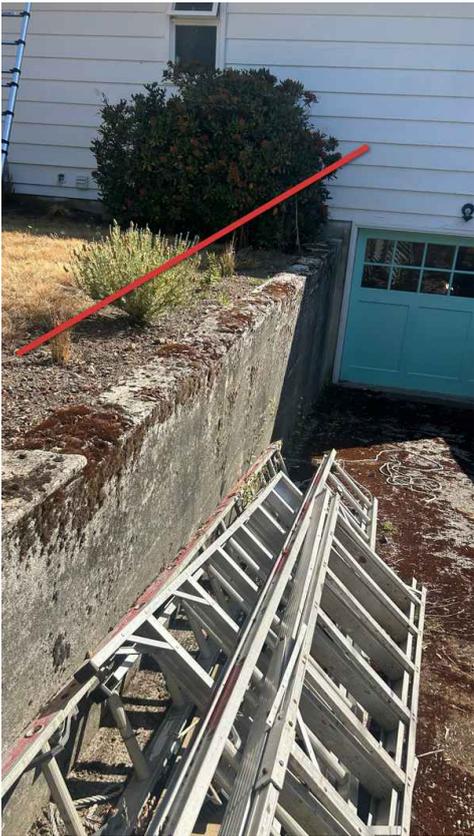
Fall hazard

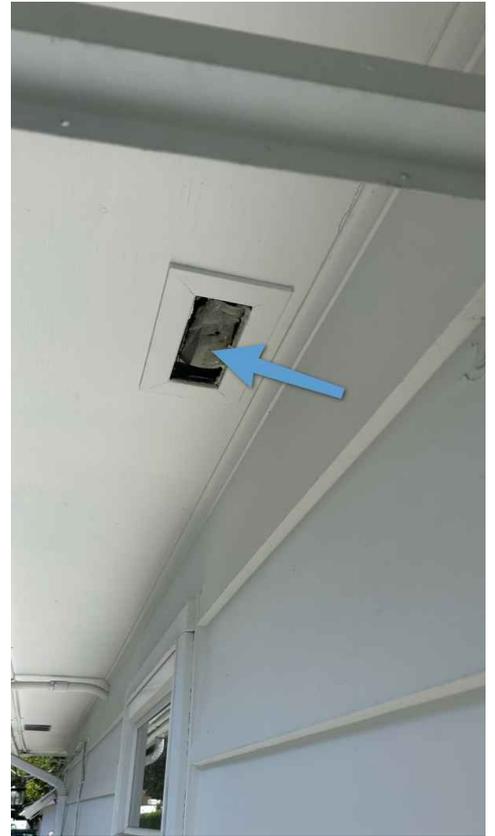
2.5.1 Eaves, Soffits & Fascia
**DAMAGED SOFFIT VENT
SCREEN**

One soffit vent was observed to have a torn screen, which may allow pests or debris to enter the attic space. Replacing or repairing the damaged screen is recommended upon possession to help maintain proper attic ventilation while preventing unwanted intrusion.

Damaged soffit screen

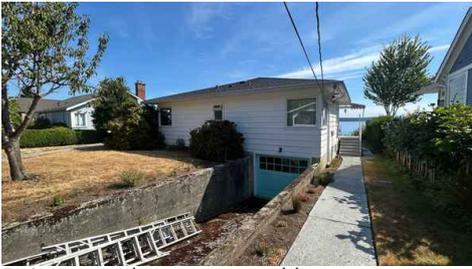
2.6.1 Grading, Drainage and Lot Surfaces

The property's perimeter drainage system appears to be constructed of concrete, a material prone to ageing, root intrusion, and collapse. The sloped driveway directing water toward the garage further increases the importance of proper drainage. A perimeter drain scope is recommended prior to subject removal to confirm that the system is functioning effectively and free of blockages or damage.

Driveway slopes toward home

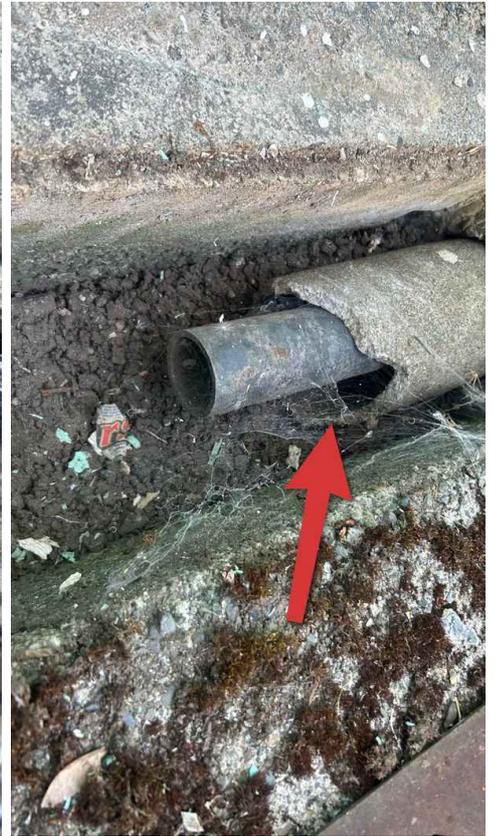
Scope drains before subject removal

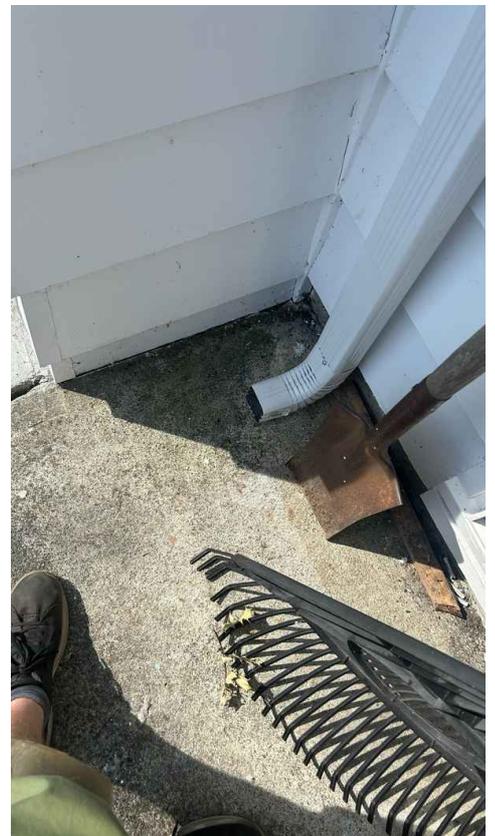
2.6.2 Grading, Drainage and Lot Surfaces

DOWNSPOUT TERMINATING NEAR FOUNDATION – REAR DECK AREA

At the back right corner of the property near the rear deck, a downspout was observed terminating too close to the foundation. Downspouts that discharge in close proximity to the structure can contribute to water pooling near the foundation, increasing the risk of moisture intrusion into the crawlspace or basement. Extending this downspout at least 6 feet away from the home is recommended upon possession to improve drainage and protect the building envelope.

Extend downspout

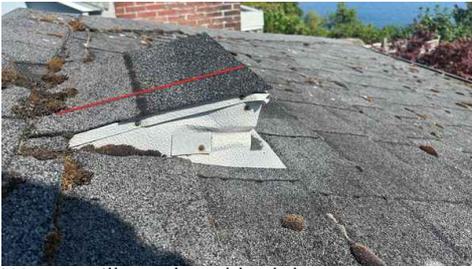
Several roof vents were improperly detailed, with tab shingles installed over top instead of properly integrated flashing. The angle and positioning of these shingles can allow water to pool around the vent openings, increasing the likelihood of moisture intrusion into the attic space over time. The flashing at the chimney was also noted to be inadequate, as outlined in a separate section of this report.

Water will pool and leak here

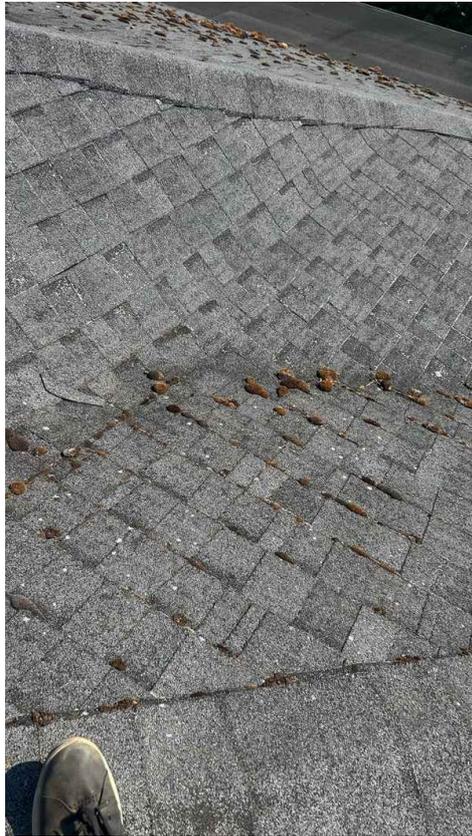
While one section of the roof appeared to have been replaced, the majority of the roofing showed significant deterioration. Widespread granular loss, exposed fiberglass matting, moss build up, exposed fasteners and torn shingles were observed throughout, indicating the roof is well beyond its serviceable life. A woven shingle valley was present, which is a less durable method of valley construction and can be prone to premature wear.

Woven valley

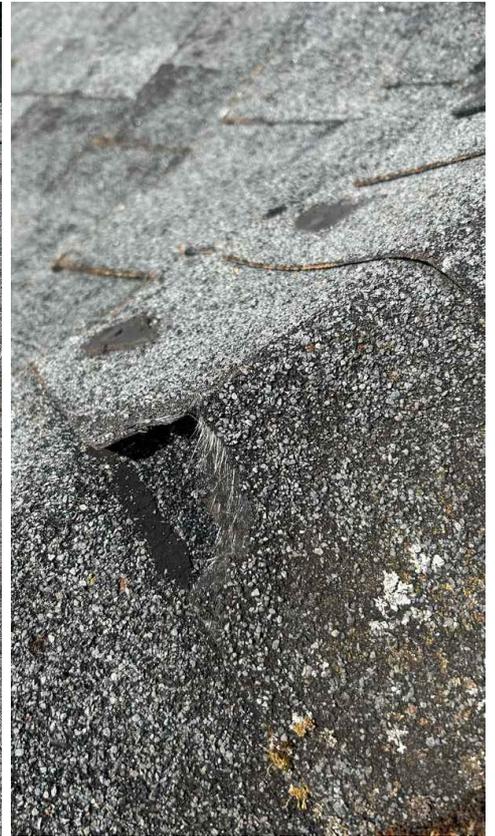
ADVANCED ROOF DETERIORATION AND EVIDENCE OF LEAKAGE

Torn shingle

Evidence of moisture intrusion was observed in the attic during the inspection, further confirming active or past leakage. Full replacement of the majority of the roof is strongly recommended almost immediately upon possession to prevent ongoing water damage and restore the integrity of the building envelope.

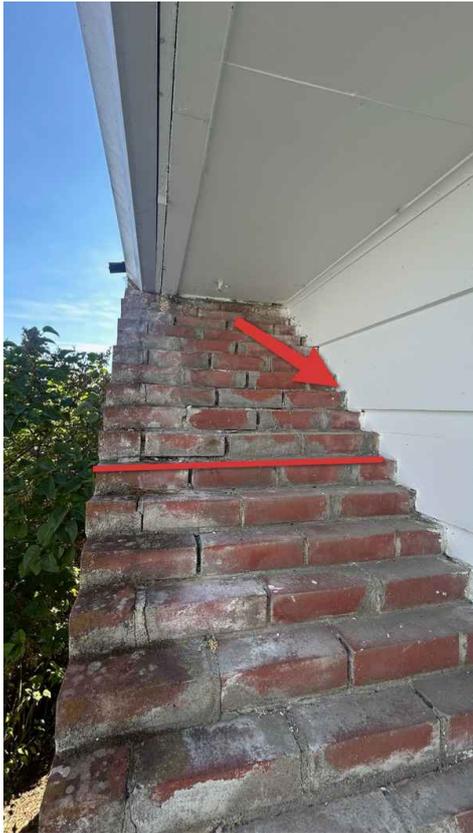
On the lower roof portion, a stepped section of masonry was observed, which creates a surface prone to holding water on the brick surface and against the siding. This condition may accelerate wear or lead to moisture infiltration at the masonry joints and wood siding. Additionally, brickwork adjacent to grade was noted—brick is porous and can absorb moisture, increasing the risk of saturation and long-term deterioration. Evaluation by a qualified mason is recommended upon possession to assess these conditions and implement corrective measures to improve water management and durability.

Flat areas will collect water

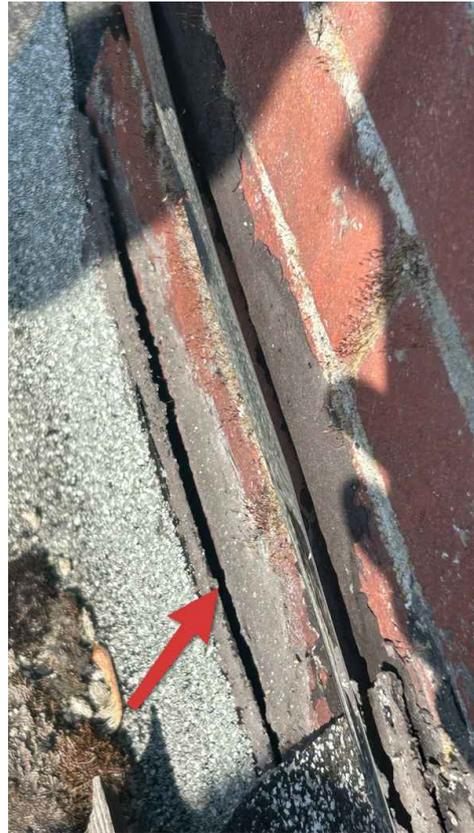
Gap, not flashed with metal, will leak in winter

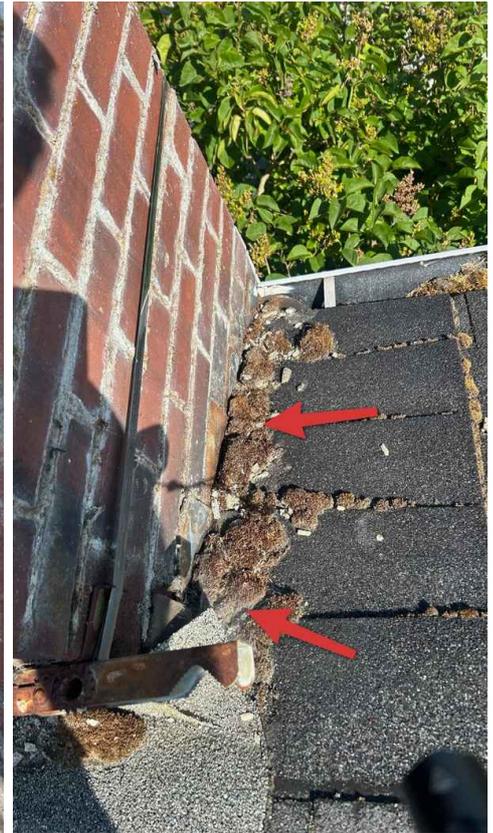
No cap flashing, Severe moss build up

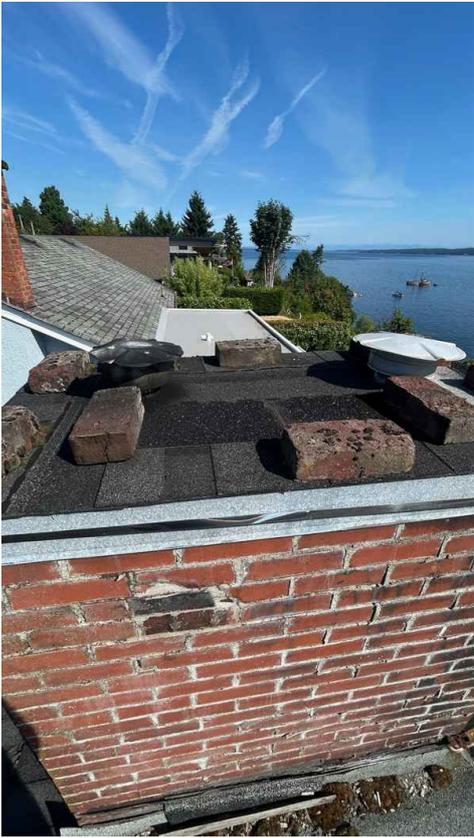
The masonry chimney was topped with an insufficient crown, currently consisting of what appeared to be an asphalt-based material and shingles (shingles need to be at a slope to appropriately shed water). This type of crown is prone to deterioration and may not provide long-term protection against water intrusion. Additionally, the flashing at the chimney base was incomplete and lacked visible counter-flashing (cap flashing), leaving it vulnerable to moisture ingress. The installation did not appear to be professionally finished and may require repair, replacement or maintenance.

Shingles as crown, Will leak in winter

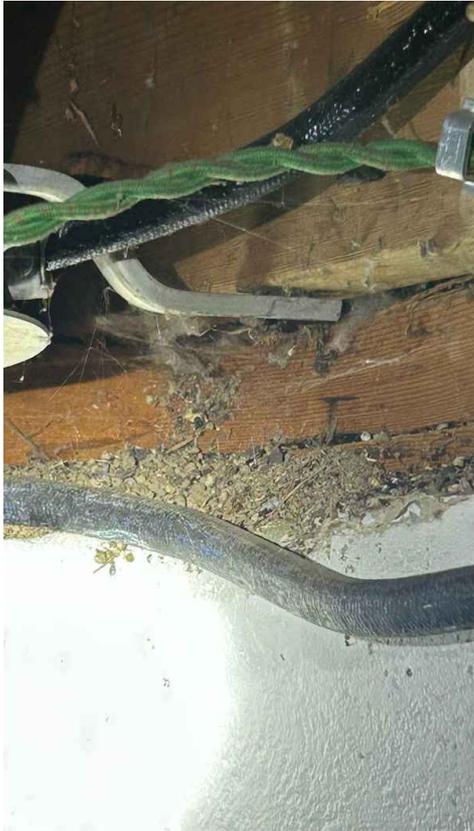
Along the perimeter of the basement, the wood sill plate did not appear to be fully sealed against the concrete foundation. In some areas, shims had likely been used to level the build surface, creating small gaps between the sill plate and foundation wall. These openings may be contributing to minor pest entry, as some insect nesting activity was observed.

Insect nest

Before undertaking any renovations, it is recommended to seal the sill plate using an appropriate gasket, spray foam insulation, or similar air-sealing method. This will help reduce pest intrusion and improve the overall energy efficiency of the basement space.

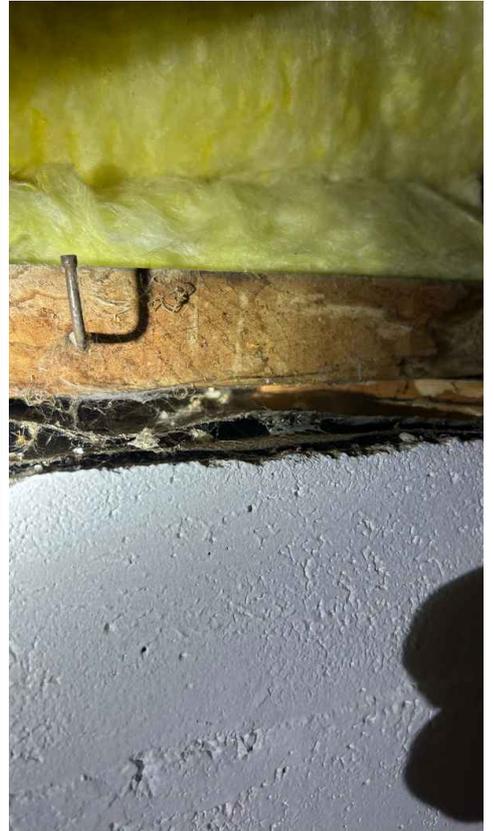
Sill gap

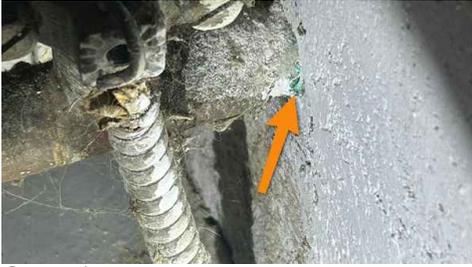
NO VISIBLE PRESSURE REDUCING VALVE AND CORROSION ON MAIN WATER LINE

There was no visible pressure reducing valve (PRV) installed on the main water supply line at the time of inspection. A PRV helps regulate high municipal water pressure and protect the plumbing system from excessive stress. Additionally, the copper main water line showed signs of green corrosion at the point of entry through the foundation wall, which may indicate minor moisture interaction or early oxidation. Installation of a PRV and further evaluation of the corrosion by a licensed plumber are recommended upon possession to ensure long-term system integrity and performance.

Corrosion

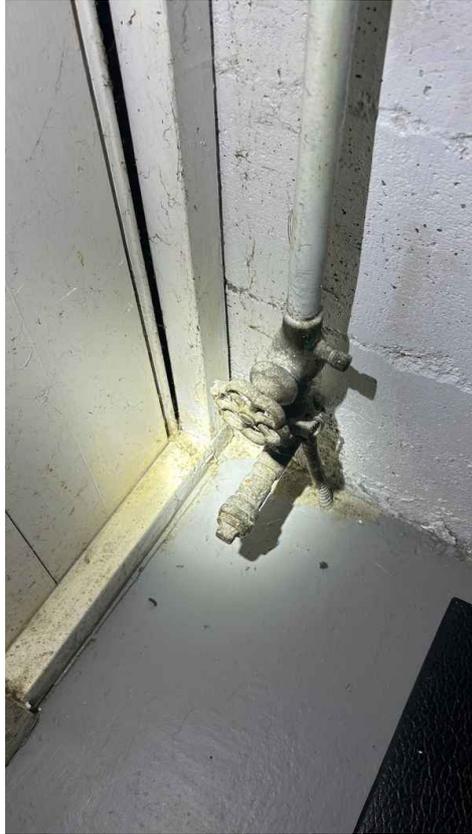
No PRV valve

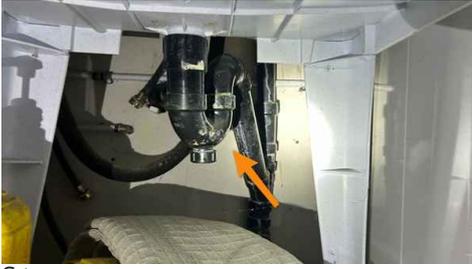
5.2.1 Drain, Waste, & Vent Systems

S-TRAPS OBSERVED AT KITCHEN AND LAUNDRY SINKS

S-trap style drain configurations were observed beneath both the kitchen sink and the laundry sink, connected with ABS piping. S-traps are prone to siphoning, which can lead to loss of the water seal in the trap and allow sewer gases to enter the living space. Replacement with a properly vented configuration is recommended upon possession by a licensed plumber to ensure safe and effective drainage.

S trap

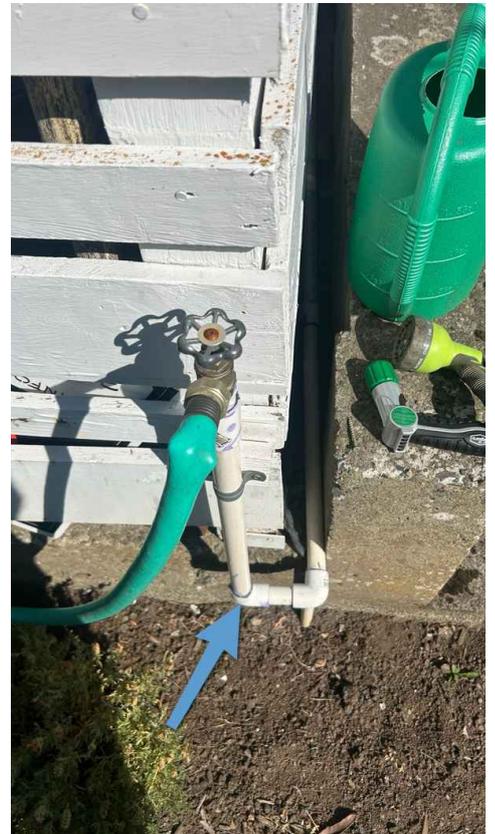
A PVC pipe was observed supplying an exterior hose bib. This material is vulnerable to damage from freezing temperatures and prolonged UV exposure, which may accelerate deterioration over time. Covering the exposed piping is recommended to limit UV damage, and upgrading to frost-resistant hose bibs throughout the property may help reduce the risk of freeze-related failures.

PVC line

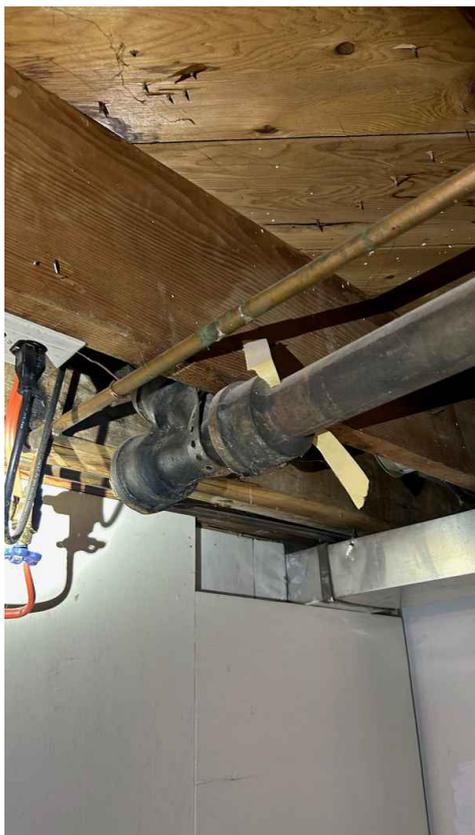
Additionally, limited sections of cast iron drain, waste, and vent (DWV) piping were observed, including one active vent stack on the roof. Cast iron is known to deteriorate from the inside out over time and is generally considered beyond its useful life in residential systems. While most of the cast iron piping appears to have been replaced, the remaining sections should be monitored, as aging DWV materials can be a concern for both functionality and insurance eligibility. Evaluation by a licensed plumber is recommended if replacement or upgrades are desired.

Cast iron DWV

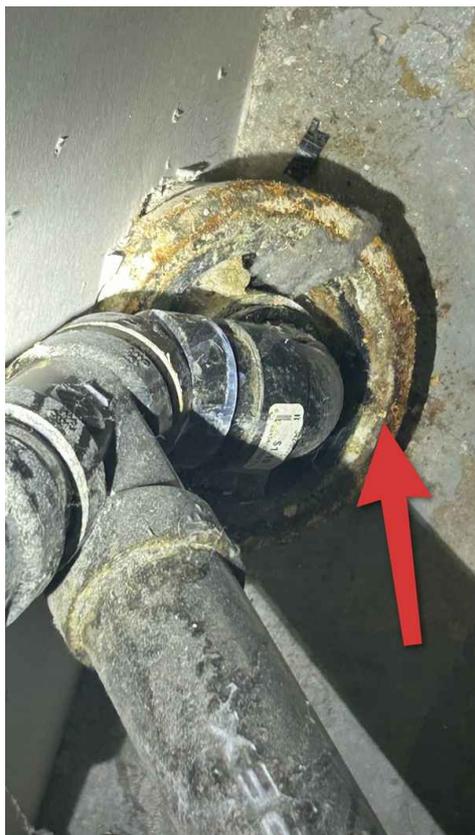
Cast Iron

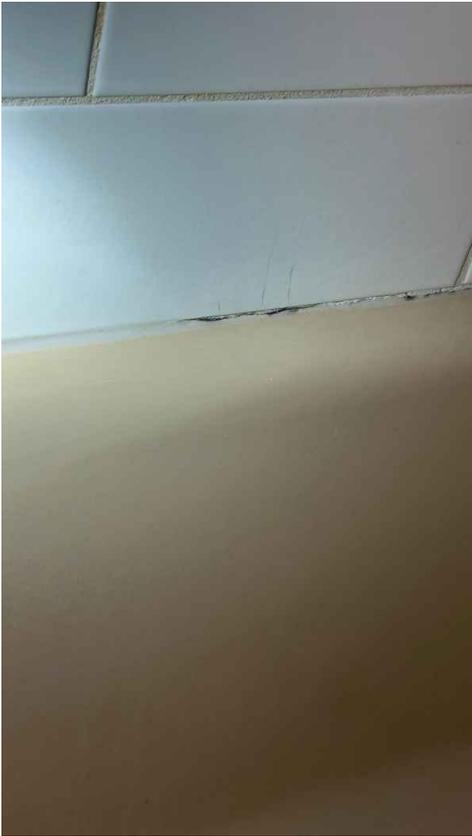
The shower pipe was observed to be wobbly and unstable, which may lead to strain on the plumbing connections behind the wall if not addressed. Additionally, the silicone sealant around the rim of the tub was deteriorated and in need of refreshing to prevent water from seeping behind the surround. The shower diverter was not functioning properly, as water continued to flow from the tub spout when the diverter was engaged. Securing the shower pipe, replacing the silicone sealant, and servicing or replacing the diverter are recommended upon possession to ensure proper function and prevent moisture intrusion.

Re silicone

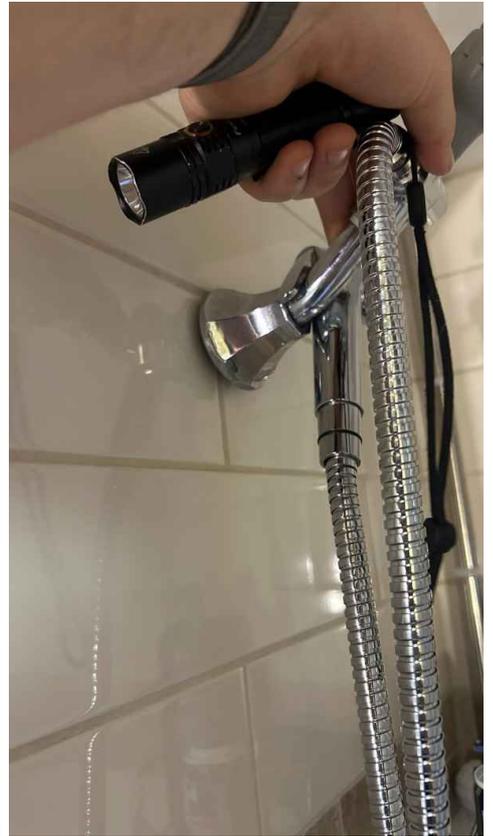
Loose shower spout

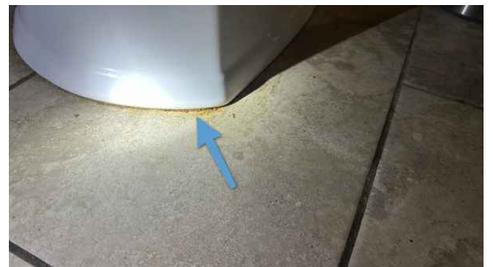
5.3.4 Distribution Systems & Fixtures

POSSIBLE SIGNS OF MOISTURE AT BASE OF UPSTAIRS TOILET

Minor signs of moisture or staining were observed at the base of the upstairs toilet. While this could be due to general cleanliness or recent use by the seller, it may also indicate minor leakage at the wax seal or supply connections. No active leaks were confirmed during the inspection, but this is noted as an awareness item. Monitoring is recommended, and resealing may be considered if any further moisture becomes apparent.

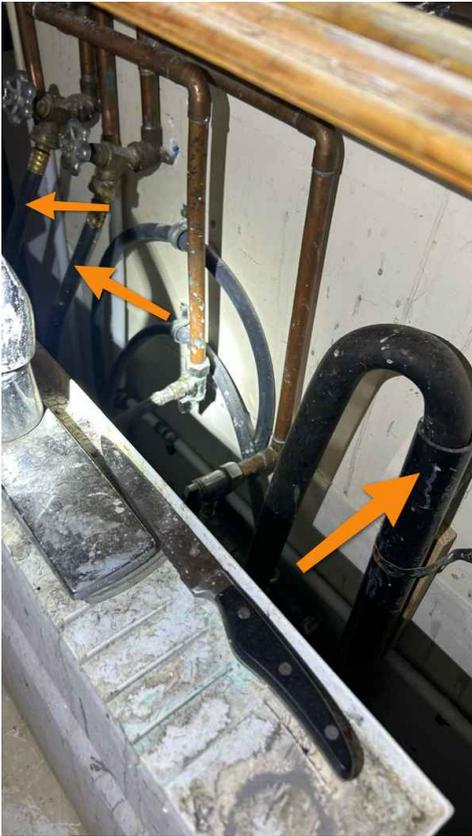
5.3.5 Distribution Systems & Fixtures

The washing machine was connected using plastic and rubber-style supply hoses, which are more prone to deterioration and bursting over time. Upgrading to braided stainless steel hoses is recommended upon possession to reduce the risk of water damage and improve durability. Additionally, the drain pipe for the washing machine appeared to lack an air gap or proper standpipe configuration, which is important to prevent potential backflow or siphoning issues. Evaluation and correction by a plumber is recommended to ensure safe and proper drainage.

Upgrade hoses, no air gap

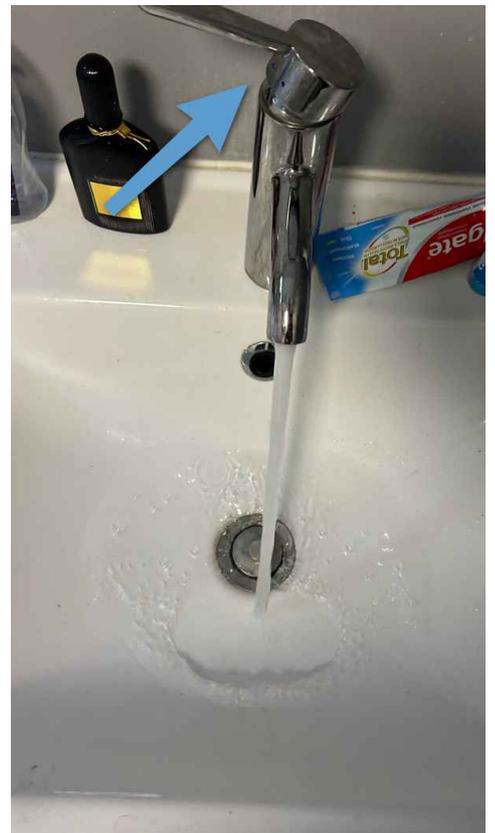
5.3.6 Distribution Systems & Fixtures

The sink fixture in the basement powder room exhibited unusual operation, with the water control handle rotating excessively far to the left. It is unclear whether this is due to a misaligned installation or if the fixture requires adjustment. While no leakage or functional issues were noted during testing, further review or correction may be considered upon possession for improved usability and to ensure proper installation.

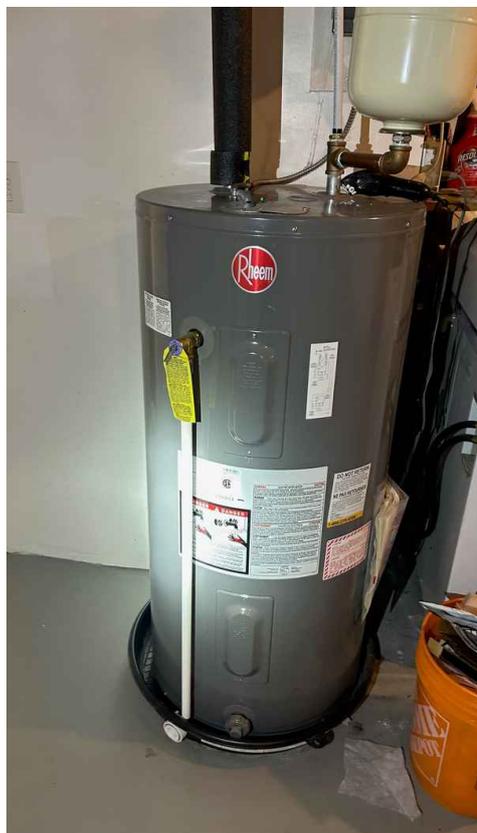
HOT WATER TANK – MISSING SEISMIC STRAPS AND VACUUM BREAKER

The hot water tank was manufactured in 2021 and appeared to be in generally good condition; however, it was missing seismic straps and did not have a vacuum breaker installed on the cold water inlet. Seismic straps are recommended to help secure the tank during seismic activity and prevent tipping, while a vacuum breaker helps prevent backflow into the potable water system. Installation of both components is recommended upon possession to improve safety and system protection.

Missing straps and vacuum breaker

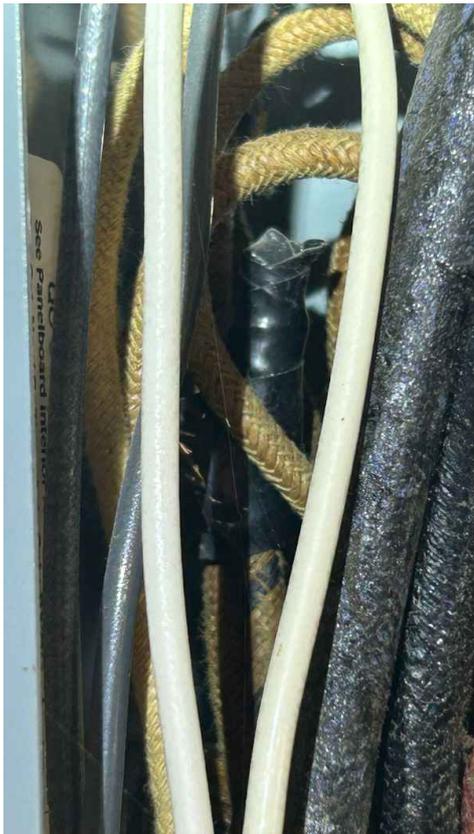
Open splice using tape

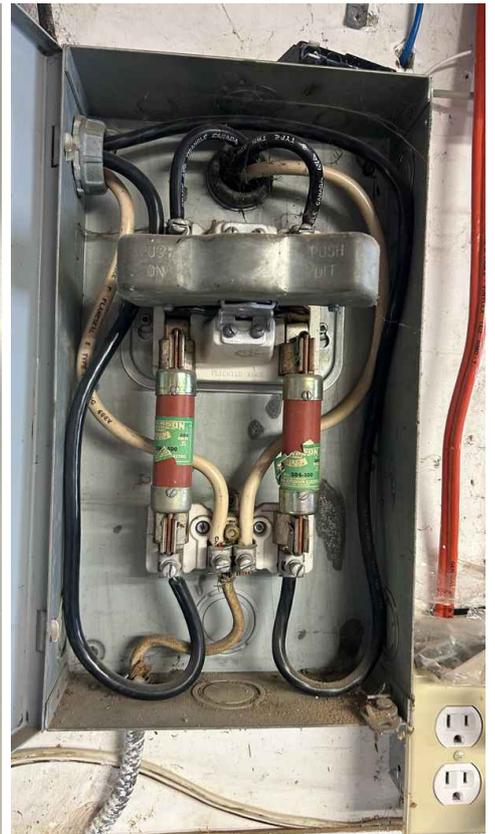
Several subpanels, including those servicing the furnace, hot water tank, and main disconnect ahead of the primary panel, were older fuse-style panels. These are considered outdated and typically past their expected service life. Additionally, a couple of these fuse panels contained double-tapped circuits, where more than one conductor was connected to a single fuse terminal—an unsafe condition that can lead to overheating. Replacement of all fuse panels with modern breaker panels and correction of double taps is strongly recommended to improve overall system safety and reliability.

Fuse box

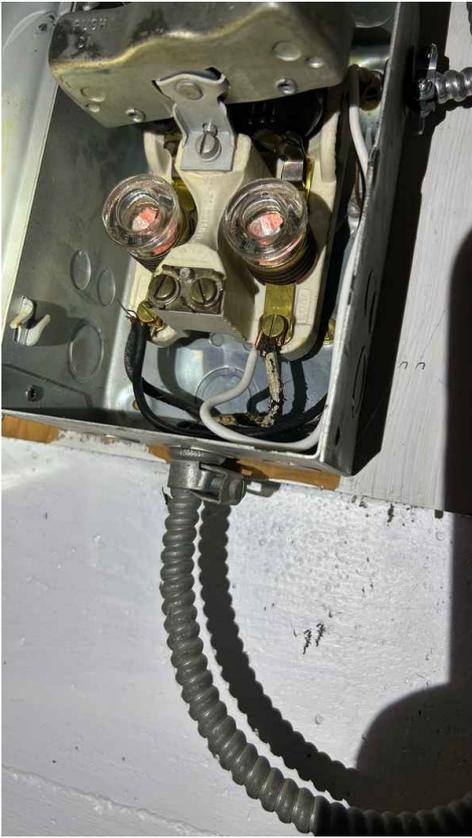
Double taps in fuse box

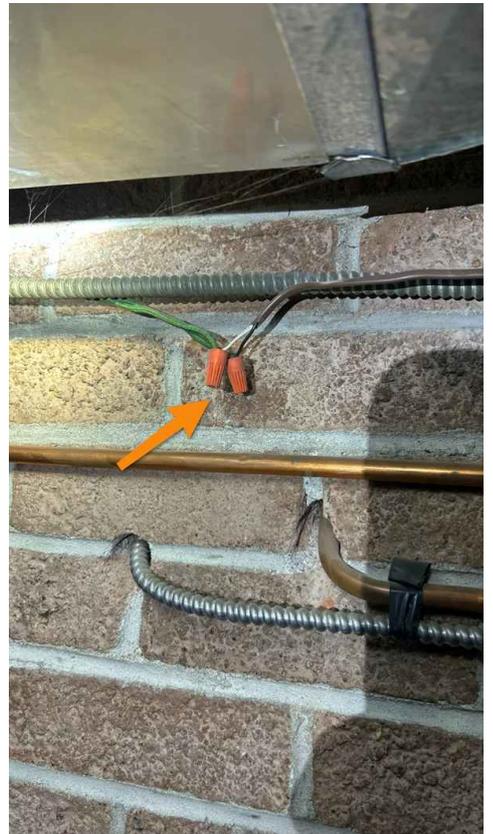
6.2.1 Branch Wiring Circuits, Breakers & Fuses and Distribution

Multiple open electrical splices were observed throughout the basement. Exposed splices present a fire and shock hazard and should be enclosed within approved electrical junction boxes with appropriate covers. Correction by a licensed electrician is recommended upon possession to ensure safe and compliant electrical connections.

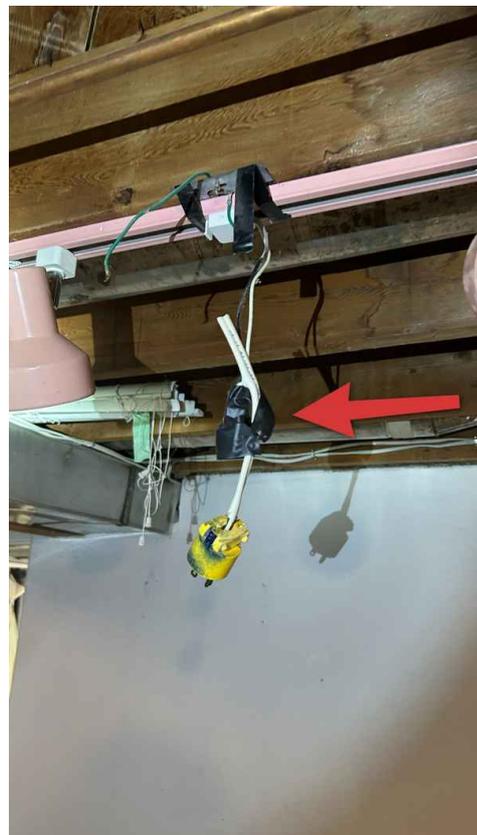
6.2.2 Branch Wiring Circuits, Breakers & Fuses and Distribution

IMPROPER ELECTRICAL MODIFICATION – BASEMENT TRACK LIGHT

A modified electrical cord resembling a rigged extension cord was observed hanging from the centre of a basement track light. This setup appeared to draw power directly from the track lighting electrical source and does not meet safe electrical standards. Such makeshift wiring poses a fire and shock hazard and should be removed immediately. Evaluation and correction by a licensed electrician is strongly recommended upon possession.

Dangerous modification

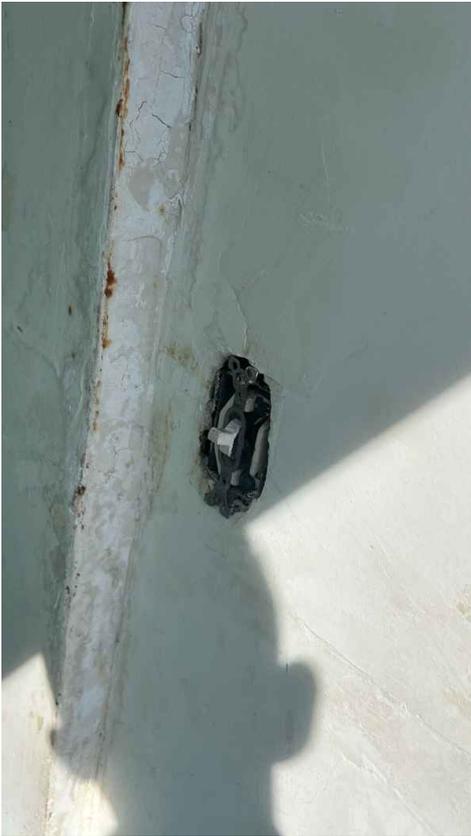
Several electrical deficiencies were observed, including reversed hot/neutral wiring and open grounds at most tested receptacles, missing cover plates on outlets and switches, lack of GFCI protection in required areas, and an extension cord used as permanent wiring in the carport. Additionally, non-weather-rated electrical conductors were used in exterior locations. These conditions present potential shock hazards and increased risk of moisture-related failure. Review and correction by a licensed electrician is recommended to improve electrical safety throughout the home.

Missing coverplate

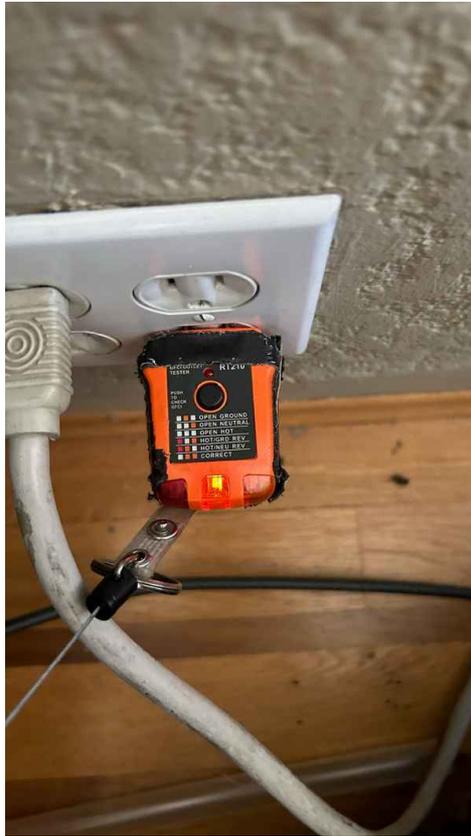
Open ground

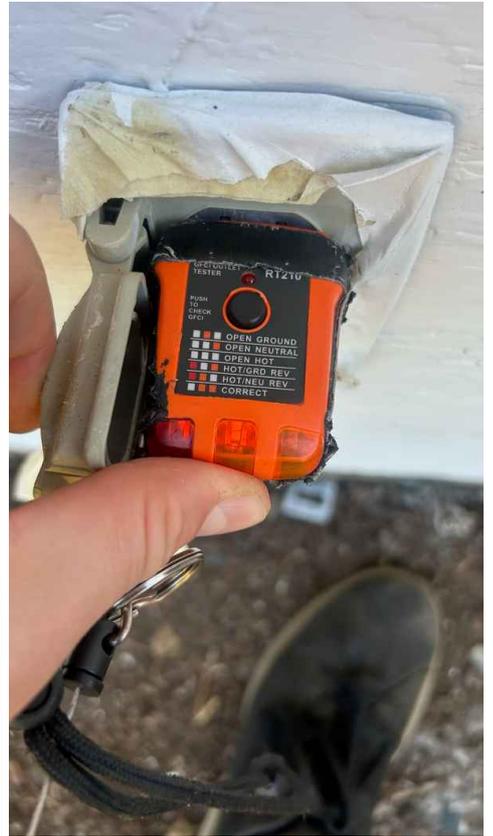
Hot Neu reversed, not GFCI

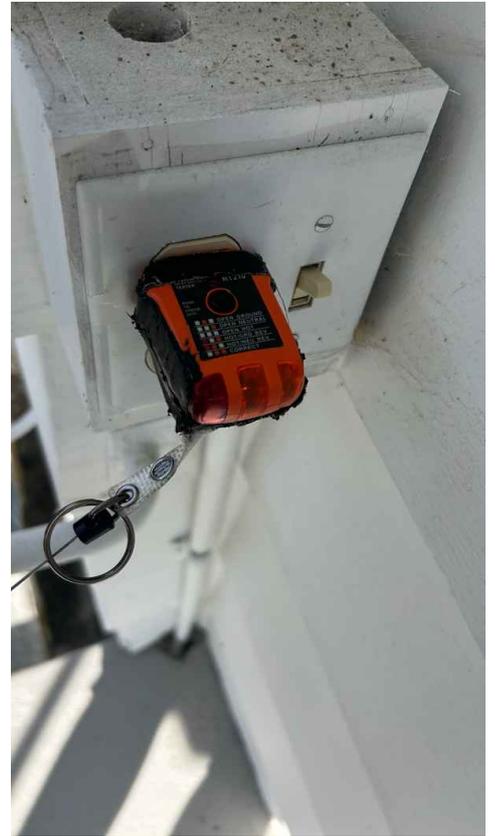
An exterior outlet located near the right-hand side entry steps was found to have no power at the time of inspection. No corresponding switch was identified, and the cause of the issue could not be confirmed. Further investigation by a licensed electrician is recommended upon possession, particularly in conjunction with other electrical work noted throughout the report.

No power to outside outlet

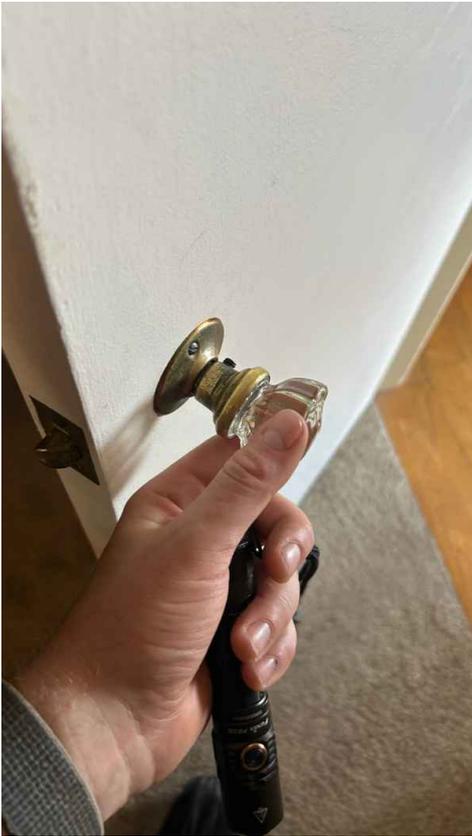
The door hardware on the primary bedroom door was loose, with the handle spinning freely when operated. This affected proper latching and function. Re-securing or replacing the door hardware is recommended upon possession to restore usability and ensure privacy.

Loose hardware
