WATCHTOWER
HOME INSPECTIONS

RESIDENTIAL REPORT

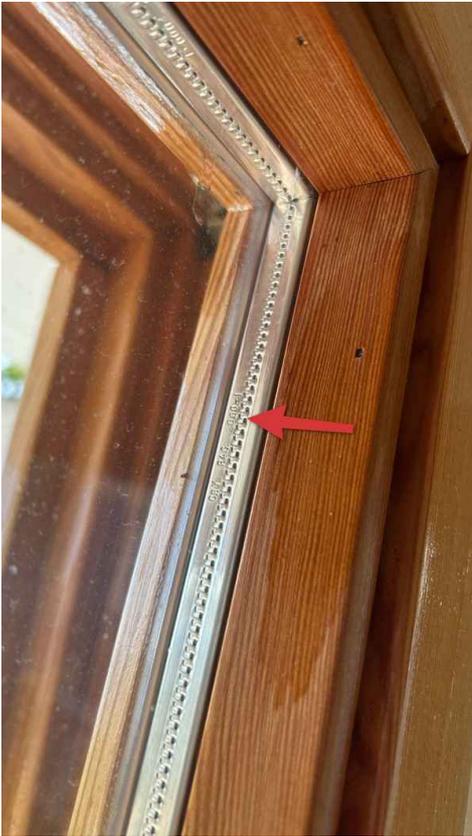
The home featured a mix of window types, including vinyl, wood-framed, and single-pane units. Several of the single-pane wood windows appear original, are missing flashings (but some have the benefit of a roof overhang) and are not energy-efficient by modern standards. A few wood-framed tilt and casement windows were approximately 25 years old, which is around the age where operational issues such as stiffness, hardware wear, or frame degradation often begin to appear. Some windows were not fully tested during the inspection: the window above the stove was obstructed by stored items, and the awning-style vinyl window in the primary bedroom could not be tested due to an installed air conditioning unit. Replacement of the older and less efficient windows may be considered for improved energy performance and function, though costs can be substantial.

25 year old window

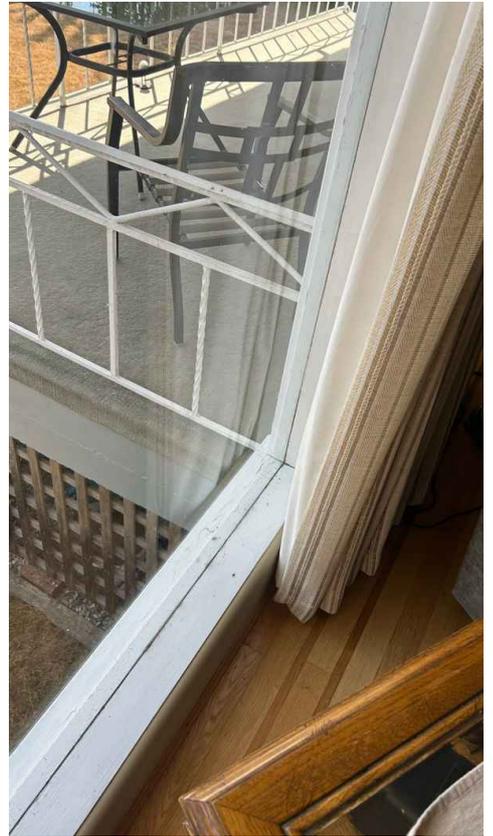
Single paned windpw

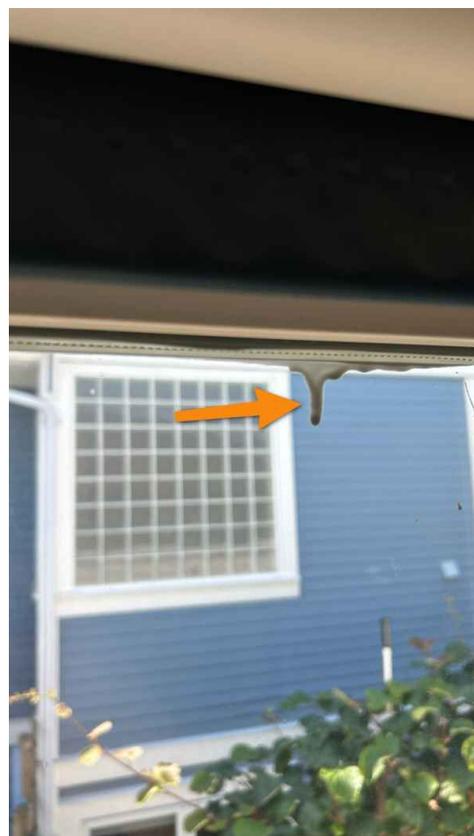
A small amount of adhesive-like residue was observed at one of the awning windows in the office. It is unclear whether this is originating from the window unit itself, from exterior sources, or possibly related to a manufacturing defect. While no functional issues were noted at the time of inspection at this window, this is included as an awareness item. Monitoring is recommended, and further evaluation may be considered if the condition worsens or affects window performance.

Adhesive\

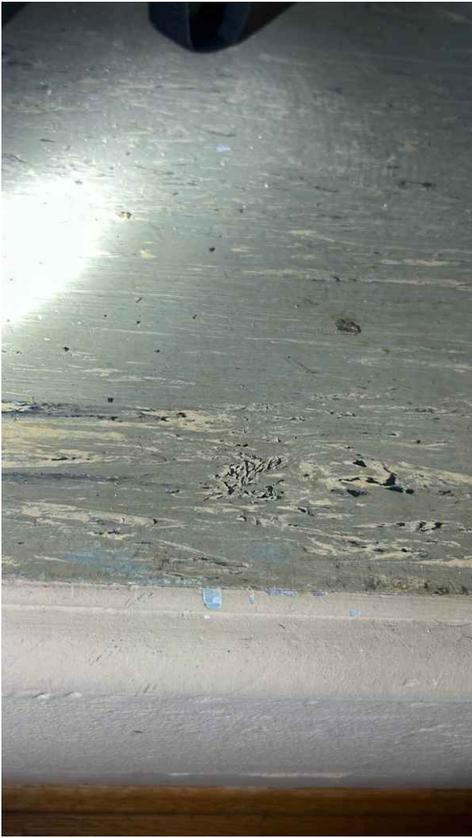
The tile flooring in the hallway closet may be an older material that potentially contains asbestos, which was commonly used in vinyl and composite tiles in mid-century homes. No testing was performed as part of this inspection, but due to the age and appearance of the material, it is recommended to treat it as potentially asbestos-containing until confirmed otherwise. If removal or disturbance is planned, consultation with an environmental professional or hazardous materials contractor is strongly advised.

Asbestos tile

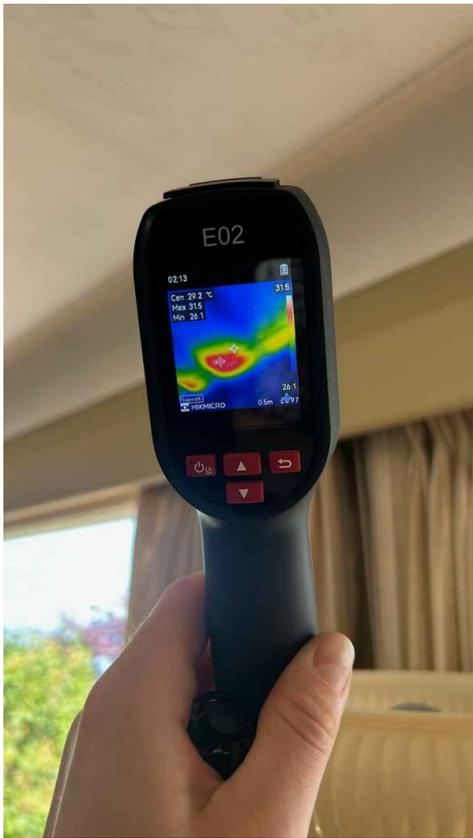
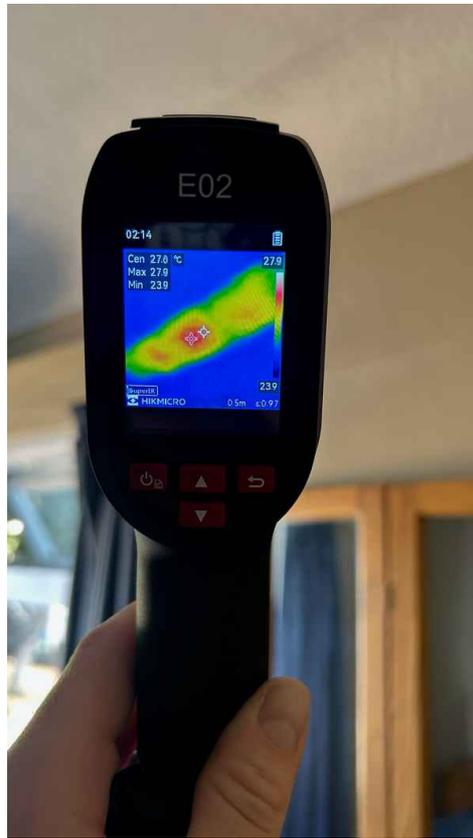
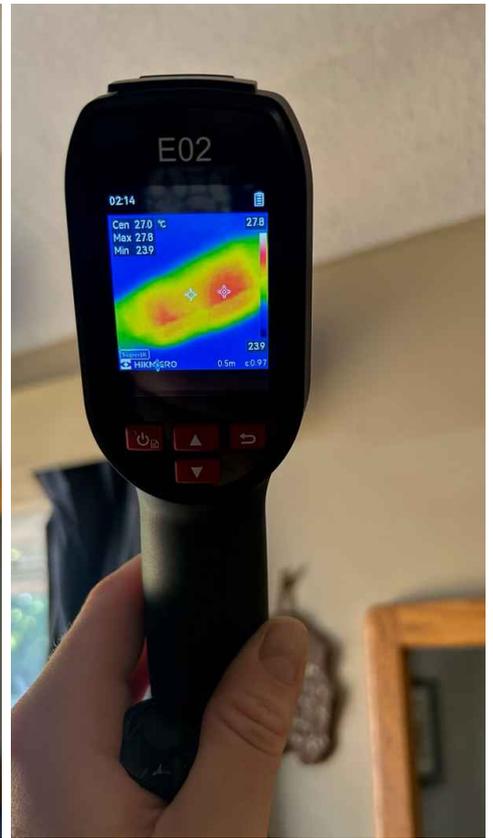
7.5.1 Ceilings

Thermal imaging revealed several anomalies along the perimeter of the upper level, primarily near exterior wall edges. These temperature variations are likely due to wind washing, where air movement within the attic reduces the effectiveness of insulation near the eaves. While improvement is possible through targeted air sealing and insulation work, addressing this issue may be limited by access and practical considerations. This is noted as an energy efficiency observation for general awareness.

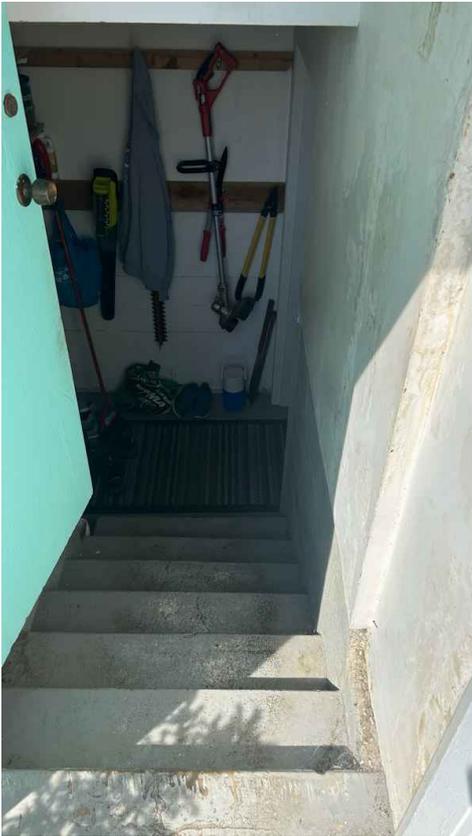
REAR WALKOUT STAIRWELL – SAFETY AND MOISTURE CONCERNS

Missing handrail, door opens inward

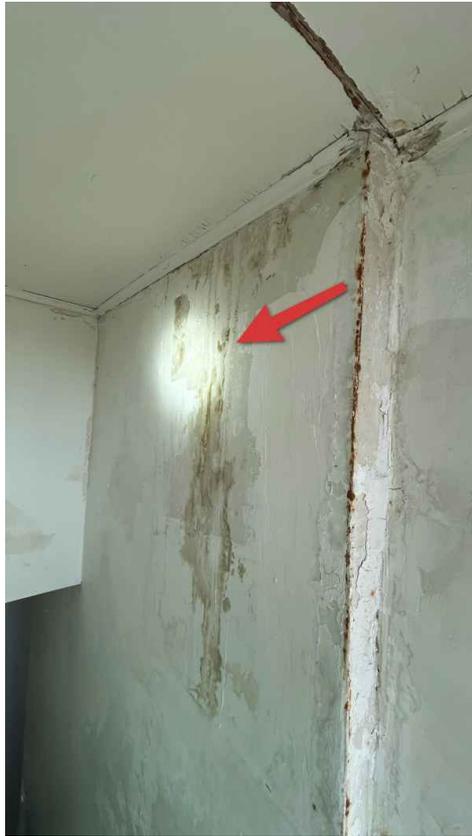
Minor staining was observed on the adjacent wall, possibly indicating a previous leak. This area is located beneath a flat roof section, which may have been the source of past moisture intrusion. While the staining appeared old and no active moisture was detected, the combination of safety and maintenance concerns warrants attention. Installing a proper handrail, improving door functionality, and monitoring for signs of further leakage are recommended upon possession.

Staining

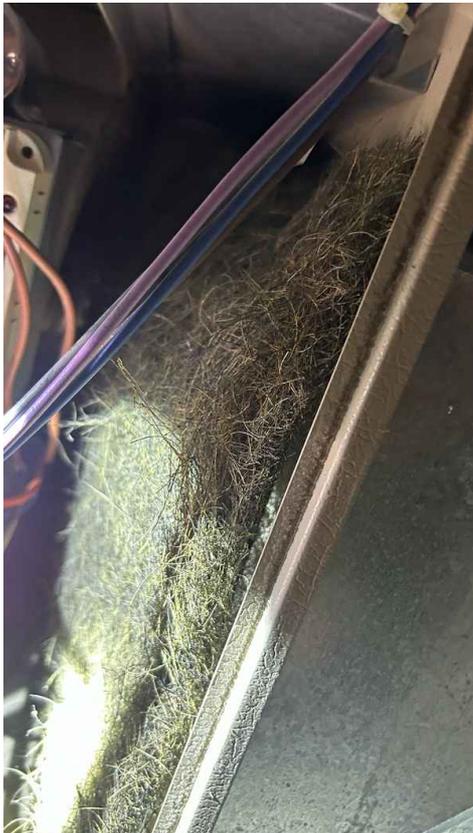
Inadequate filter

At a minimum, servicing by a licensed HVAC technician is strongly recommended upon possession to address the induced draft motor condition, verify safe operation, and install a proper filter. Given the unit's apparent age and condition, budgeting for replacement in the near future is also advised.

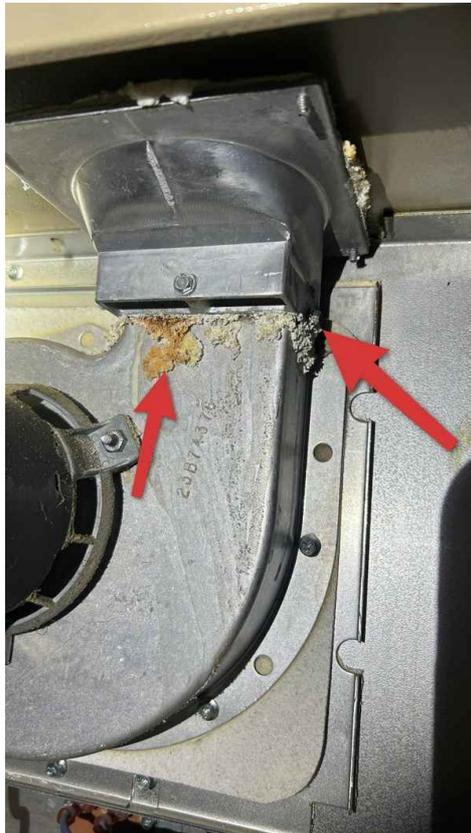
Corrosion at flu collar

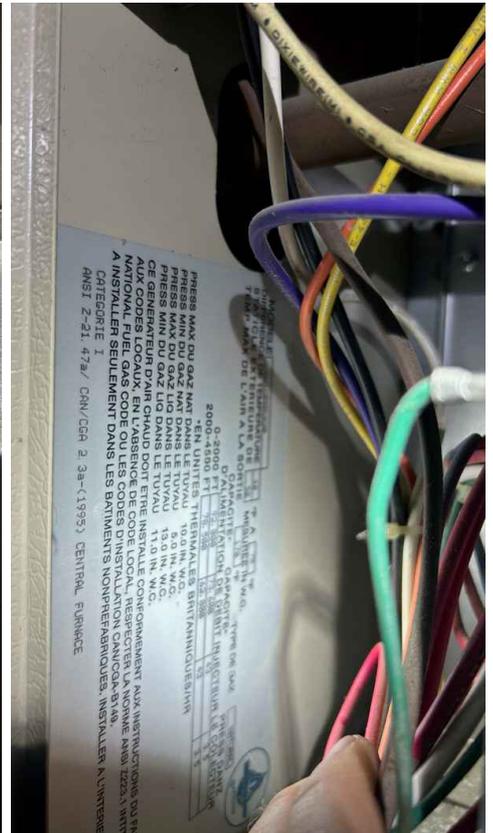
No serial number visible on unit

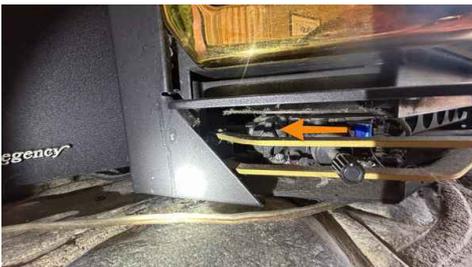
The gas fireplace insert could not be started at the time of inspection. The gas supply appeared to be shut off, but this could not be confirmed. The unit also appeared to be older, and the glass front was notably cloudy, suggesting it may not have been serviced in some time. Servicing by a licensed gas technician is recommended upon possession to confirm safe and proper operation. During servicing, ensure that a readily accessible gas shut-off is present at the unit for emergency use—if one is not present, installation should be requested.

Supply off

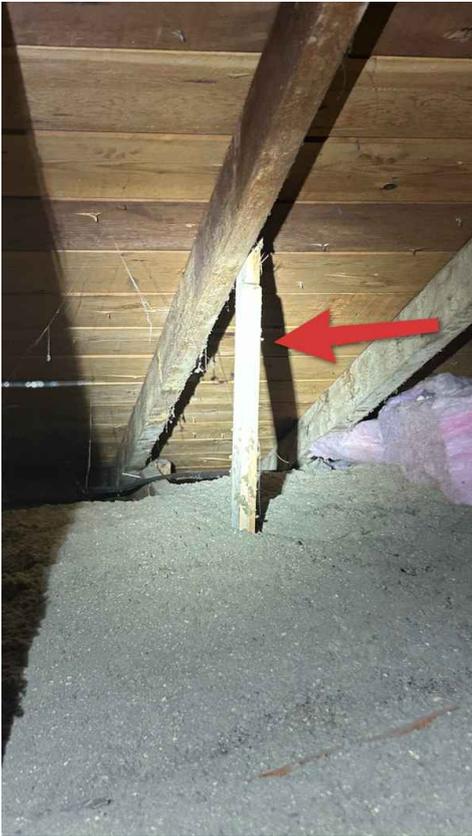
Thin lumber as additional support

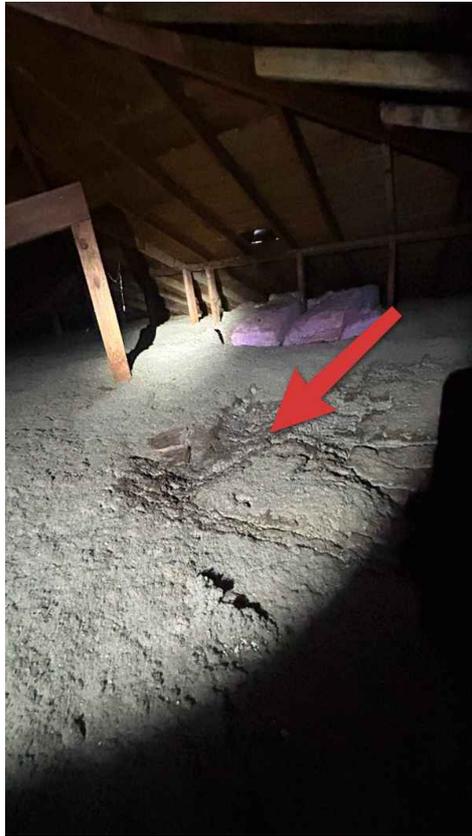
Sign of previous moisture or leak

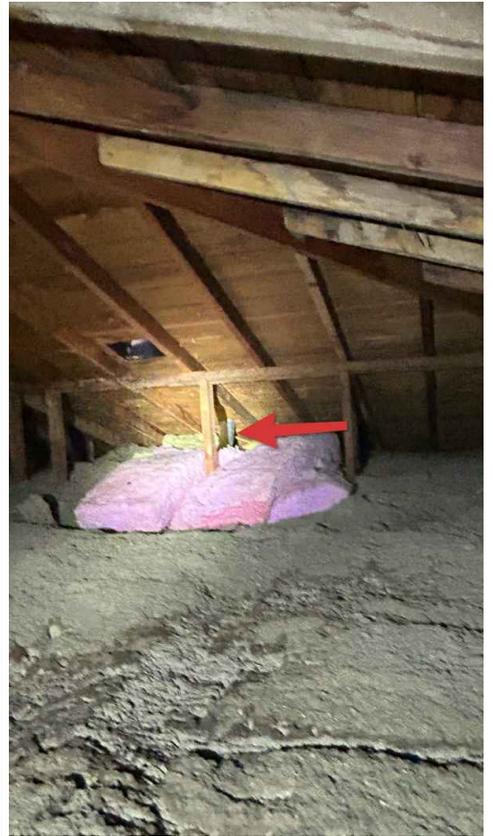
Additionally, a bathroom vent duct running through the attic was uninsulated, which may result in condensation during colder months. The attic hatch was also missing insulation and weatherstripping, contributing to potential heat loss. Insulating the hatch and vent duct is recommended upon possession to improve energy efficiency and moisture control.

Uninsulated duct

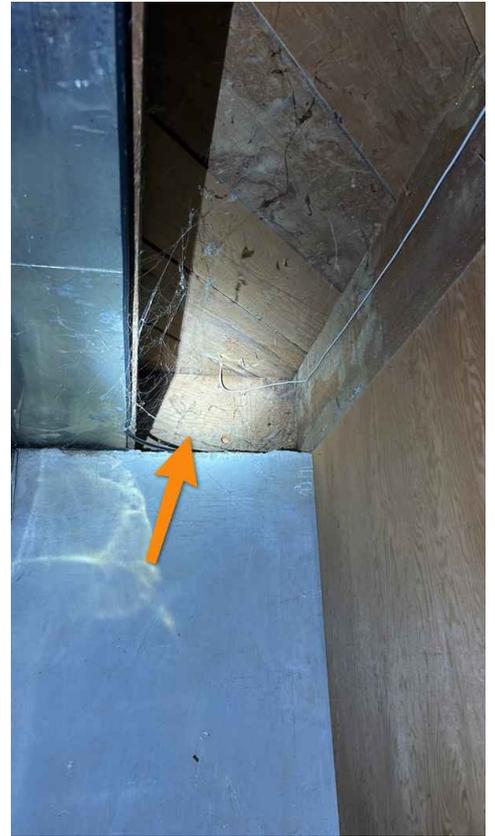
Several insulation voids were observed in the joist cavities (rim joists) around the perimeter of the basement. These areas are common points of heat loss and air infiltration if not properly insulated. Adding insulation in these sections is recommended upon possession to improve energy efficiency and overall comfort within the home.

Insulation void

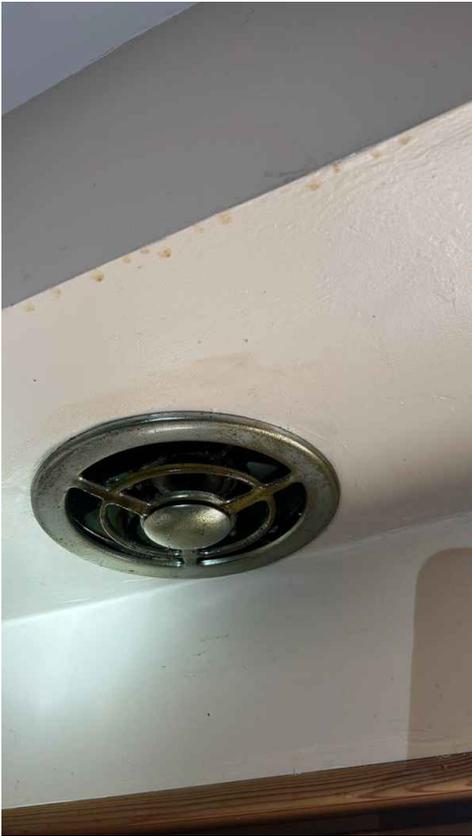
In the kitchen, only a basic circular vent was present, with no proper hood to capture grease or cooking vapours. Installing a functional range hood is recommended to improve ventilation and reduce buildup of grease and odours in the cooking area. Both fans should be upgraded or serviced upon possession for improved indoor air quality and functionality.

Add proper hood

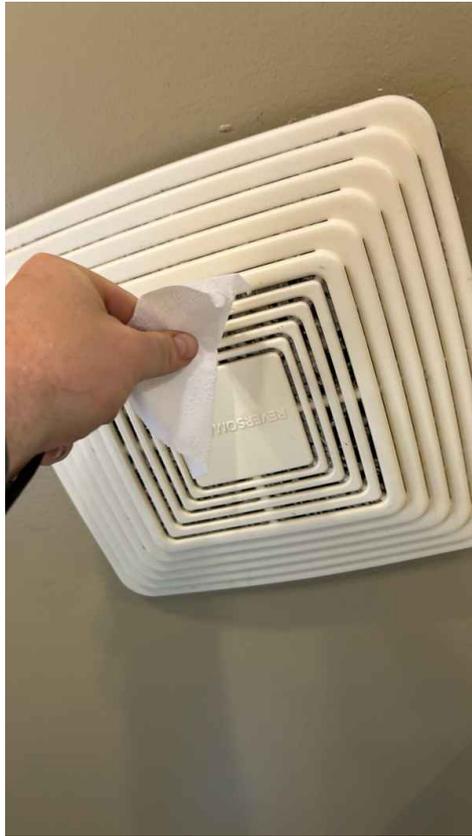
Inadequate suction

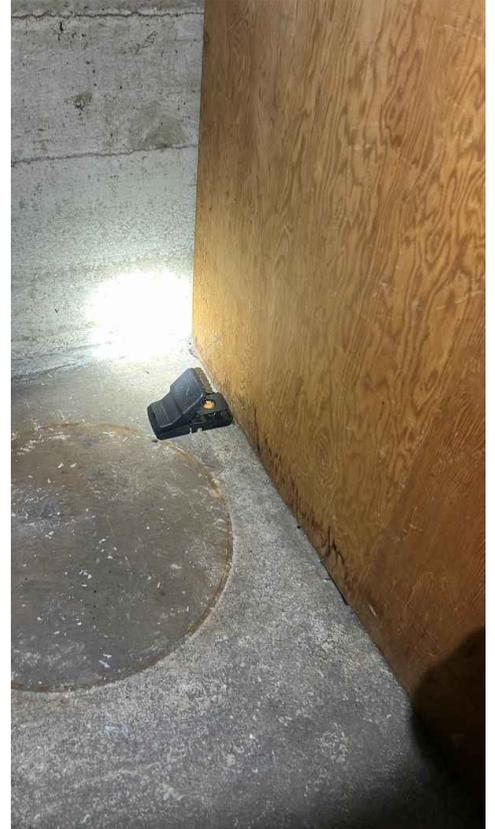
Rodent traps were observed in the basement, though no clear evidence of active infestation (such as droppings or nesting material) was noted during the inspection. The presence of traps suggests the previous owner may have experienced rodent activity. Monitoring the signs of pests is recommended, and a professional may be warranted.

Rodent traps
