WATCHTOWER
HOME INSPECTIONS

RESIDENTIAL REPORT

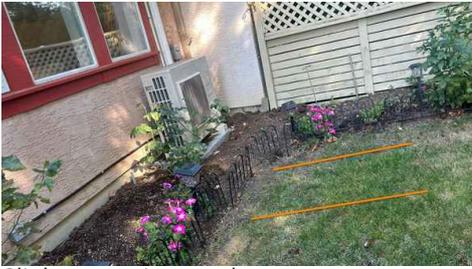
At the front of the home, the siding was noted to be too close to grade in areas (garden beds), particularly near the crawlspace vents. This condition reduces clearance for ventilation and has already allowed some soil to enter the crawlspace, which can contribute to moisture concerns or pest entry over time. In the backyard, minor grading issues were also observed, which may affect surface drainage if not maintained.

Slight negative grade

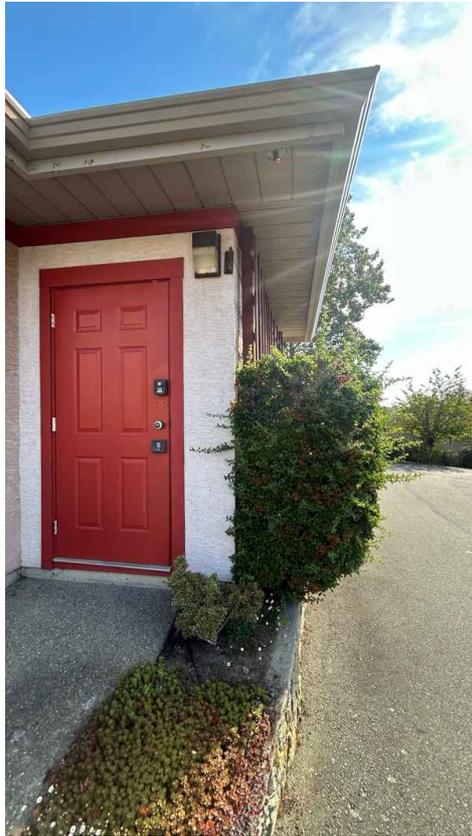
Vegetation around the property was positioned too close to the structure; trimming back trees and shrubs at least 0.9 metres (3 feet) is recommended to promote airflow, prevent contact with siding, and reduce the potential for material deterioration. Improving grading where needed and maintaining clearance at siding and crawlspace vents will help protect the building envelope and overall crawlspace conditions.

Vegetation too close to siding

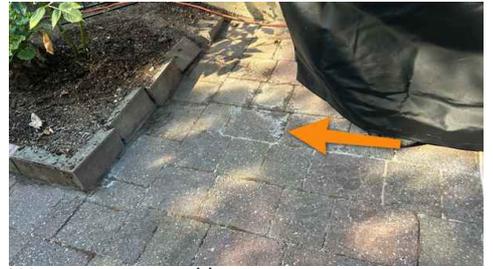
Water may pool here

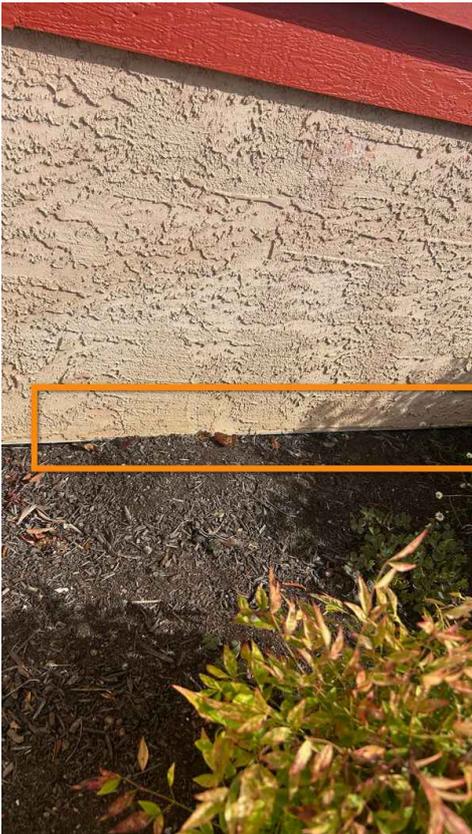
Siding too close to grade

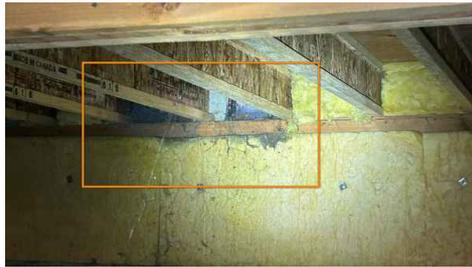
Grade too close to crawlspace vents

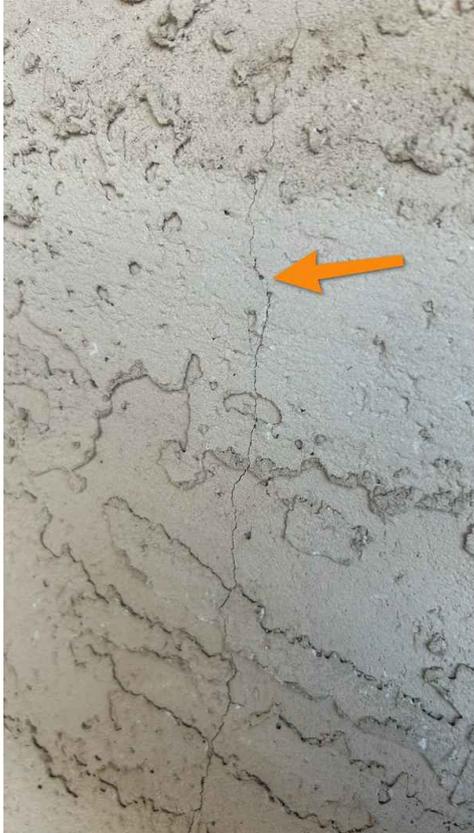
Several areas of deteriorated caulking were observed around windows and at transitions where the siding meets, along with minor cracking in the stucco. These conditions can allow limited moisture intrusion if not addressed, though they appear cosmetic at present. As this is a strata property, exterior maintenance is typically the responsibility of the strata corporation; confirmation with strata management is recommended. Routine resealing and minor stucco repairs will help maintain the building envelope.

Minor stucco cracks

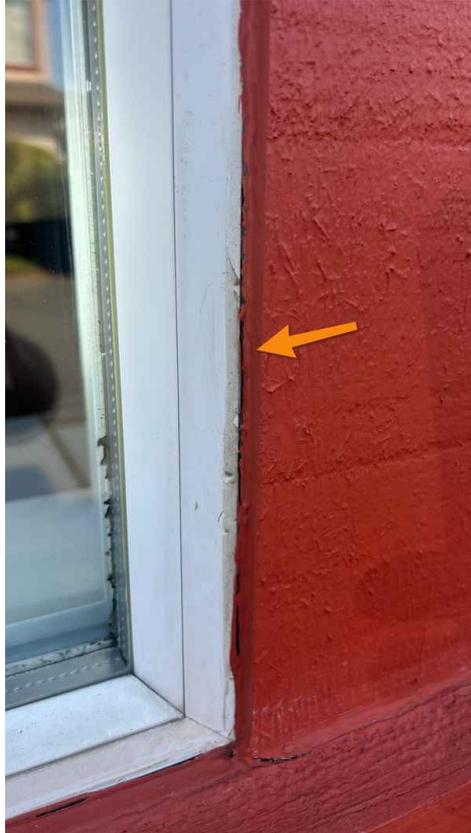
Caulk Gap

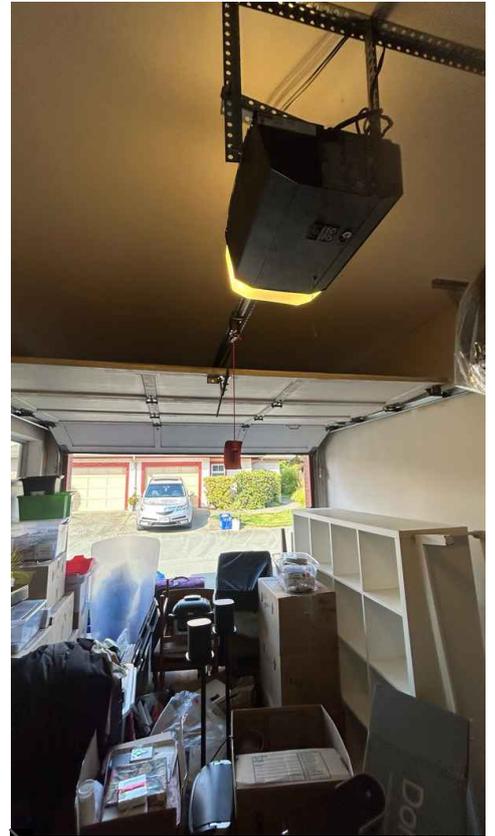
The garage door is a wood-panel style equipped with a motorized opener. The door operated and closed when tested; however, inspection was limited due to significant storage in the garage. The photoelectric safety sensors were obstructed at the time of inspection, preventing full testing. When the door button was held, the door closed, and the sensors appeared responsive when activated, though not fully confirmed under normal conditions. Clearing storage away from the sensors and ensuring they remain unobstructed is recommended for safe operation. Regular servicing of the garage door and opener will also help maintain reliable performance.

Garage full, limited inspection, door functional

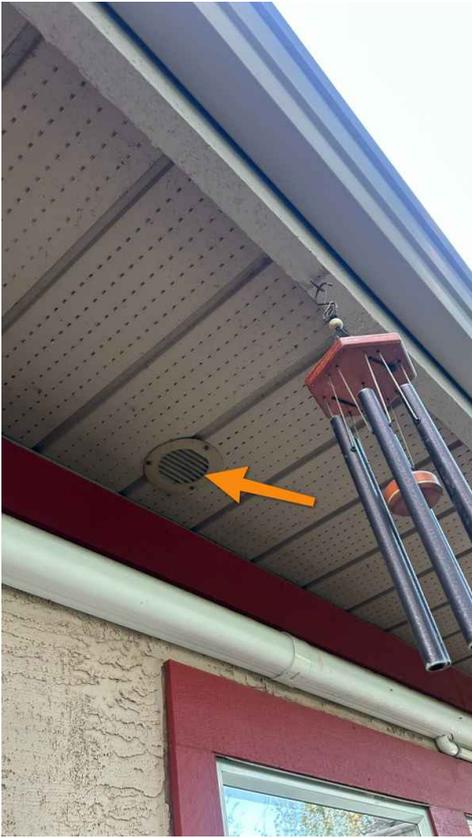
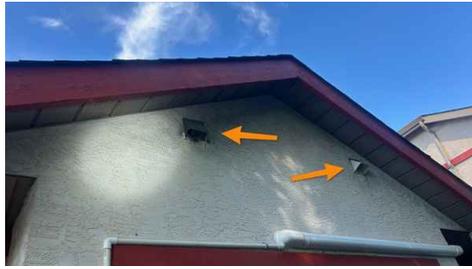
Exhaust vents were noted at the rear exterior of the home, terminating directly beneath the soffits. This configuration can allow warm, moist air to be drawn back into the attic space, contributing to localized staining or moisture concerns over time. Isolated attic staining consistent with this condition was observed and is noted in the attic section of the report. Redirecting exhaust vents to discharge away from soffits is recommended to reduce the risk of recurring attic moisture issues.

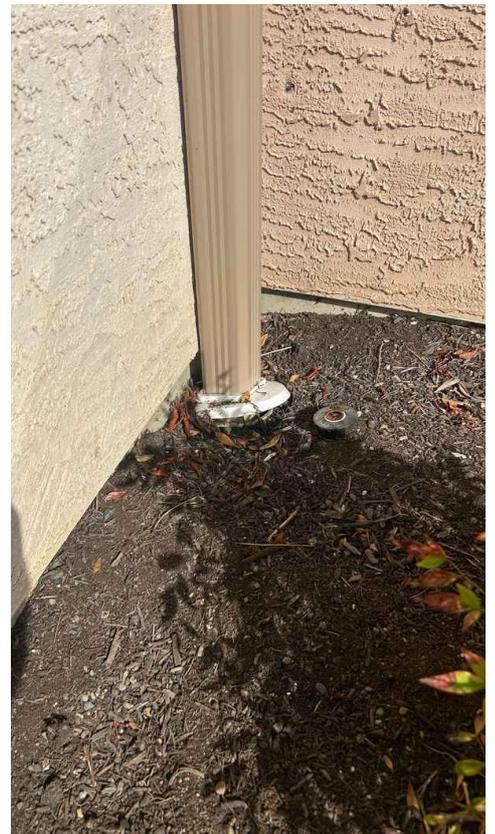
One of the downspouts on the right-hand side of the home terminated almost at or below grade. This, combined with limited clearance between the siding and soil, reduces visibility of the foundation and perimeter drainage riser. Downspouts that discharge too close to grade can increase the risk of moisture accumulation near the foundation. Adjusting the grading in this area to maintain clearance at the siding, expose more of the foundation wall, and ensure proper drainage away from the home is recommended to help protect the building envelope and perimeter drainage system.

Clear landscaping from drain

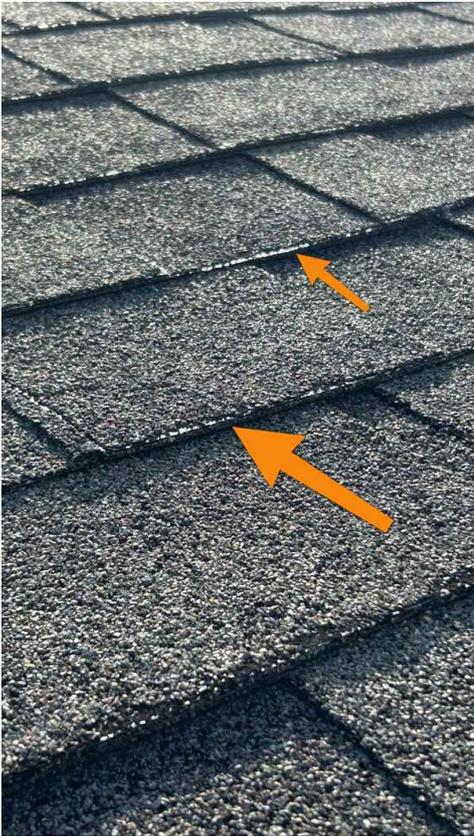
The roof is surfaced with architectural laminate asphalt shingles and appeared to be in the mid to later stages of its service life. Exposed fiberglass matting was visible along some edges, and moderate granular loss was noted in areas. While the roof remained in serviceable condition at the time of inspection, exposed matting typically indicates that shingles are approaching the end of their useful life. As this is a strata property, it is recommended to review the strata documents to confirm the roof's age, assess ongoing maintenance practices, and determine any upcoming replacement or repair plans.

Exposed fiberglass matting

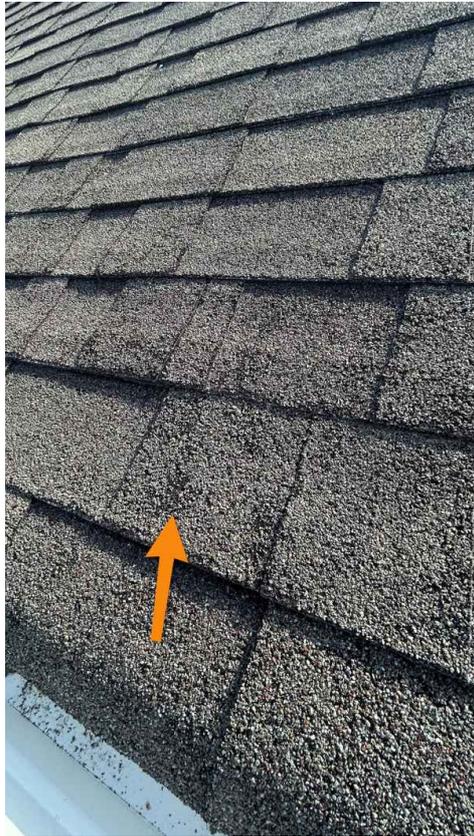
Moderate granular loss

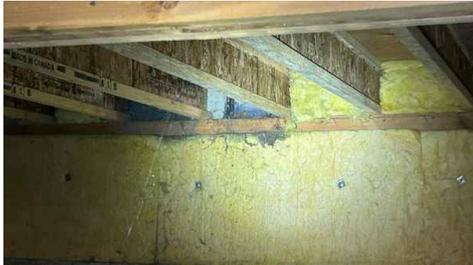
The crawlspace was finished with a concrete slab and was dry at the time of inspection. A few small, minor cracks were noted in the slab, along with some localized efflorescence, which is common and typically indicates past moisture movement through the concrete. One joist bay had missing insulation, but overall insulation and ventilation were adequate. The party wall was properly taped and sealed, and the baseboard heater in the crawlspace was functional. No significant concerns were observed other than the Poly B plumbing noted elsewhere in the report, though ongoing monitoring and minor maintenance are recommended.

Dirt coming in from vent

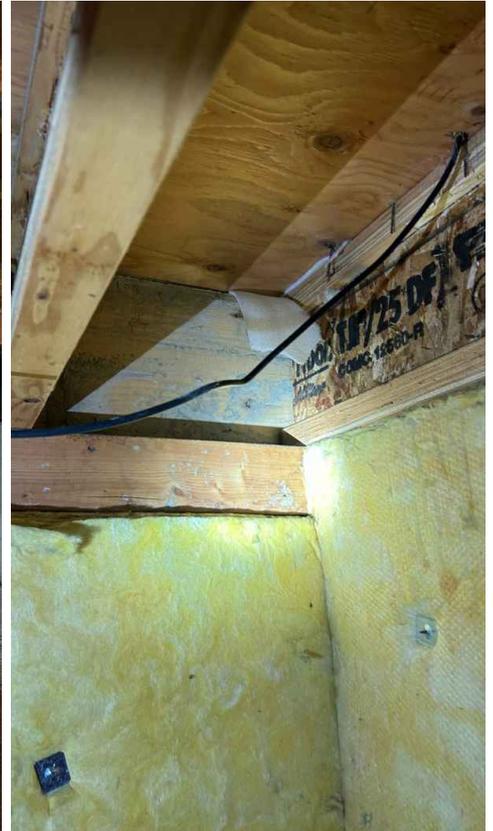
Insulation void

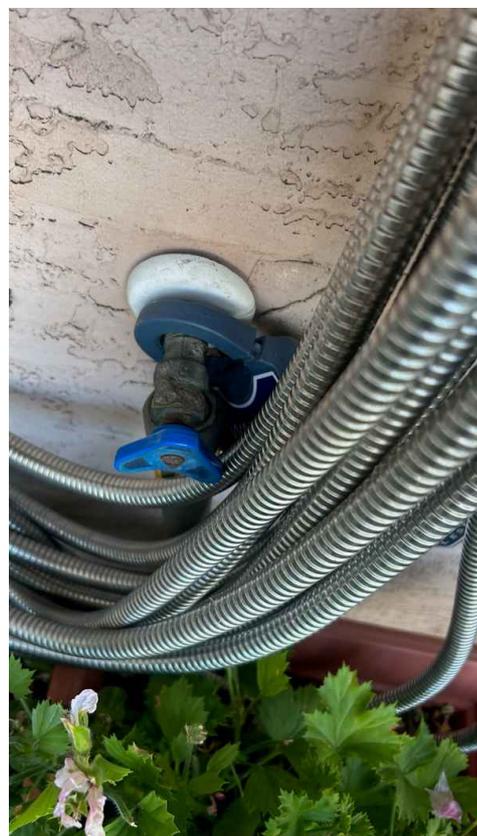
The rear hose bib was a frost-free type, while the front hose bib was not. Non-frost-free hose bibs are more susceptible to freezing during cold weather, which can lead to pipe damage or leaks. Upgrading the front hose bib to a frost-free model is recommended to provide better protection and reduce the risk of winter-related plumbing issues.

Upgrade bib

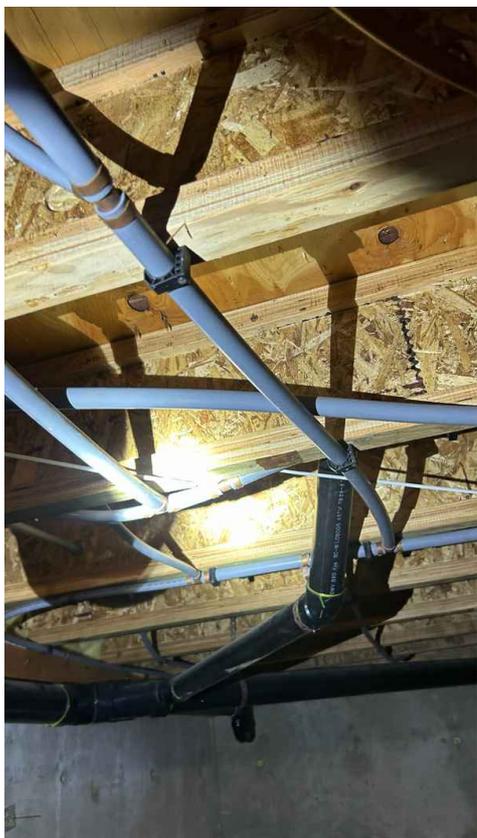
Polybutylene piping was observed throughout the home, including as the main water supply line from the municipal connection. Polybutylene has a known history of premature failure and bursting, and many insurance providers restrict or deny coverage for homes with this material. Confirmation with your insurance provider prior to subject removal is strongly recommended to ensure coverage can be obtained.

Poly B

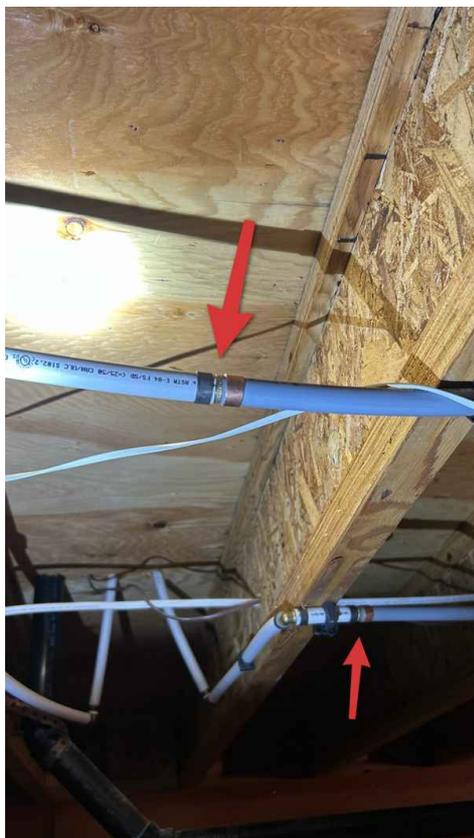
Much of the interior plumbing near fixtures appeared to have been updated with other materials, reducing overall reliance on Poly-B within the living spaces. The presence of a crawlspace provides relatively good access if replacement of piping is pursued, which may reduce costs compared to homes with finished basements. Replacement of Poly-B can still represent a significant expense and may also fall under strata responsibility; verification with the strata corporation is advised.

Poly B connected with Pex

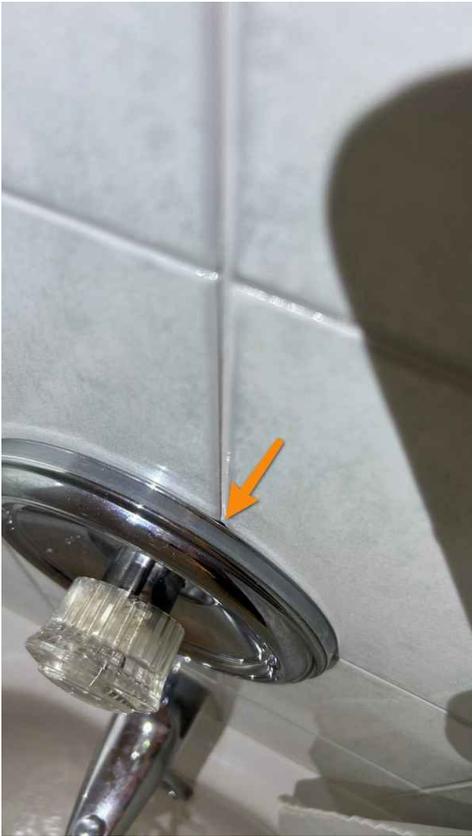
Both bathroom tub and shower areas required caulking maintenance, as existing caulking showed signs of wear. In the primary en-suite, the glass shower door did not fully latch, allowing it to remain slightly open during use. More notably, sections of grout were missing in the tiled areas. Missing grout can allow water to penetrate behind the tile, creating negative pressure that may draw moisture into wall cavities and lead to concealed damage. Replacement of missing grout is recommended immediately upon possession, along with resealing caulking and adjusting the shower door, to help maintain a watertight enclosure and prevent deterioration.

Re silicone gaps

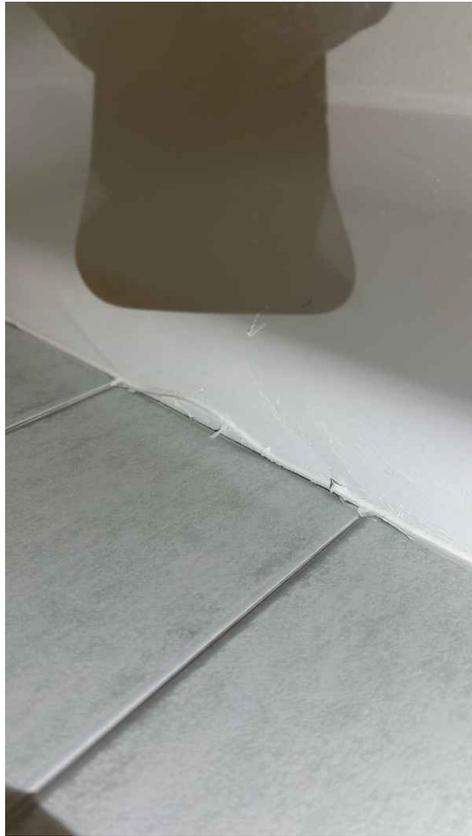
Re silicone tub tile connection

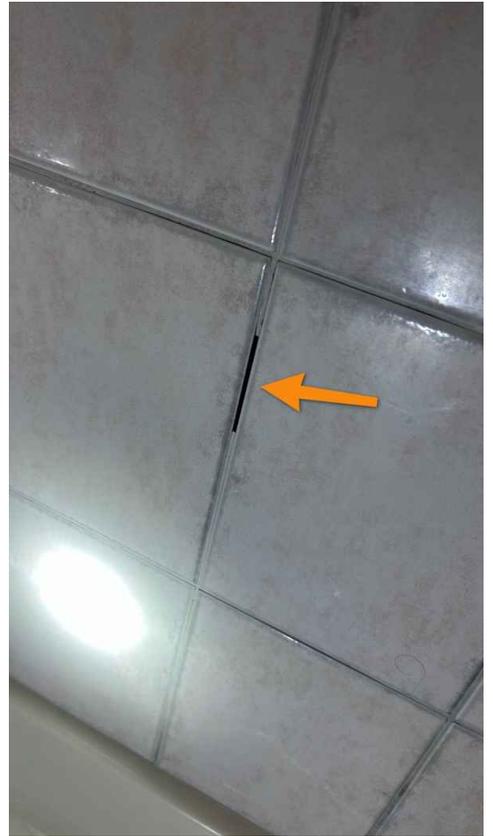
Grout gaps

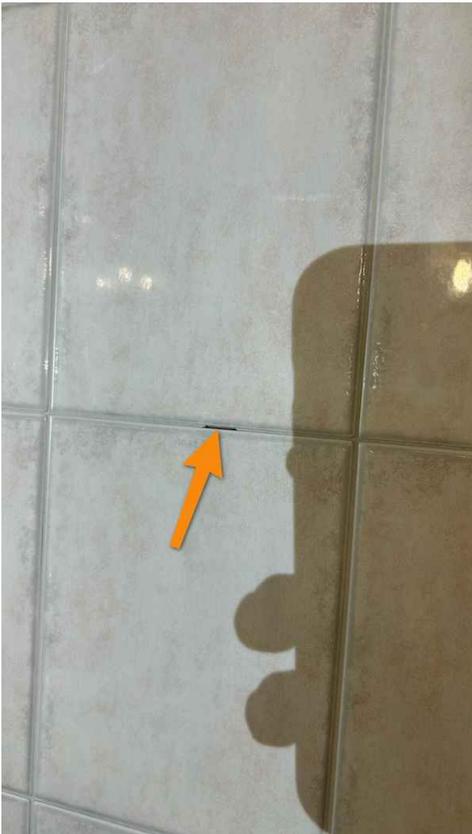
Grout gaps

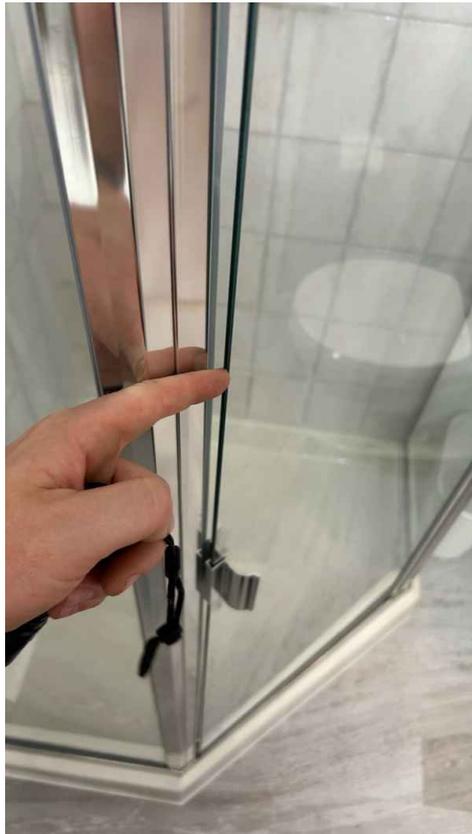
Door doesnt latch

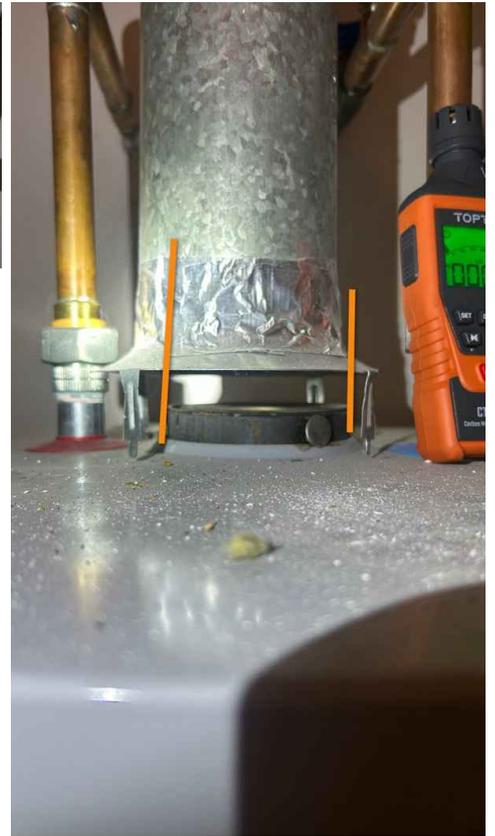
The home was equipped with a natural gas John Wood hot water tank manufactured in 2023. The unit appeared in good condition at the time of inspection, with no functional issues observed. The only noted concern was that the vent flue was slightly out of alignment with the unit's exhaust outlet; however, testing with a carbon monoxide detector did not indicate any leakage at the time of inspection. Obtaining warranty documentation from the seller is recommended for future reference, and alignment of the venting can be reviewed during routine servicing.

Flue slightly out of center

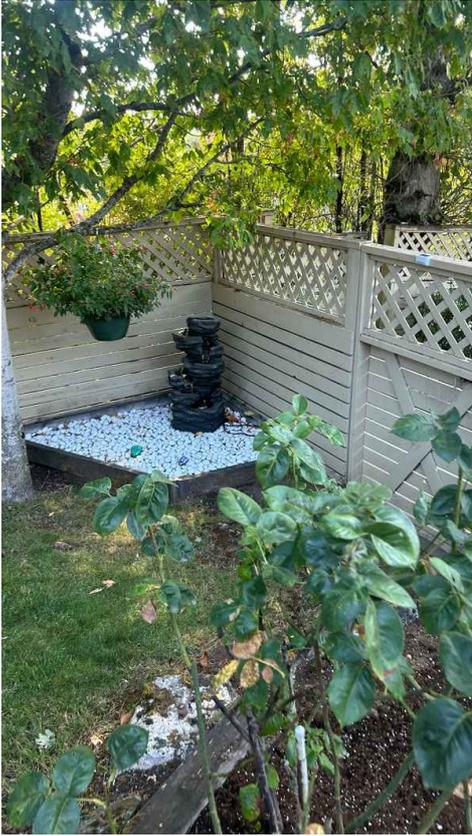
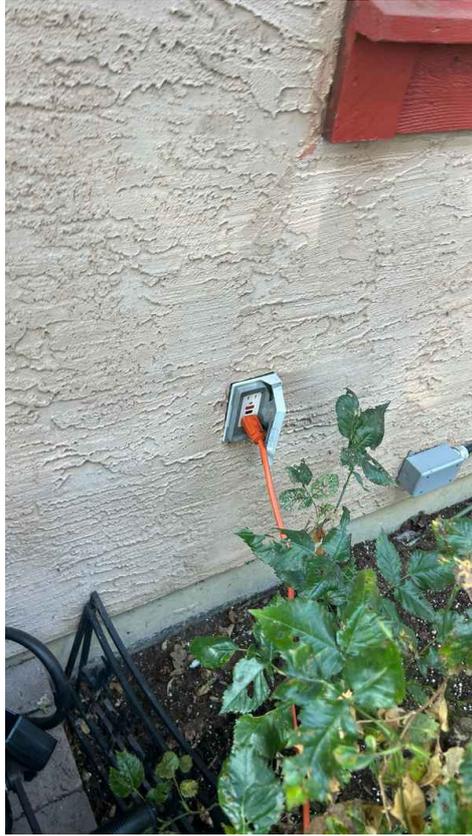
A fountain in the backyard was powered by an extension cord that appeared to be used as semi-permanent wiring. Extension cords are not intended for permanent outdoor use, as they are more susceptible to weathering, damage, and electrical risk. While the fountain may be seasonal, a dedicated exterior receptacle or proper outdoor-rated wiring is recommended if long-term use is desired.

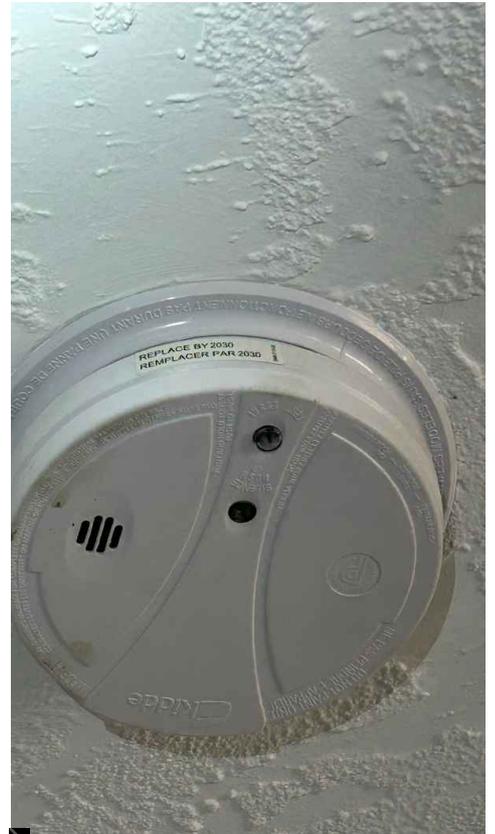
The unit was equipped with a single smoke detector in a common area, with an expiry date of 2030, and one receptacle-mounted carbon monoxide detector. While these devices provide some coverage, modern safety standards recommend installing smoke detectors in or near all sleeping rooms and using ceiling-mounted carbon monoxide detectors in common areas and near appliances that emit CO for more reliable protection. Upgrading by adding smoke detectors to each bedroom and installing a permanent, ceiling-mounted carbon monoxide detector is advised to enhance occupant safety.

Add to sleeping rooms, test regularly

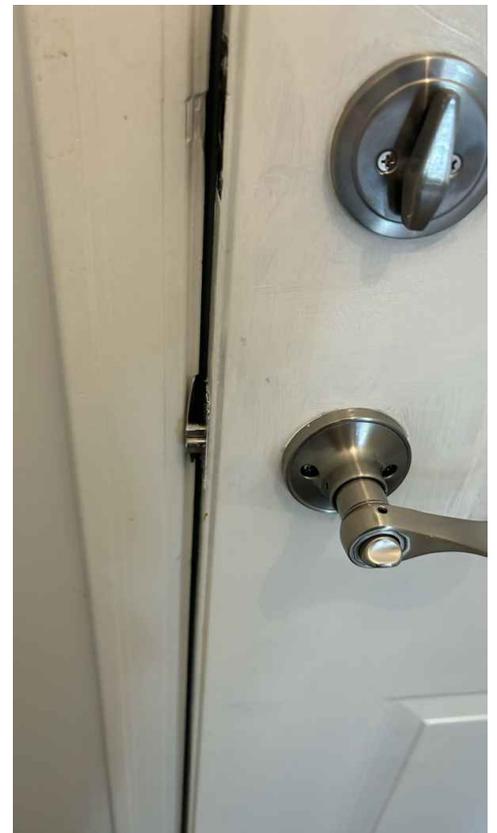
The man door between the garage and living space was equipped with self-closing hinges but did not fully close on its own, only latching partially. A properly self-closing door helps reduce the risk of products of combustion or garage fumes entering the home. Adjustment of the self-closing hinges is recommended to ensure the door fully closes and latches securely.

Adjust hinges

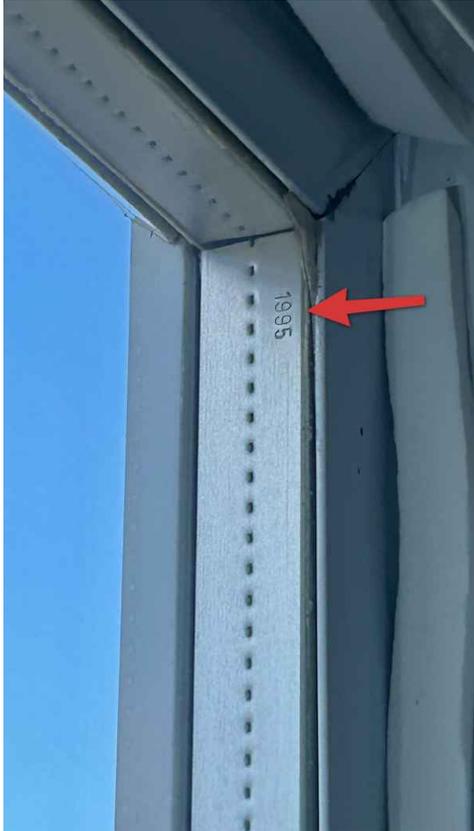
The home was fitted with original metal-framed fixed and awning windows from 1995, now approaching 30 years of age. Windows of this vintage commonly begin to lose functionality, and some were noted to be sticky or more difficult to operate. Many of the units were missing insect screens, and one window had exterior pane damage with a small hole where the glass had chipped through; this unit also appeared to have lost its seal. While all windows were still serviceable, age-related wear will continue to impact efficiency and usability, and replacement should be anticipated in the coming years. As this is a strata property, review of the strata documents is recommended to confirm planned maintenance or replacement schedules for the windows.

Original windows 1995

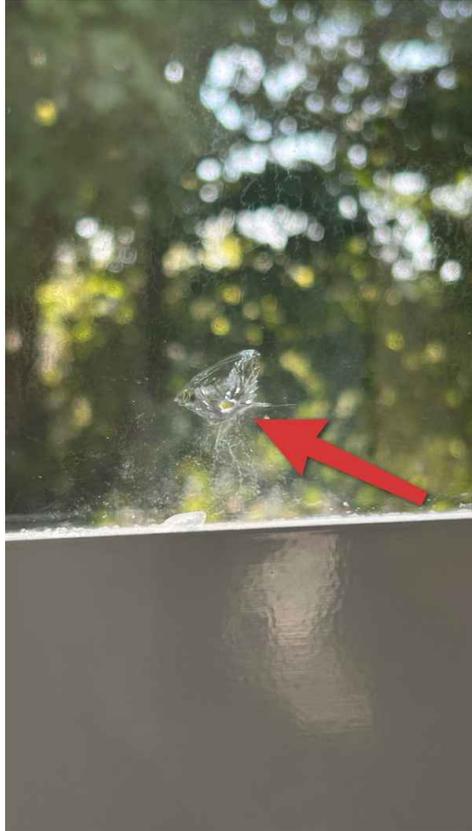
Chipped Pane, Lost seal

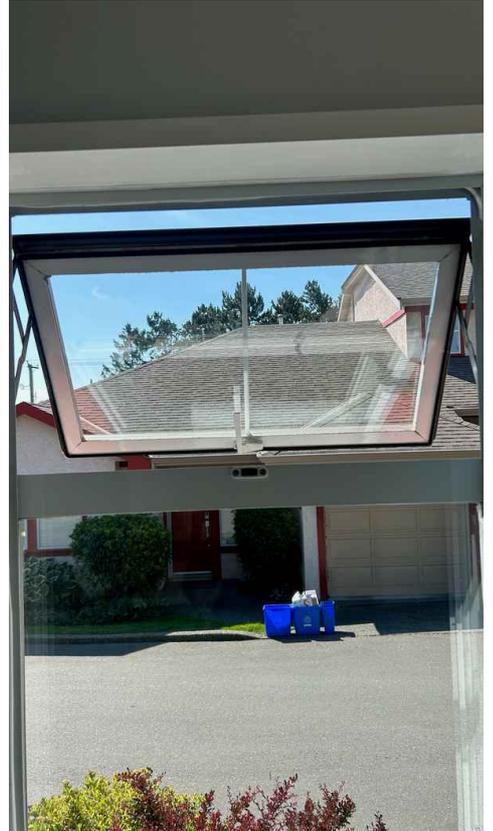
Sticky Awning window

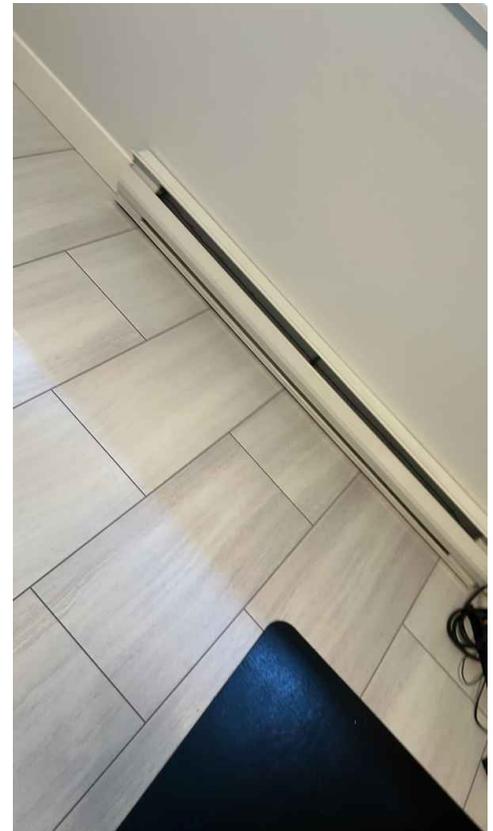
The primary bedroom contained an electric baseboard heater; however, it was disabled, with no thermostat present. Heating for this room is now provided by a heat pump head, making the baseboard heater unnecessary. This is noted for information only and does not affect comfort or functionality.

Disabled Baseboard heater

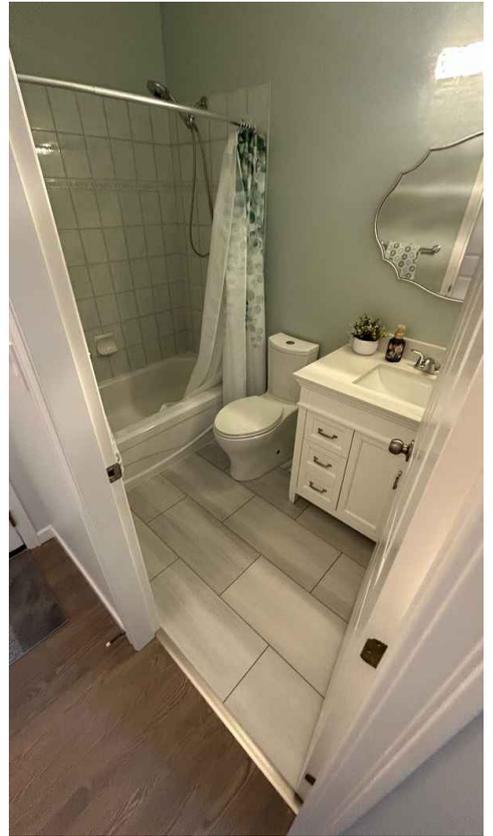
The front entry bathroom did not contain an independent heat source. Given its interior placement within the unit, with walls not exposed to the exterior, the space is likely to maintain adequate warmth from adjacent heated areas. This is noted for information only and is not expected to affect functionality or comfort.

No independent heat source

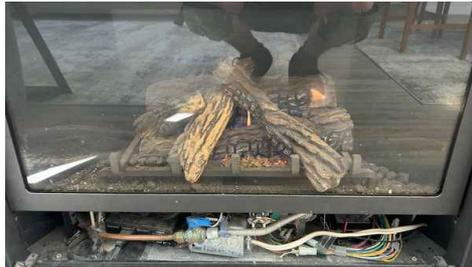
The gas fireplace was operational at the time of inspection and included a shutoff valve at the unit. As with all combustion-producing appliances, routine servicing is important to ensure safe and efficient performance. It is recommended to have the fireplace professionally serviced upon possession and to establish an ongoing maintenance schedule thereafter.

Service gas fireplace

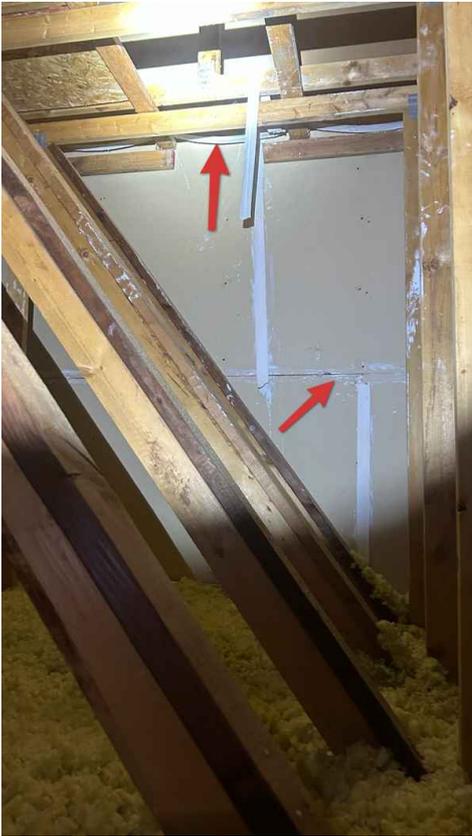
The party wall between units had sections where joint tape and compound had failed or fallen off, leaving seams exposed, and one area of drywall damage was noted. **Properly sealed party walls are important for maintaining the required fire separation between units**; as this is a strata property, repair should be confirmed with strata management.

Party wall not sealed

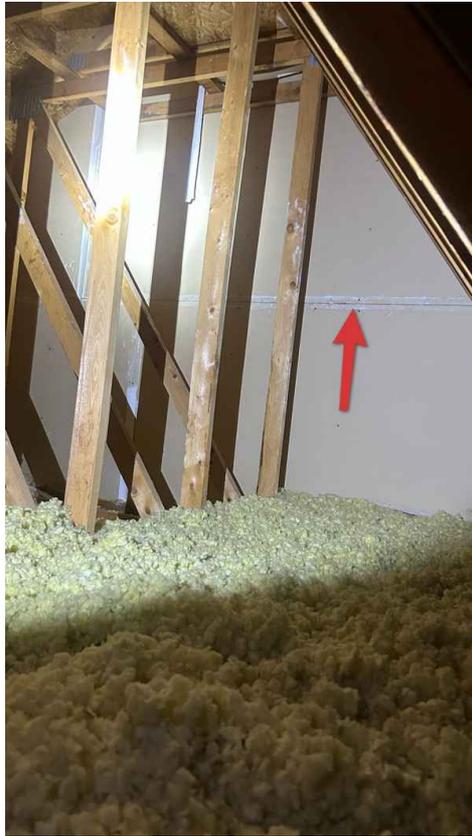
Missing tape and compound

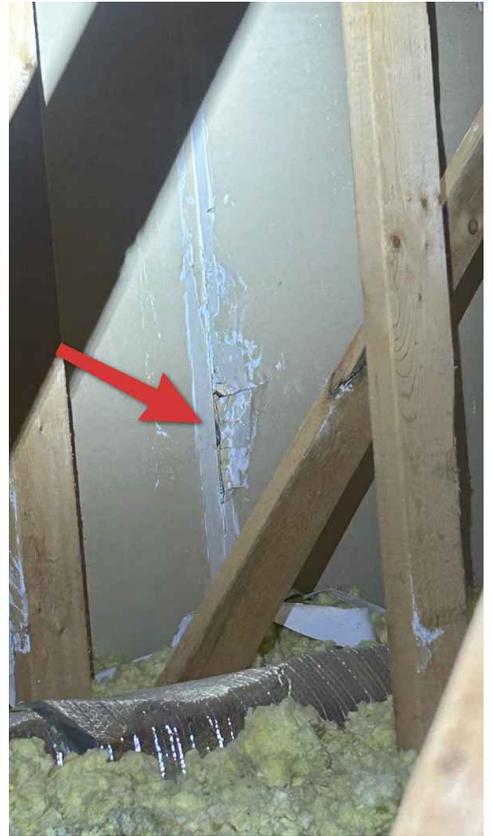
Damaged party Wall

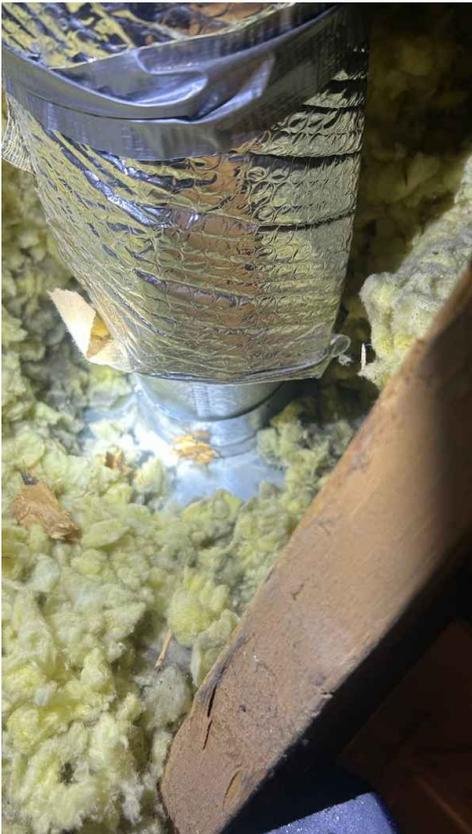
B-Vent combustible clearance

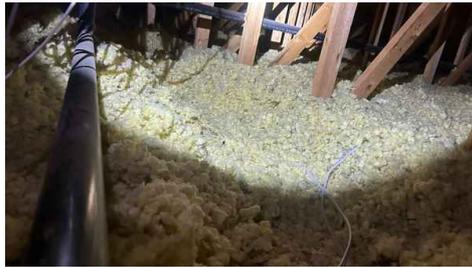
Lastly, some attic insulation was displaced, likely from previous work, and had not been redistributed. Re-spreading insulation is recommended to maintain even coverage and thermal performance.

Displaced Insulation

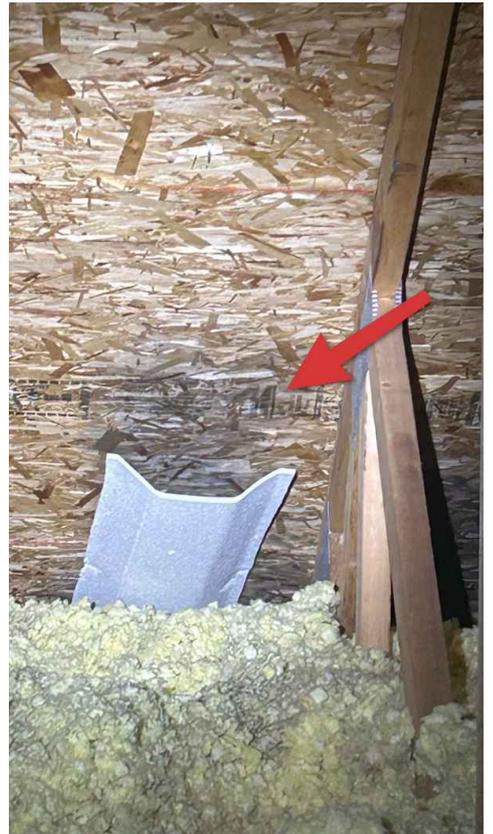
The attic space showed several conditions worth noting. **Isolated staining was observed on the sheathing**, consistent with moist air from vents terminating beneath the soffits and being drawn back into the attic. This configuration is better corrected during a future roof replacement, when vents can be redirected through the roof rather than beneath the soffits.

Isolated attic staining

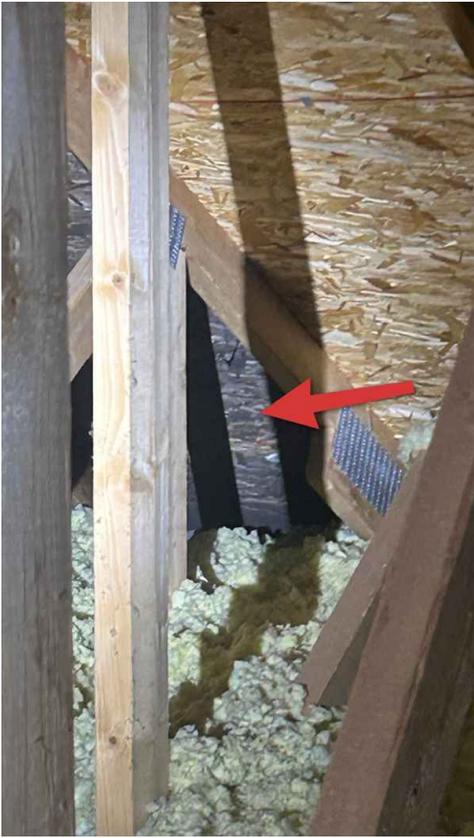
Isolated attic staining

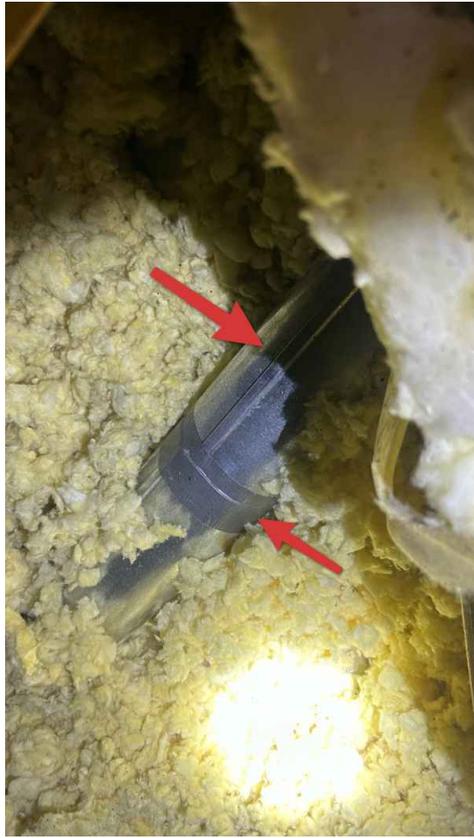
Uninsulated vent using duct tape
