**WATCHTOWER**  
HOME INSPECTIONS

## RESIDENTIAL REPORT

2400 Dalhousie St  
Victoria, BC V8R 2H6

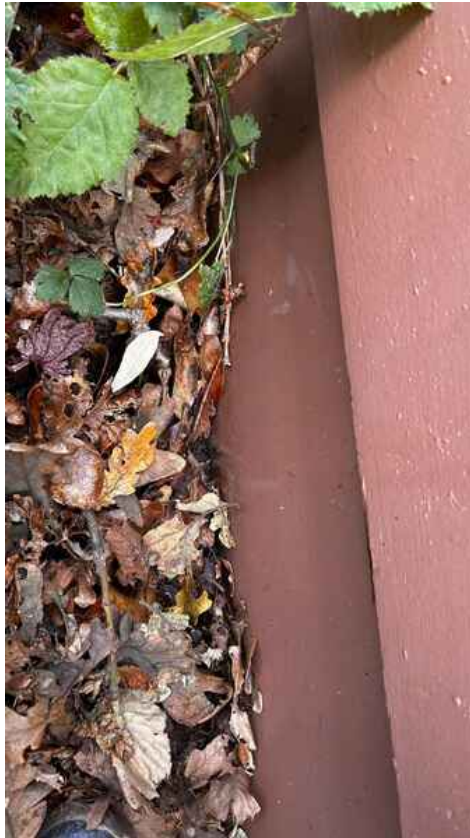
Siding too close to grade

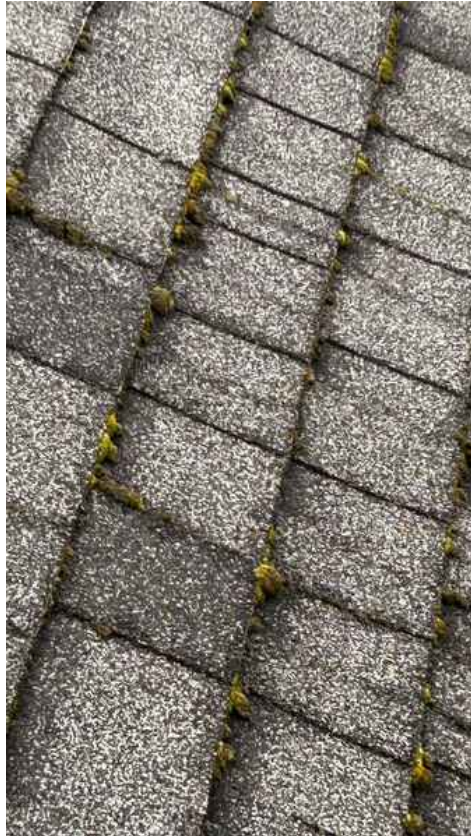
Granular loss and moss

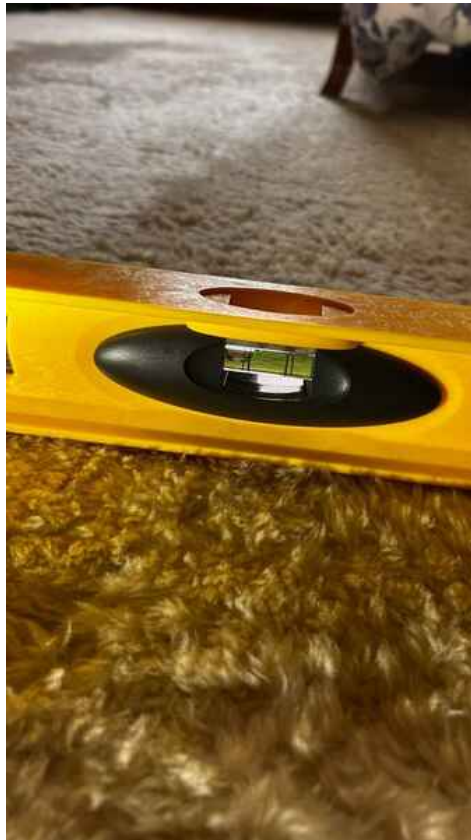
Level Showing floor displacement

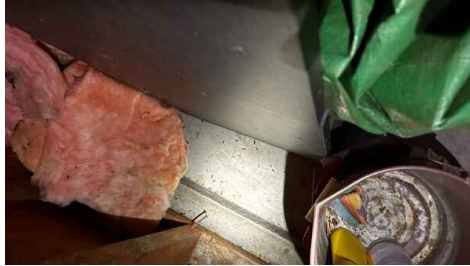
Rodent droppings in garage

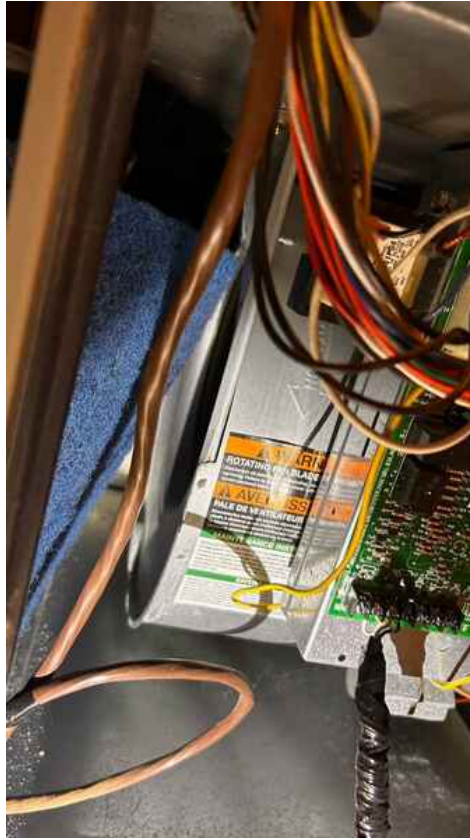
Filter interfering with furnace blower

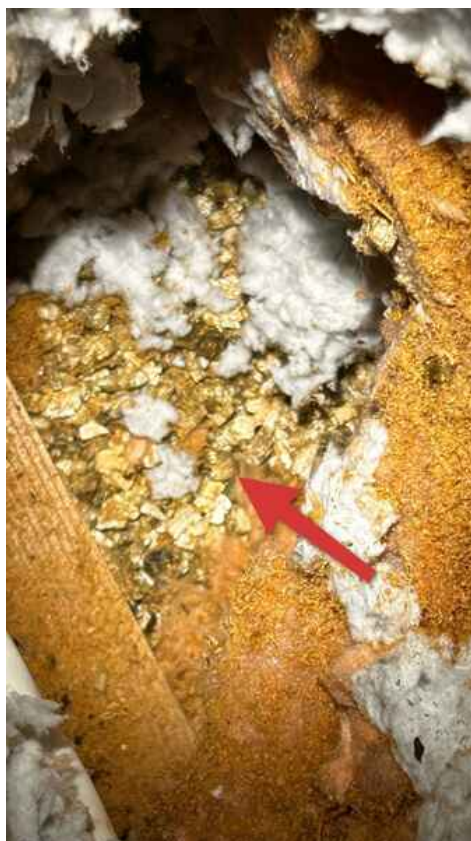
Vermiculite insulation contains asbestos
