WATCHTOWER HOME INSPECTIONS

RESIDENTIAL REPORT

7124 Willis Point Road, BC

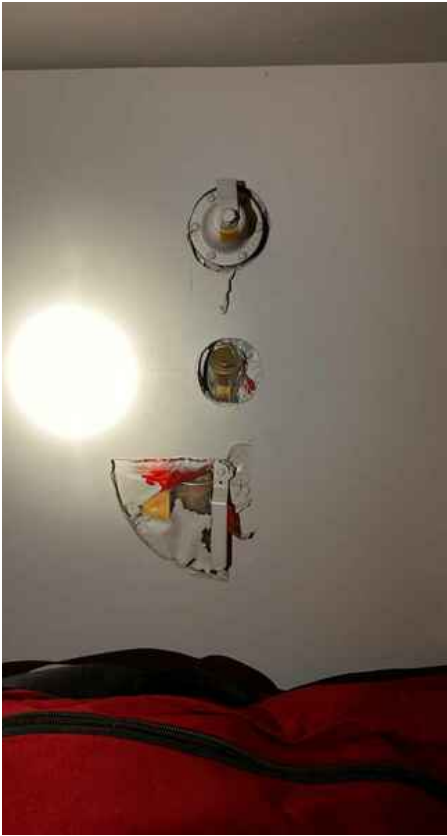
Main Water Shut Off

The valve is not operated to test its functionality. The supply material is suspected to be Polyethylene, but cannot be confirmed due to the vapour barrier in the way.

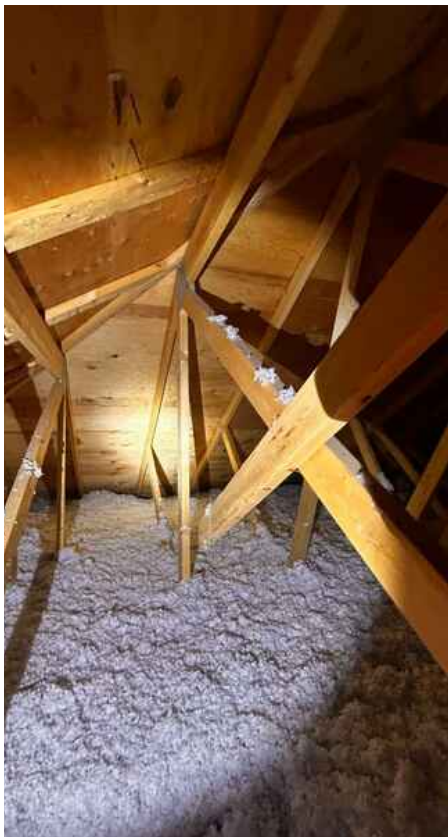
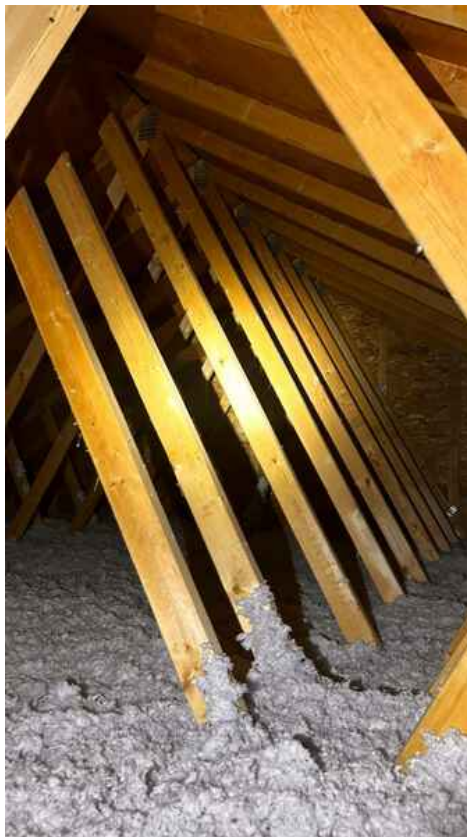
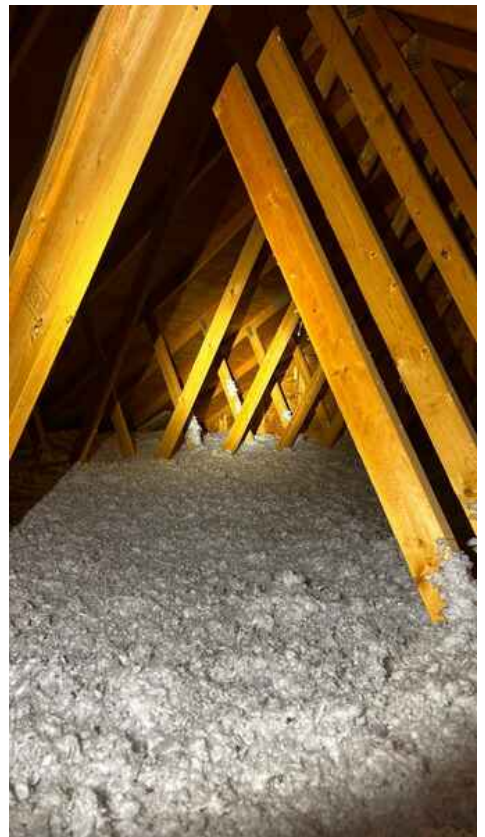
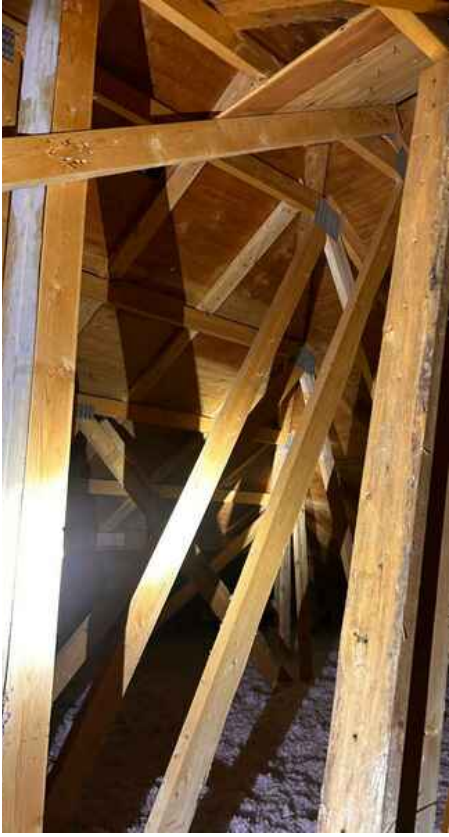
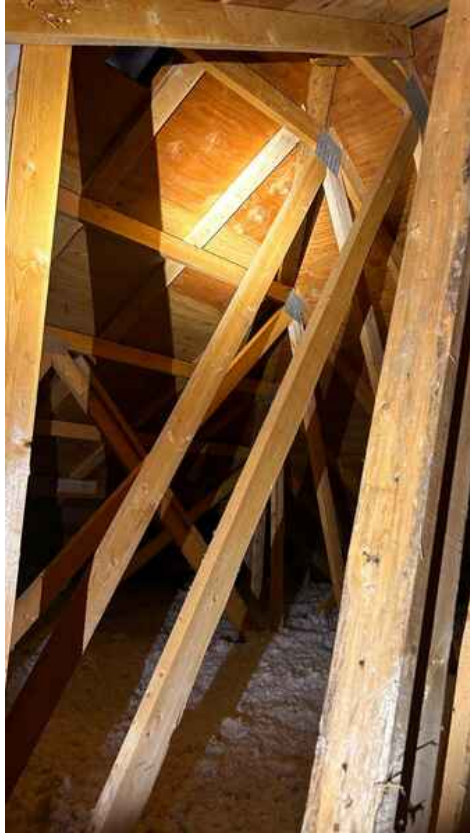
Attic photos

MINOR ATTIC STAINING ON SHEATHING
