**WATCHTOWER**  
HOME INSPECTIONS

## RESIDENTIAL REPORT

7124 Willis Point Road, BC

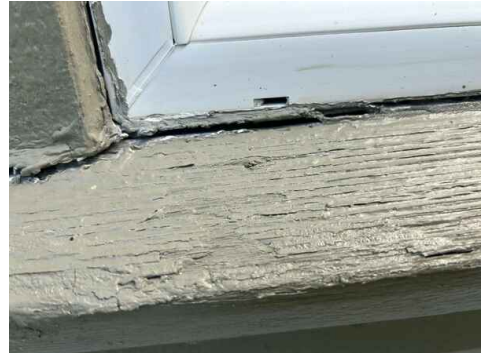
Caulk window gaps

Routine caulking maintenance is recommended around the exterior of the property, including around windows and in small gaps in the siding. Proper caulking helps prevent moisture intrusion and ensures the home's exterior remains well-sealed. It is advised to inspect and reapply caulking where needed upon possession to maintain the home's integrity.

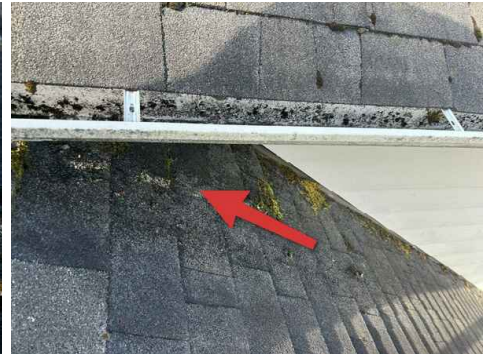
Gutter draining directly onto roof surface
