**WATCHTOWER**  
HOME INSPECTIONS

## RESIDENTIAL REPORT

APRIL 4, 2024

7124 Willis Point Road, BC

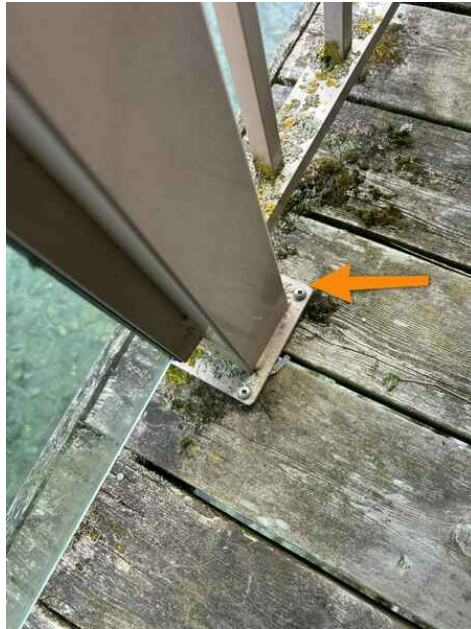
The deck railing is mounted directly onto the deck's surface, creating a vulnerability to accelerated deterioration from water ingress around the hardware. This configuration facilitates the collection of water, promoting wood rot and potentially undermining the railing's stability. To counteract this, applying mastic to the railing's hardware is advised. This action will serve as a waterproof barrier, significantly reducing water ingress and helping preserve the wood's integrity, thereby prolonging the railing's lifespan and maintaining its stability.

Hardware drilled into surface

Apply mastic to hardware to prolong, and fix deck boards to secure gate

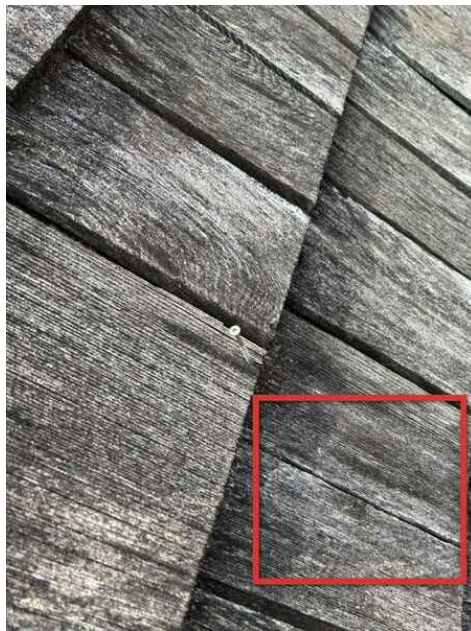
Multiple split shakes throughout

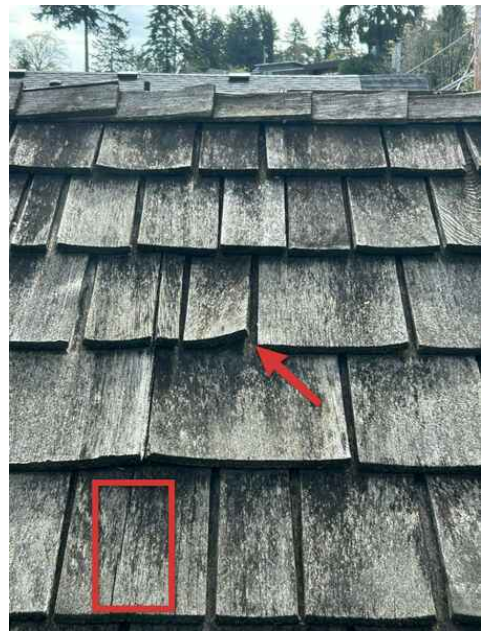
Lifted and split shakes

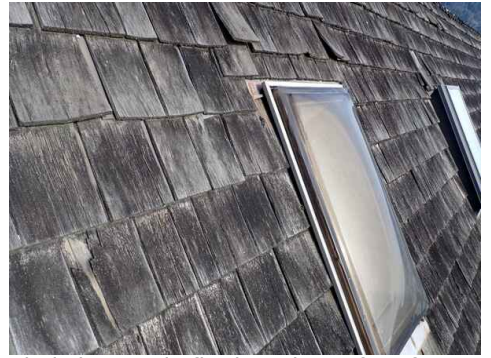
Skylight nearly flush with roof surface

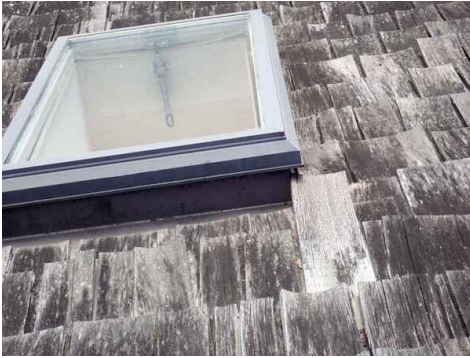
Skylight built on curb

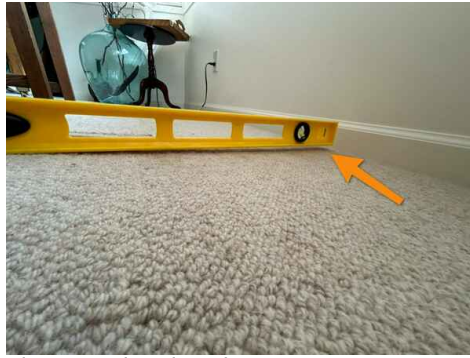
Floor not level in short span

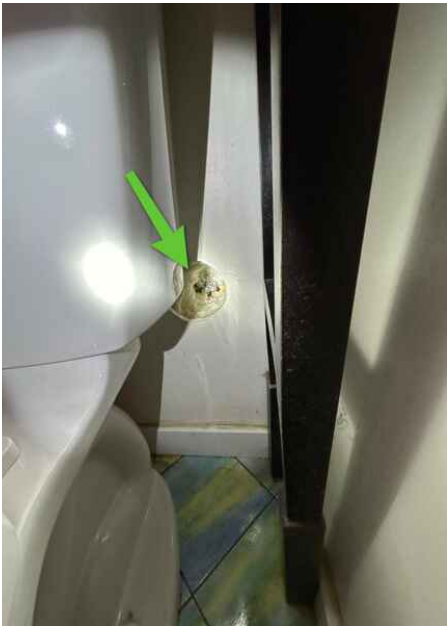
It is suspected that the main water shut off for the home is behind the guest bathroom toilet, but it cannot be confirmed to be the actual main water shut off and therefore cannot confirm the supply piping material. The amount of storage in the home may be concealing other main plumbing lines. Engage a plumber to gain essential knowledge of the home's plumbing upon possession.

Possible main water shut off

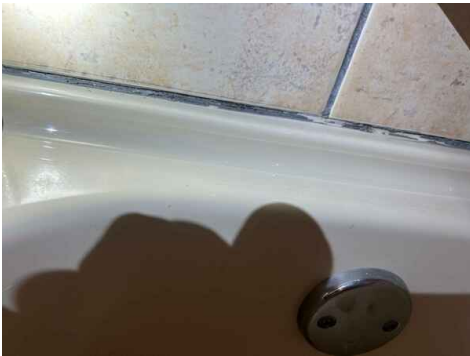
The caulking in the master bathroom is cracked and has deteriorated, which could lead to water infiltration into adjacent surfaces, potentially causing damage to the tile and wall assembly or mold growth. Addressing this issue promptly by removing the old caulking and applying new, high-quality caulking upon possession will seal the gaps effectively, protecting the area from water damage and maintaining the bathroom's appearance and hygiene.

Missing caulk/ silicone

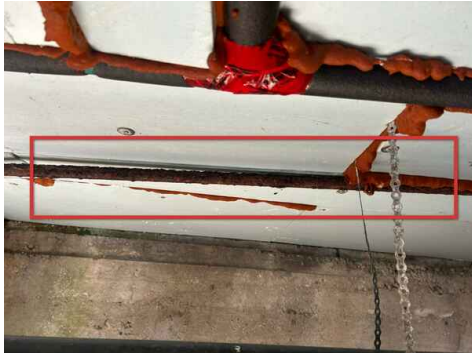
The gas line located underneath the home shows severe corrosion due to its marine environment, raising concerns about potential gas leaks. While the outdoor setting reduces the risk of explosion, it remains essential to address this issue promptly to ensure safety and uninterrupted gas service. Contact a certified professional immediately to inspect and repair the corroded gas line, preventing any potential hazards and maintaining a safe environment around the home.

Gas line corroded

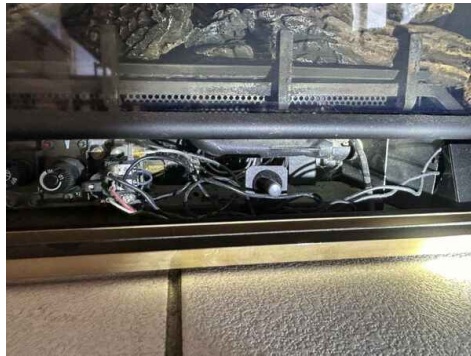
No shut off valve at unit
