WATCHTOWER
HOME INSPECTIONS

RESIDENTIAL REPORT

7124 Willis Point Road, BC

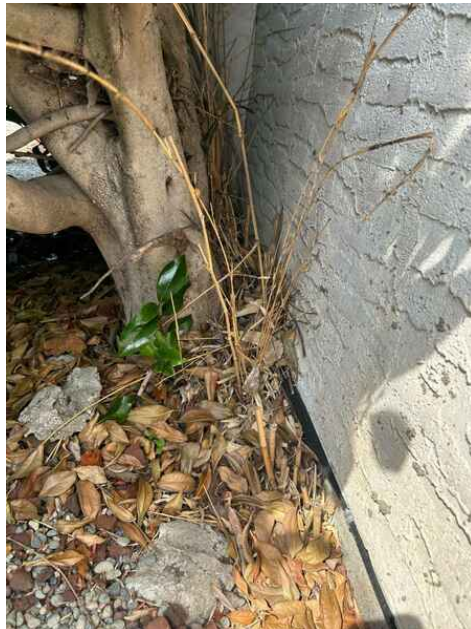
Tree very close to slab

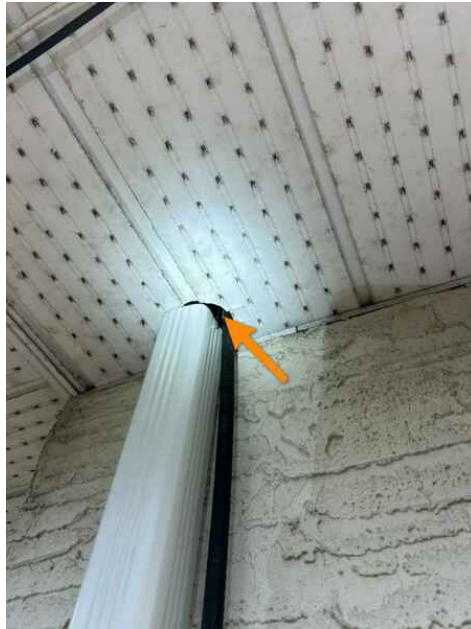
Gap where downspout meets soffit

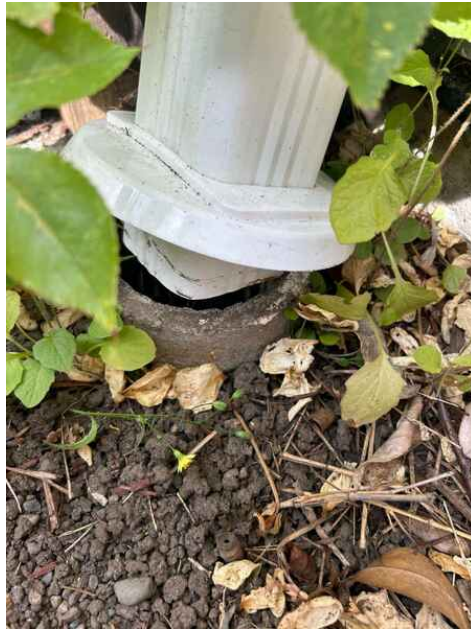
Scope for blockages/collapse

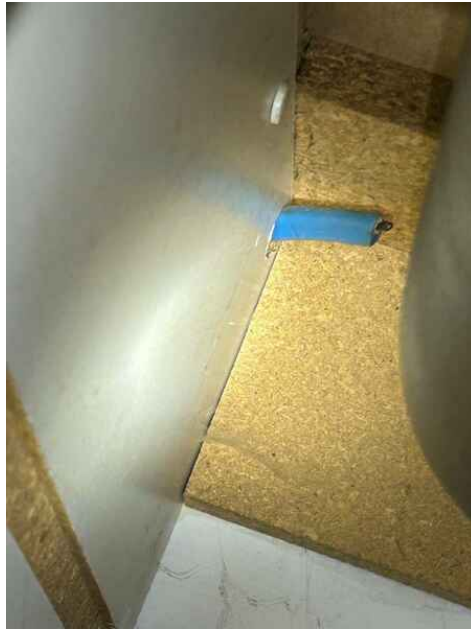
Stray conductor under sink (not tested)

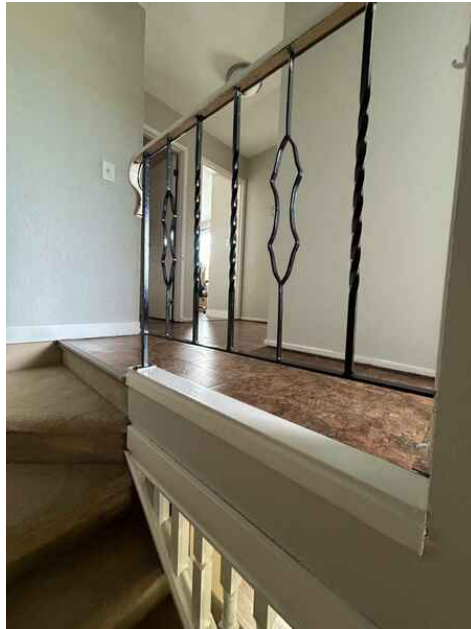
un-sturdy guard rail, wide balusters

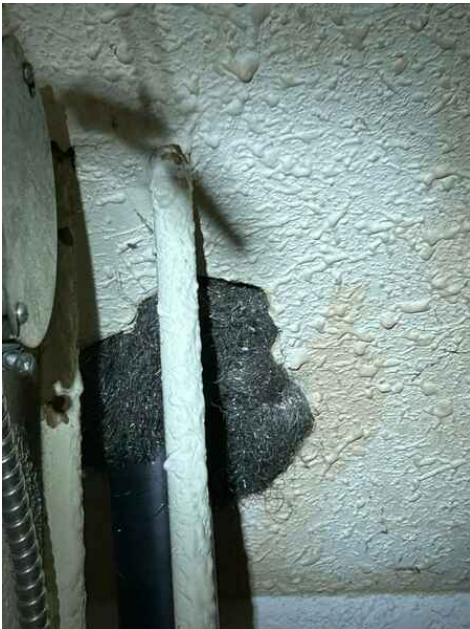
Steel wool used in living space as deterrence.

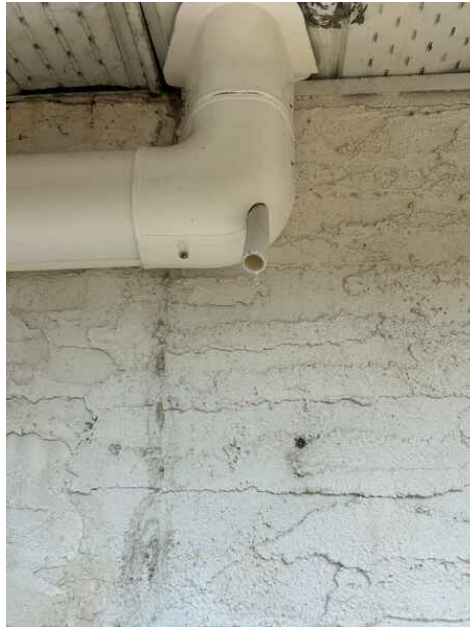
Condensate drain close to home (annoyance)
