WATCHTOWER
HOME INSPECTIONS

RESIDENTIAL REPORT

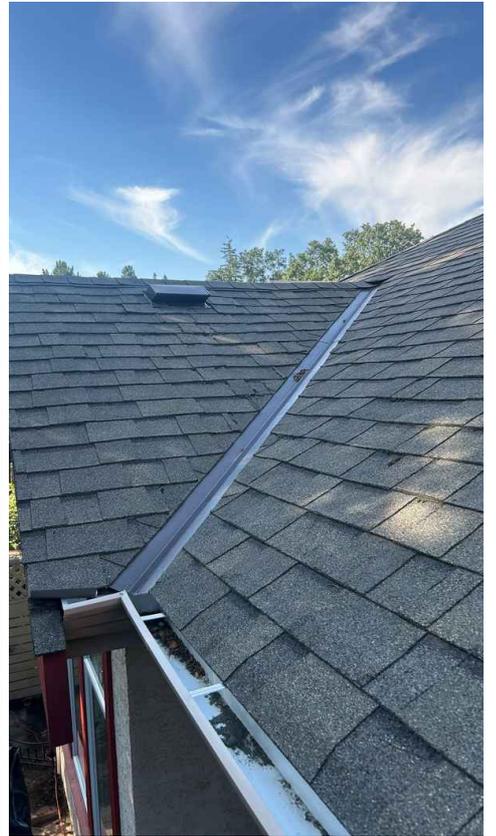
Roof photo

Moderate granular loss

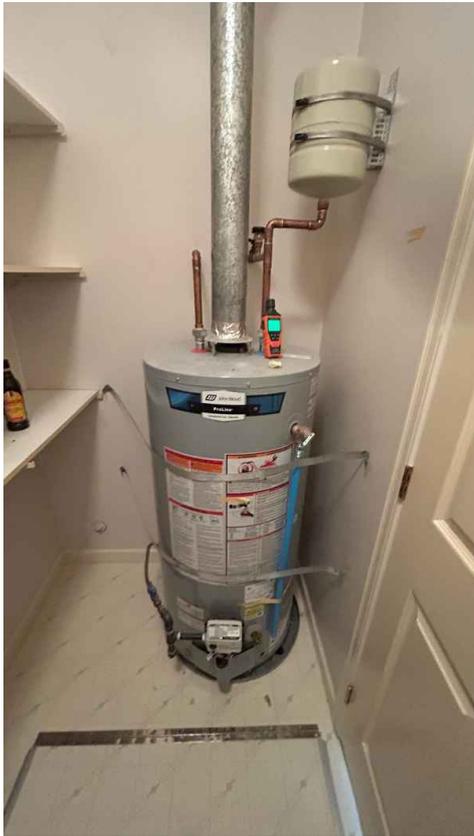
Hot water tank

The home was equipped with a natural gas John Wood hot water tank manufactured in 2023. The unit appeared in good condition at the time of inspection, with no functional issues observed. The only noted concern was that the vent flue was slightly out of alignment with the unit's exhaust outlet; however, testing with a carbon monoxide detector did not indicate any leakage at the time of inspection. Obtaining warranty documentation from the seller is recommended for future reference, and alignment of the venting can be reviewed during routine servicing.

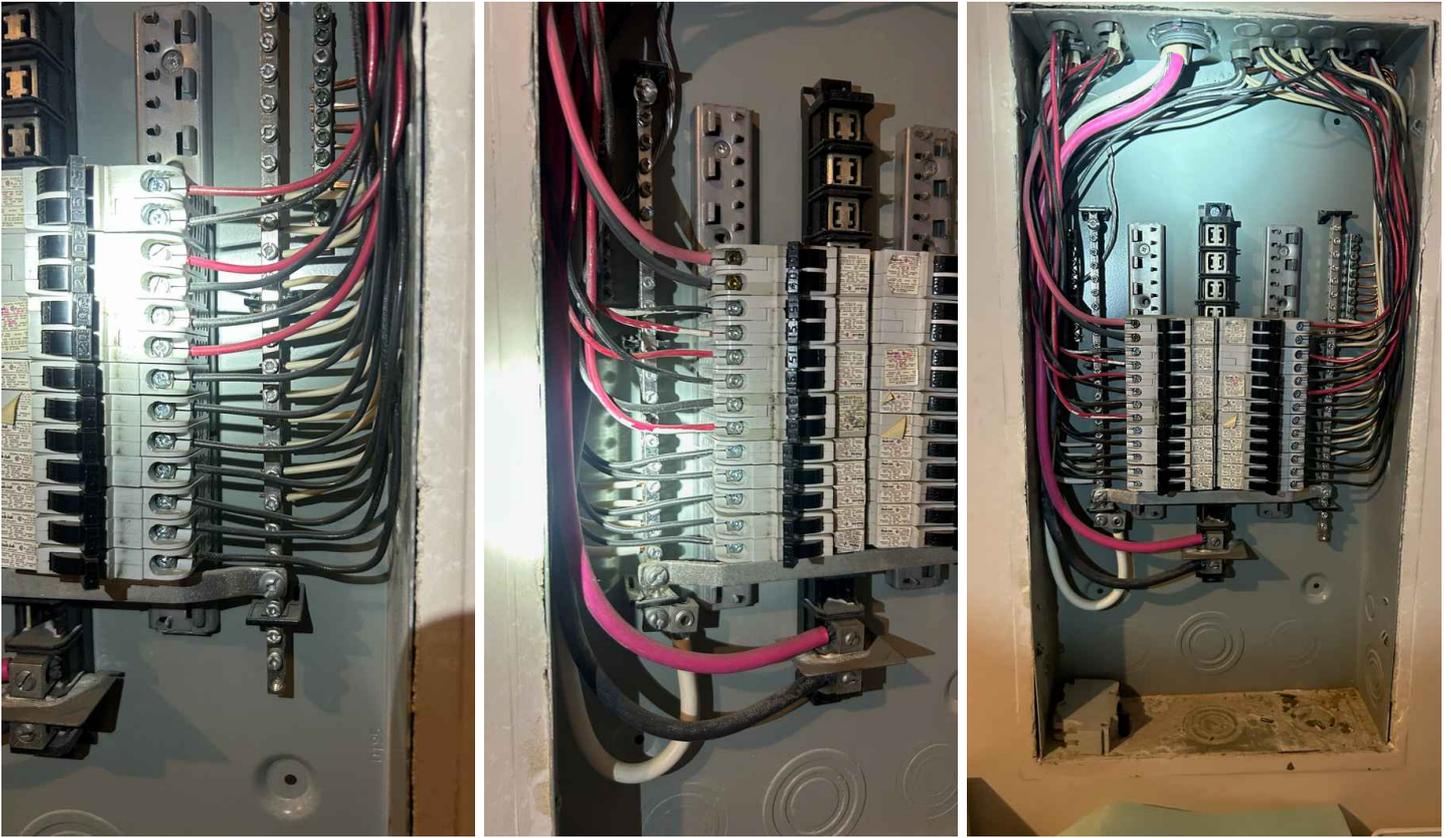
Panel Photos:

The unit's electrical panel did not contain a main shutoff switch, which is likely located in a common area of the complex. As a result, the overall service size could not be confirmed during the inspection. The panel itself appeared in good condition, with wiring neatly arranged and no visible deficiencies noted. The panel was rated for 125 amps, which may reflect the service size, but confirmation would require locating the main disconnect within the common area of the townhouse complex.

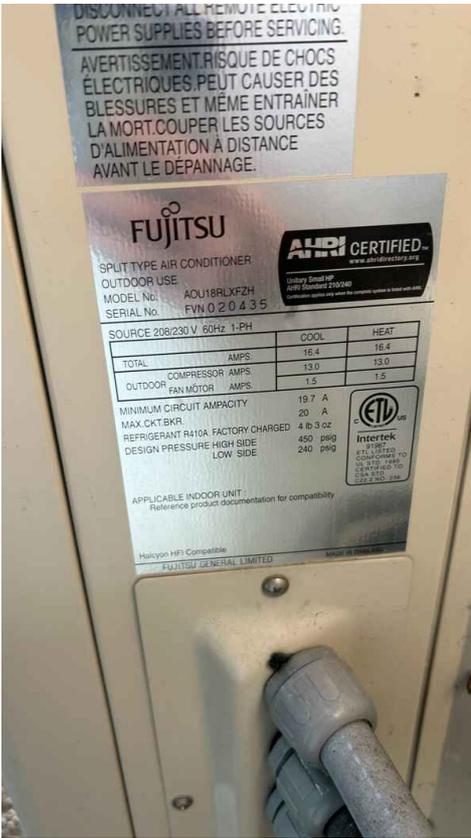
Heat pump unit

The home was equipped with a Fujitsu heat pump. While the exact manufacturing date could not be confirmed from the data plate, the model appears to have been released around 2015, placing the unit at an estimated 8–10 years old (ask seller for exact age of unit). Heat pumps typically have a service life of 15–20 years, depending on maintenance and usage. The unit was operational at the time of inspection. Servicing by a qualified HVAC contractor upon possession is recommended to confirm proper function, improve efficiency, and help extend the remaining lifespan of the system.

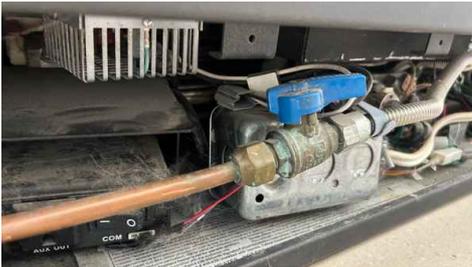
Shutoff at unit

The gas fireplace was operational at the time of inspection and included a shutoff valve at the unit. As with all combustion-producing appliances, routine servicing is important to ensure safe and efficient performance. It is recommended to have the fireplace professionally serviced upon possession and to establish an ongoing maintenance schedule thereafter.
