**WATCHTOWER**  
HOME INSPECTIONS

## RESIDENTIAL REPORT

2400 Dalhousie St  
Victoria, BC V8R 2H6

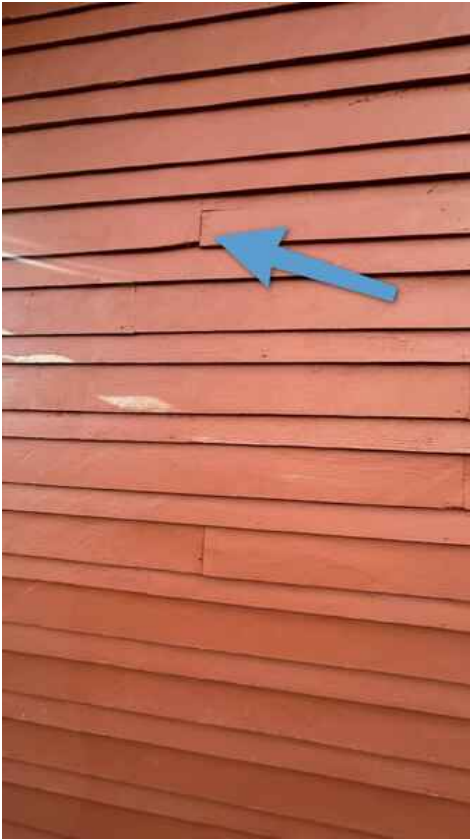
Lifted boards

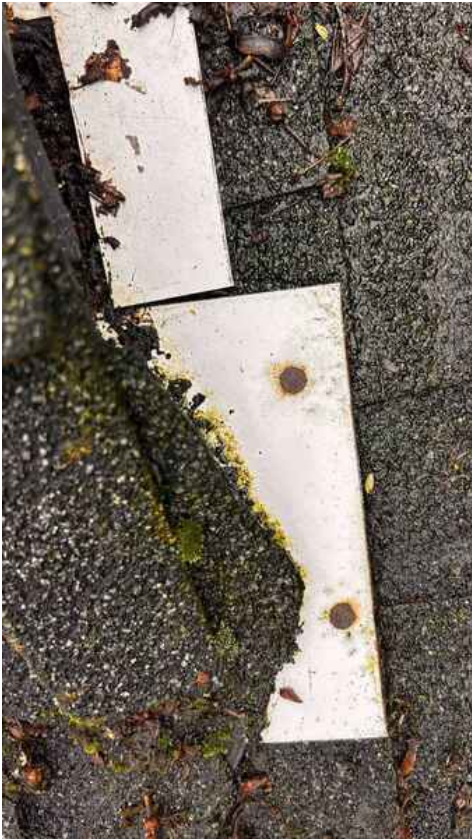
Exposed Fasteners

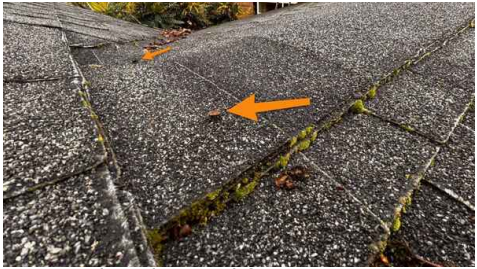
Exposed and proud fasteners

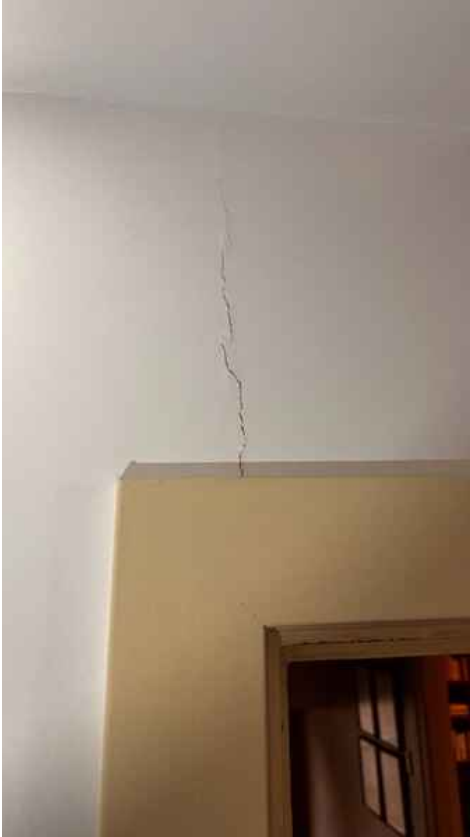
Bathroom door wont shut

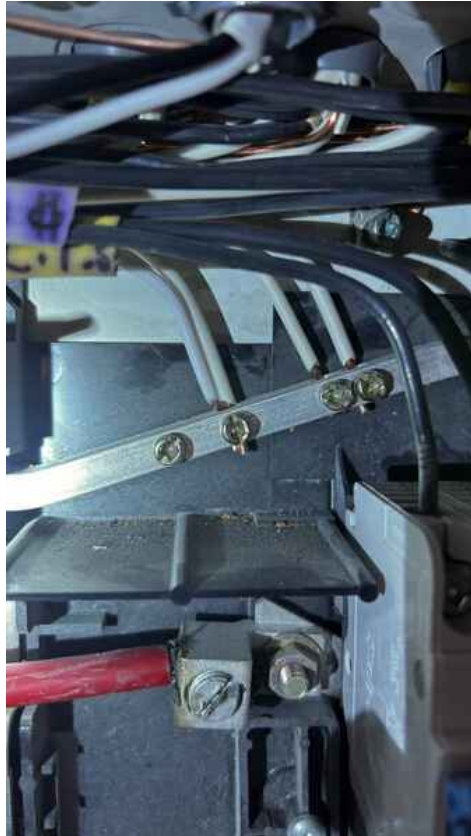
Double tapped neutral (may be ok, depends on panel specs)
