**WATCHTOWER**  
HOME INSPECTIONS

## RESIDENTIAL REPORT

7124 Willis Point Road, BC

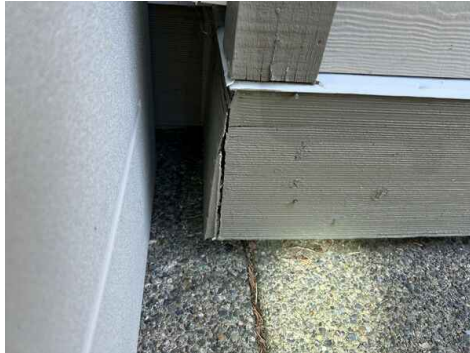
Caulk trim

Routine caulking maintenance is recommended around the exterior of the property, including around windows and in small gaps in the siding. Proper caulking helps prevent moisture intrusion and ensures the home's exterior remains well-sealed. It is advised to inspect and reapply caulking where needed upon possession to maintain the home's integrity.

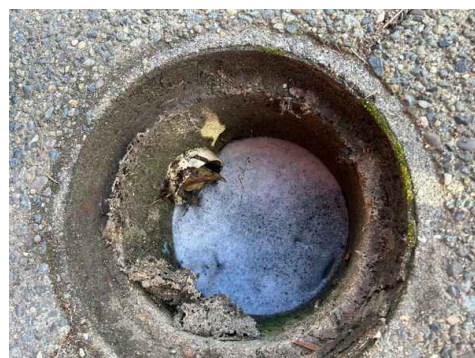
The driveway, which slopes towards the house, has a drain that appears to be functioning effectively. However, the drainpipe is left open and should have a 90° elbow facing downward to prevent debris from clogging the system. This is an easy fix that can be addressed by fitting a 90° elbow over the pipe.

Add 90 degree elbow to improve drain function

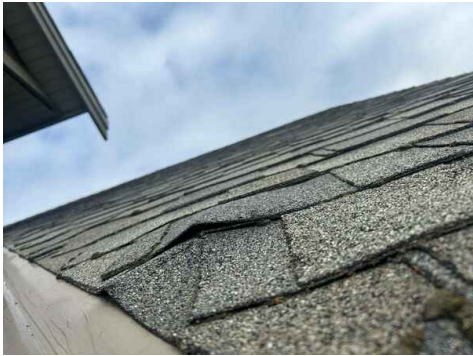
Bulging Shingle

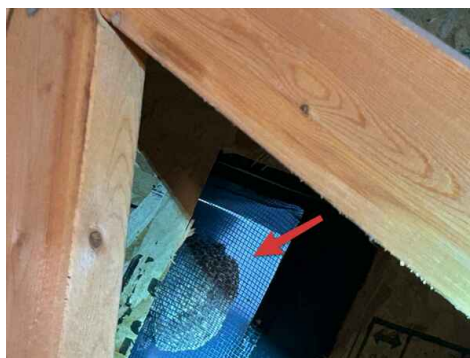
Box vent wasp nest
