**WATCHTOWER**  
HOME INSPECTIONS

## RESIDENTIAL REPORT

APRIL 4, 2024

7124 Willis Point Road, BC

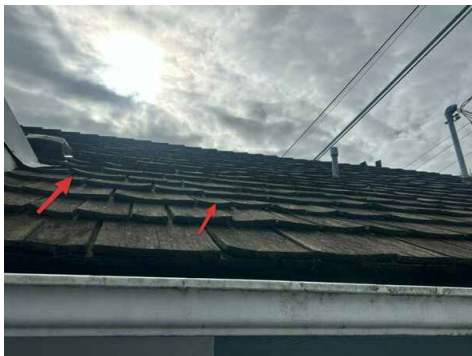
Multiple sections are cupping and lifting

Given the extensive nature of the required repairs, it is strongly advised to have this roof thoroughly assessed by a roofing professional who specializes in wood shingle/shake roofs. Such an assessment will not only provide a detailed overview of the necessary repairs but also offer insight into the ongoing maintenance needed to prolong the roof's lifespan. It's essential to address these concerns promptly upon taking possession of the home to avoid further deterioration and potential leaks.

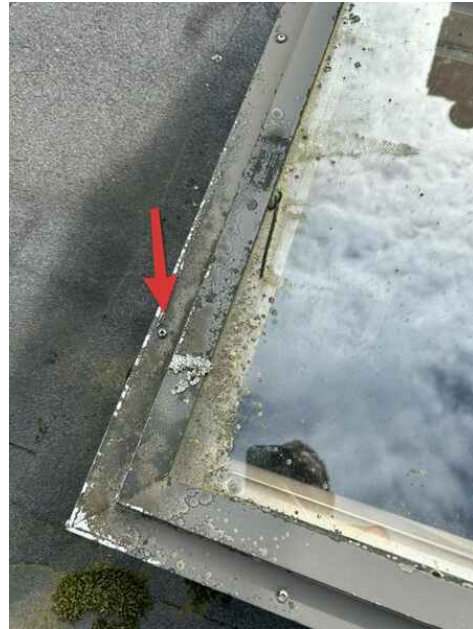
Exposed hardware on skylight, evidence of water pooling

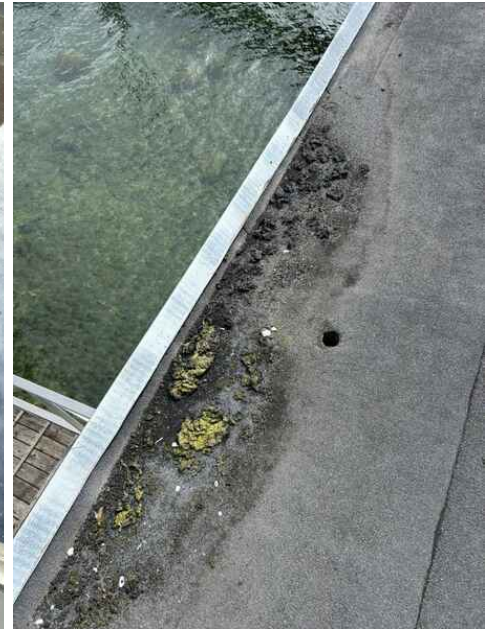
Pooling evidence = Drainage issues

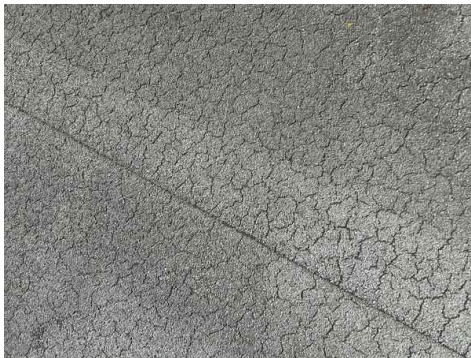
Extensive alligatoring

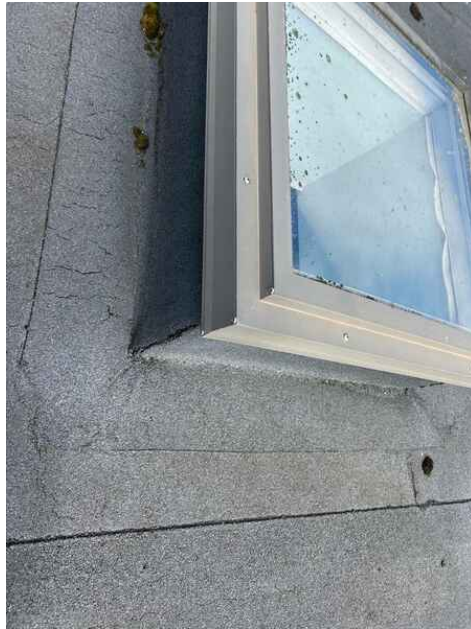
Maintenance is key for longevity

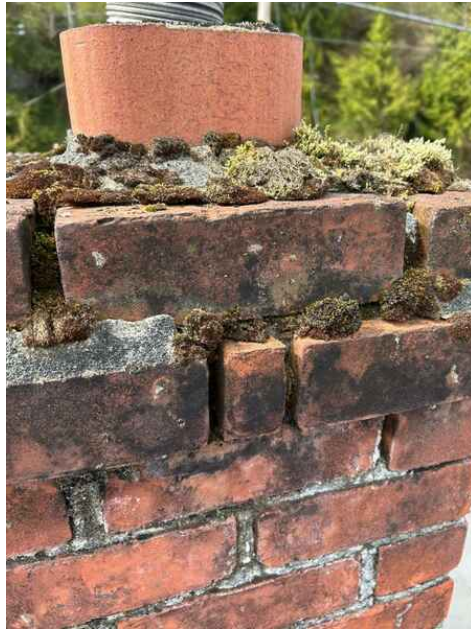
Repoint of mortar and possible rebuild needed

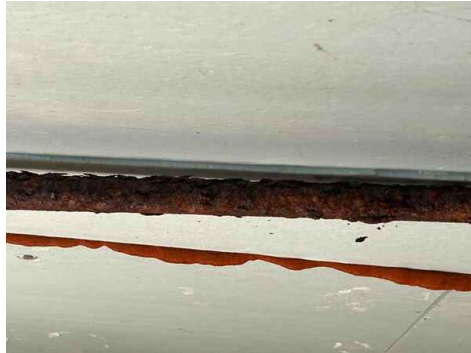
The gas line located underneath the home shows severe corrosion due to its marine environment, raising concerns about potential gas leaks. While the outdoor setting reduces the risk of explosion, it remains essential to address this issue promptly to ensure safety and uninterrupted gas service. Contact a certified professional immediately to inspect and repair the corroded gas line, preventing any potential hazards and maintaining a safe environment around the home.

Severe corrosion

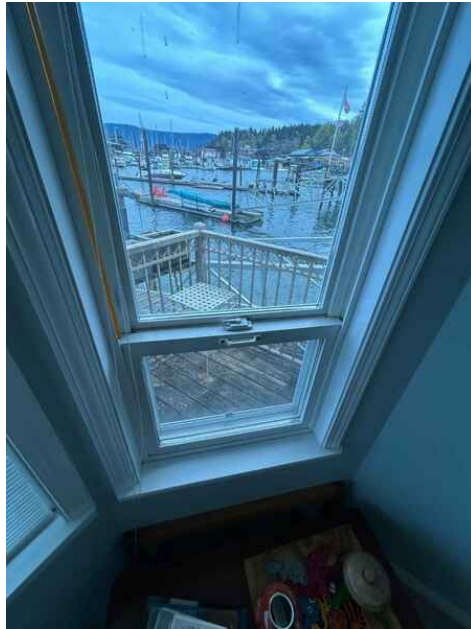
Hung window needs to be pushed a certain way to close
