WATCHTOWER
HOME INSPECTIONS

RESIDENTIAL REPORT

7124 Willis Point Road, BC

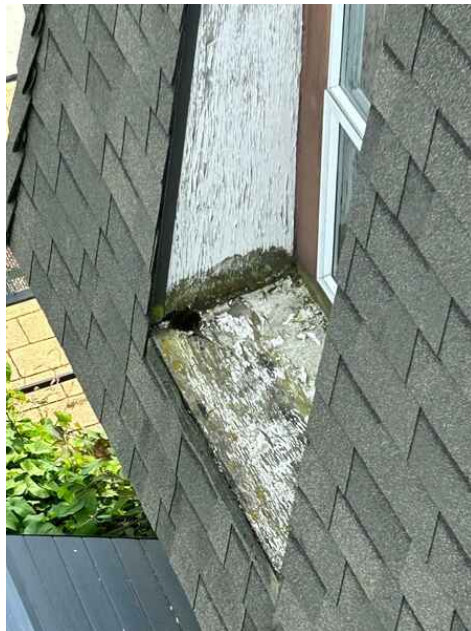
Possible entry point for water due to deep window well design

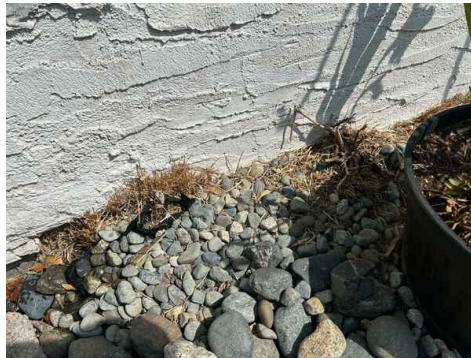
Siding and grade touching

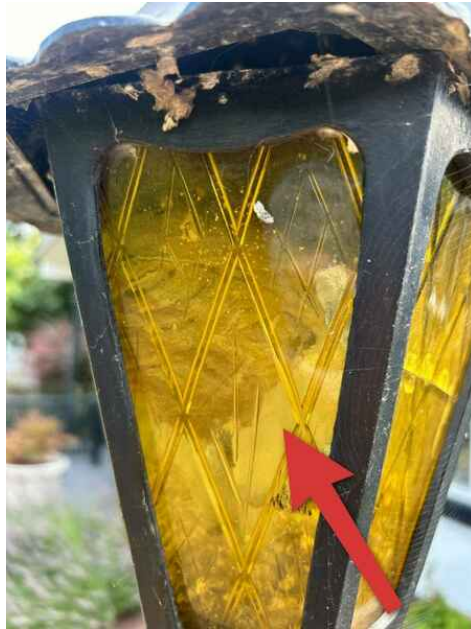
Wasp nest

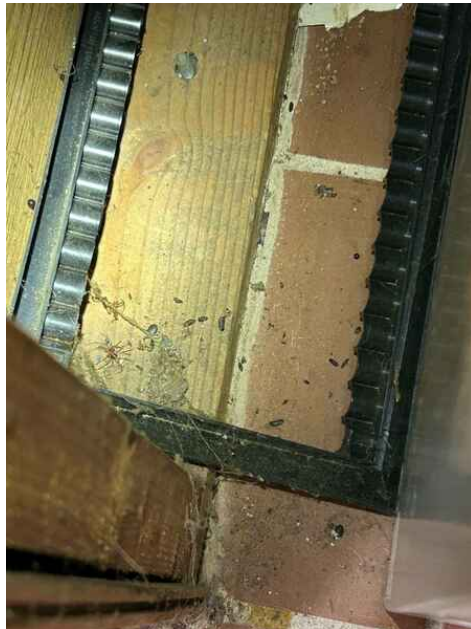
Mice droppings
