WATCHTOWER HOME INSPECTIONS

RESIDENTIAL REPORT

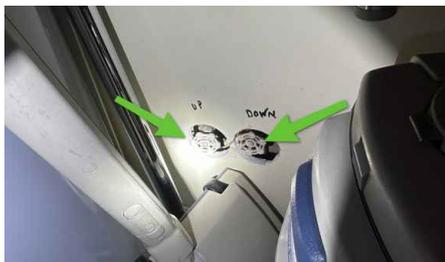
Washer Dryer/ Utility Room

The valve is not operated to test its functionality.

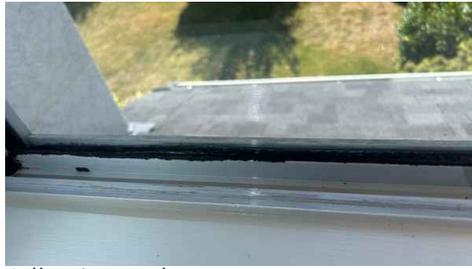
Lost seal
