WATCHTOWER HOME INSPECTIONS

RESIDENTIAL REPORT

1: INSPECTION DETAILS

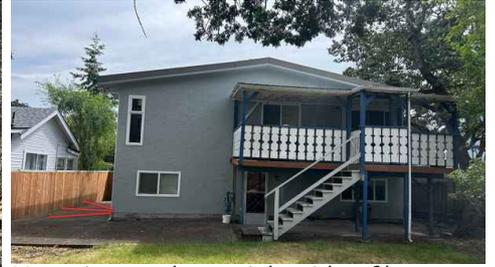
Negative grade on right side of house

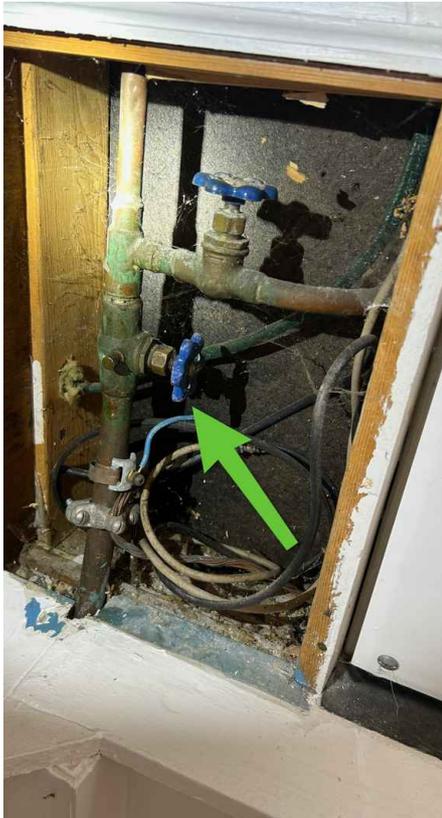
Near electrical panel

The valve is not operated to test its functionality.

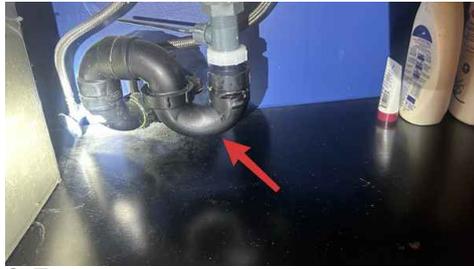
S-Trap

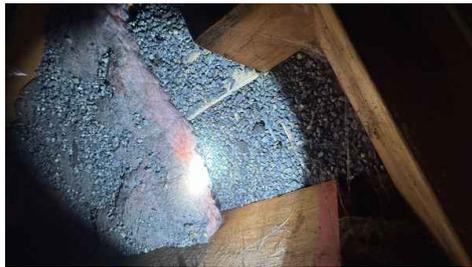
Pebbles
