WATCHTOWER
HOME INSPECTIONS

RESIDENTIAL REPORT

1: INSPECTION DETAILS

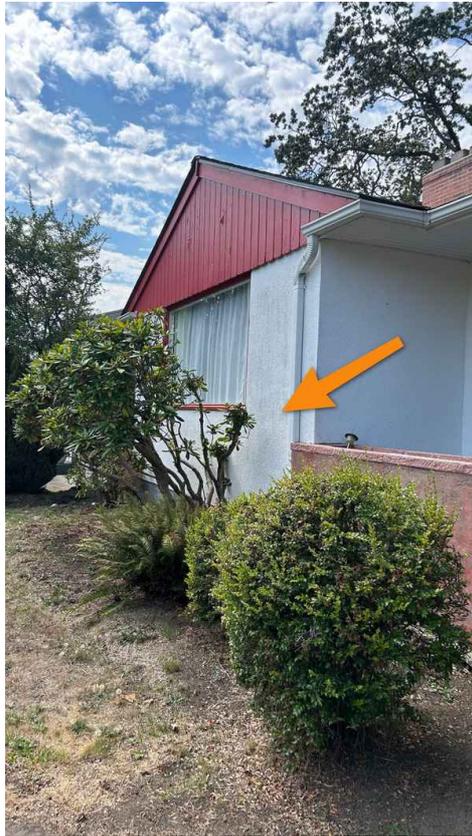
The exterior stucco showed multiple areas of cracking and general degradation. The front-facing wood siding also displayed peeling paint, likely due to exposure from the limited roof overhang at the front of the home. In addition, vegetation was noted in contact with the siding in several locations. Stucco cracking and peeling paint can allow moisture intrusion and accelerate deterioration if not addressed, while vegetation contact restricts airflow and promotes wear. Maintenance is recommended, including sealing stucco cracks, repainting the exposed siding, and trimming vegetation back from the home's exterior.

Tree too close to house

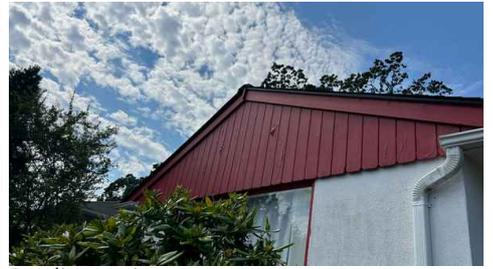
Peeling paint

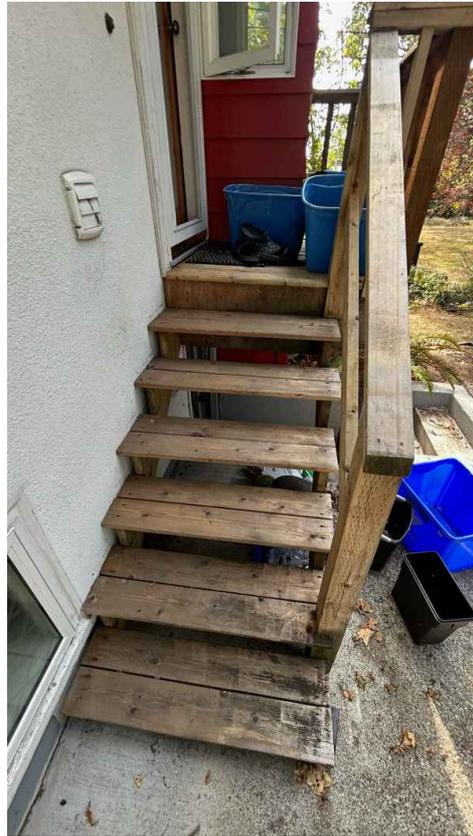
Insuff handrail, treads sag

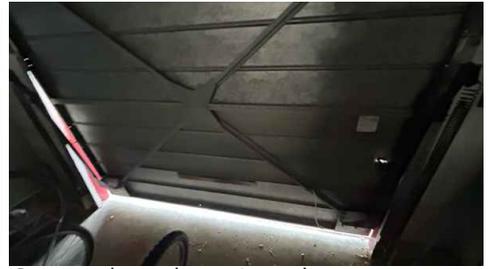
Garage door doesn't seal

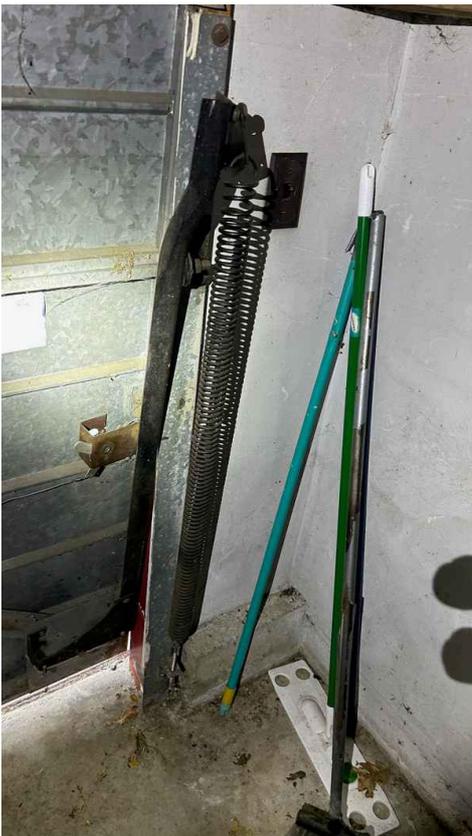
Springs under tension

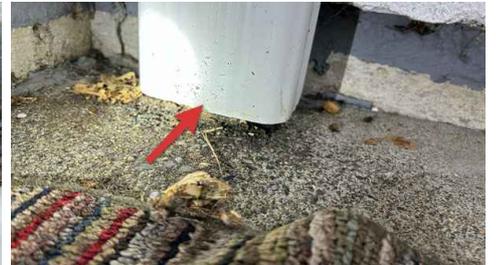
Downspout bigger than drain

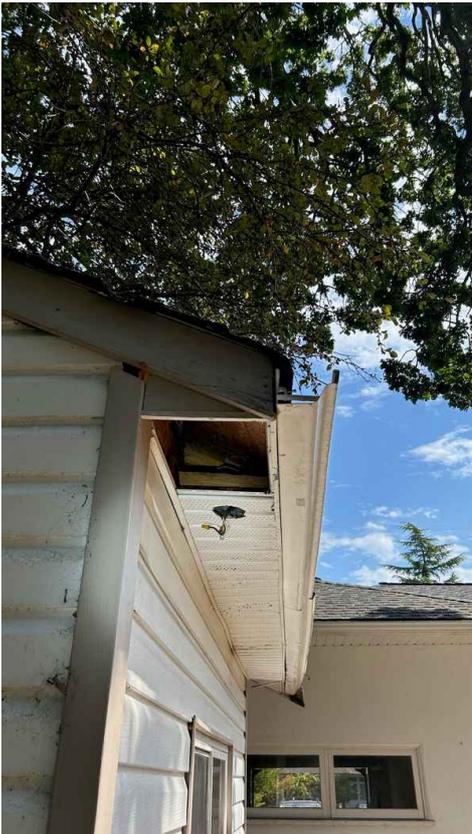
Holes in soffits

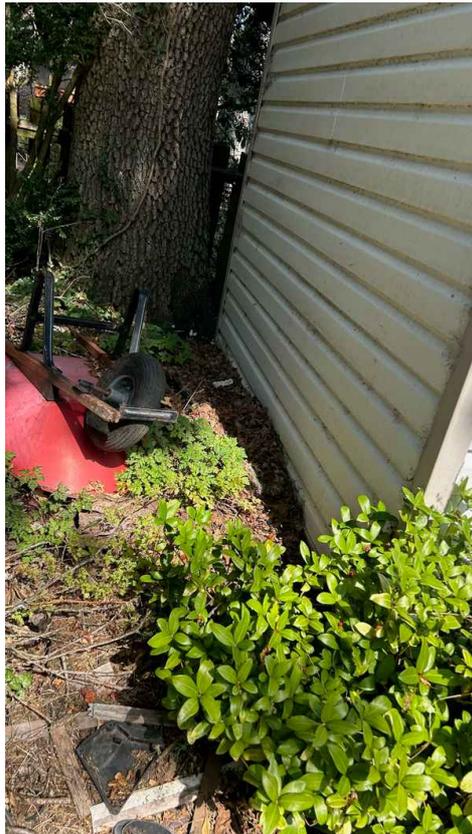
Siding covered in grade

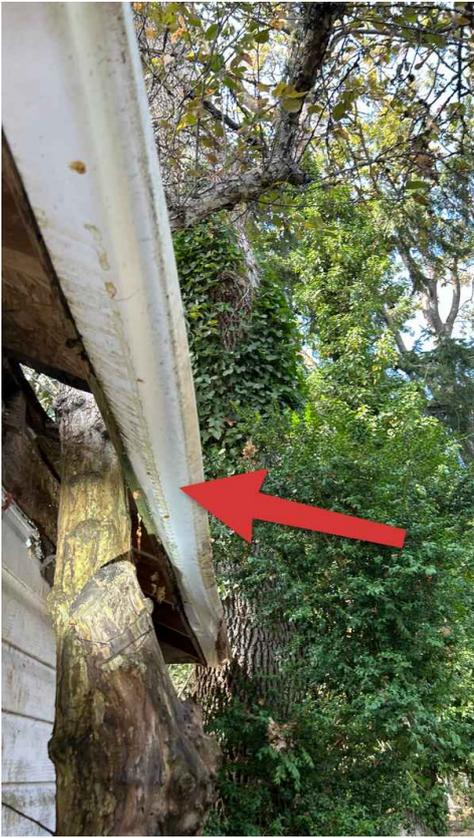
Tree growing through soffit

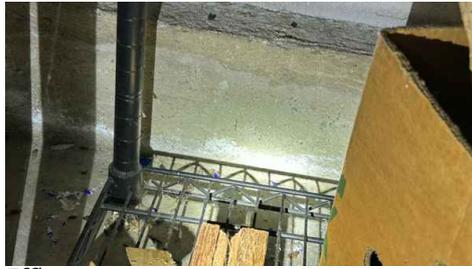
Efflorescences

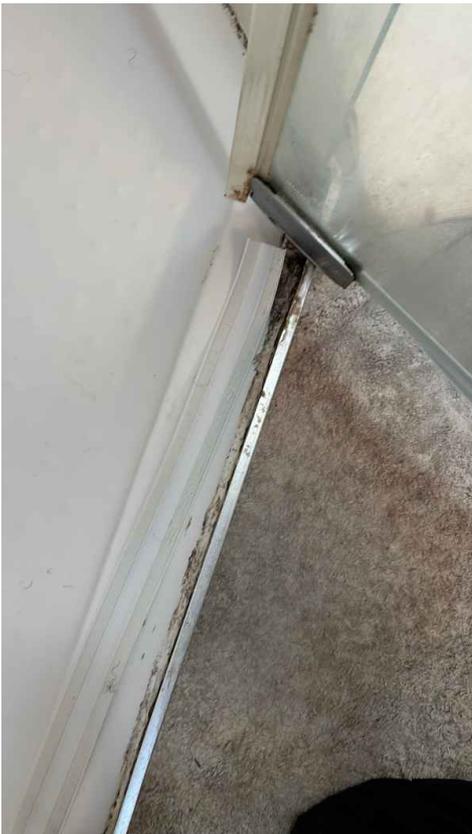
Poor seal

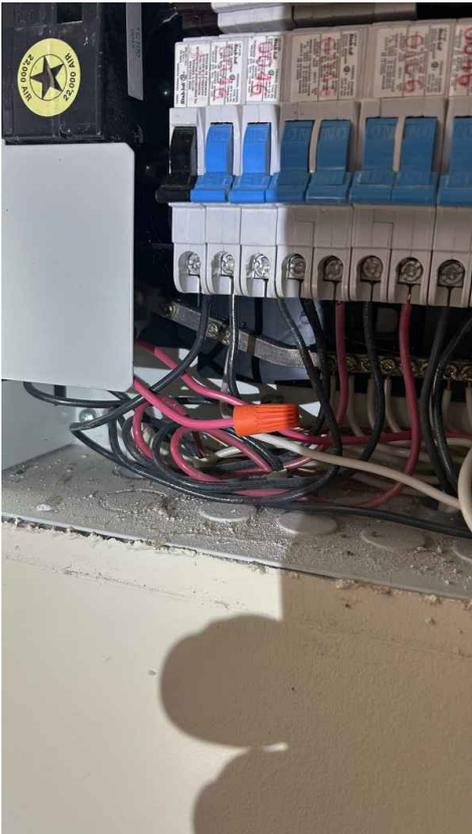
Terminated conductor

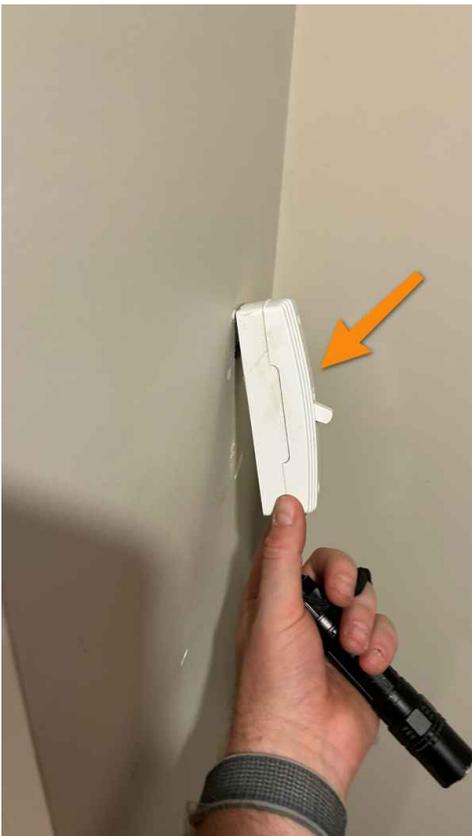
Unattached switch

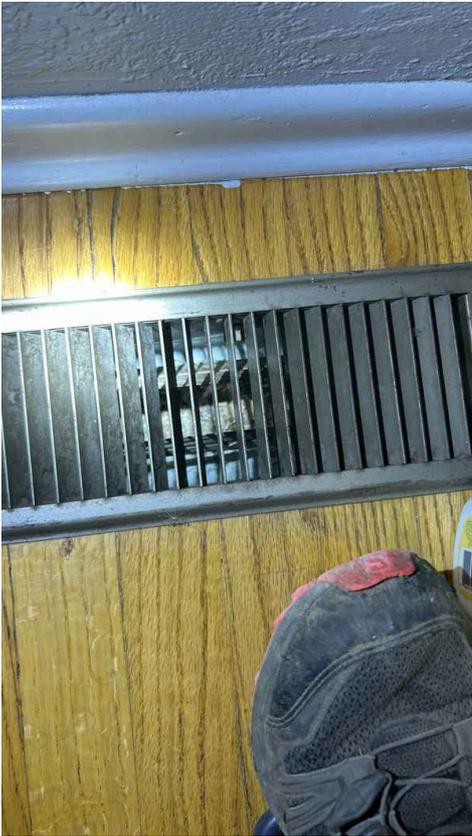
Dirty register

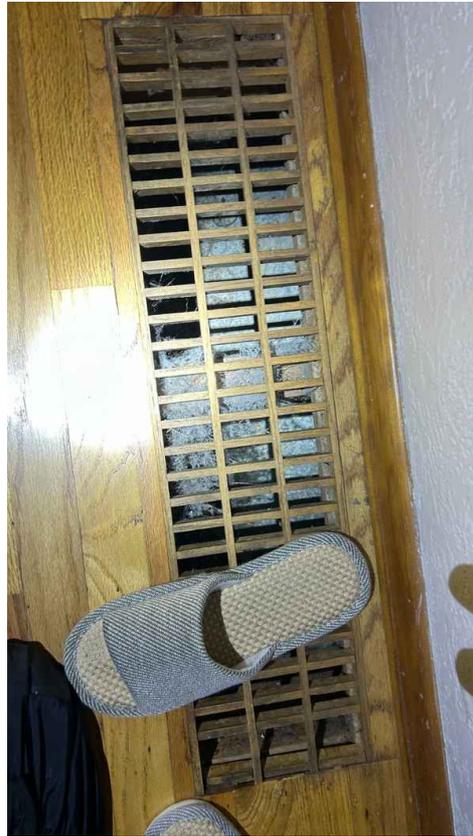
Dirty return duct
