WATCHTOWER
HOME INSPECTIONS

RESIDENTIAL REPORT

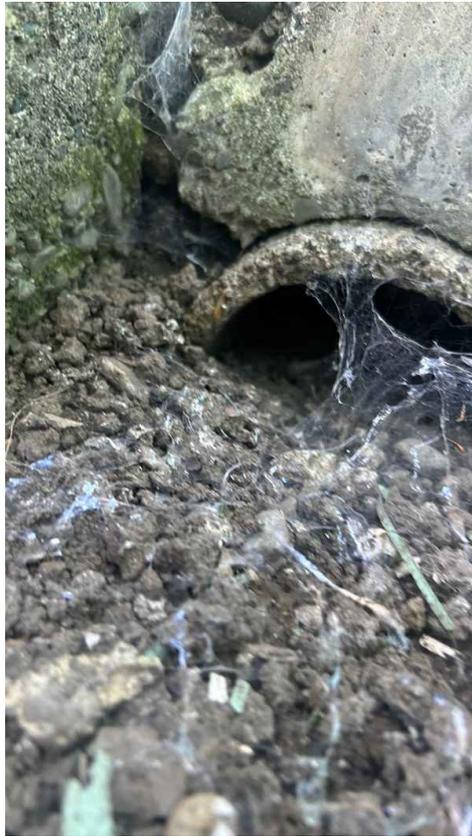
Scope perimeter drains

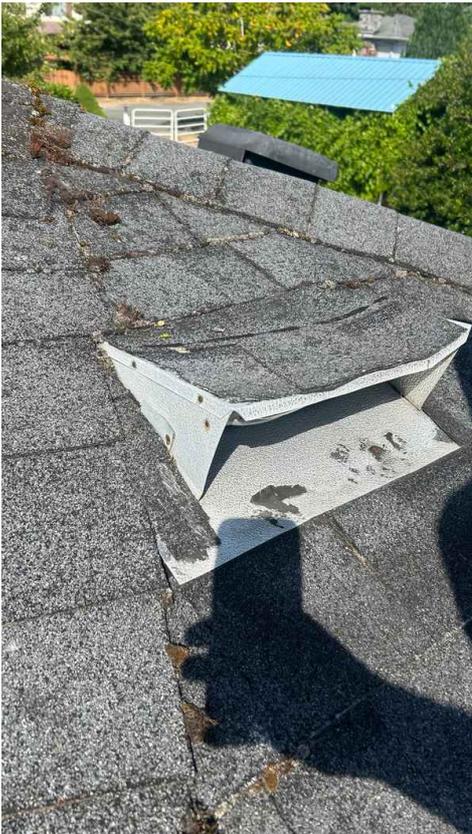
Poorly installed vent

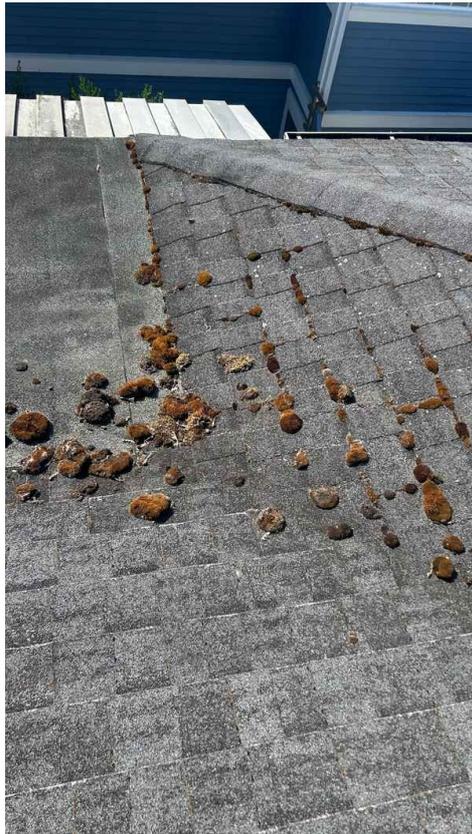
Moss build up

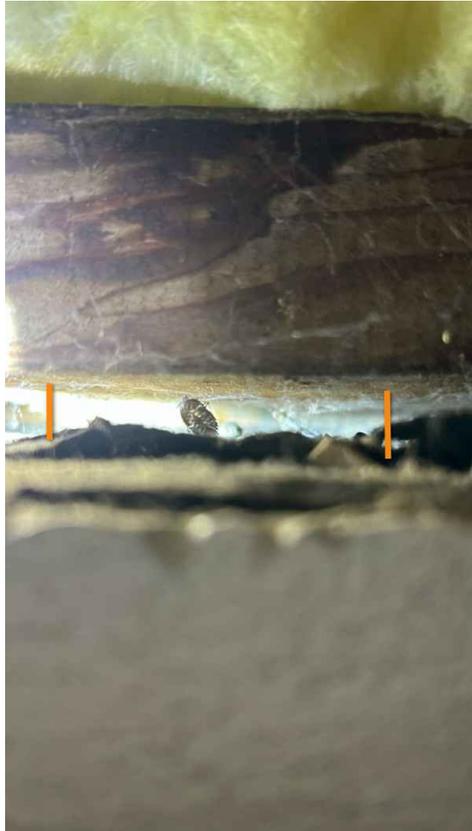
Sill gap

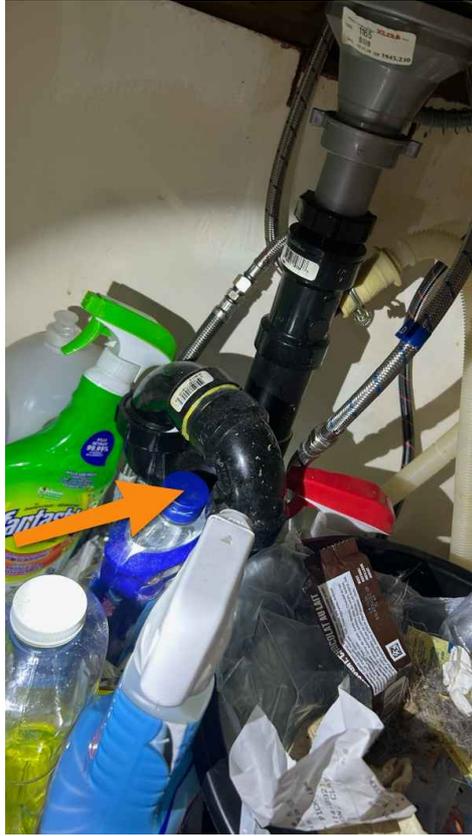
S trap

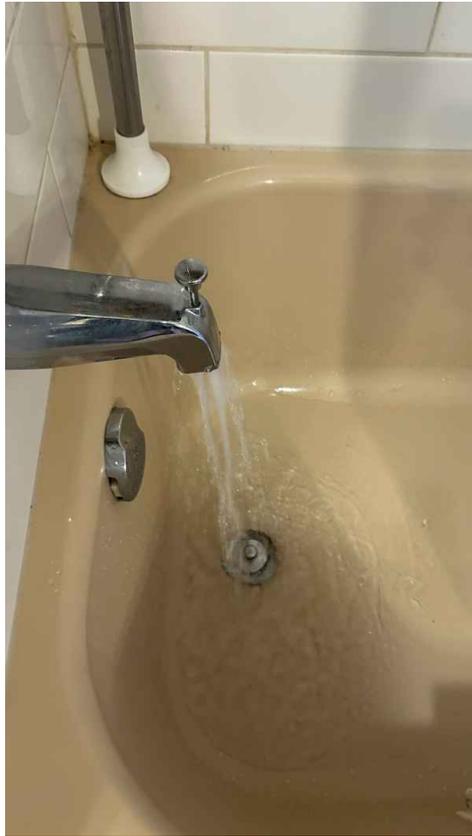
Diverter Doesn't divert fully

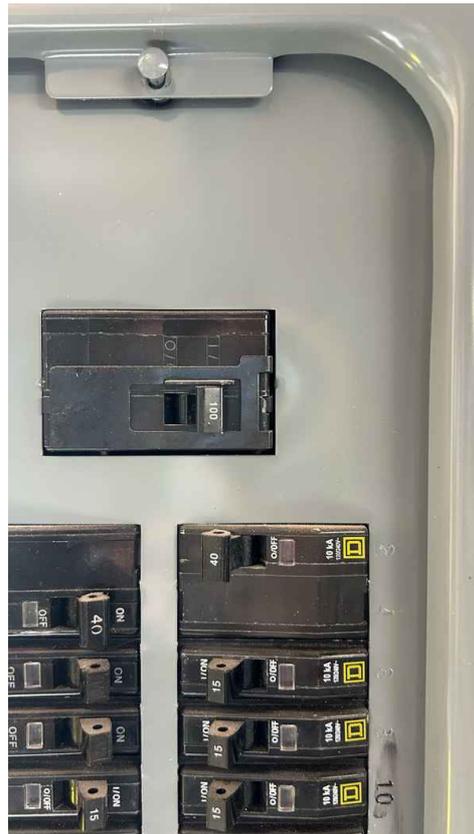
100 A service may be undersized

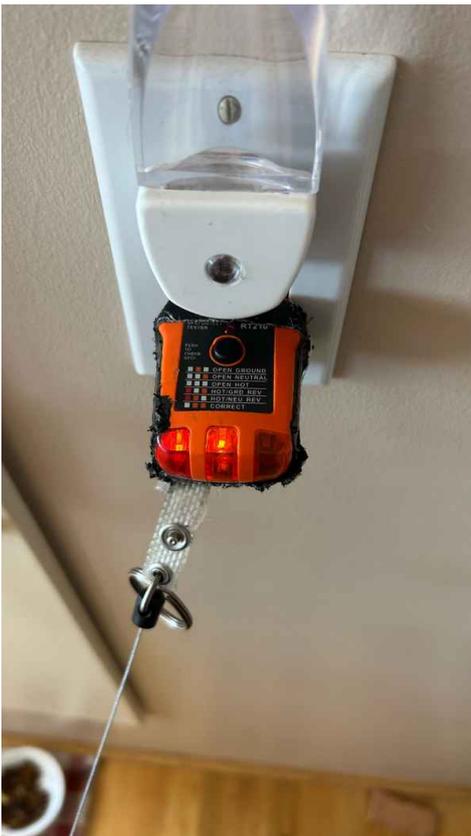
Hot neu Reversed

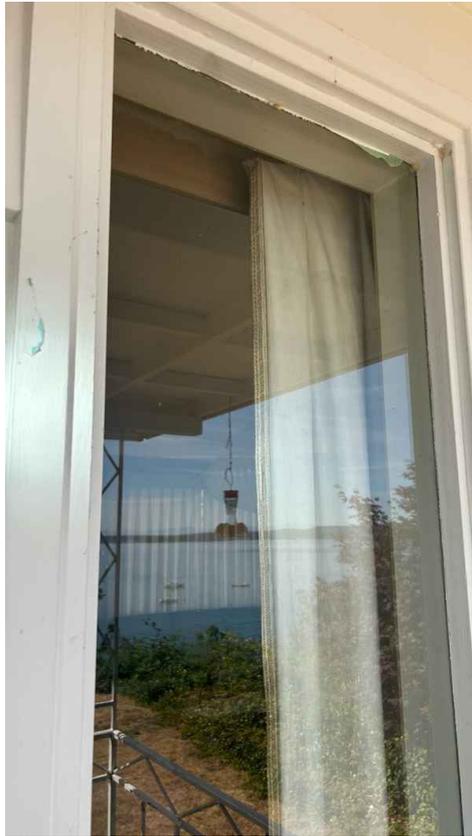
Single paned window

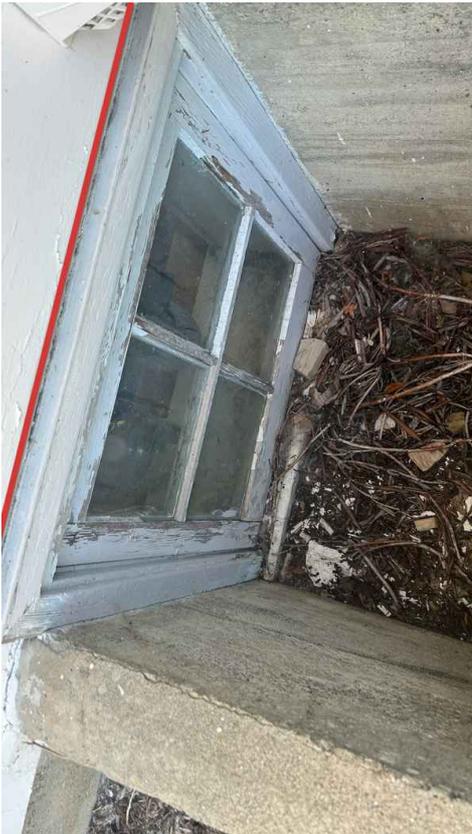
Single pane awning, no flashing

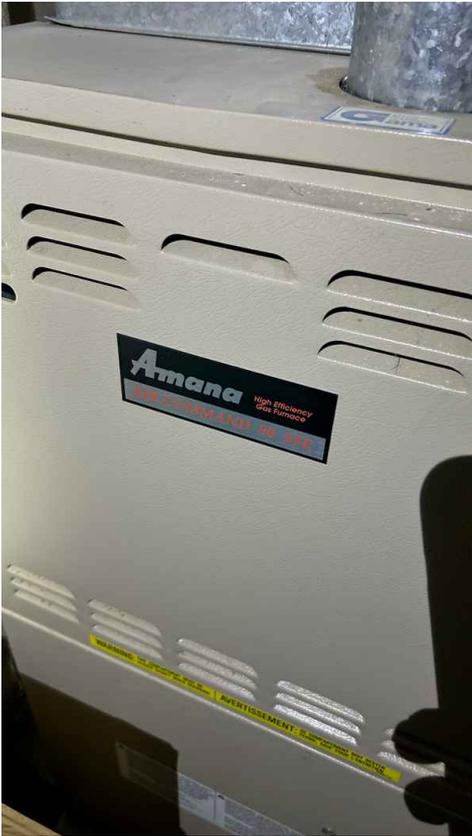
ASBESTOS TAPE ON DUCTING AND LACK OF INSULATION

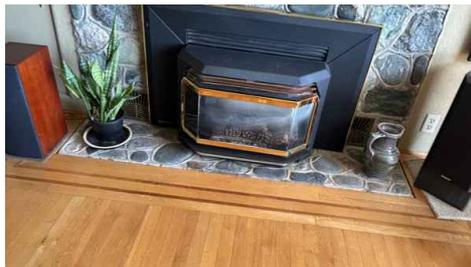
Service unit

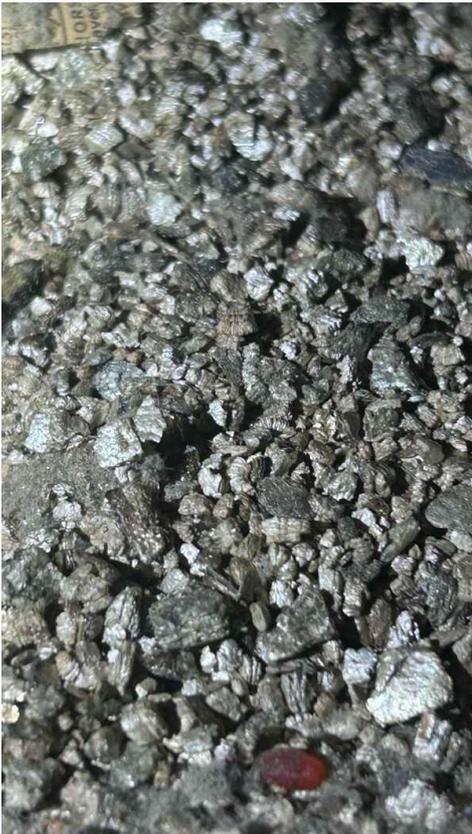
Vermiculite
